INTERSTATE COMMERCE COMMISSION

IN RE INVESTIGATION OF AN ACCIDENT WHICH OCCURRED ON THE NEW YORK CENTRAL AND MICHIGAN CENTRAL RAIL- ROADS AT PORTER, IND ON FEBRUARY 27 1921

MARCH 14 1921

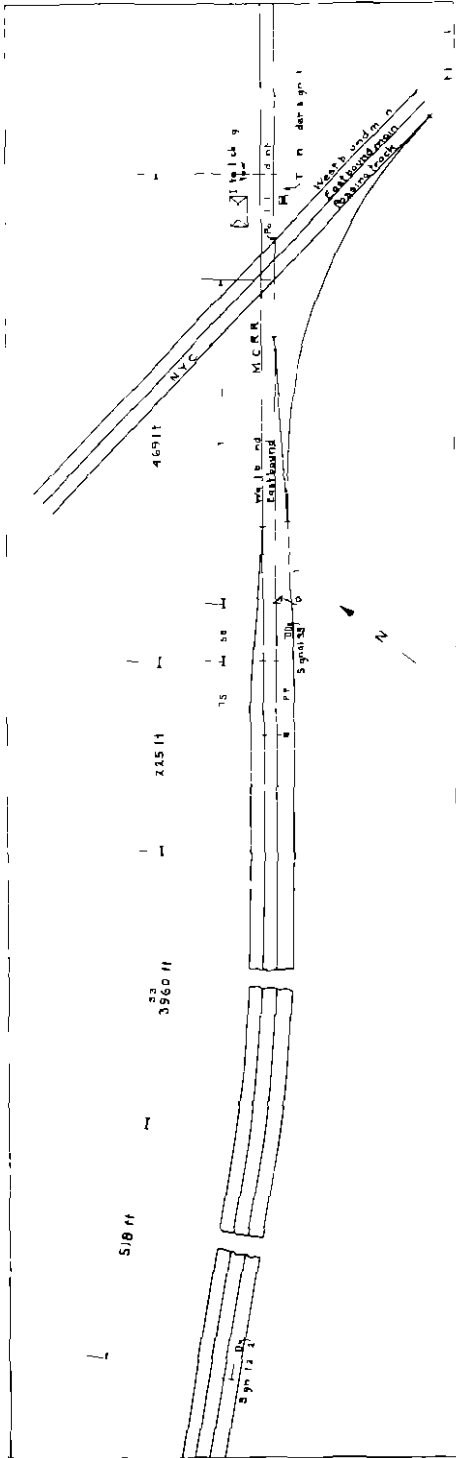
Diagram showing, tracks and signals involved

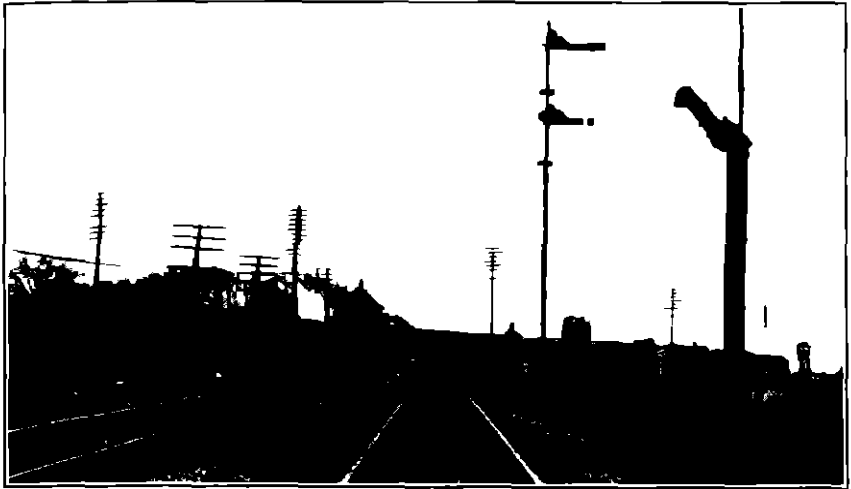
FIG. 3.—Signal 35, New York Central train on crossing.

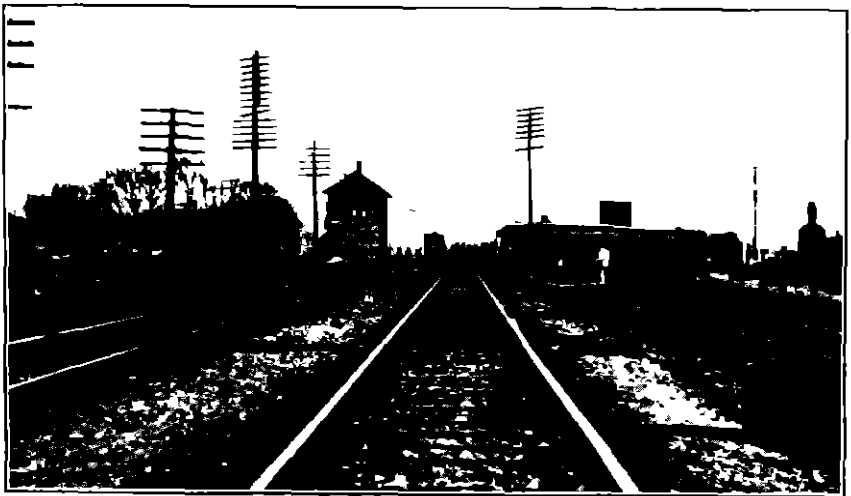
FIG. 4.—Drift east of signal 35.
