INTERSTATE COMMERCE COMMISSION

REPORT OF THE CHIEF OF THE BUREAU OF SAFETY IN RE INVESTIGATION OF AN ACCIDENT WHICH OCCURRED ON THE PHILADELPHIA & READING RAILWAY NEAR WOODMONT, PA , ON DECEMBER 5, 1921

DECEMBER 23, 1921

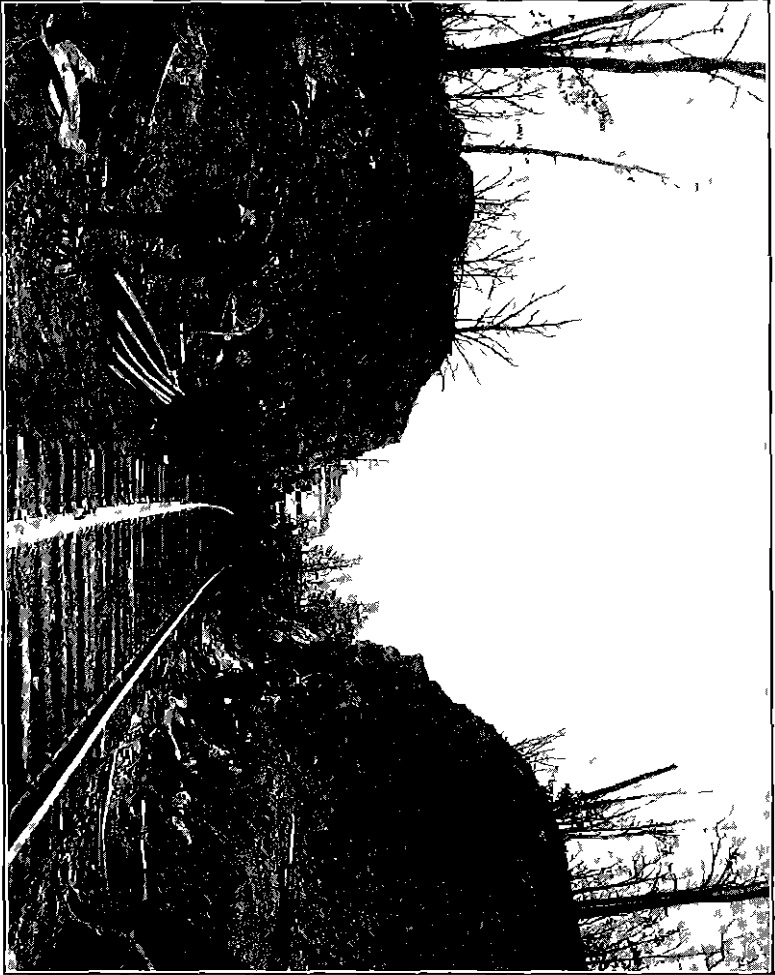
The point of collision was about 1.3 miles east of Bryn Athyn, and 0.8 mile west of Woodmont, it occurred in the middle of a rock cut about 200 feet in length and having a maximum depth of 30 feet. The cut is located on a compound curve to the south about 1,000 feet in length, having a maximum curvature of 7 degrees. On account of this curve and cut, the range of vision was much restricted, and there was little opportunity for either engineer to see the opposing train. The weather was clear at the time of the accident, which occurred at about 7:55 a. m.

FIG 4—LOOKING EAST TOWARD POINT OF ACCIDENT.

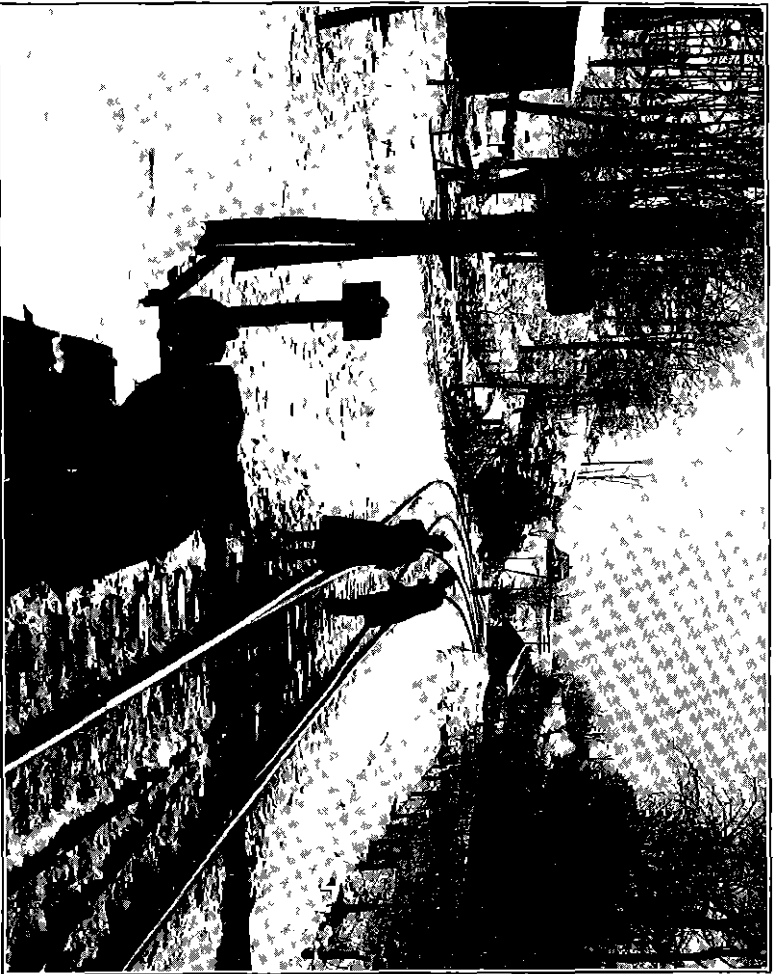
FIG 5—LOOKING WEST TOWARD STATION AT BYRN ATHYN SPUR TRACK ON LEFT
