✓ RAILROAD ACCIDENT INVESTIGATION

CHICAGO, BURLINGTON AND QUINCY RAILROAD COMPANY

MONTGOMERY, ILLINOIS

SEPTEMBER 27, 1964

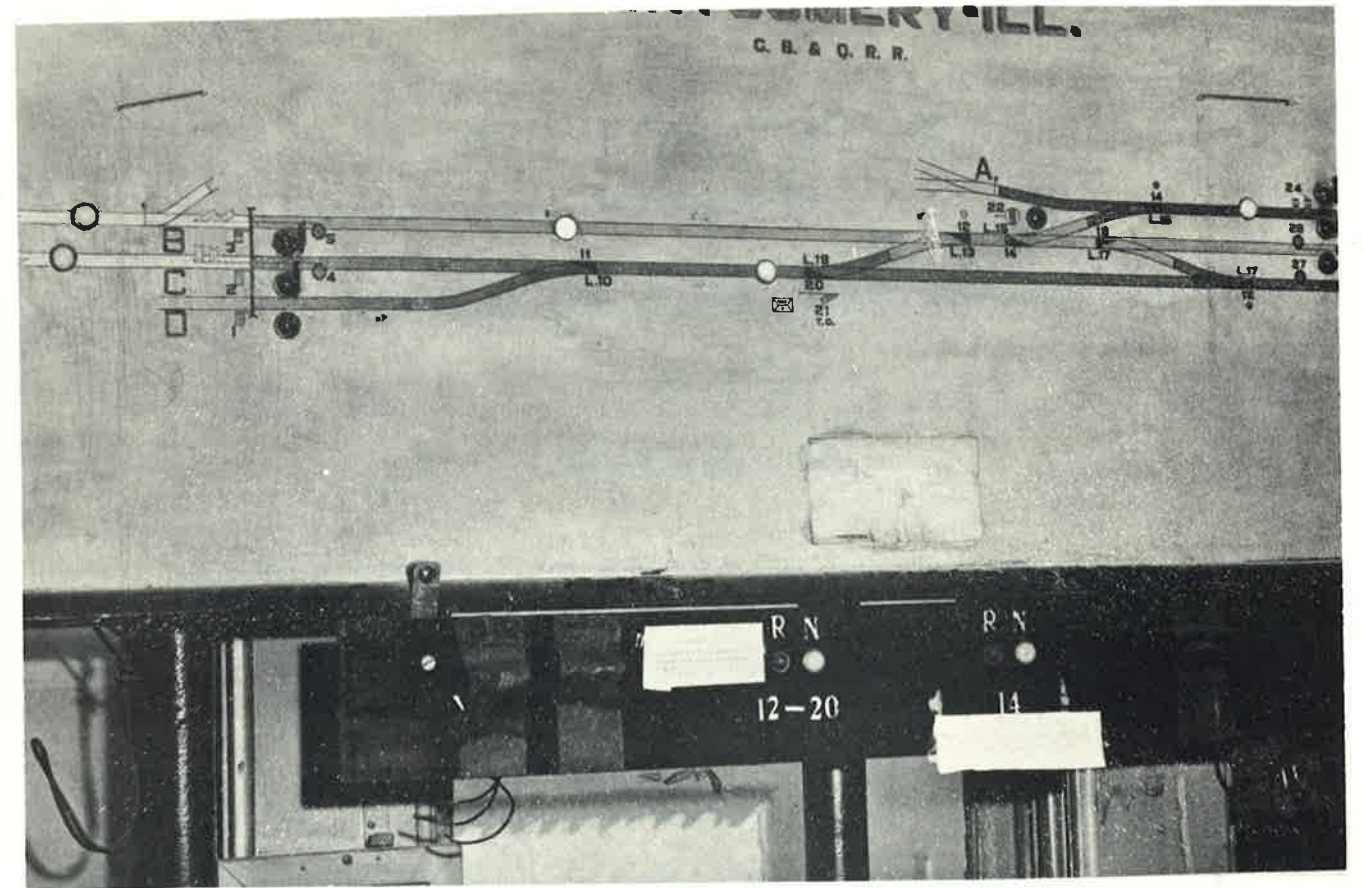
Track model board at Montgomery interlocking. Indicator lights associated with switches 12, 20 and 14 on panel below model board. Handwritten notice involved is attached to panel below switch 14 indicator lights on the right.

From all indications, the interlocking operator failed to heed the handwritten notice attached to the panel bearing the indicator lights associated with switch 14, and operated locking lever 15 and cleared signal 5-3 while the red indicator light was indicating that switch 14 was still in reverse position. However, had the interlocking system conformed to the Commission's regulations, the operator would not have been able to clear signal 5-3 while switch 14 was in improper position and the accident probably would have been averted.

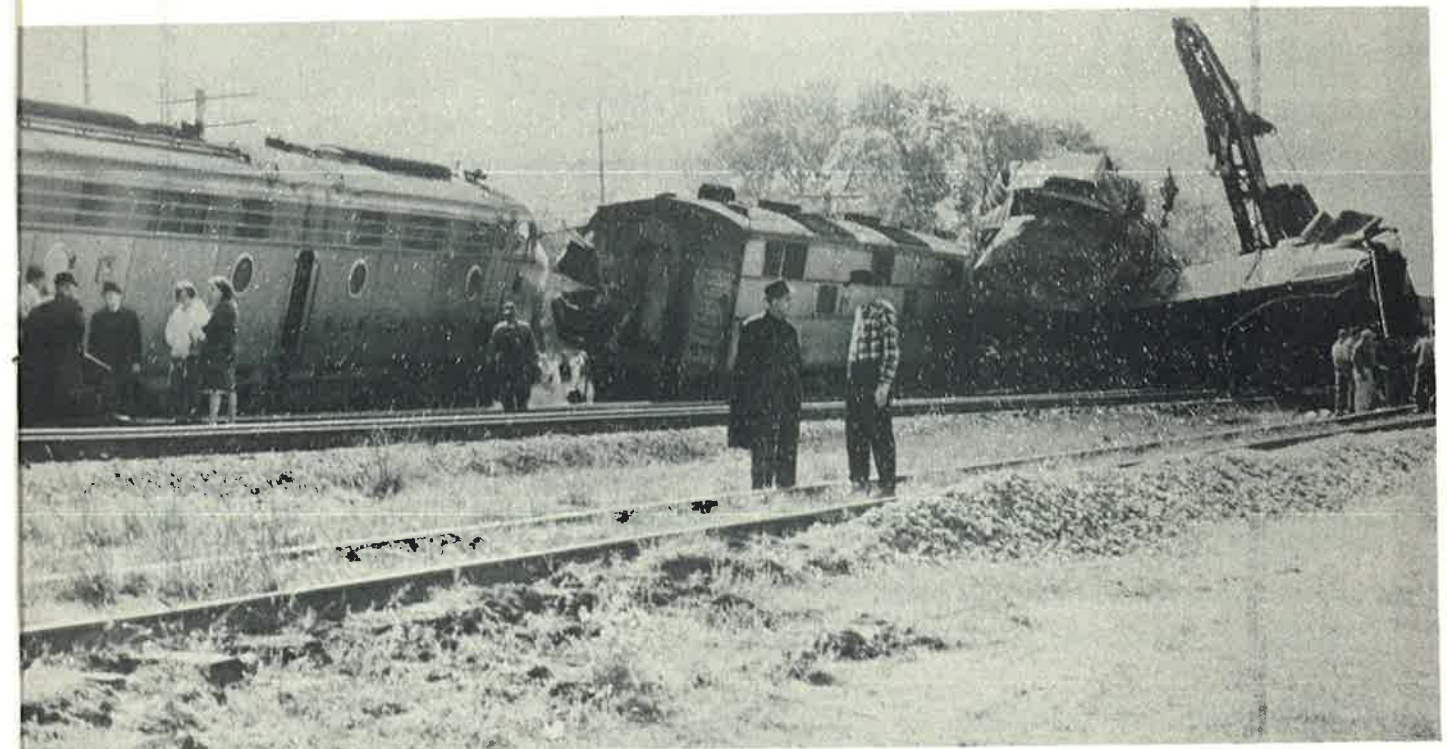
At right, first diesel-electric unit of No. 3 shown overturned with first diesel-electric unit of Extra RI 656 East on top. Second and third locomotive units of No. 3 at left and center.

No. 3 stopped with the front end about 23 feet west of the accident point. All trucks of the three diesel-electric units and the 1st to 12th cars, inclusive, were derailed. Separations occurred at both ends of the 2nd diesel-electric unit, at both ends of the 2nd, 3rd, 4th, 5th, 6th and 9th cars. The 1st diesel-electric unit overturned onto its left side and stopped across tracks No. 1 and No. 2 at right angles to the Streator Branch main track, and with the front end underneath the front end of the 1st diesel-electric unit of Extra RI 656 East. The 2nd unit stopped upright with the front end on the structure of the Streator Branch main track opposite the 1st unit, and with the rear end between the Streator Branch main track and track No. 2. The 3rd unit stopped upright, diagonally across the

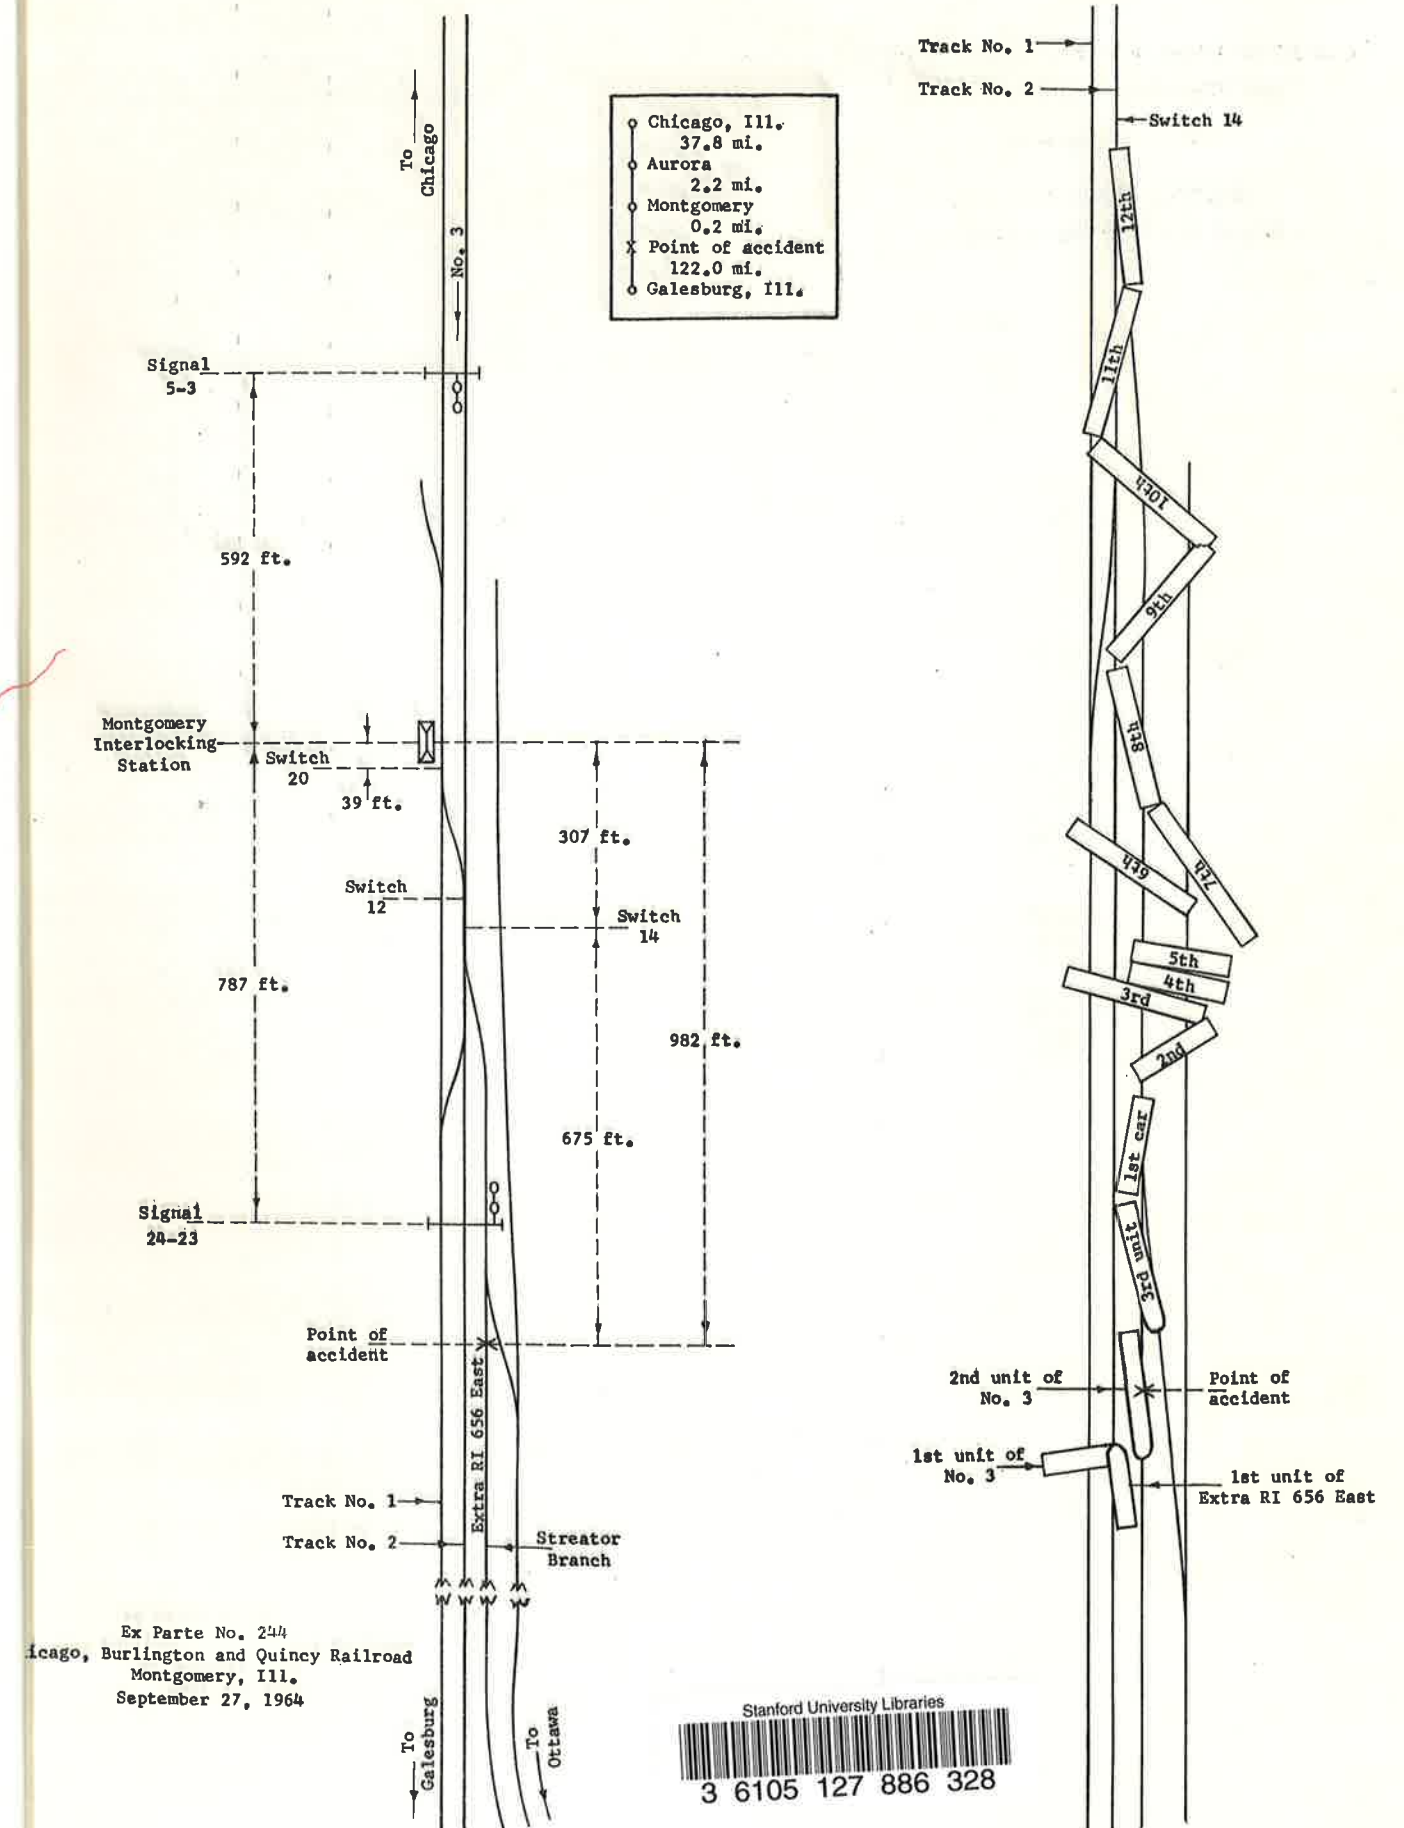
The Streator Branch, a single-track line, diverges southwestward from track No. 2 at switch 14 of the interlocking. This switch is facing point for westbound movements on track No. 2 and is 307 feet west of the interlocking station. A crossover connects tracks No. 1 and No. 2 within the interlocking. Its switches are designated as No. 12 and No. 20. The latter switch is facing point for westbound movements on track No. 1 and is 39 feet west of the interlocking station. Other switches and tracks are at the interlocking as indicated in the sketch at the rear of this report.

Streator Branch main track with the front end a few feet south of the rear end of the 2nd unit, and with the rear end on the north side of the Streator Branch main track. The derailed cars stopped in various positions on or across the track structures near the accident point as indicated in the sketch at the back of this report. The 2nd, 4th and 5th cars overturned and stopped on their sides. The 3rd car stopped in a 45-degree leaning position to the west. The 1st diesel-electric unit was destroyed. The other 2 locomotive units, the 3rd car, and the 6th to 11th cars, inclusive, were heavily damaged. The other 5 derailed cars were somewhat damaged.
