National Transportation Safety Board  
Washington, D.C. 20594  
Railroad Accident Brief

Railroad Accident Number:	ATL-00FR-005
Rail System:	Metropolitan Atlanta Rapid Transit Authority (MARTA)
Train:	Unscheduled train 166
Accident Type:	Train striking bucket of self-propelled lift containing two contract workers
Location:	MARTA Lenox rail transit station in Atlanta, Georgia
Date and Time:	April 10, 2000, about 2:30 a.m.
Fatalities/Injuries:	Two fatalities

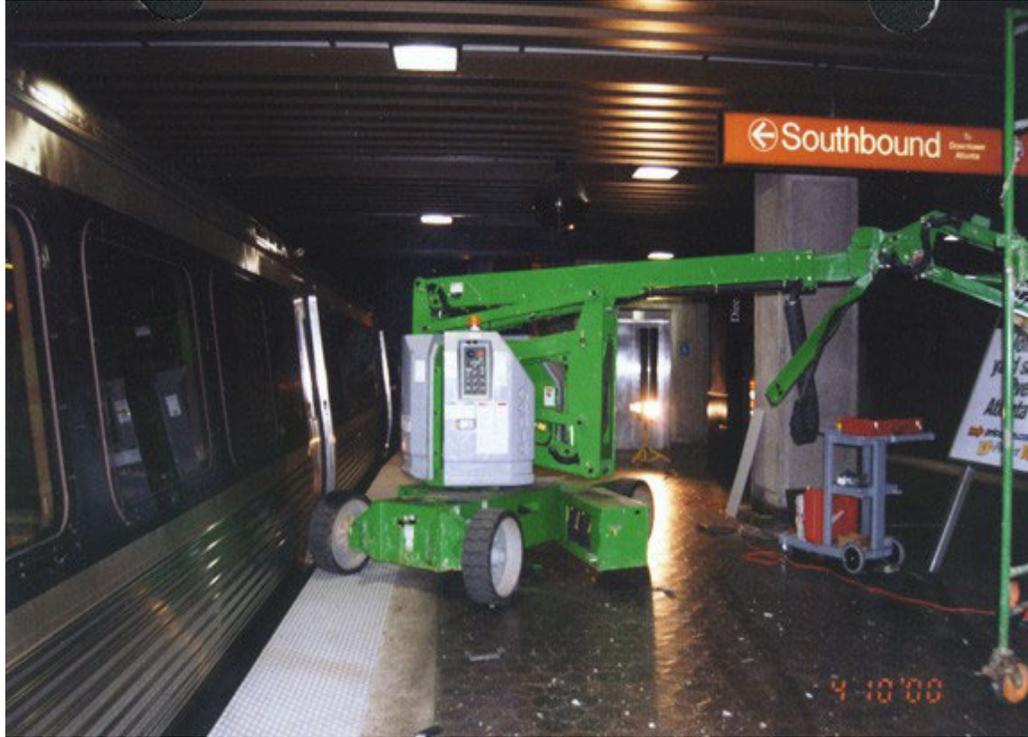
According to the train operator, the train was moving about 35 mph when it entered the station. He said his first indication of a problem was when he saw someone on the platform gesturing to him. He said that as soon as he realized that the person wanted him to stop, he placed the train brakes in emergency and moved the controller to the "off" position. The train did not stop before it struck the work boom and ejected the two Lions workers from the bucket to the station platform. (See figures 2 and 3.) One of the workers was killed instantly; the other died in the hospital.

**Figure 2.** Damaged self-propelled lift.

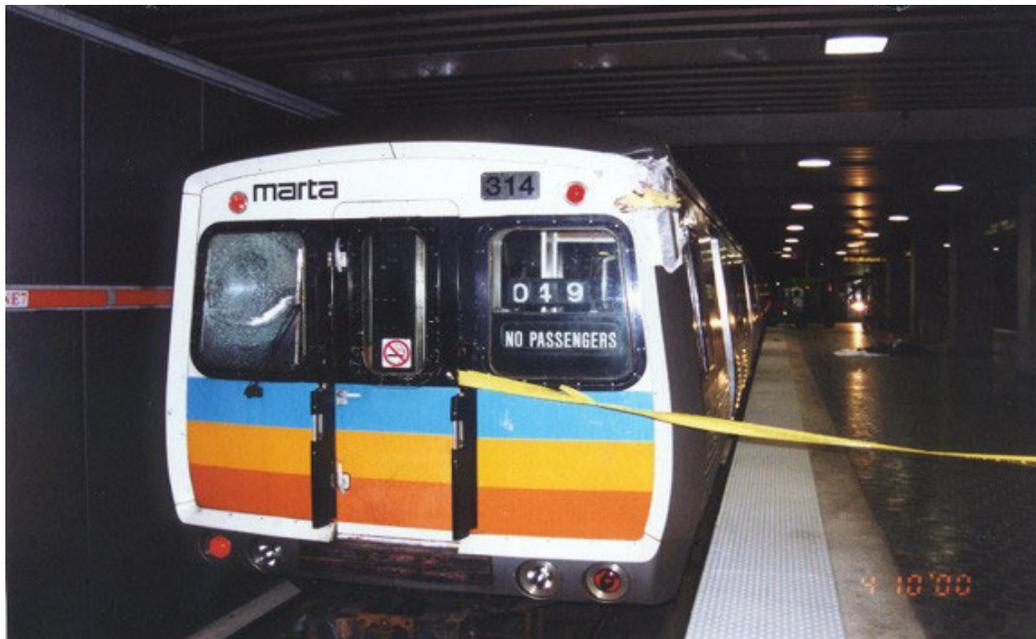
**Figure 3.** Lead car of April 10, 2000, Lenox Station accident train; window damaged by contact with work boom of self-propelled lift.
