# National Transportation Safety Board

## Railroad Accident Brief

Accident No.:	DCA-05-FR-012
Location:	Shepherd, Texas
Date:	September 15, 2005
Time:	12:07 a.m. central daylight time <sup>1</sup>
Railroad:	Union Pacific Railroad
Property Damage:	\$1,514,000
Fatalities:	1
Injuries:	2 minor
Type of Accident:	Collision

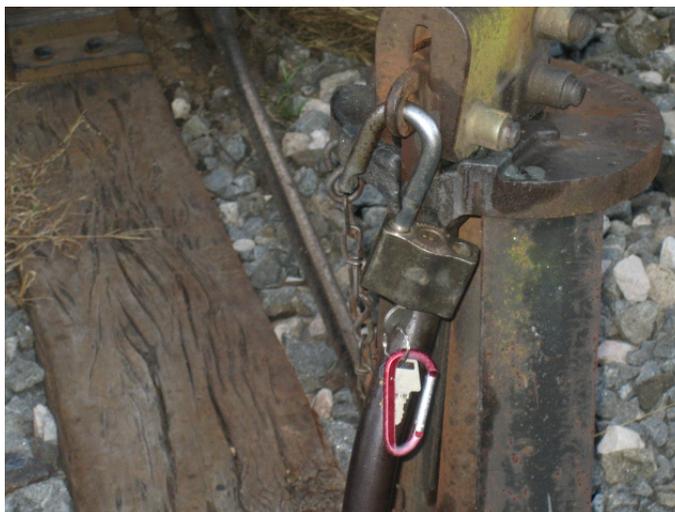
Right before the collision, the crewmembers on train MPBSR 13, realizing that their train was entering the siding, applied the brakes in emergency at approximately 37 mph. Following the impact, the engine rolled onto its side, and the two crewmembers sustained minor injuries. During the postaccident inspection, investigators found that the switch was still lined for the siding and that although the lock had been applied to the switch, it was still unlocked and held the keys belonging to the original conductor of train LEF52 14. (See figure 1.)

Based on the position of the switch and the presence of the keys, it is likely that the original conductor of train LEF52 14 had not re-lined the switch, thus making it impossible for train MPBSR 13 to stay on the main track.

**Figure 1.** Conductor's key in switch lock.

The National Transportation Safety Board determines that the probable cause of the September 15, 2005, collision of Union Pacific Railroad trains MPBSR 13 and LEF52 14 in Shepherd, Texas, was the failure of the previous crew for train LEF52 14 to return a main track switch to the normal position after they had secured the train on the siding and departed the area.

Following this accident, the UP revised the procedures for operating a hand-operated switch in non-signaled territory. The new rule requires that the crewmember who is operating the switch immediately notify the engineer by radio or hand signal when the switch position is to be changed. Further, the rule now specifies that the engineer and conductor must initial Form 20849 before releasing the track warrant for the main track authority to the dispatcher.
