# National Transportation Safety Board

## Railroad Accident Brief

**Accident No.:** DCA-05-MR-013  
**Location:** Chicago, Illinois  
**Date:** September 17, 2005  
**Time:** 8:35 a.m. central daylight time<sup>1</sup>  
**Railroad:** Northeast Illinois Regional Commuter Railroad Corporation (Metra)  
**Property Damage:** \$6.35 million  
**Fatalities:** 2  
**Injuries:** 117  
**Type of Accident:** Derailment

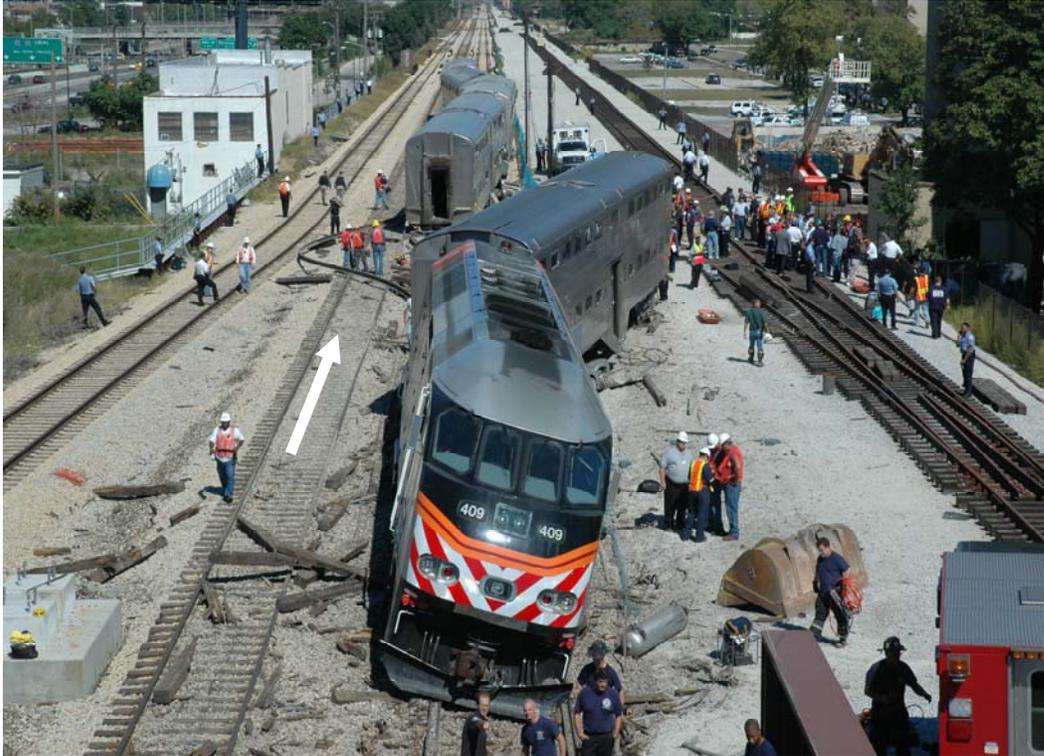
The train derailed as it traversed a crossover from track 2 to track 1 that had a prescribed maximum operating speed of 10 mph. (See figure 1.) The train was traveling 69 mph as it entered the crossover. The second through the fifth cars from the lead end of the train struck a steel girder that was part of a bridge that carried the tracks over 47th Street. Both turnouts of the crossover and one power switch machine were destroyed. Following the accident, Metra relocated the track to a new bridge adjacent to the original bridge.

**Figure 1.** Train after derailment. (It was operating in push mode and traveling in the direction of the arrow.)

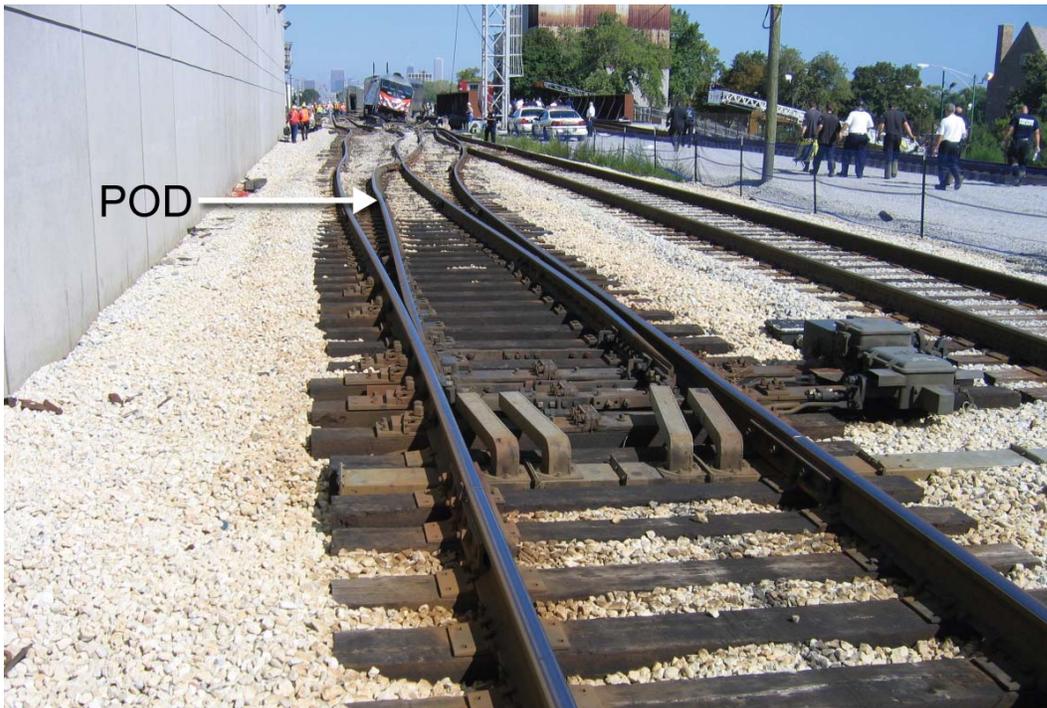
Track 2 leading to the crossover was designated by Metra as meeting the Federal Railroad Administration (FRA) standards for Class 4 track.<sup>16</sup> Metra's maximum allowable operating<sup>17</sup> speed between MP 7.0 and MP 3.9 was 70 mph for passenger trains and 30 mph for freight trains, except between MP 6.9 and MP 6.6, where passenger and freight train speeds were restricted to 40 mph and 20 mph, respectively. In addition, all trains operating through the crossover at CP 48th Street, MP 4.7, were limited to 10 mph. This 10-mph speed restriction is intended to provide for a safe transition of equipment through the crossover. The train derailed about 8:35:19 a.m., when it was 242 feet past the CP 48th Street signal and operating at 69 mph, as it attempted to traverse the crossover. No emergency brake application was recorded before the derailment. (See figure 3.)

**Figure 3.** The point of derailment (POD); the beginning of the crossover is in the foreground.

October 21, 2005). As noted above, train 504 had a recorded speed of 69 mph while traveling into the crossover. The excessive train speed and the severe angle of attack between the wheel flanges of the lead set of trucks of the cab control car and the gage corner of the curve closure rail caused the wheels to cross over the railhead and derail. The leading cab control car (8570) derailed first and passed through the 47th Street Bridge<sup>18</sup> without impact. The second car (7331) derailed and scraped the bridge girder. The third through fifth cars (8548, 7488, and 7351) derailed, struck, and rode over the low girder of the bridge. (See figure 4.)

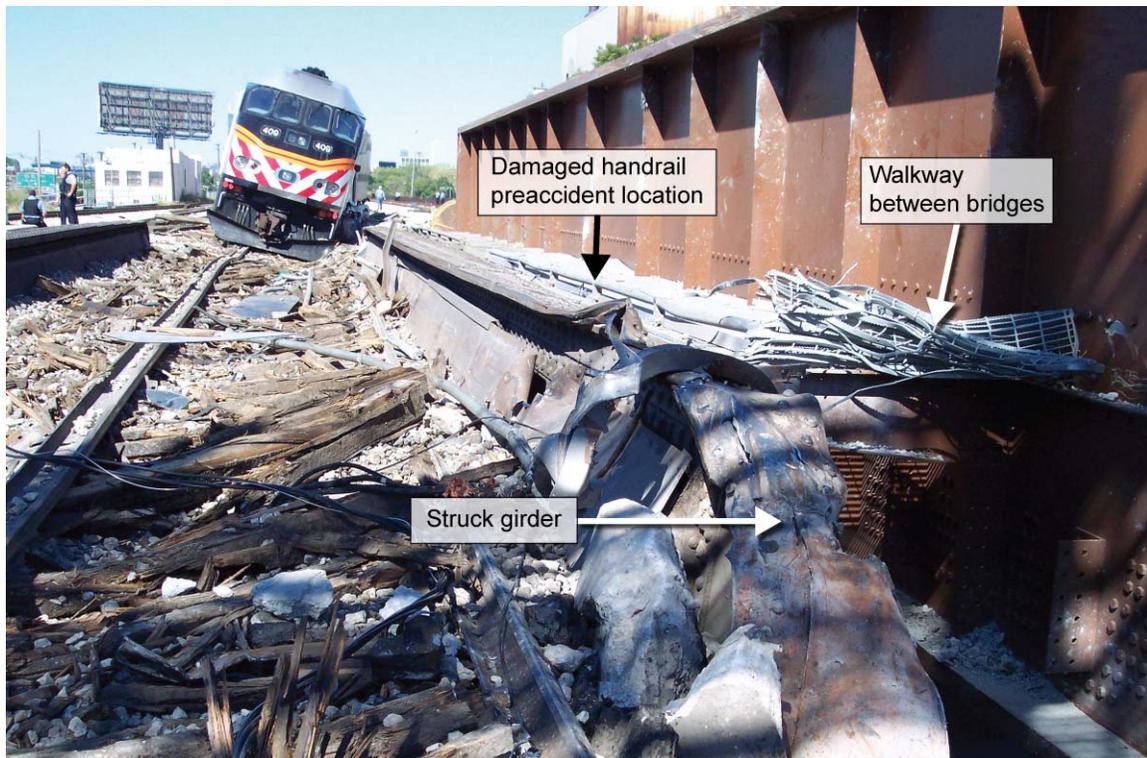
**Figure 4.** Damage to the 47th Street Bridge and adjacent walkway and handrail.

<sup>18</sup> The 47th Street Bridge was a typical highway overhead crossing for the former Chicago, Rock Island and Pacific Railroad built in 1897-98. It was a 70-foot-through girder span, and the top of the girder projected 1.8 feet above the top of rail.
