National Transportation Safety Board
Washington, D.C. 20594
Railroad Accident Brief

Accident No.: DCA-06-FR-004
Location: Lincoln, Alabama
Date: January 18, 2006
Time: 4:17 p.m. central standard time
Railroad: Norfolk Southern Railway
Property Damage: \$5.2 million
Injuries: 3
Fatalities: None
Type of Accident: Rear-end collision and derailment

Accident Synopsis

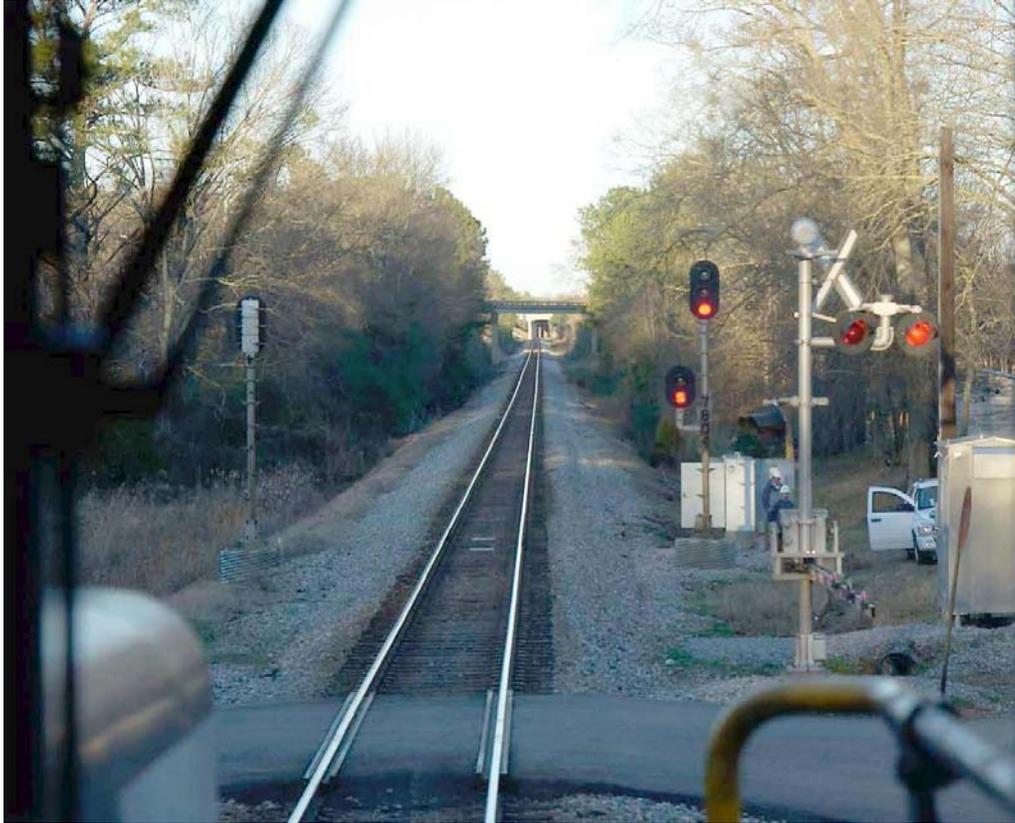
Figure 2. Eastbound signal at Riverside as seen from a locomotive cab during postaccident sight distance testing. The high signal head has three aspects: green over yellow over red. The lower, offset, signal head has two aspects: green over red. This configuration should be considered an improperly or imperfectly displayed signal.

About 1,230 feet before the Riverside signal, investigators observed two red aspects (one on the upper signal head and one on the lower signal head), which is the correct aspect for a *restricting* indication.

The train then slowly moved forward by 40 feet, until it was within 1,189 feet of the signal. At that point, the green aspect at the top of the upper signal head appeared to be illuminated, even though the green aspect was not energized. As the locomotive pulled slowly forward, the green aspect became even more prominent. The red aspect in the same signal head remained energized and continued to be visible to those in the locomotive cab. The upper signal head's top aspect continued to appear to display green as the locomotive approached and then passed the signal. During a subsequent test run at accident train speed, the Riverside upper signal head again appeared to display two aspects—green over red—even though the green was not energized.

The next day, investigators again performed sight distance tests at Riverside. The results were the same as on the previous day, and investigators determined that the period of time the green aspect appeared to be illuminated was about 1 hour. Although the green light was not energized, it appeared to be illuminated because of sunlight reflecting from its lens. After the sight distance tests, the railroad installed devices at Riverside to better shield the lights from sun reflection.

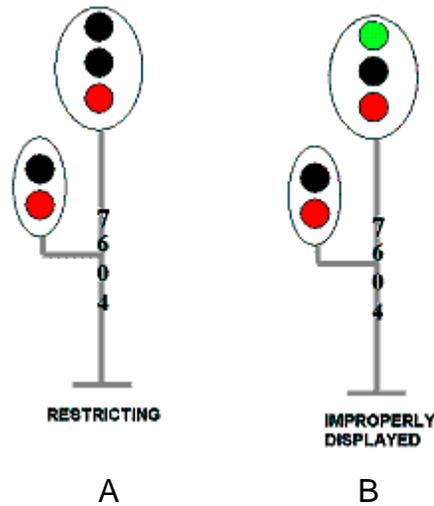
Signal A in figure 3 illustrates the signal as energized at the time of the accident, displaying a *restricting* indication. Note that the *restricting* indication is displayed as a single red light illuminated in each of the upper and lower signal heads. Signal B in figure 3 illustrates the signal as it appeared in postaccident sight distance tests. Signal B is somewhat similar to signal A, but it has one critical difference: in addition to the single red light on each of the signal heads, a green light appears to be illuminated in the upper head. Because no legitimate NS signal indication uses this combination of illuminated aspects, this configuration should be considered an improperly or imperfectly displayed signal.

Figure 3. Signal at Riverside at time of accident as it was energized (A) and as it was observed during postaccident tests (B).

Neither NS operating rule No. 27 nor any of the rule book’s signal illustrations or accompanying text informed employees that extra lighted aspects²⁰ in a signal head indicate an anomaly in the observed signal, that such a signal should be considered an imperfectly displayed signal, and that it should be treated as if it were displaying its most restrictive indication.

The National Transportation Safety Board determines that the probable cause of the January 18, 2006, collision of Norfolk Southern Railway train 226 with the rear of Norfolk Southern Railway train 22R at Lincoln, Alabama, was the failure by the crew of train 226 to recognize an extra lighted aspect (caused by reflected sunlight) as an imperfectly displayed signal and to treat it as a most restrictive indication. Contributing to the accident was Norfolk Southern Railway's inadequate illustrations and text in the rulebook and inadequate training to prepare crews to recognize a signal displaying an extra lighted aspect as an imperfectly displayed signal. Also contributing to the accident was the lack of a positive train control system that would have intervened when the crew did not respond appropriately to the signal.

Modify your initial and recurrent training and operating rules to emphasize to your employees and the crews of other railroads operating on your territory that any signal that appears to display extra lighted aspects in a signal head should be treated as an imperfectly displayed signal. (R-07-29)
