National Transportation Safety Board

Railroad Accident Brief

Accident No.:	DCA-09-MR-004
Location:	Boston, Massachusetts
Date:	May 8, 2009
Time:	7:14 p.m., eastern daylight time ¹
Railroad	Massachusetts Bay Transportation Authority (MBTA)
Property Damage:	\$9.6 million
Injuries:	68
Fatalities:	None
Type of Accident:	Collision

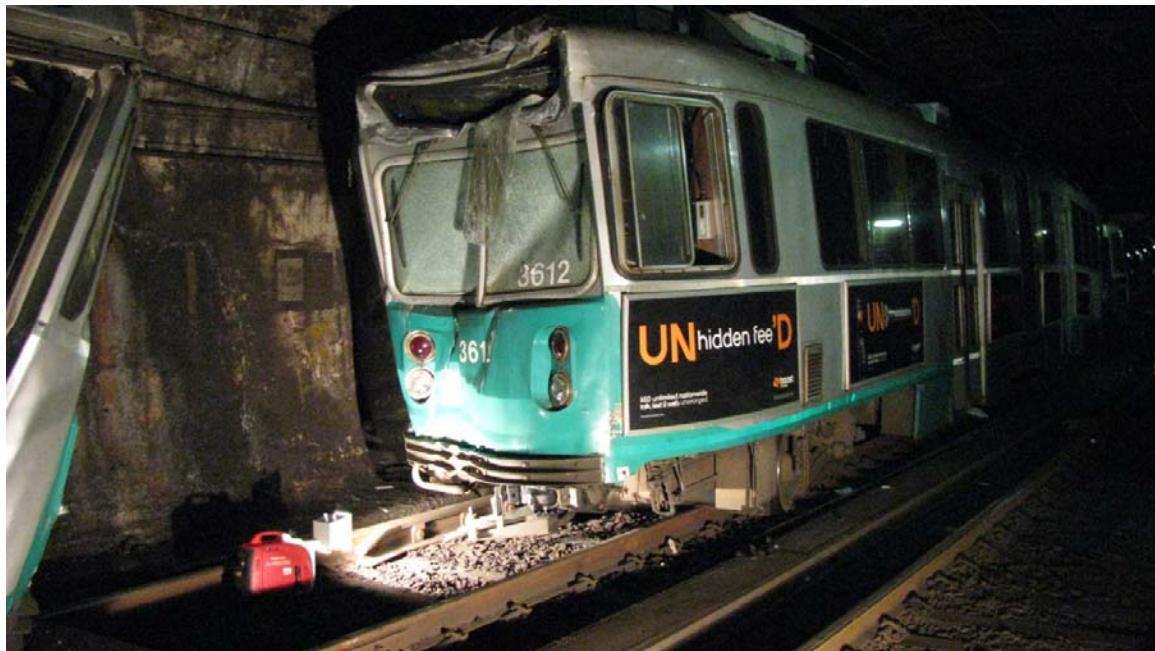
Train 3612 had struck standing train 3808 while it was stopped behind trains waiting to enter Park Street Station. (See figure 2.) The rear of standing train 3808 was about 98 feet beyond a red signal, and the left rear red marker light was visible to the pilot operator of striking train 3612 for 447 feet. (See figure 3.) Both rear red marker lights of the standing train were visible for 216 feet, and the entire rear end of the standing train was visible for 80 feet. (See *Sight-Distance Test* later in this brief.)

Figure 2. Photograph showing damage to front (cab) of striking train 3612.

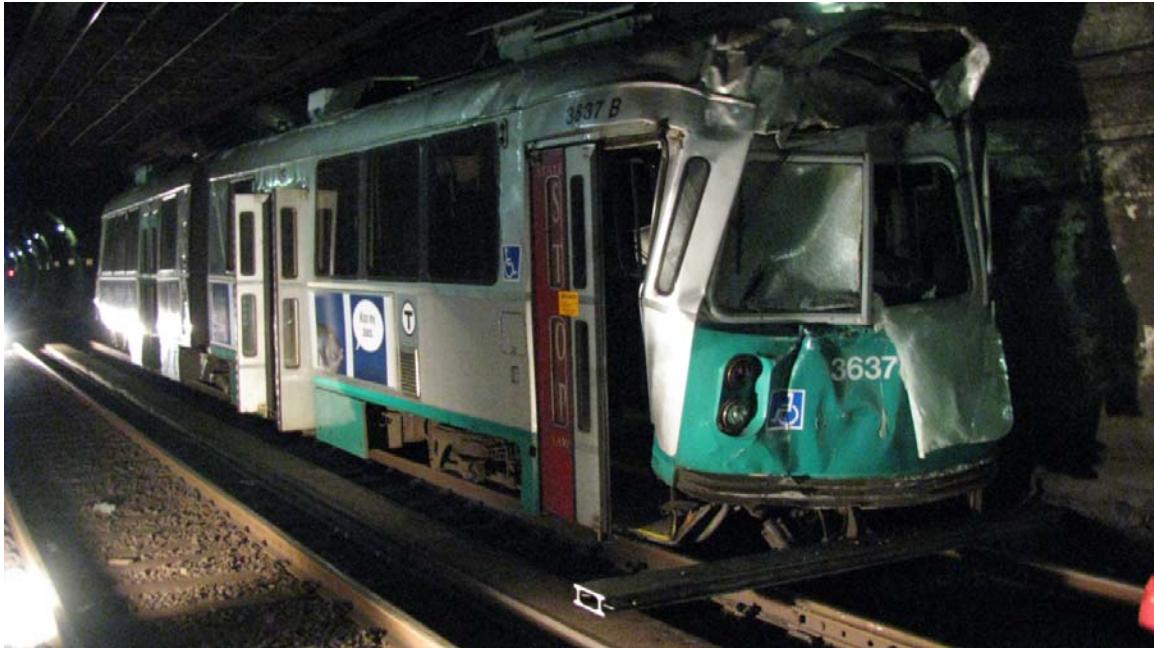
Figure 3. Photograph showing damage to rear of standing train 3808.

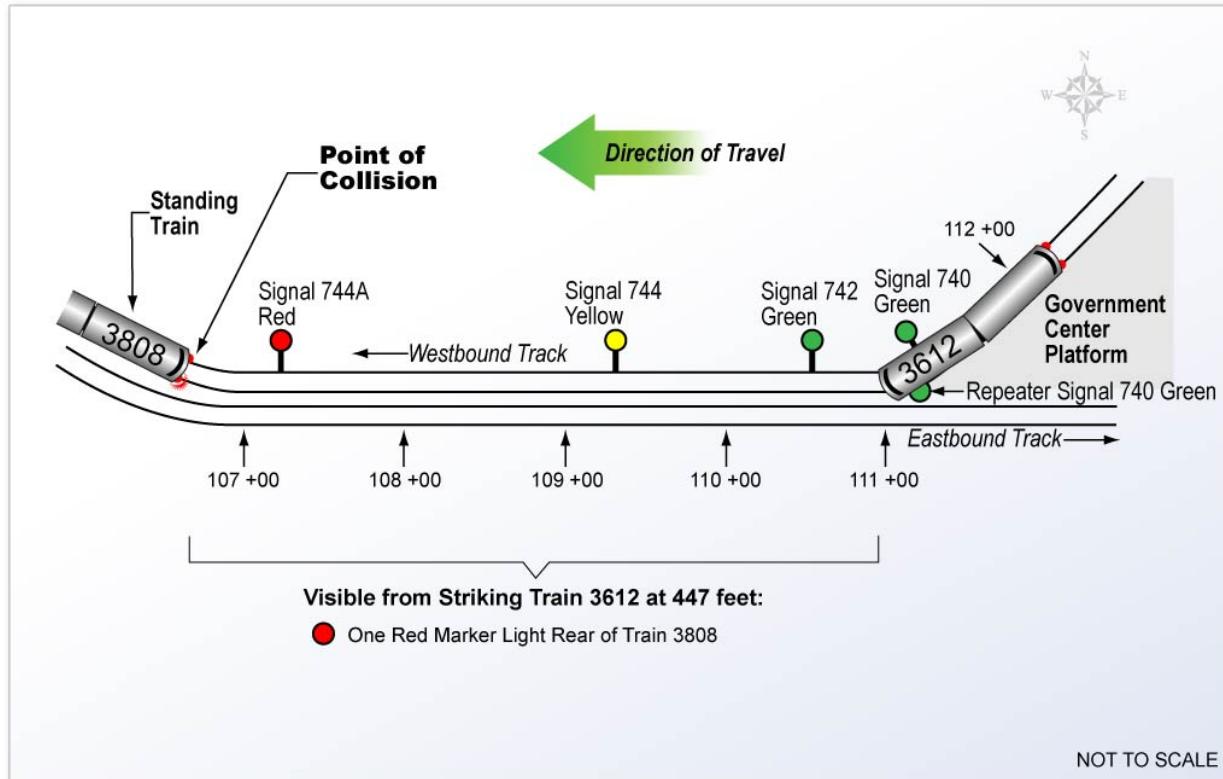
Before the train departed from the platform, the green repeater signal 740 on the left side of the track at Government Center Station was visible from the cab of the train. The next green signal, 742, was also visible from the cab at 112 feet. The train was moved westward where yellow signal 744 was seen from 181 feet. Red signal 744A (the signal closest to the rear of the standing train) was seen from 367 feet. The left red marker light on the rear of the standing train was visible from 447 feet, both red marker lights could be seen from 216 feet, and the entire rear end of the car of the standing train was visible from 80 feet. (Figure 4 shows signal locations and displays at the time of the accident.)

The pilot operator of train 3612 did not comply with either the yellow signal or the red signal, and he accelerated the train to near the maximum allowed track speed (25 mph) until just before the collision, when the onboard train data log showed that the train was placed in emergency. At the time, the pilot operator was text messaging on his wireless device, and it is likely that this activity caused him to lose his situational awareness and his focus on operating the train.

Figure 4. Diagram of track at accident location with signal arrangement and signal displays at time of accident.
