# National Transportation Safety Board

## Railroad Accident Brief

**Accident No.:** DCA-11-FR-004  
**Location:** Mineral Springs, North Carolina  
**Date:** May 24, 2011  
**Time:** 3:35 a.m. eastern daylight time  
**Railroad:** CSX Transportation  
**Property Damage:** \$1.6 million  
**Injuries:** 2  
**Fatalities:** 2  
**Type of Accident:** Rear-end collision

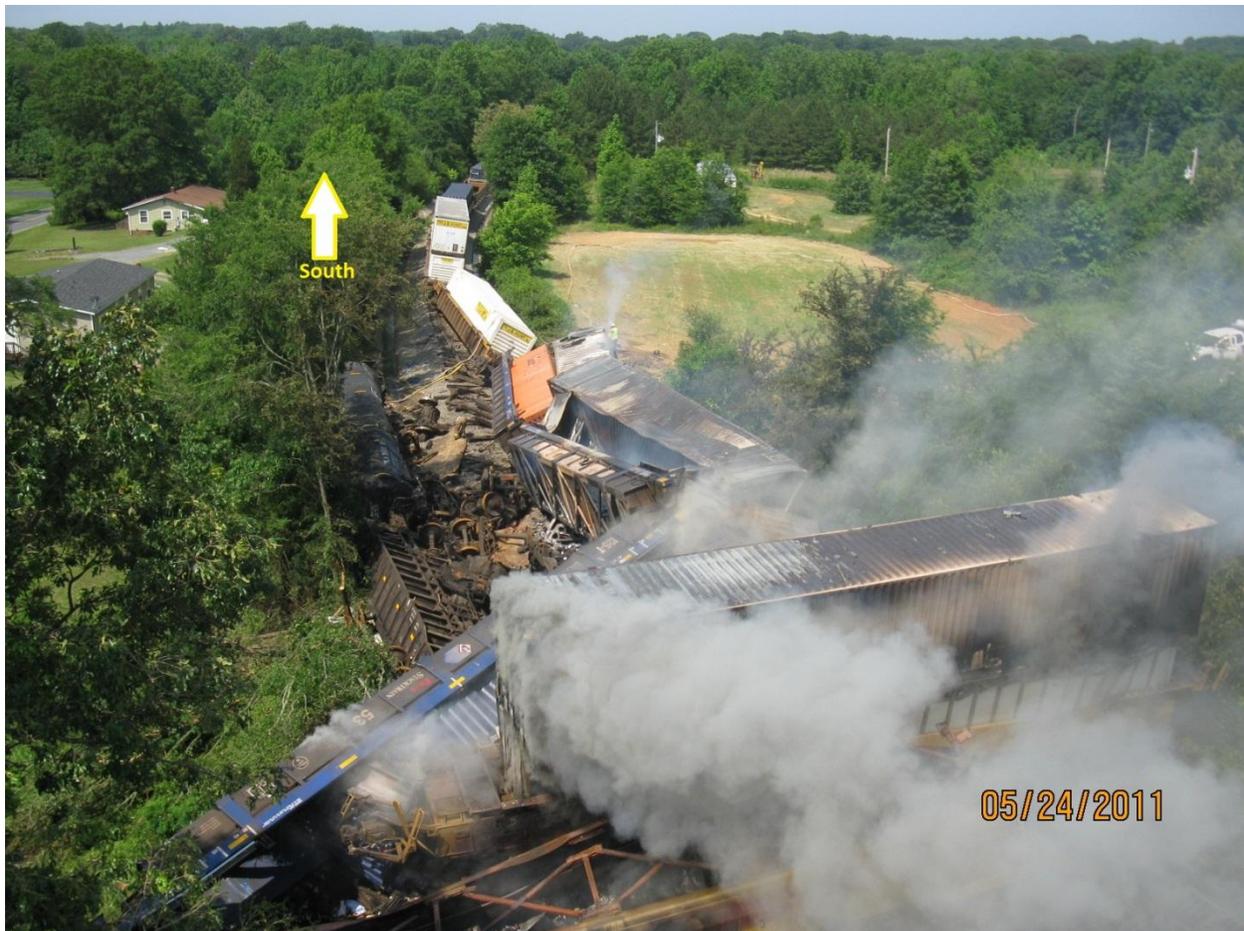
In the accident, two locomotives and the first nine cars of the striking train and the last four cars of the struck train derailed. (See figure 1.) The two crewmembers of the striking train were fatally injured; the two crewmembers of the struck train were treated for minor injuries. Property damage was estimated to be \$1.6 million.

**Figure 1.** View of accident site showing derailed cars from the striking train.

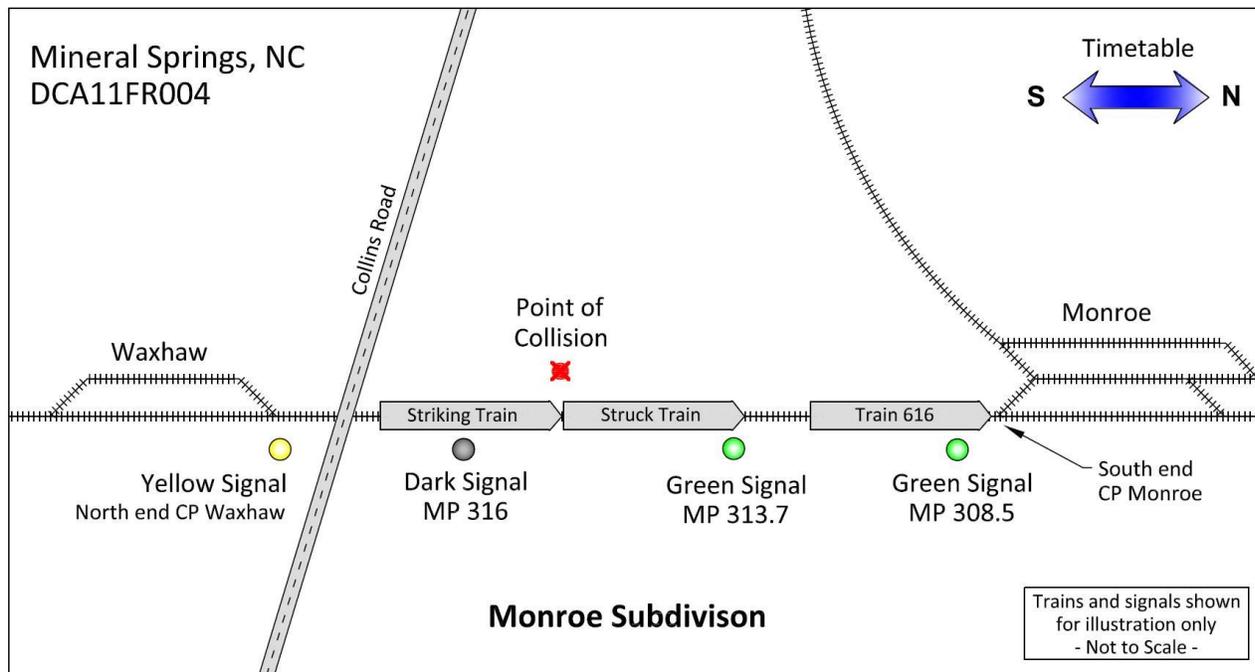
After stopping at the signal for about 10 minutes, train 616 began to move northward after receiving a green signal. Then the crew of the struck train received a green signal to proceed, and their train was struck by the striking train. (See figure 2.)

**Figure 2.** Diagram of accident area.

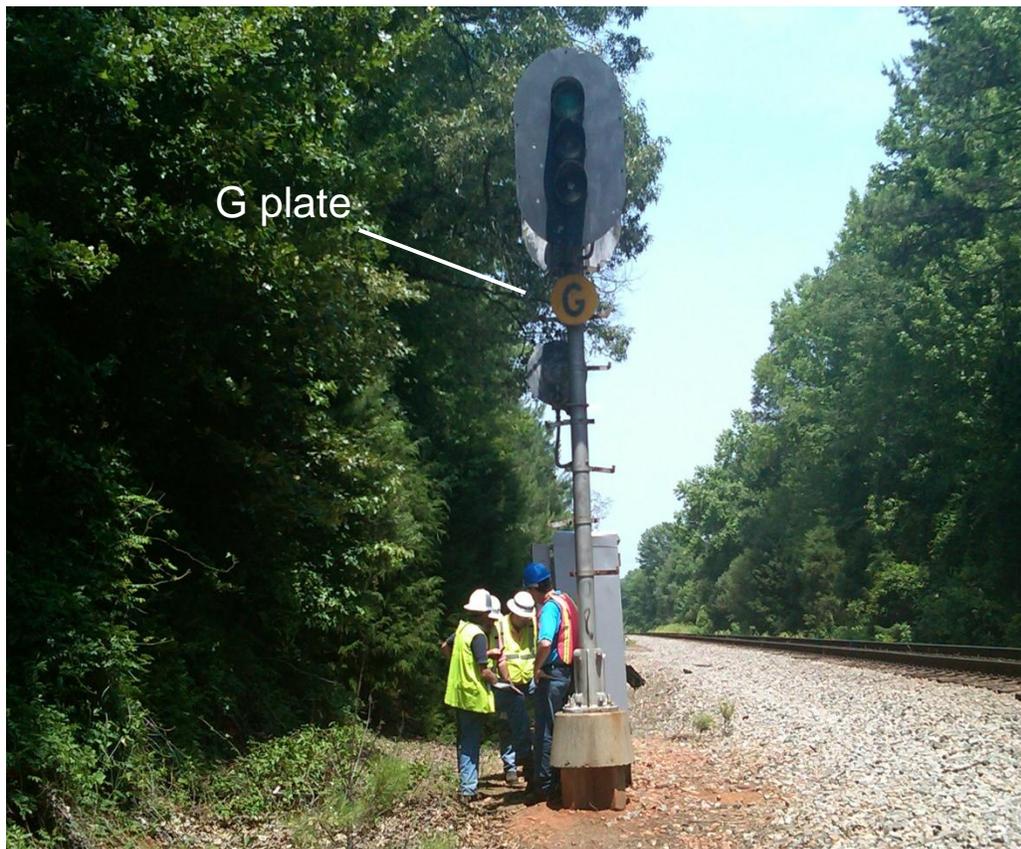
National Transportation Safety Board (NTSB) investigators examined data from the forward-facing video camera on the striking train's locomotive. The data showed that when the striking train reached the signal at MP 316, the signal was dark (that is, not illuminated). This dark signal also was verified by investigators during postaccident signal testing. According to the CSX operating rules, a dark signal requires train crews to reduce train speed to the most restrictive indication the signal can convey and to contact the train dispatcher promptly. A G plate,<sup>4</sup> which was attached to the signal mast, allowed the train to pass the dark signal without stopping at a restricted speed of no more than 15 mph.<sup>5</sup> (See figure 3.) However, the striking train proceeded at 31 mph past the dark signal. The train accelerated and was traveling about

**Figure 3.** NTSB signal investigators inspecting signal at MP 316 with attached G plate.

Testing of the signal at MP 316 revealed that the red aspect<sup>6</sup> of the signal was not illuminated. Further testing found that the signal lamp for the red aspect was burned out.

During the on-scene investigation, CSX representatives recognized a fault in the CSX signal incident reporting procedures. The CSX implemented a corrective change, and reporting procedures now allow only one signal incident to be reported on each trouble ticket. To close a ticket, signal personnel must enter a specific remedy for the reported incident.
