**National Transportation Safety Board**  
Washington, DC 20594

**Railroad Accident Brief**

**Accident No.:** DCA-12-FR-002  
**Location:** Westville, Indiana  
**Date:** January 6, 2012  
**Time:** 1:18 p.m. central standard time<sup>1</sup>  
**Railroad:** CSX Transportation  
**Property Damage:** \$5 million  
**Injuries:** 2  
**Fatalities:** 0  
**Type of Accident:** Collision

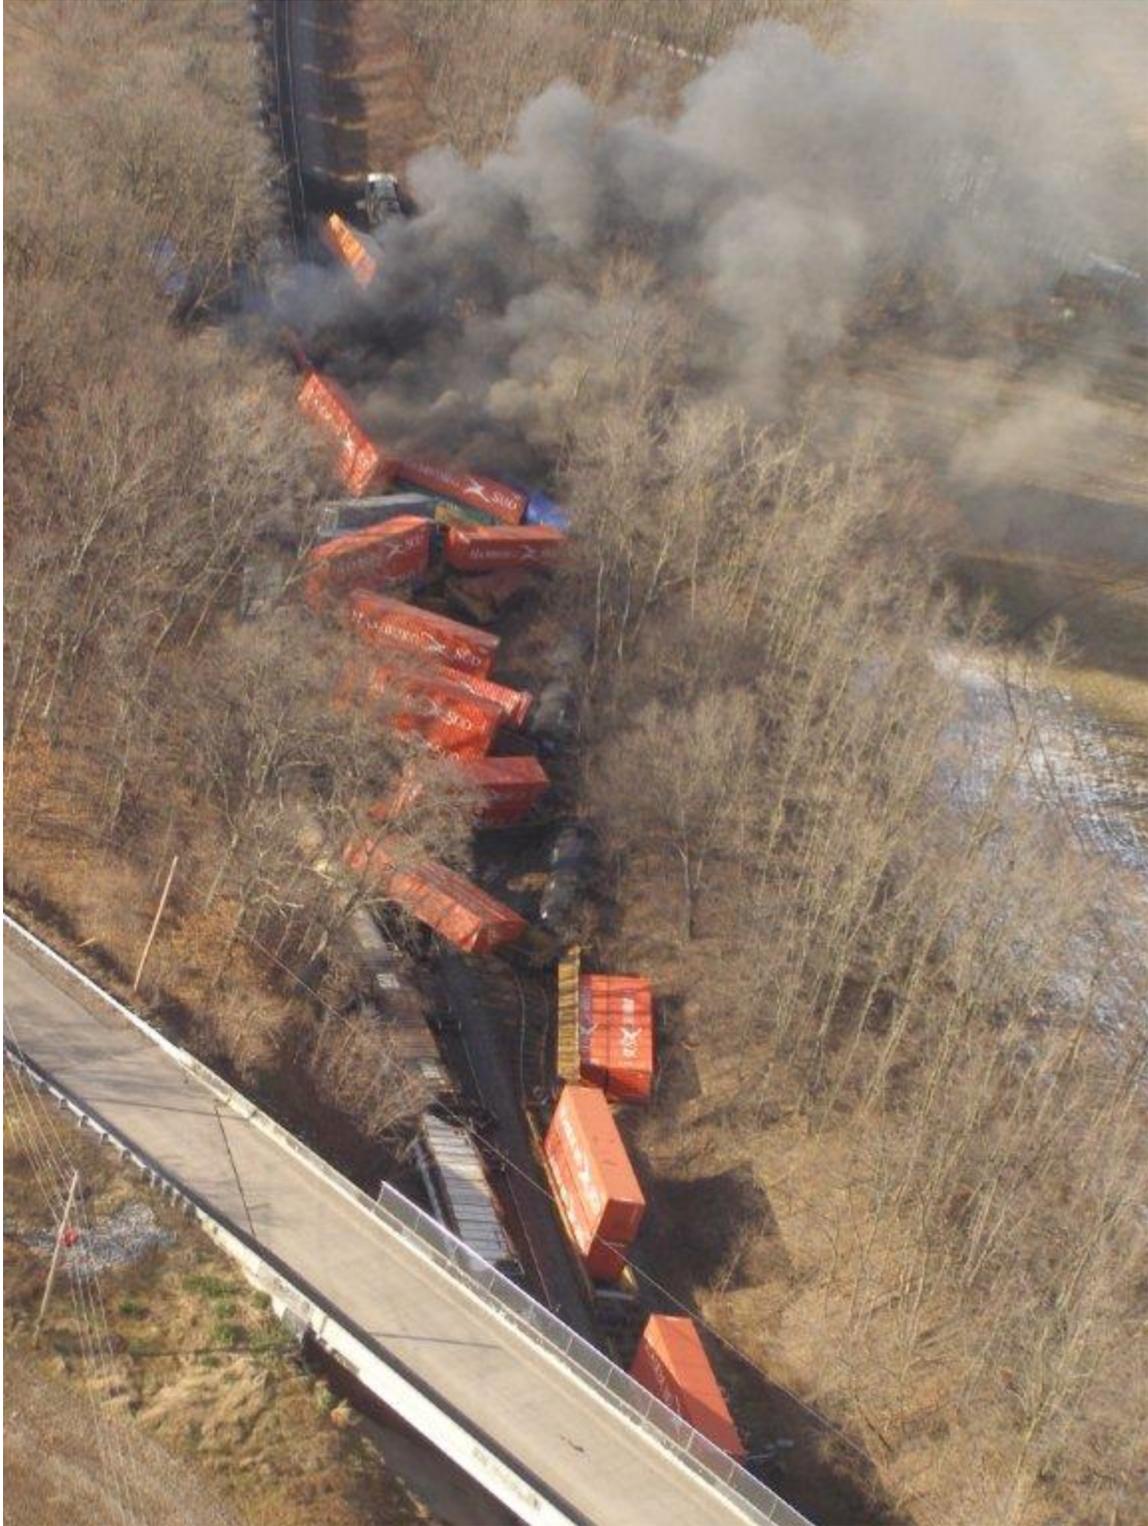
On January 6, 2012, at 1:18 p.m., westbound CSX Transportation (CSX) freight train Q39506 struck the rear end of standing westbound CSX freight train K68303 on track 2 at milepost (MP) 224.5 near Westville, Indiana. (See figures 1 and 2.)

The crew of train Q39506 had just escaped the locomotive, which had derailed on its side onto track 1, when CSX westbound freight train Q16105, operating on track 1, struck the derailed locomotive.

The derailed equipment from both collisions included the last 7 cars of train K68303, both locomotives and 6 cars of train Q39506, and all 3 locomotives and 12 cars of train Q16105. Spilled diesel fuel from the locomotives caught fire.

**Figure 1.** Accident site.

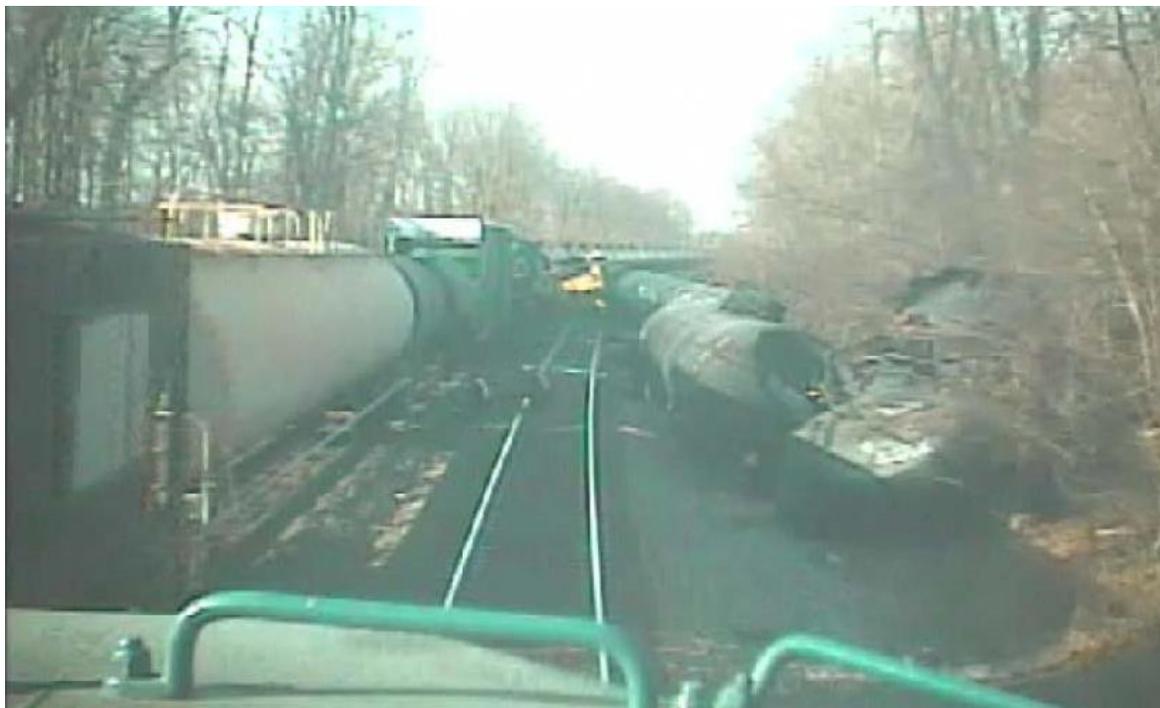
Train Q39506 collided with the last car of stopped train K68303 at 1:18 p.m. near MP 224.5. The rearmost tank cars of train K68303 were pushed off the track and across track 1 and came to rest north of track 1. The lead locomotive of train Q39506 rolled onto its right side on top of track 1. (See figure 4.) The conductor and the engineer said that they evacuated the locomotive cab and proceeded toward an open field on the north side of track 1. They had not gone far when train Q16105 collided with their overturned locomotive.

**Figure 4.** View from forward-facing video on train Q16105 as it approached the first collision.

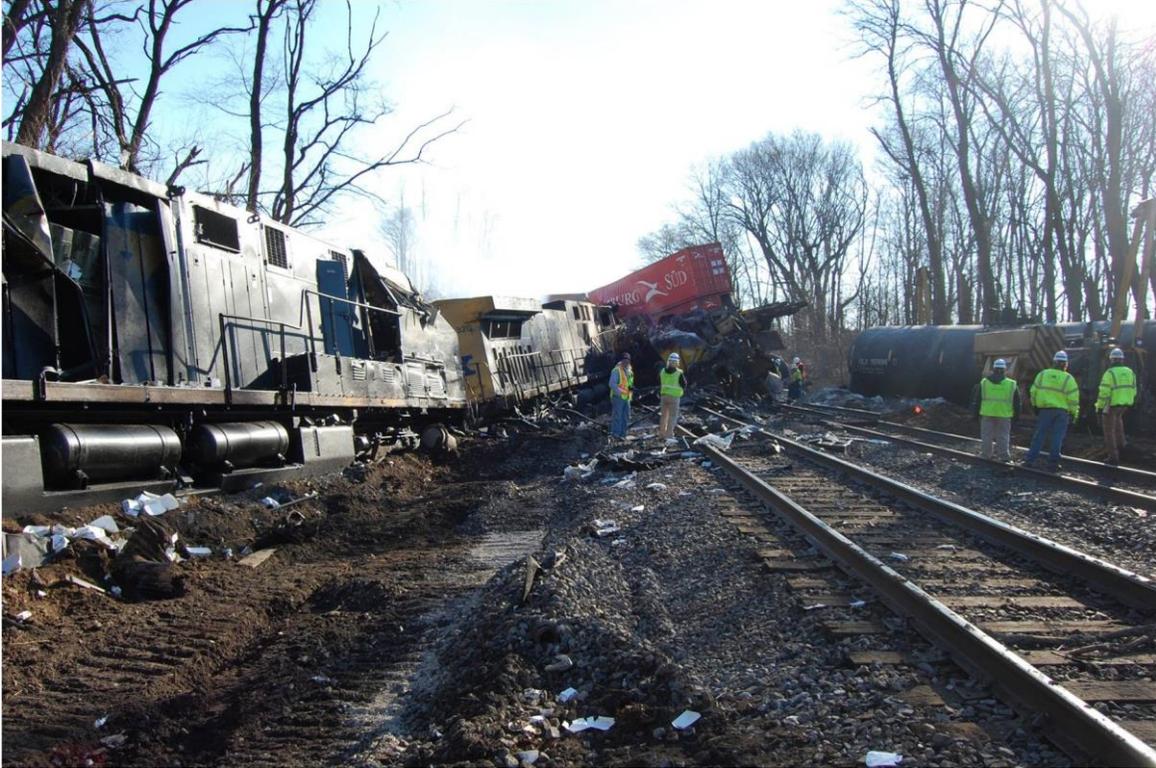
The train Q16105 engineer said that he and the conductor saw the rear end of train Q39506 three times before the accident: (1) moving on the adjacent track (track 2) near MP 219, 5.5 miles before the point of collision (POC); (2) moving on track 2, 2 miles before the POC; and (3) stopped on track 2, less than 1 mile before the POC. As train Q16105 rounded a curve, the engineer recalled thinking “that train sure stopped quickly.” Less than 2 minutes later, while their train was operating at 57 mph, he and his conductor saw the derailed equipment from train Q39506 blocking track 1. The engineer immediately applied the emergency brake, and both crewmembers braced themselves for the impending collision. The three locomotives pushed through the wreckage and derailed, remaining upright as they came to rest in an embankment to the right of and parallel to track 1. (See figure 5.)

**Figure 5.** View of train Q16105 locomotives after derailing from track 1 and coming to rest on embankment.

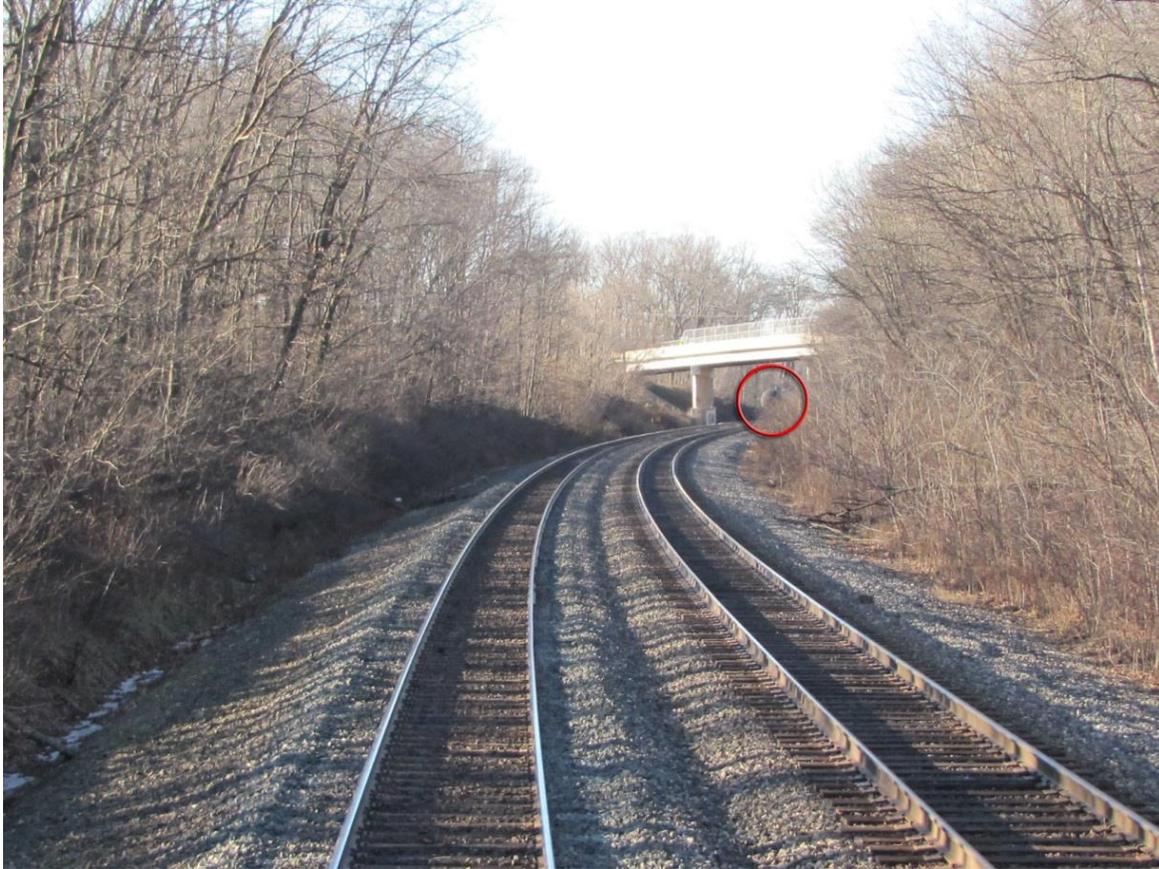
On January 10, 2012, about the same time of day as the accident and with similar weather conditions, NTSB investigators conducted sight-distance observations to determine when the rear of train K68303 would have been visible to the crew of train Q39506 on track 2. The investigators could see the rear of an exemplar standing train when their test train was 1,304 feet away. The test train used a lead locomotive with the same configuration as that of train Q39506. (See figure 6.)

**Figure 6.** Rear of exemplar standing train (circled) is first visible at about 1,304 feet away.
