# National Transportation Safety Board

## Railroad Accident Brief

### Collision of Two Union Pacific Railroad Freight Trains

<b>Accident No.:</b>	DCA14FR012
<b>Location:</b>	Galva, Kansas
<b>Date:</b>	September 25, 2014
<b>Time:</b>	5:44 a.m. central daylight time
<b>Train 1:</b>	Eastbound train ILXG4X-22 (UP 8572 East)
<b>Train 2:</b>	Westbound train KG4GSX-23 (UP 8120 West)
<b>Railroad:</b>	Union Pacific Railroad
<b>Property Damage:</b>	\$3,156,000
<b>Injuries:</b>	2
<b>Fatalities:</b>	0
<b>Type of Accident:</b>	Collision of two freight trains

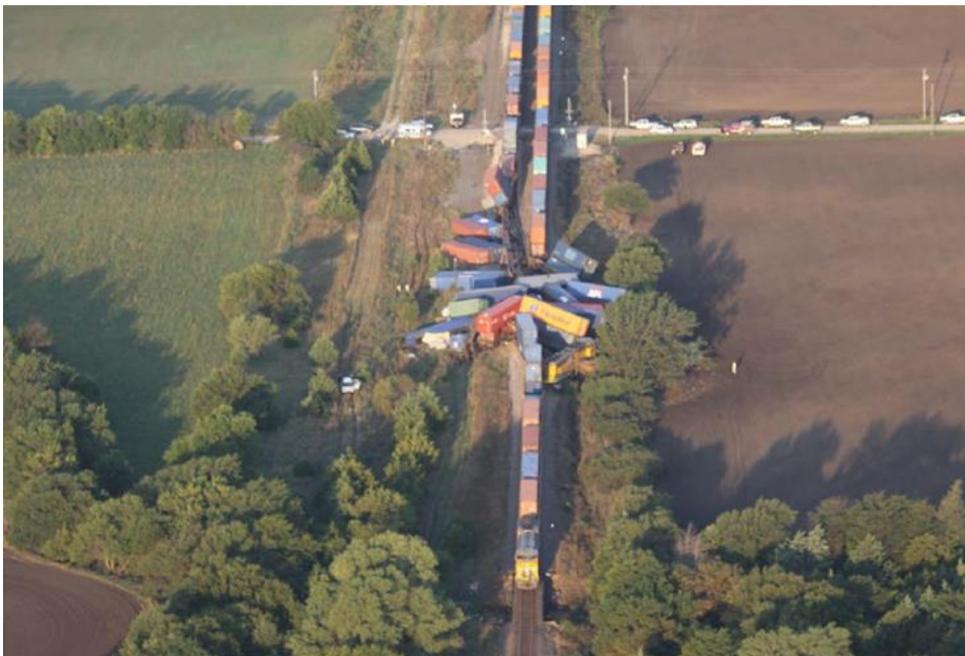
On September 25, 2014, at about 5:44 a.m., eastbound Union Pacific Railroad (UP) train ILXG4X-22, collided with the side of westbound UP train KG4GSX-23 near Galva, Kansas.<sup>1</sup> (See figure 1.) The westbound train was entering a siding, but it had not cleared the main track when it was struck by the eastbound train.<sup>2</sup> Five multi-platform intermodal cars derailed from the westbound train. Two locomotive units and four multi-platform intermodal cars derailed from the eastbound train.<sup>3</sup> The UP estimated about 200 gallons of diesel fuel leaked from the fuel tank of one of the derailed locomotives. No crewmembers on either train were seriously injured. No fire resulted from the collision.

**Figure 1.** Accident scene.

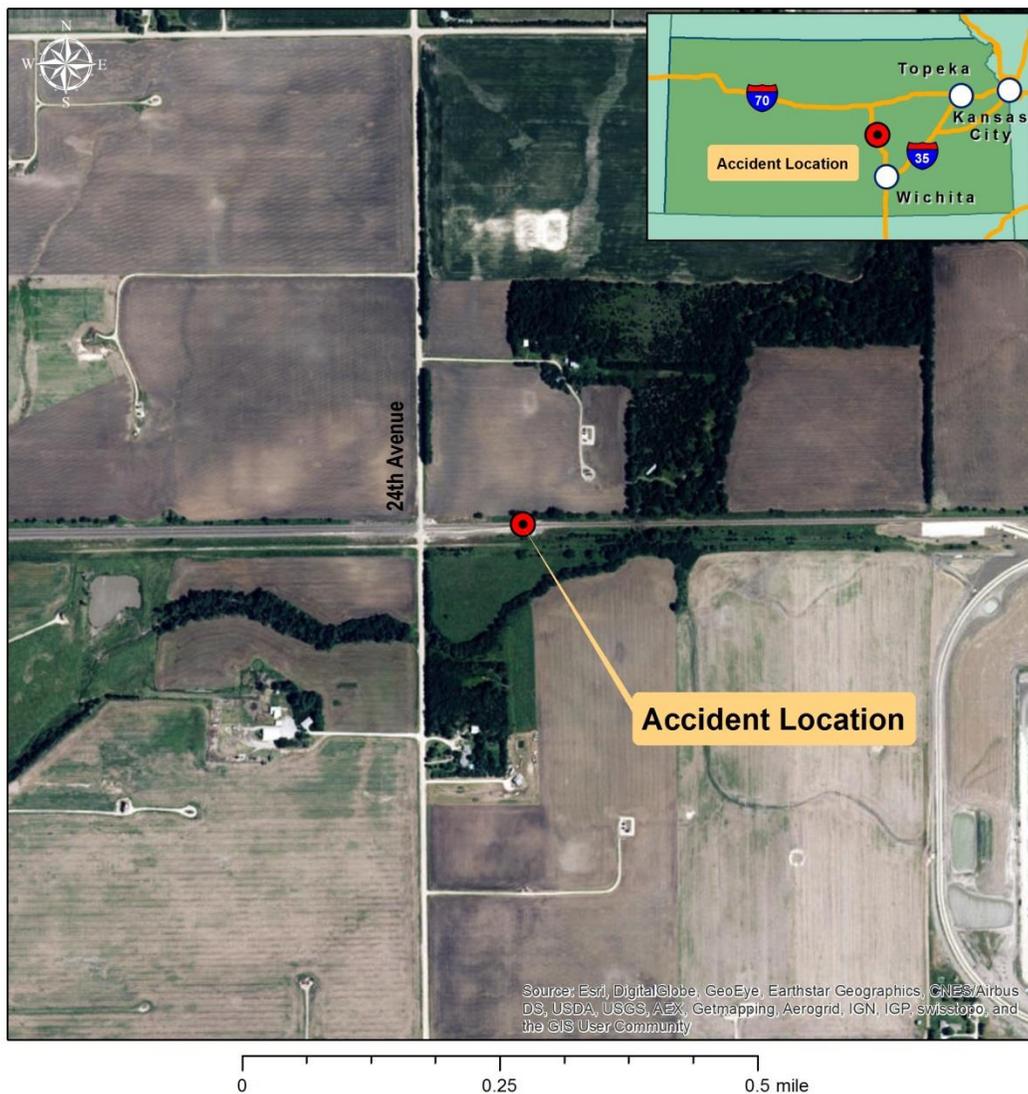
The collision occurred at the clearance point where the UP single main track approached the east switch at the Galva siding at milepost (MP) 207.67, located at latitude 38°23'4" and longitude -97°28'9". (See figure 2.)

**Figure 2.** Accident location.
