# NATIONAL TRANSPORTATION SAFETY BOARD

## RAILROAD ACCIDENT REPORT

COLLISION INVOLVING THREE  
CONSOLIDATED RAIL CORPORATION FREIGHT TRAINS  
OPERATING IN FOG ON A DOUBLE MAIN TRACK  
NEAR BRYAN, OHIO  
JANUARY 17, 1999

RAILROAD ACCIDENT REPORT  
NTSB/RAR-01/01 (PB2001-916301)

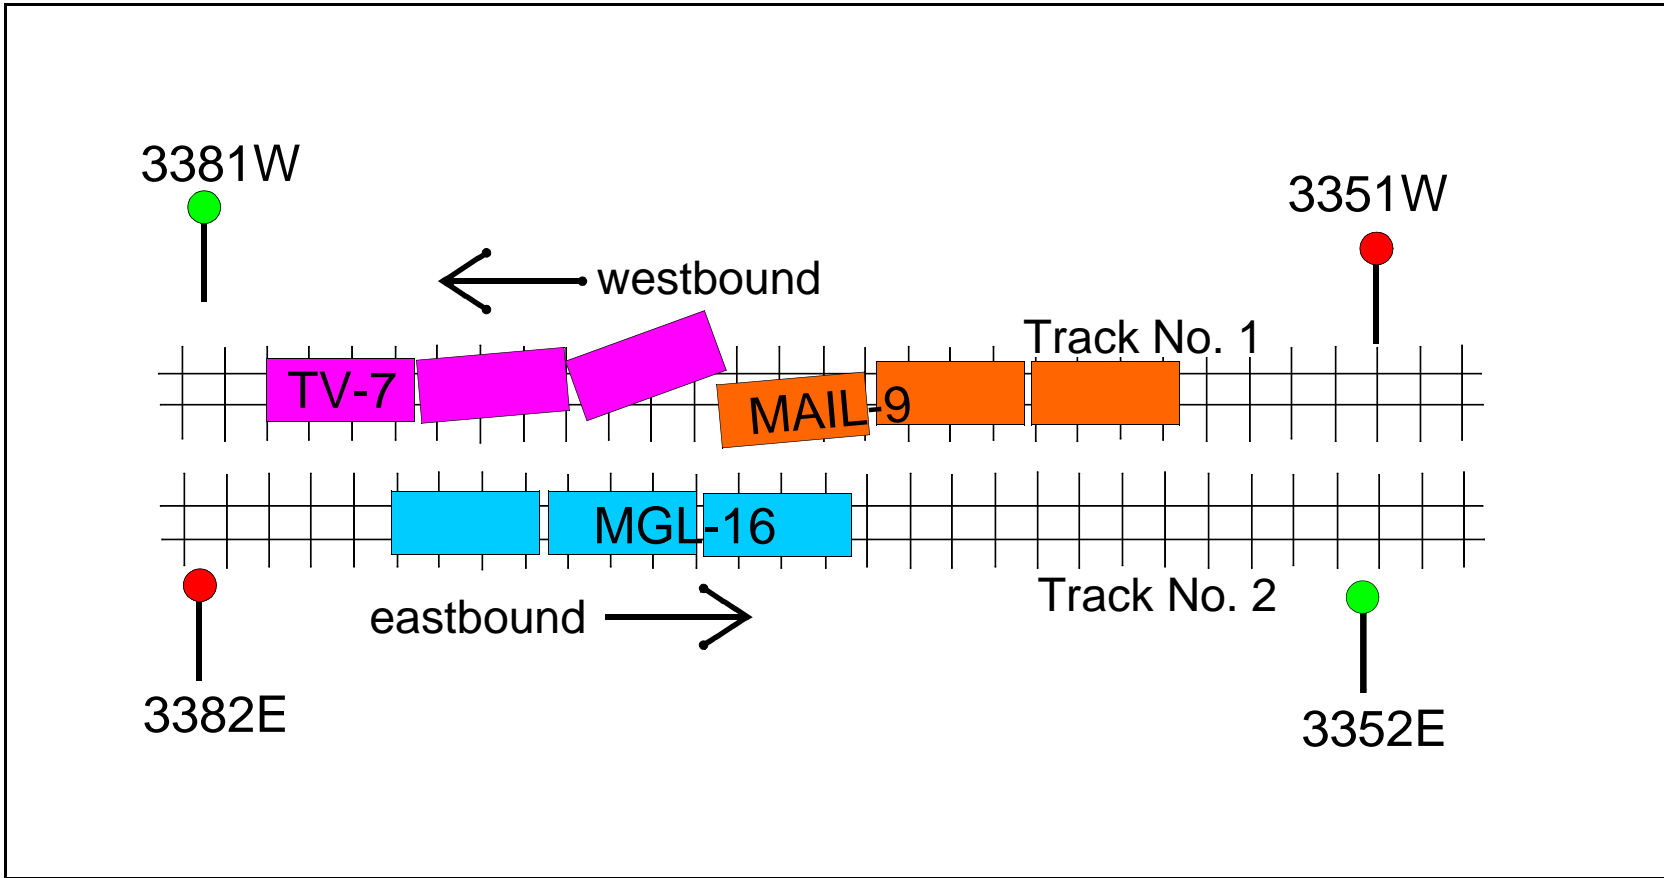
**Figure 2.** When train Mail-9 struck the rear of train TV-7, equipment from both trains derailed and struck train MGL-16, causing 18 cars from the MGL-16 consist to derail.

The collision of Mail-9 with TV-7 caused the derailment of the 3 locomotive units and the first 13 cars of Mail-9 and the last 3 cars of TV-7. Eastbound train MGL-16 was traveling about 49 mph on the adjacent track at the time of the collision. The derailed equipment of the Mail-9 and TV-7 trains struck the MGL-16’s 12th car and caused cars 12 through 29 in the MGL-16 consist to derail. (See figure 4.)

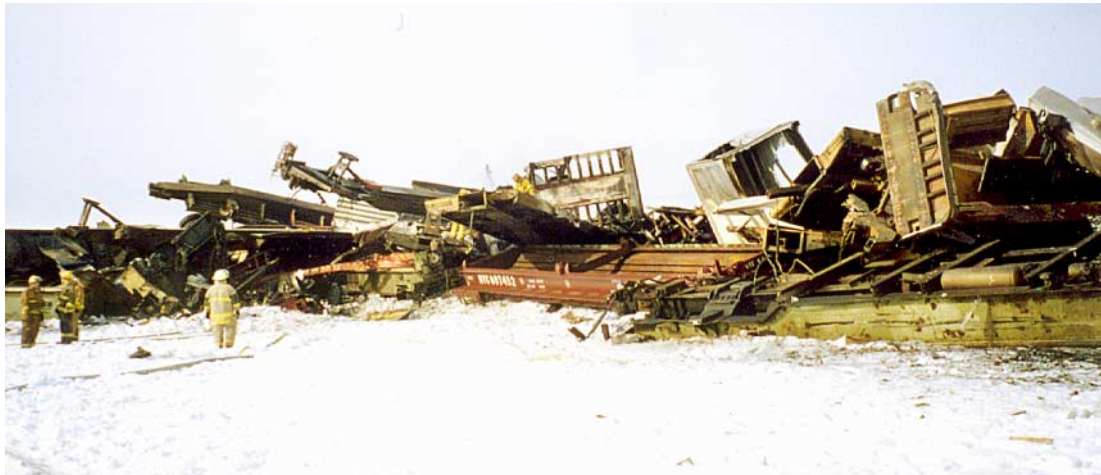
**Figure 4.** Firefighters survey the wreckage of the accident. Of the 3 locomotives and 34 cars that derailed, 2 locomotives and 30 cars were destroyed. (Photograph courtesy of the Bryan Fire Department.)

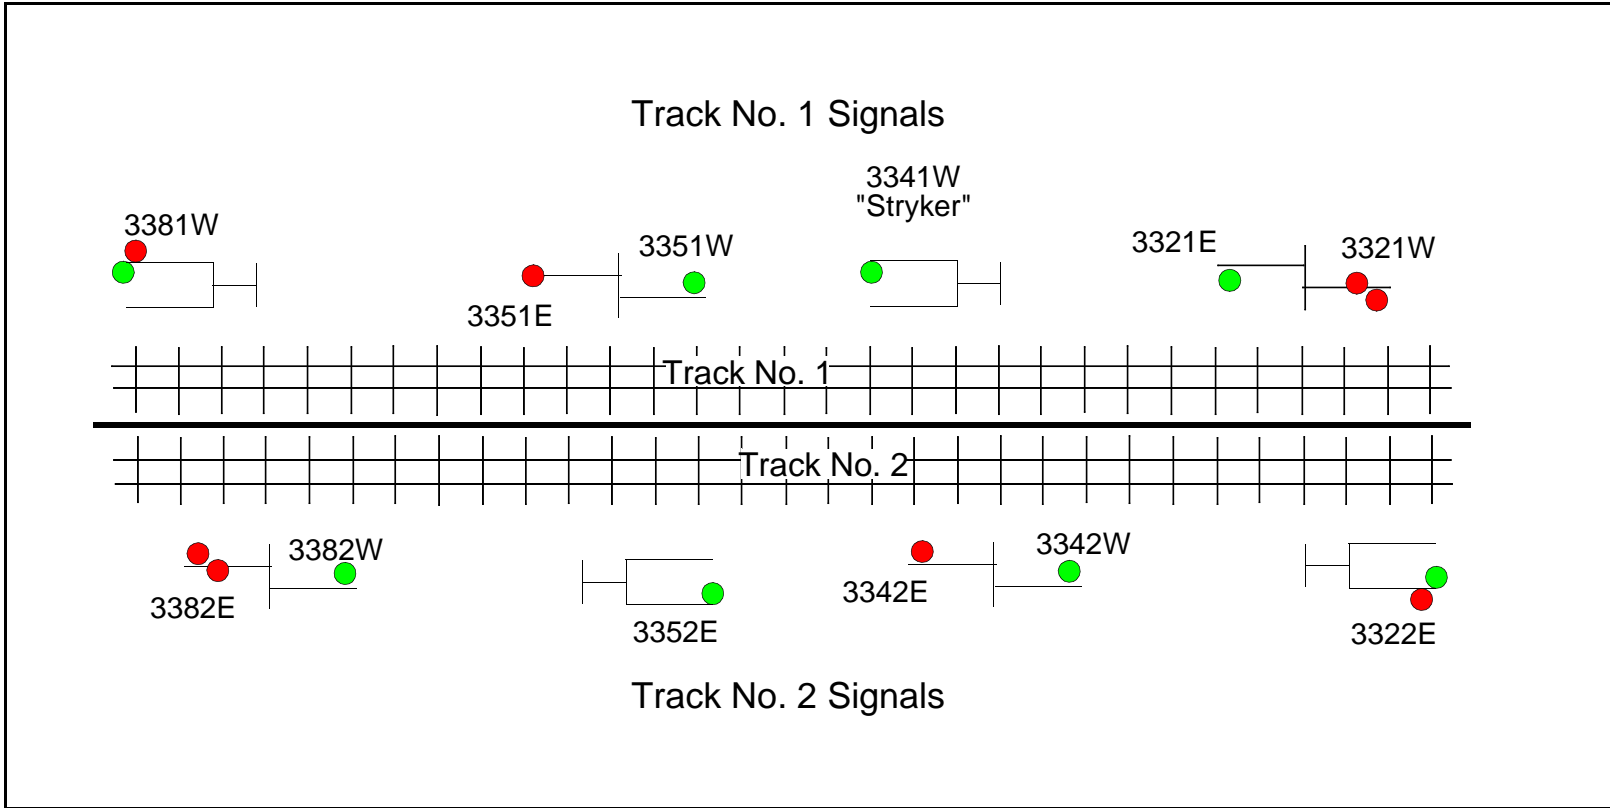
**Figure 5.** The signals in the accident area were on bracket masts alternating with ground masts. In the layout of the accident area shown above, the westbound signals at MP 334 (Stryker) and MP 338 are bracketed masts with single-direction light units. The westbound signal at MP 335 is a ground mast with back-to-back light units.

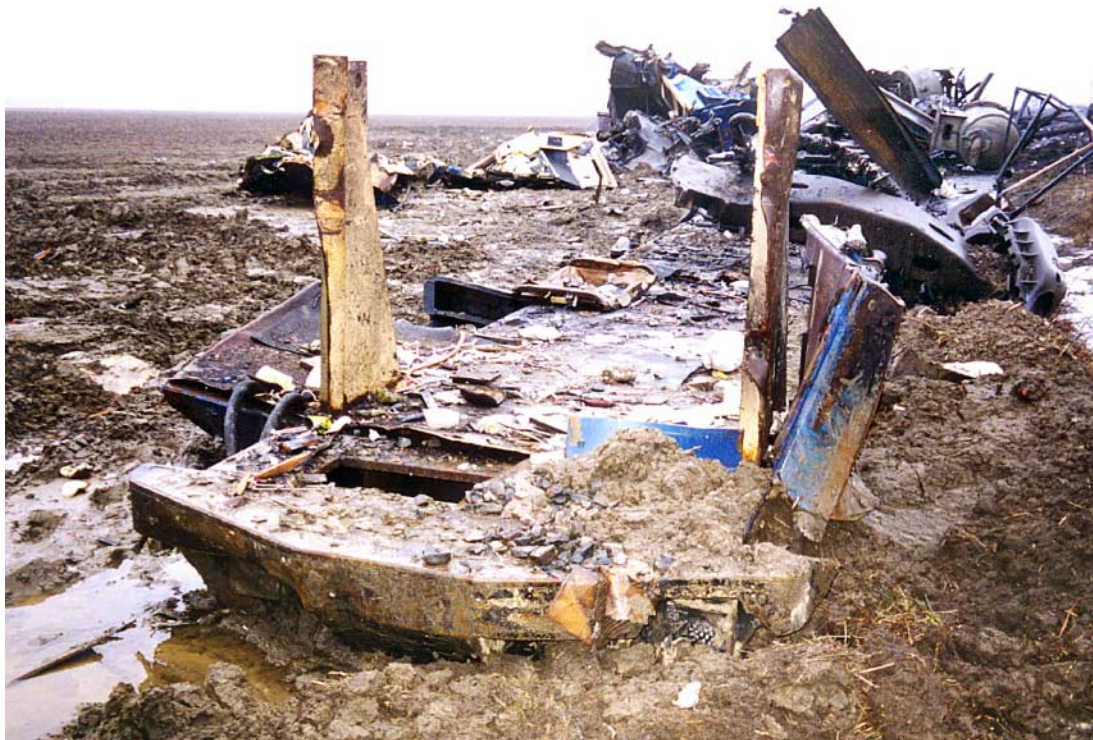
Locomotive No. 6096, the lead unit of Mail-9, was destroyed. The locomotive's collision post assemblies<sup>17</sup> were in place; however, the short hood structure, operating cab assembly, electrical cabinet, prime mover (diesel engine), main generator, and air compressor equipment had been sheared off at the surface of the underframe assembly. (See figure 6.) The diesel engine and main generator were found adjacent to the underframe assembly. The diesel locomotive fuel tank and both truck assemblies had separated from the unit. Investigators noted a large quantity of diesel fuel residue around the wreckage.

**Figure 6.** Locomotive underframe assembly.

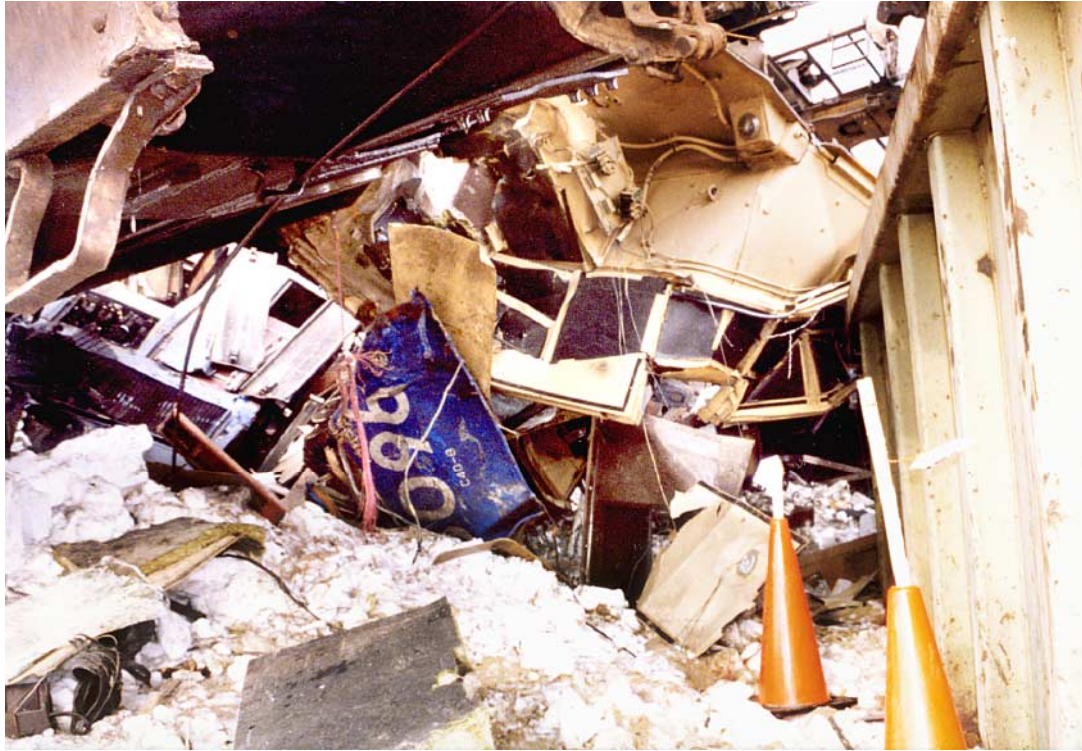
The locomotive cab had been breached, crushed, and displaced from the underframe assembly and had come to rest almost inverted against a gondola car, which was about 10 feet in front of the underframe debris of locomotive No. 6096. The cab interior did not show evidence of fire damage. (See figure 7.) The event data recorder, which was found beneath the wreckage, sustained such significant damage that the Safety

**Figure 7.** Postaccident cab interior.

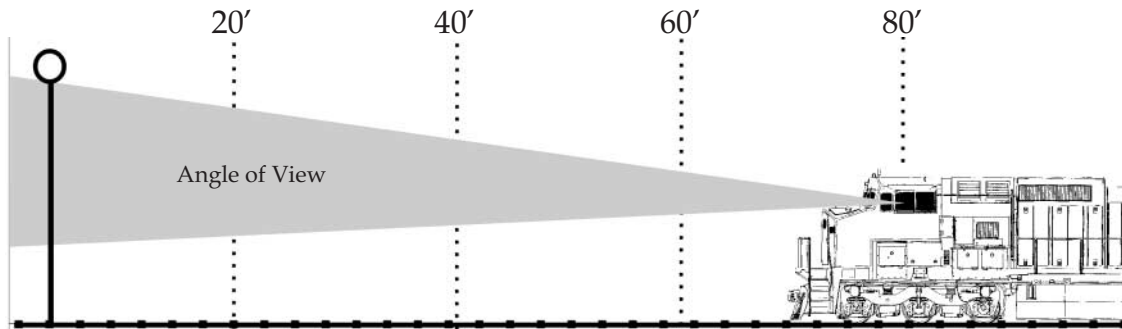
**Figure 8.** At about 80 feet away, the engineer's view of the 28-foot-high signal is completely obstructed by the top of the cab window.

Visibility tests determined that, in clear weather, both 17- and 28-foot-high signals were first visible from the locomotive cab at a distance of more than 10,000 feet. Based on the calculated angle of view, a 28-foot-high signal would begin to move out of the engineer's angle of view once the locomotive moved to within about 83 feet of the signal. At about 80 feet, the calculations indicated that the engineer's view of the signal would be completely obstructed by the top of the locomotive window.
