Collision of Burlington Northern Santa Fe Freight Train With Metrolink Passenger Train Placentia, California April 23, 2002

Railroad Accident Report **NTSB/RAR-03/04**

**NTSB/RAR-03/04
PB2003-916304
Notation 7590
Adopted October 7, 2003**

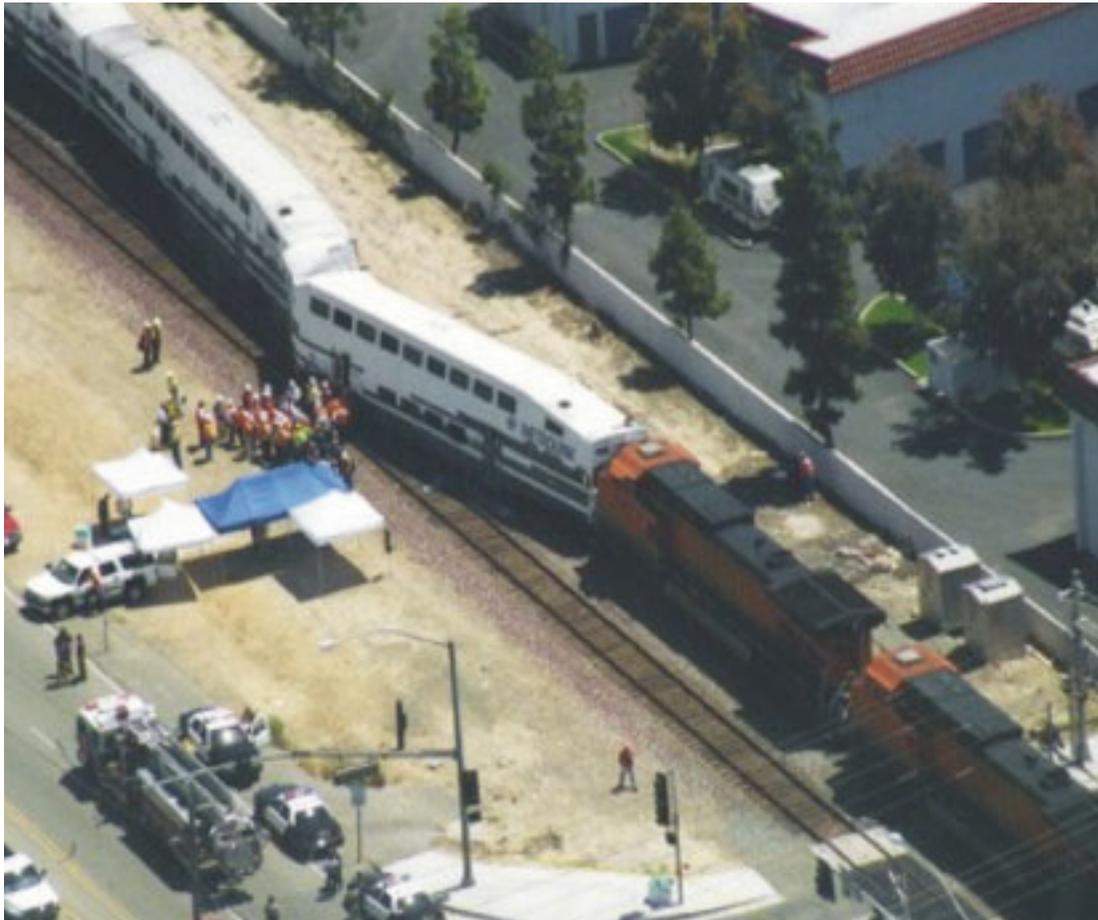
A security surveillance video camera at a commercial storage facility adjacent to CP Atwood captured a portion of the collision on tape. The tape shows Metrolink 809 coming to a complete stop with the trailing (third) Metrolink passenger car standing in the center of the video camera view. After being stopped for about 12 seconds, Metrolink 809 is propelled backward as BNSF 5340 makes contact. The BNSF 5340 lead locomotive comes to rest in the center of the video image after both trains have stopped. Based on the known length of the Metrolink passenger cars and of BNSF locomotive 5340, the easterly movement of Metrolink 809 during impact was calculated to be about 243 feet. (See figure 3.)

Figure 3. Aerial photo of accident scene (courtesy Orange County Sheriff's Department).

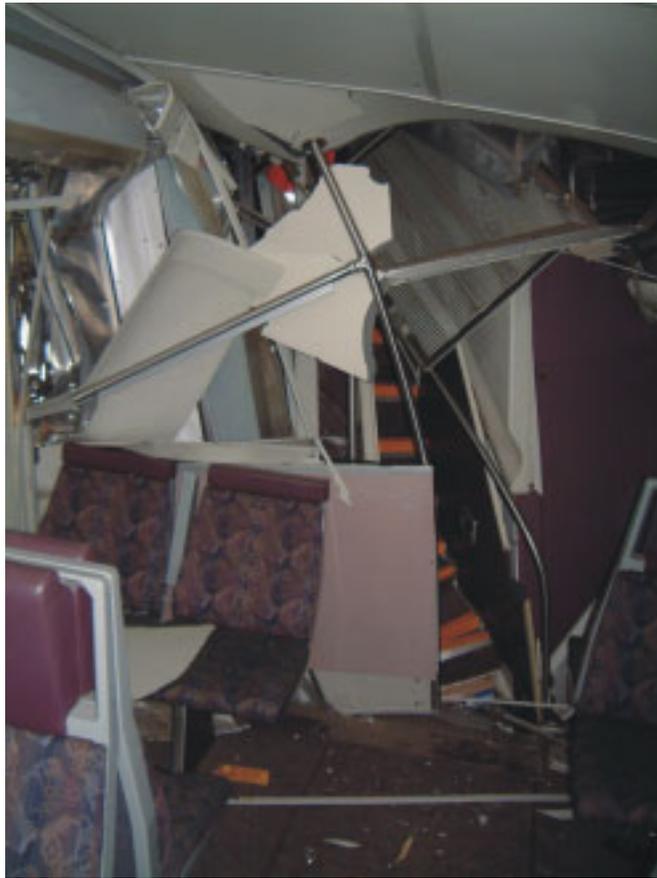
The Metrolink cab car, 634, sustained substantial crush damage and debris in and around the aft stairwell, which rendered the stairwell impassable. (See figure 4.) The stairwell provides access between the upper-level deck, the intermediate level, and the lower-level deck of the railcar (where the main doors are located). There is an intermediate level at each end of the railcar where an end door allows passage to an adjacent coach car. When the cab car came to rest, the aft end door was misaligned relative to the adjacent coach car. (See figure 5.) Emergency responders reported that those passengers on the intermediate level were able to remove the emergency exit windows without external assistance and were readily able to exit through the emergency exit windows and climb to the ground on ladders.

Figure 4. Damaged stairway in Metrolink cab car.

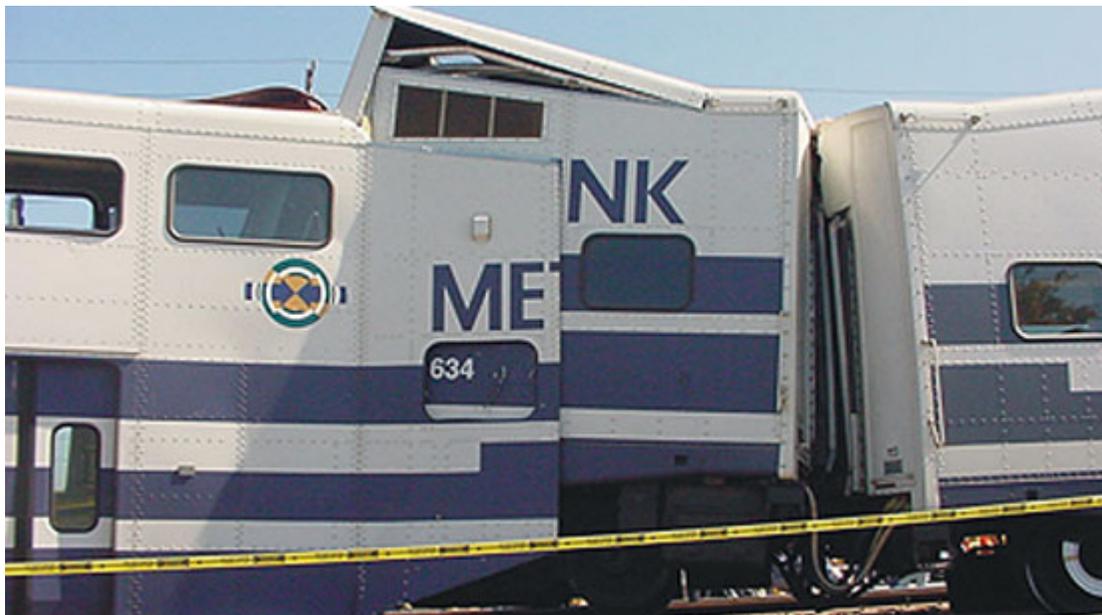
Figure 5. Damaged exterior of Metrolink cab car.

Metrolink cab car 634 had both its truck assemblies derailed, and the aft end of the railcar had skewed about 11 feet to the north. The carbody received relatively moderate impact damage to the front exterior and operator's cab. The aft end of the carbody structure was substantially damaged. The carbody in the vicinity of the aft stairwell was bent to the left (relative to the direction of travel) and displayed a 30° bend from its linear configuration. The aft end of the carbody was laterally displaced about 89 inches relative to its linear configuration, with the displacement point occurring about 178 inches from the aft bulkhead exterior fascia. Debris and crush damage rendered the aft stairwell impassable. There were no occupants reported in the stairwell area at the time of the accident. A section of the roof panel above the aft stairwell of the car had separated from

its attachment and was buckled upward about 35 inches. A segment of the left sidewall panel near the aft stairwell of the car had been longitudinally displaced from its structural attachment. This resulted in a localized partial telescoping of the carbody sidewall panel structure in that area.²³ On the underside, severe damage was apparent on the structural steel center sill assembly.

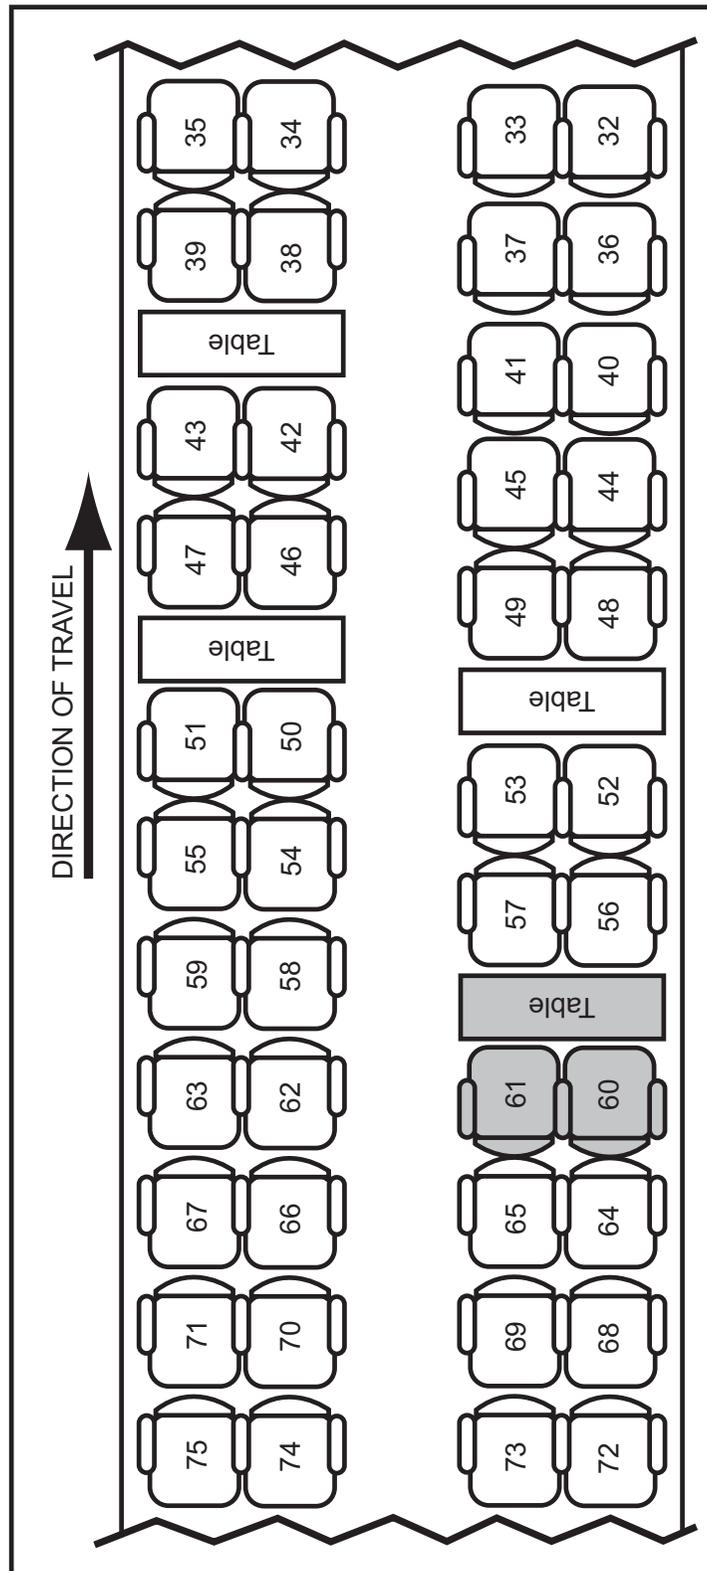
A review of the pathology reports on the two fatalities indicated that both persons received severe blunt impact trauma injuries to the chest and upper abdomen. These two fatally injured persons were found near seats 58 and 61 and 66 and 70, respectively, on the upper level of the lead railcar. They were apparently sitting next to each other on the right side of the aisle (relative to the direction of travel) in seats numbered 60 and 61, with both persons facing the direction of travel. (See figures 7 and 8.) These seats are about in the middle of the railcar and are a paired seating set arranged in an opposing (face-to-face) layout with another paired seating set (seat numbers 56 and 57), with a workstation table between them. The workstation table was found to have been pushed forward relative to its normal service location and was partially resting against the seatback of the opposite seat pair set. Although the table pedestal had not fully separated from its attachment to the floor, its attachment joint with the floor was bent and partially separated.¹³ No one was identified as having been occupying seats 56 or 57 at the time of the collision.

Figure 7. Seating layout of the upper-deck level of the Metrolink cab car. (Fatally injured passengers were seated in seats 60 and 61 at workstation table.)

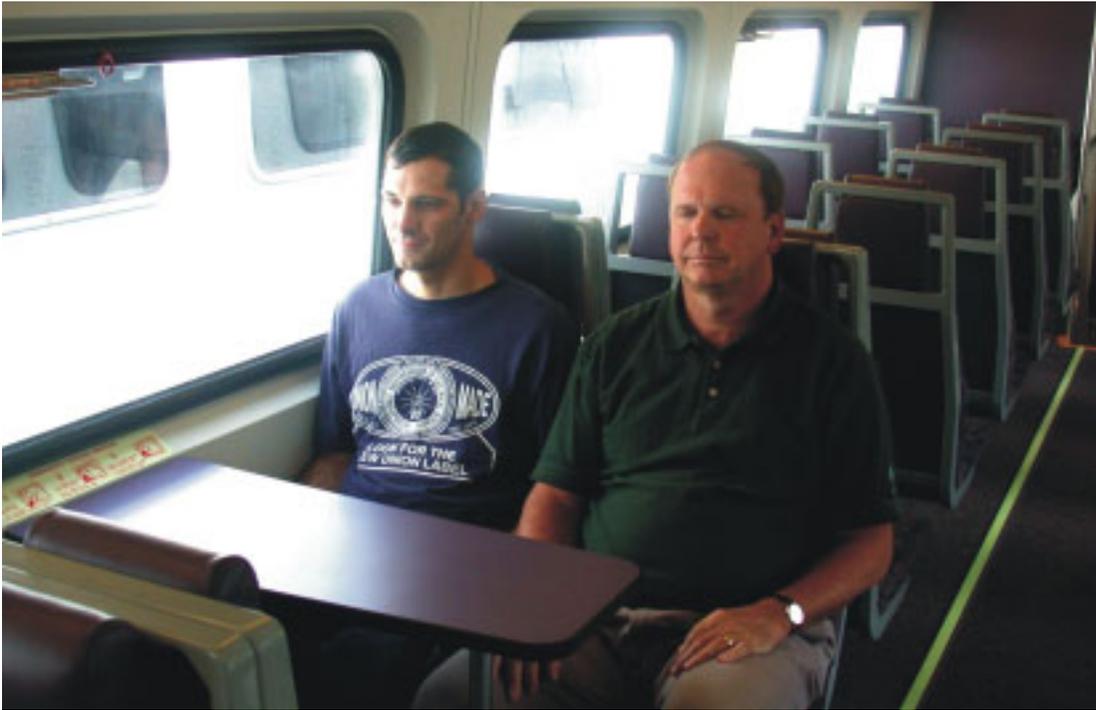
Figure 8. Photograph depicting a simulation of the positions of the two fatally injured passengers relative to an exemplar workstation table. (The passengers were facing the direction of travel.)

The identification of crash injury causation hazards of workstation tables is accomplished only through a detailed biomechanical assessment using finite element simulation modeling or physical testing. The Volpe Center is currently performing finite element computer simulation modeling of carbody structural deformation and of occupant kinematics in order to identify an improved table design. The Safety Board has also been informed that the Volpe Center, in conjunction with the FRA, plans to conduct a full-scale two-car passenger railcar crash test in December 2003. The test will involve the use of crash test dummies and seats with tables similar to those that were in place in the Placentia accident. Data obtained from this test could form the basis for new standards or regulations regarding workstation tables in passenger railcars.
