**Collision of Norfolk Southern Freight Train 192 With
Standing Norfolk Southern Local Train P22 With
Subsequent Hazardous Materials Release at
Graniteville, South Carolina
January 6, 2005**

NTSB/RAR-05/04

**NTSB/RAR-05/04
PB2005-916304
Notation 7710A
Adopted November 29, 2005**

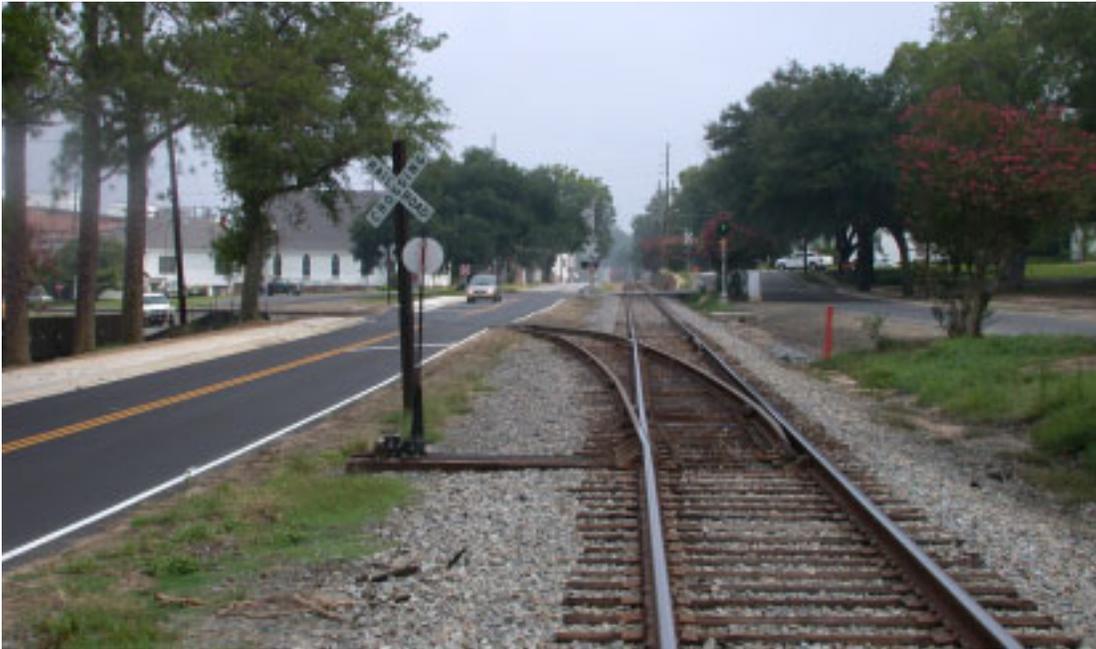
Figure 4. Looking north at the switch and turnout from the NS R main line onto the Avondale Mills industry track at Graniteville. The switch banner, or target, shows white, indicating that the switch is in the “normal” position, that is, aligned for movement along the main line track. (The banner shows red when the switch is set for the industry track.) North of the turnout and to the right of the main line is the wayside light indicating the position of the switch for the Vaucluse Siding.

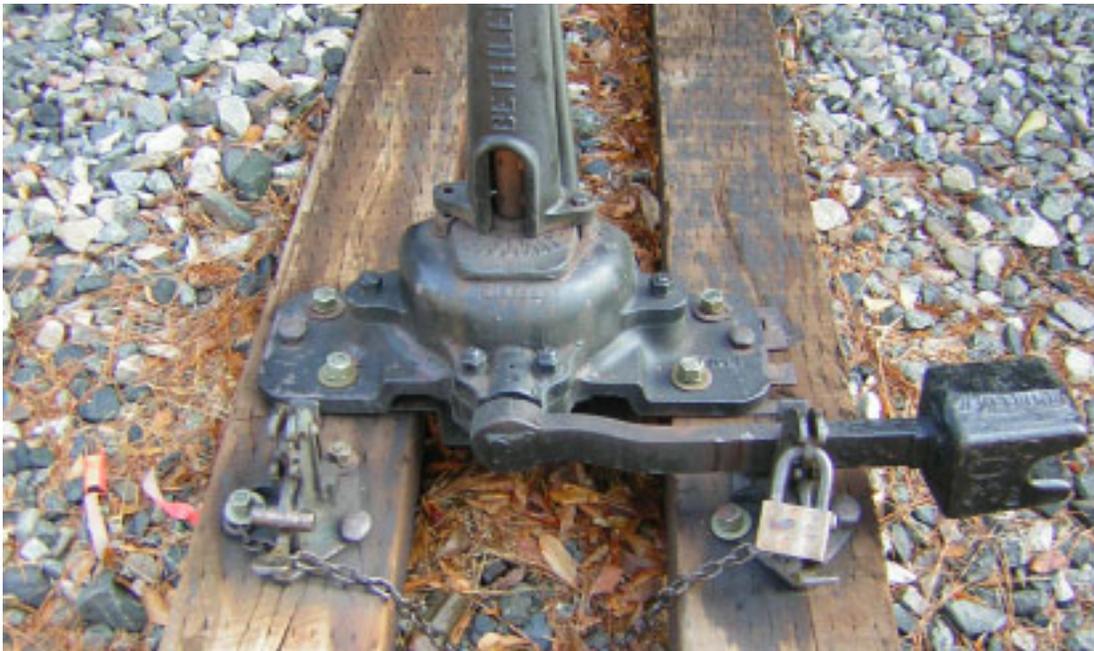
Figure 6. The switch stand for the Avondale Mills turnout switch at Graniteville showing the switch locked in position.

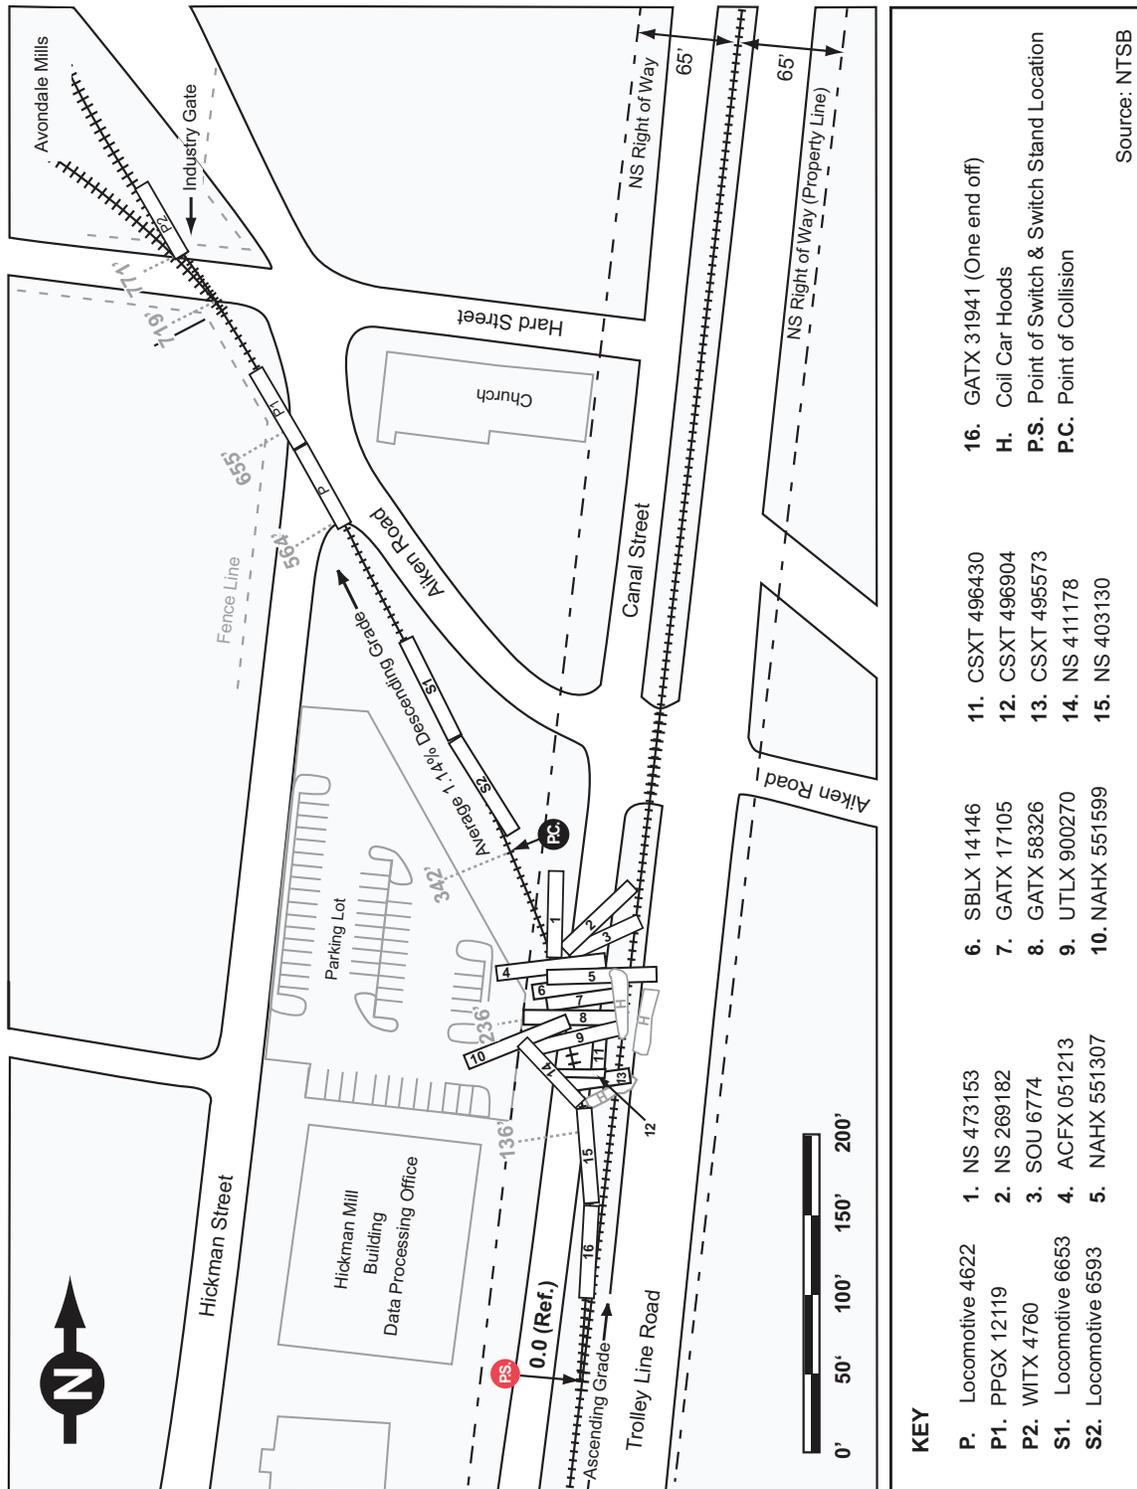
Figure 7. Distribution of wreckage after the derailment and collision. “P.C.” indicates estimated point of collision

Wreckage and debris of the derailed railroad equipment extended more than 500 feet, beginning at the industrial turnout switch and continuing in a northerly direction along the industry track. Investigators were not able to perform a detailed documentation of the wreckage because of the continuing potential of a hazardous gas release and because of the wreckage cleanup efforts that prevented access to the site.

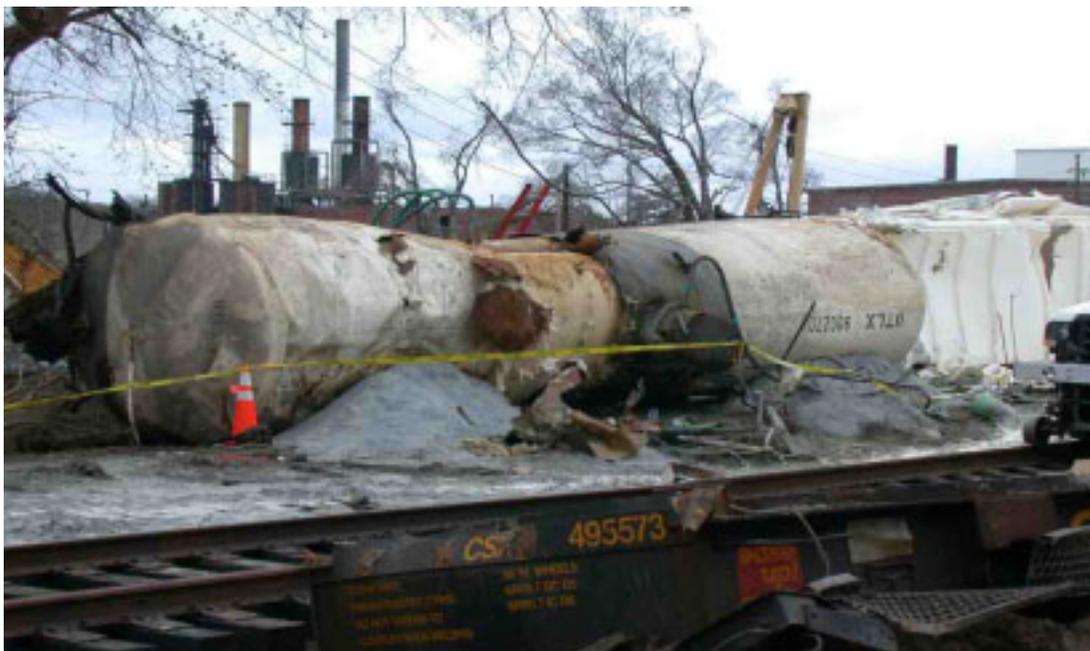
Figure 8. Ruptured chlorine tank car during unloading. The tank has been rotated so that the patched puncture is at the top. Hoses attached to the patch are drawing off chlorine vapors that are then bubbled through a sodium hydroxide solution to reduce their hazard.

flattening, and there was a dent on the shell near the A-end head weld at about the 2 o'clock position. Emergency responders on the day of the accident measured the liquid level of the chlorine remaining in the tank and found that about one-third of the original load, or 30 tons (4,609 gallons), remained in the tank.²³ The responders also noted that the B-end coupler²⁴ of a steel coil car (the 11th car in the train) was in contact with the damaged tank jacket near the puncture and that it had frost on its surface. Metallurgical examination of the puncture area revealed that the dents in the puncture area mated with damaged protrusions on the 11th-car coupler.

About 11:00 p.m. on January 6, responders inserted a temporary polymer patch in the opening of the punctured ninth tank car. At 7:00 p.m. on January 8, responders began unloading sodium hydroxide from the eighth tank car. At 8:50 p.m., the temporary polymer patch in the ninth tank car failed, releasing chlorine vapors and causing the unloading of the eighth tank car to be temporarily discontinued. By 8:37 a.m. on January 9, responders had inserted a second polymer patch in the opening in the punctured ninth tank car. Chlorine vapor was then drawn from the car to create a vacuum that would reduce the amount of chlorine gas escaping. The chlorine vapor removed from the tank was transferred into a sodium hydroxide solution to neutralize it. Following these measures, the unloading of the eighth tank car was resumed and completed by 3:30 p.m. While the eighth car was being unloaded, construction began on a permanent lead patch for the punctured ninth car.

About 1:10 a.m. on January 12, responders began unloading chlorine from the derailed seventh car. By 9:30 a.m., the steel patch was in place on the punctured tank car, and the unloading was started. Because the punctured tank car had extensive damage, the remaining chlorine could not be removed as it had been from the unbreached cars. The chlorine in this car had to be vaporized and transferred from the tank as a gas, after which it was bubbled through a sodium hydroxide solution held in a separate tank. This process, which converted the chlorine into a relatively safe and easily transportable liquid bleach and salt solution, required several days to complete.

By midnight on January 18, the unloading of the punctured tank car was complete. (See figure 8.) On January 19, by 9:00 a.m., the tank car was cleaned and purged on site. It was then loaded on a flat car and moved to the Augusta Yard the following morning, January 20.

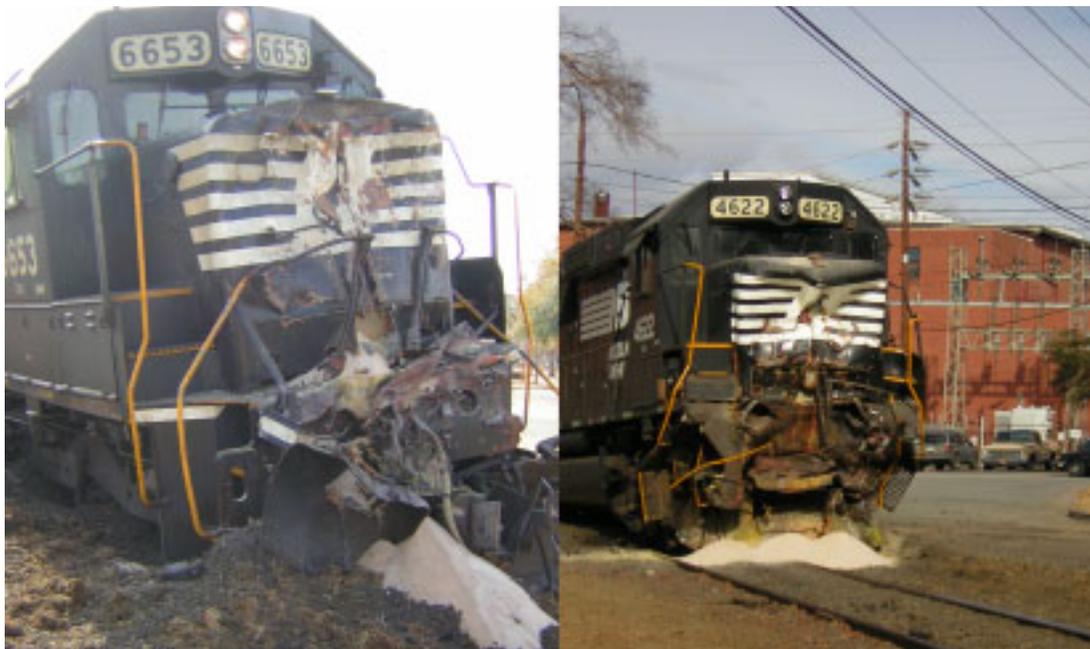
The lead locomotive unit of train 192 derailed but remained upright (leaning to the east at about a 12° angle) and positioned somewhat aligned with and about 4 feet from the centerline of the industry track. (See figure 9.) The locomotive unit appeared not to have lost overall structural integrity or to have sustained significant loss of occupant survival space. The cab windows were not broken. The unit sustained severe impact damage to the front end, with the front coupler, pilot plate structure, and stepwell elements severely mangled and with various components bent and displaced in an upward and aft direction by about 2 feet. Except for the front impact damage, the carbody of this unit did not exhibit substantial collision damage.

Figure 9. The lead locomotive of train 192 (left) and the lead locomotive of train P22 (right) showing collision damage.

The P22 locomotive unit sustained severe impact damage to the front carbody cowl (short hood), which was displaced in an aft direction by about 2 feet. The right side-sill was buckled downward several inches, proximate to the area above the fuel tank. The left side-sill was also buckled, but to a lesser degree than the right. Except for the front impact damage and the damaged side-sills, the carbody of this unit did not exhibit substantial collision damage. There was visible evidence of a diesel fuel spill beneath the fuel tank but no evidence of fire. The cab compartment appeared to be relatively intact and did not lose overall structural integrity or sustain significant loss of survival space. One window on the left side of the cab was shattered.
