# Collision Between Two BNSF Railway Company Freight Trains Near Gunter, Texas May 19, 2004

NTSB/RAR-06/02

## **Collision Between Two BNSF Railway Company Freight Trains Near Gunter, Texas May 19, 2004**

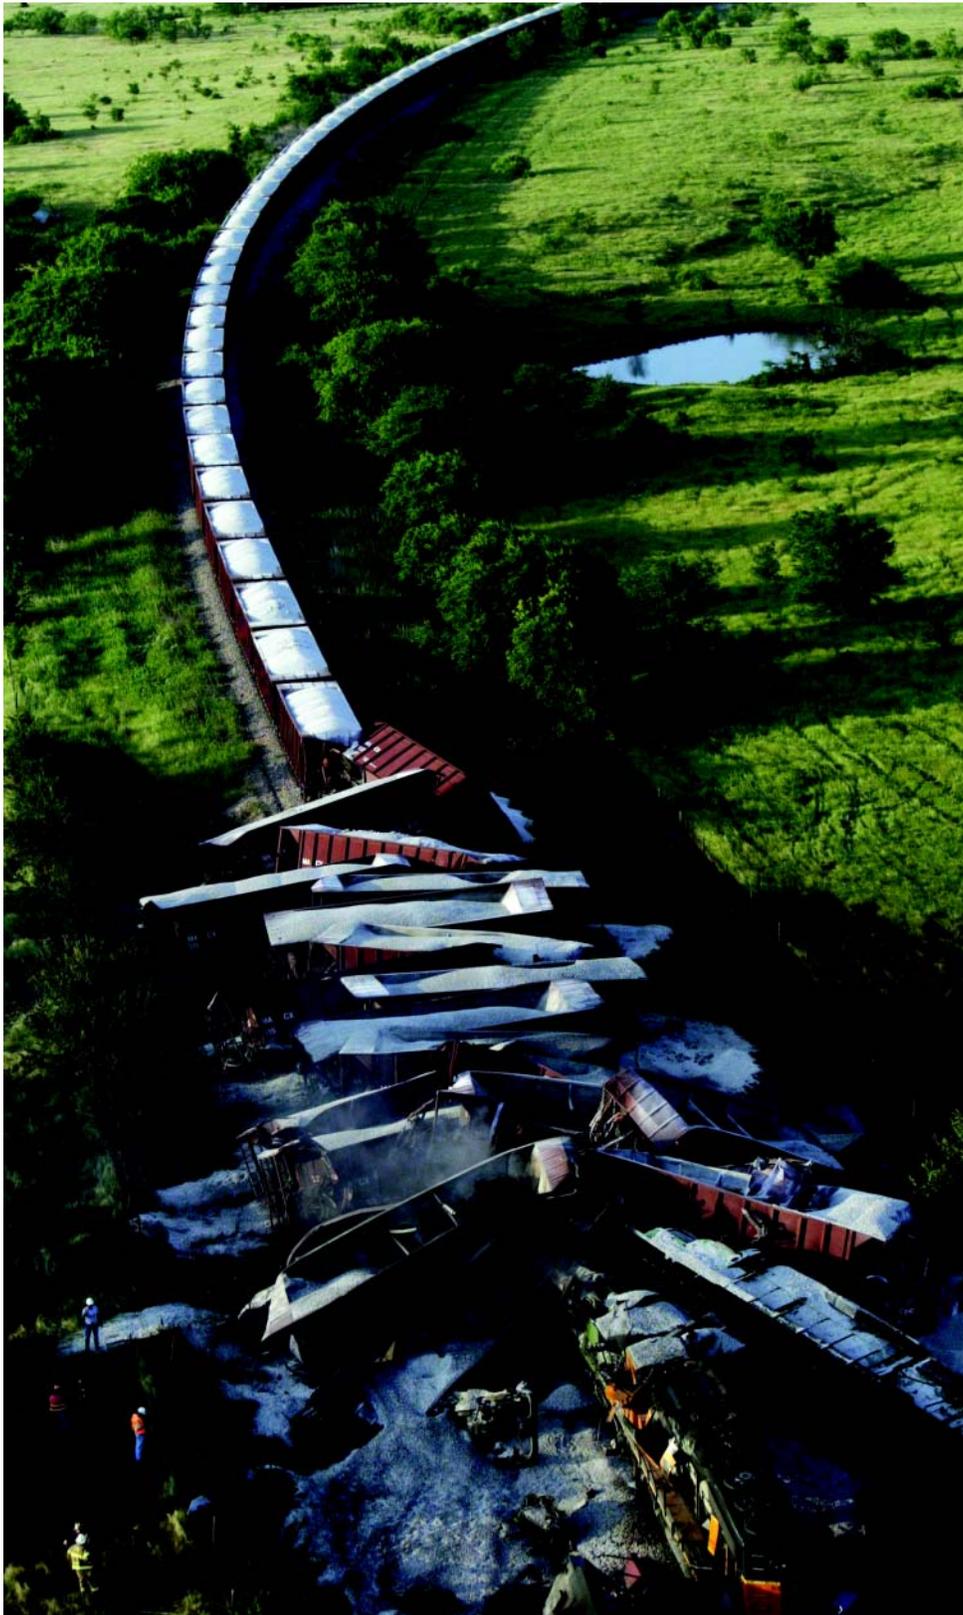
**Figure 4.** Aerial photo of accident scene.

During the collision, both trains were extensively damaged. A total of 28 cars were derailed. BNSF 6789 South had three locomotives, all of which were derailed and

destroyed. BNSF 6351 North had four locomotives. The lead locomotive and the second locomotive were derailed and destroyed. The third and fourth locomotives also sustained extensive damage; however, they were not derailed.

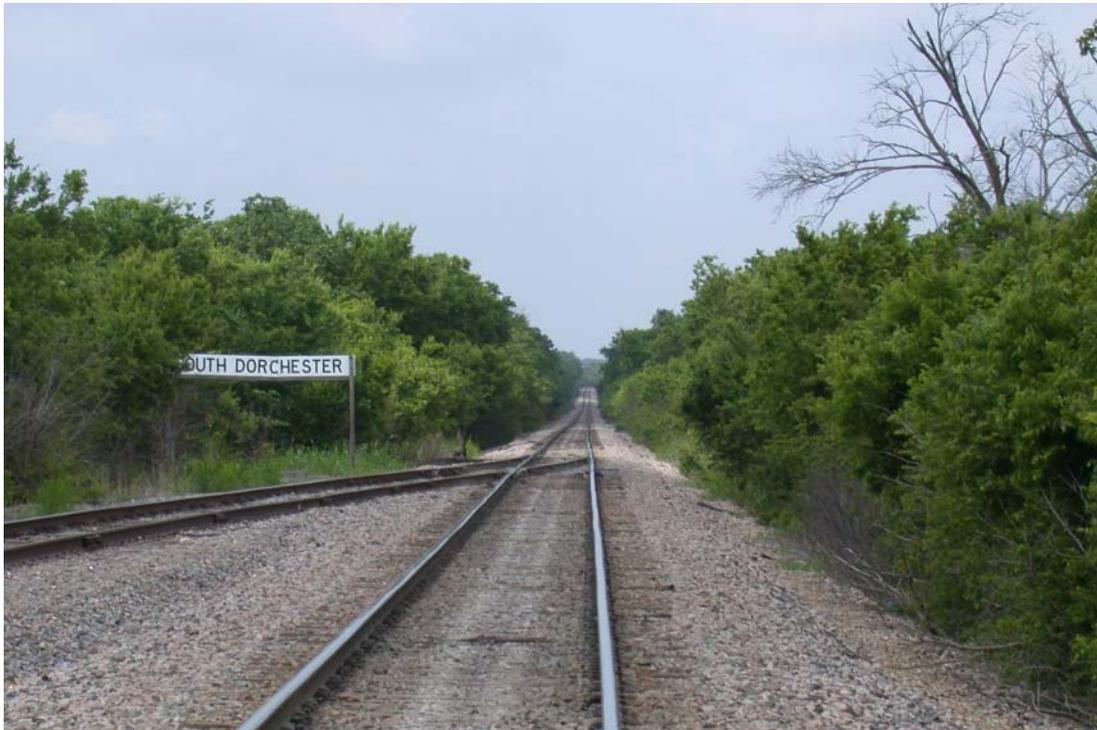
**Figure 6.** South siding switch at Dorchester

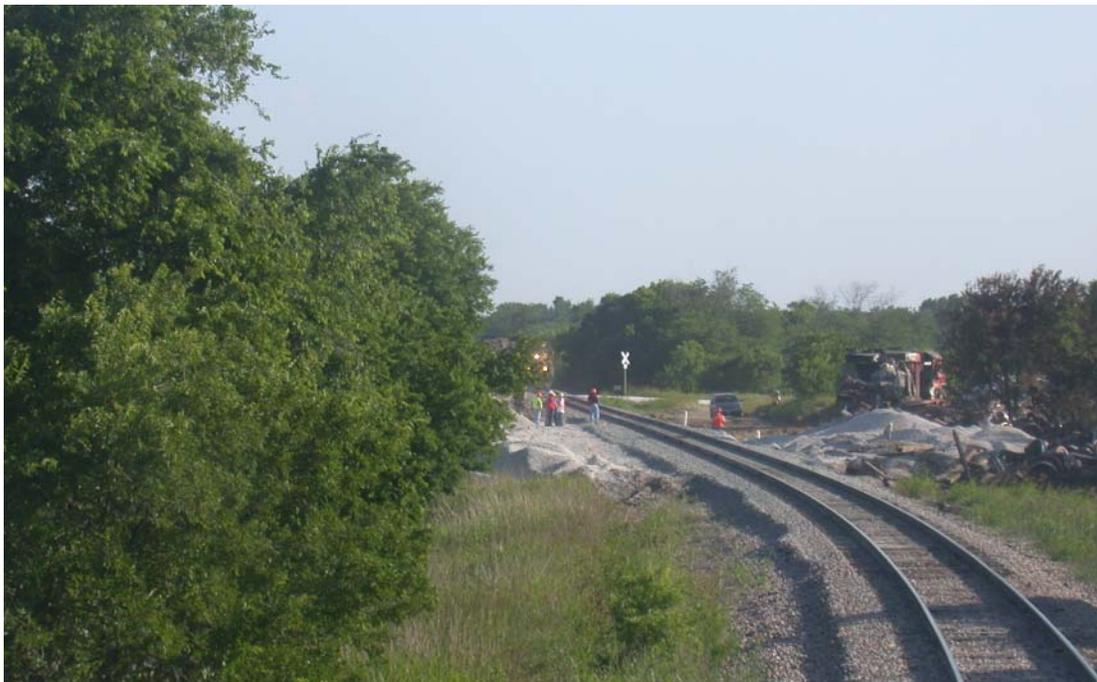
During the testing, both locomotives stopped at the point of collision at MP 661.9 and backed away from each other in 100-foot increments until they were 1,700 feet apart. Both locomotives were then moved 25 feet farther apart until the southbound locomotive was backed into the curve and lost sight of the northbound locomotive. At 875 feet from the point of collision, personnel on each locomotive lost sight of the other locomotive. The distance between the two locomotives measured 1,750 feet. (See figure 7.) The sight-distance observations and the event recorder speed data indicate that the crewmembers in the control cabs had about 15 seconds to recognize the impending collision, apply the emergency brakes, and jump from the moving trains before impact.

**Figure 7.** Collision site as viewed from southbound train (BNSF 6789 South).
