Collision of Two CN Freight Trains
Anding, Mississippi
July 10, 2005

Railroad Accident Report

**NTSB/RAR-07/01
PB2007-916301
Notation 7870A
Adopted March 20, 2007**

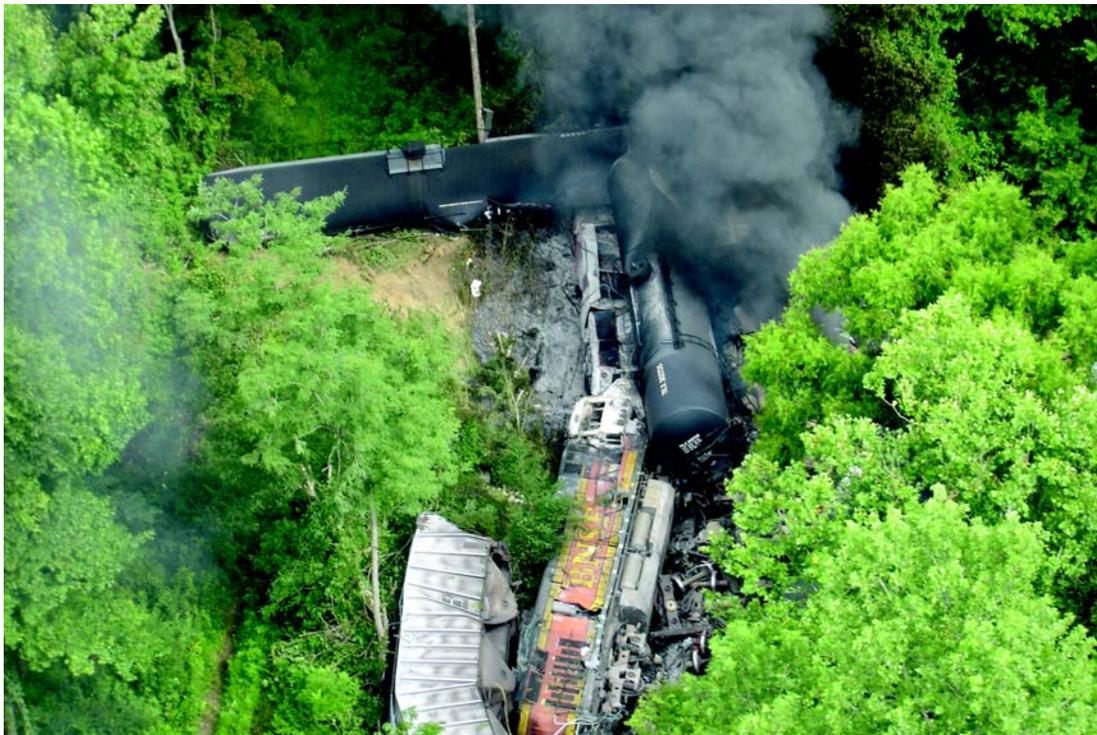
About 4:15 a.m., shortly after the northbound train passed the *stop* signal at North Anding, the two trains collided head on about 1/4 mile north of the north siding switch. (See figure 3.) The estimated point of collision was milepost (MP) 189.6 in the community of Anding. Most of this area was undulating agricultural land. The track was relatively straight with occasional curves, one of which was the curve at the accident site. The CN timetable limited freight train speed on this curve to 40 mph.

Figure 3. Aerial view of small portion of accident site.

The track was located in an excavated ravine, and trees restricted the view as trains rounded the curve at the accident site. The southbound train was placed into emergency braking about 3 to 5 seconds before the collision, and it was traveling about 23 mph with the throttle in position 6 (of 8). The event recorders on the northbound train were destroyed because of extensive collision and fire damage to the locomotives. However, signal system data indicated that the northbound train was traveling about 45 mph as it passed the North Anding *stop* signal just before the collision.

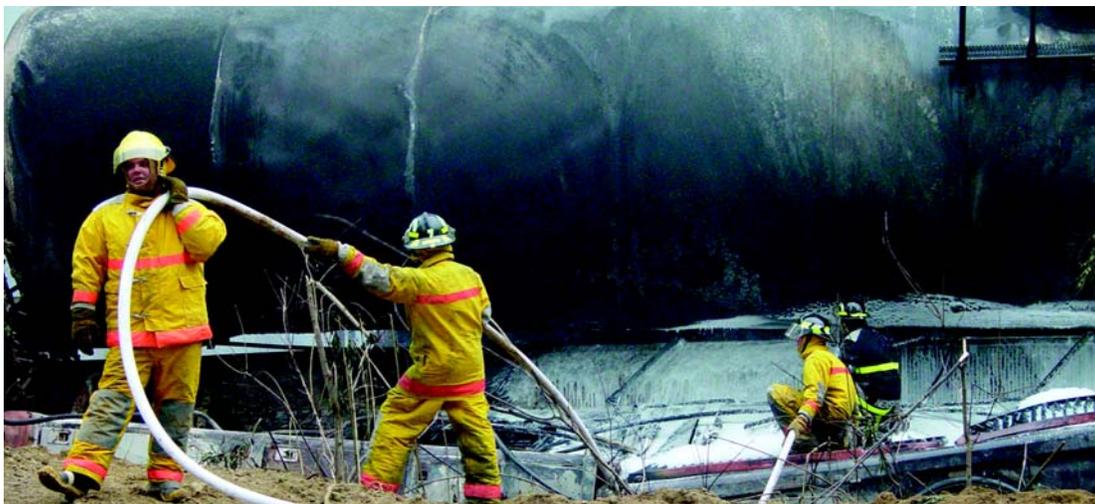
About 8:25 a.m., fire suppression efforts commenced using aqueous film forming foam on the diesel fire. (See figure 4.) After about 25 minutes, the initial supply of foam (approximately 65 gallons) was exhausted, suppression efforts were suspended, and the fire continued to burn. Wreck-clearing equipment began arriving on scene about 9:00 a.m., and an access road was created to move equipment to the accident site. While efforts were made to obtain additional fire-fighting foam, some of the derailed tank cars were rerailed and moved away from the fire. The CN’s contractor, U.S. Environmental Services, began efforts to obtain additional foam. It took until about 4:40 p.m. to obtain enough foam and related equipment to resume fire suppression activities. Fire suppression efforts resumed about 6:00 p.m., and the fire was declared suppressed about 7:40 p.m. (See appendix C for a time line of emergency response events.)

Figure 4. Firefighters applying foam during early evening fire suppression effort.

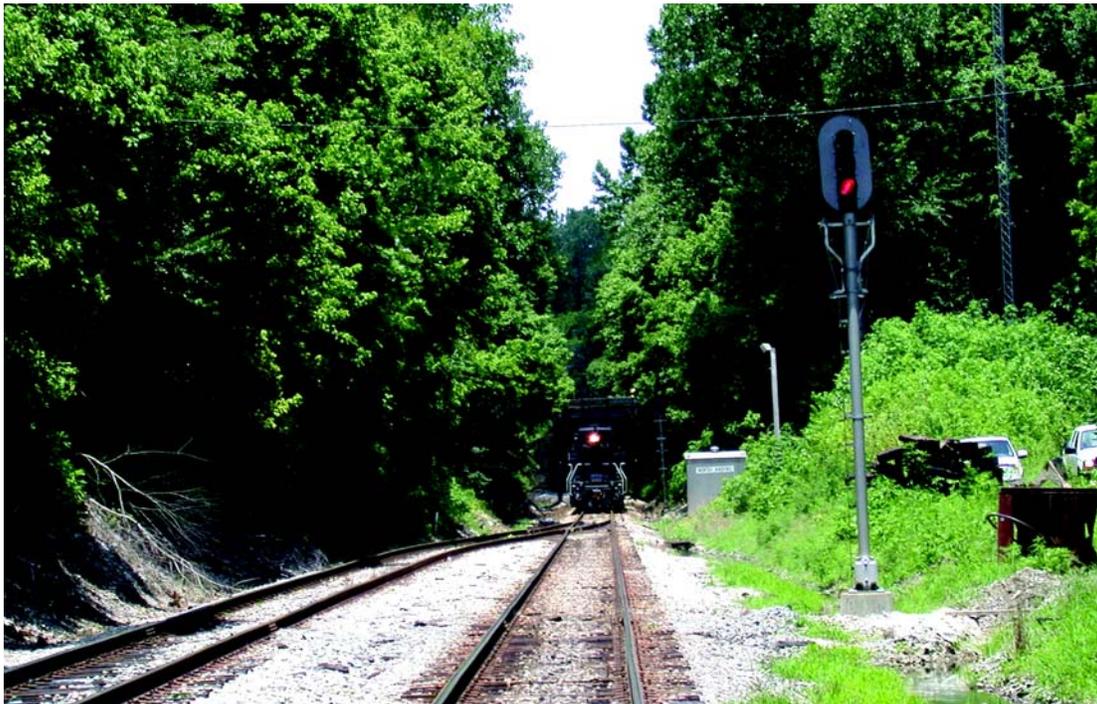
Figure 5. North Anding siding switch viewed from south, facing north (viewpoint of northbound train, IC 1013 North).

Investigators noted damaged rods and wheel marks on the backside switch point at North Anding consistent with the northbound train trailing through¹⁵ a switch that was lined for the southbound train to enter the siding. Inspectors also observed that the switch machine internal locking mechanism was still locked and that the contacts of the circuit controller were centered.

Investigators conducted a track inspection on both sides of the collision area. The siding switch at North Anding previously had been aligned for a movement into the siding. The left-hand switch point had wheel markings on the backside indicating that wheels had damaged the points, forcing them over. Investigators also noted that the various rods connected to the switch points were damaged. Other than the damage to the track at the point of collision, no other track defects were noted.

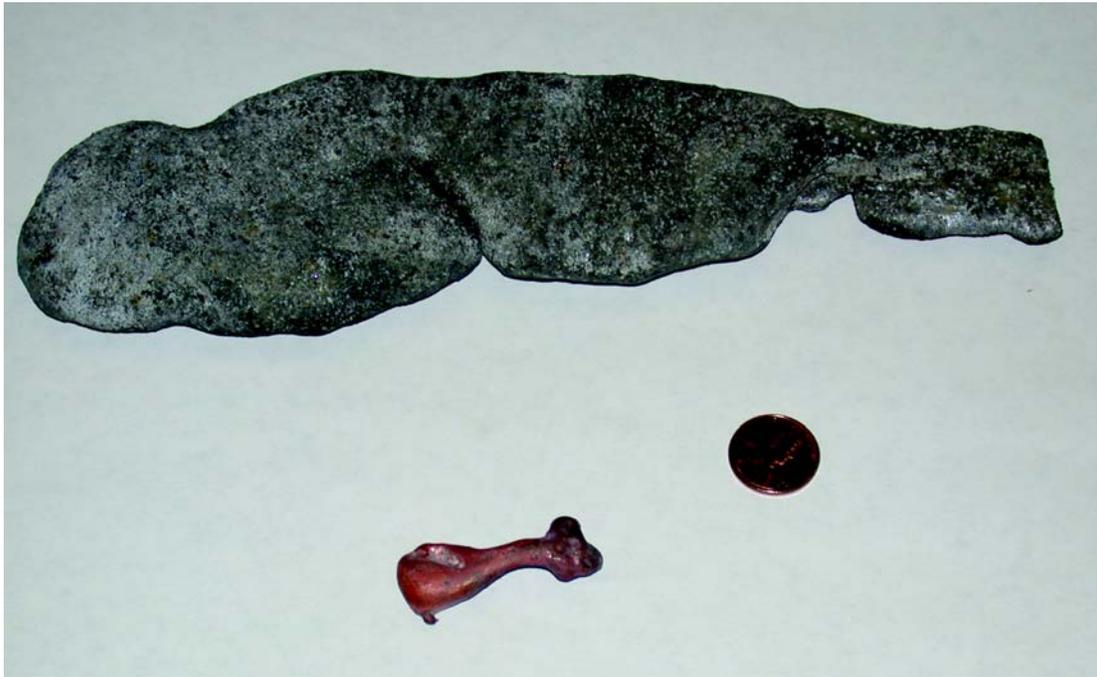
The primary fuel for the postcollision fire was diesel and lube oil. The fire was extremely intense, and it burned for about 15 hours. About 8 hours after it was suppressed, the temperature of some locomotive components measured nearly 400° C. Melted aluminum and copper components also were found in the wreckage. (See figure 6.) According to the *Handbook of Chemistry and Physics*,²³ the melting point of copper is 1084° C, which is higher than the melting point for aluminum or aluminum alloys. According to CN records, all six locomotives involved in the collision were equipped with event recorders. The substantial collision damage and subsequent fire destroyed all but one.

No event recorders were recovered from the northbound train, nor could any remnants of event recorder wreckage be identified due to the extensive damage from the intense, prolonged fire. A Pulse Electronics²⁴ Train Trax solid-state type event recorder was recovered from IC 1014, the trailing locomotive unit on the southbound train. It was shipped to the NTSB Vehicle Recorder Division Laboratory in Washington, D.C. Event

Figure 6. Melted aluminum (top) and copper (bottom) recovered from IC 1013 locomotive on northbound train.
