Derailment of Chicago Transit Authority
Train Number 220 Between Clark/Lake
and Grand/Milwaukee Stations
Chicago, Illinois
July 11, 2006

ACCIDENT REPORT

NTSB/RAR-07/02
PB2007-916302

Railroad Accident Report

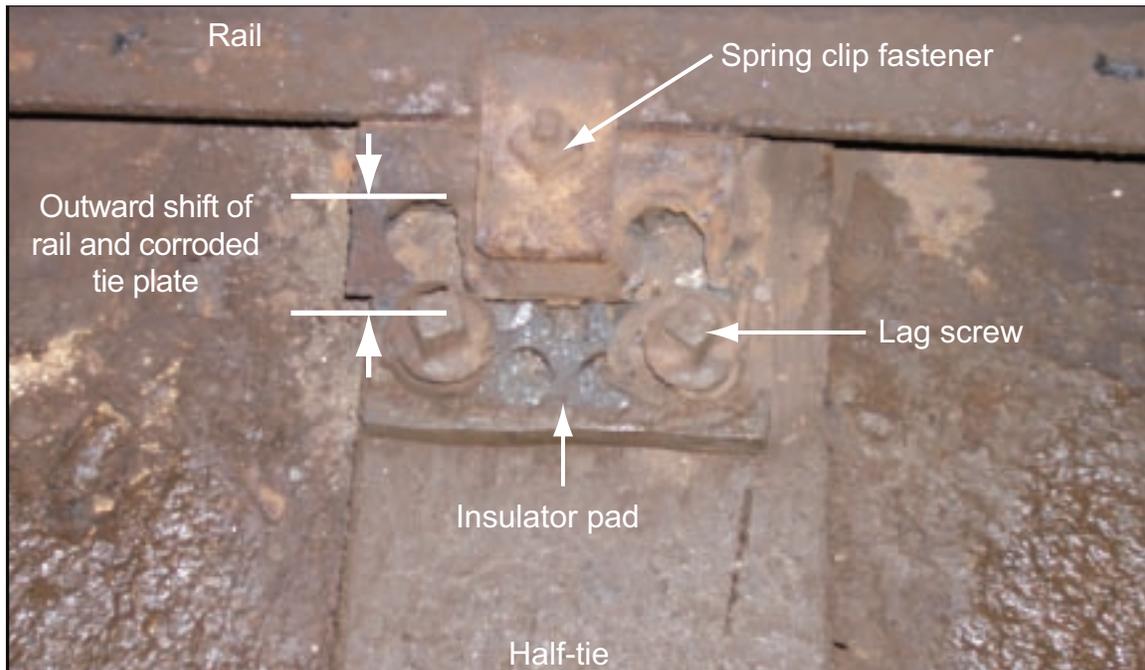
Postaccident examination revealed that multiple rail fastener devices (lag screws, rail clip assemblies, and tie plates) for the outer rail in the curve at CTA station 106+53 had been corroded, worn, bent, broken, and/or displaced from their associated half-ties,¹² and the rail had moved laterally outward under load. (See figure 2.)

Figure 2. Outside rail of curve near point of derailment.

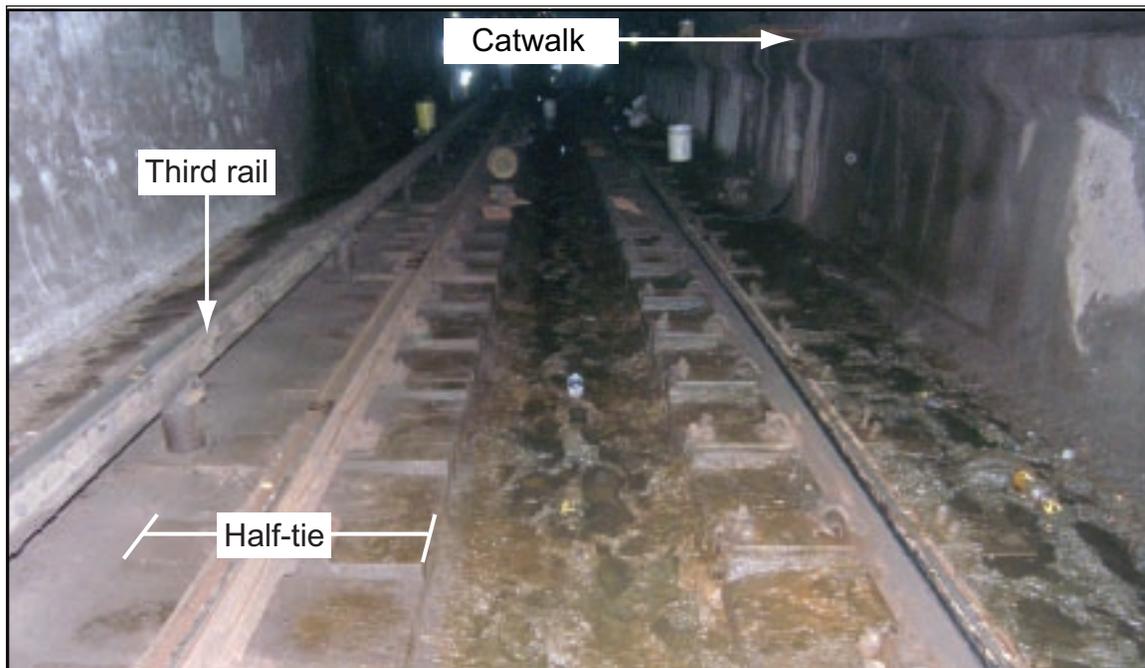
Investigators examined the accident site and found that a major portion of the track structure was directly fixed to the wood half-ties, which were embedded in the concrete subway floor. (See figure 3.) The half-ties' centerlines were spaced 2 feet apart. Placed on top of the half-ties were 7 3/4-inch by 12-inch tie plates. These tie plates were primarily fastened to the half-ties with lag screws.¹⁹ The rail was fastened to the tie plates with spring clips. The rail was 100 pound²⁰ jointed rail manufactured in Illinois in 1948. Most track components were original equipment and had been in place since the track was constructed in 1951.

Figure 3. Chicago Transit Authority subway tunnel in derailment area, showing mud and water conditions.

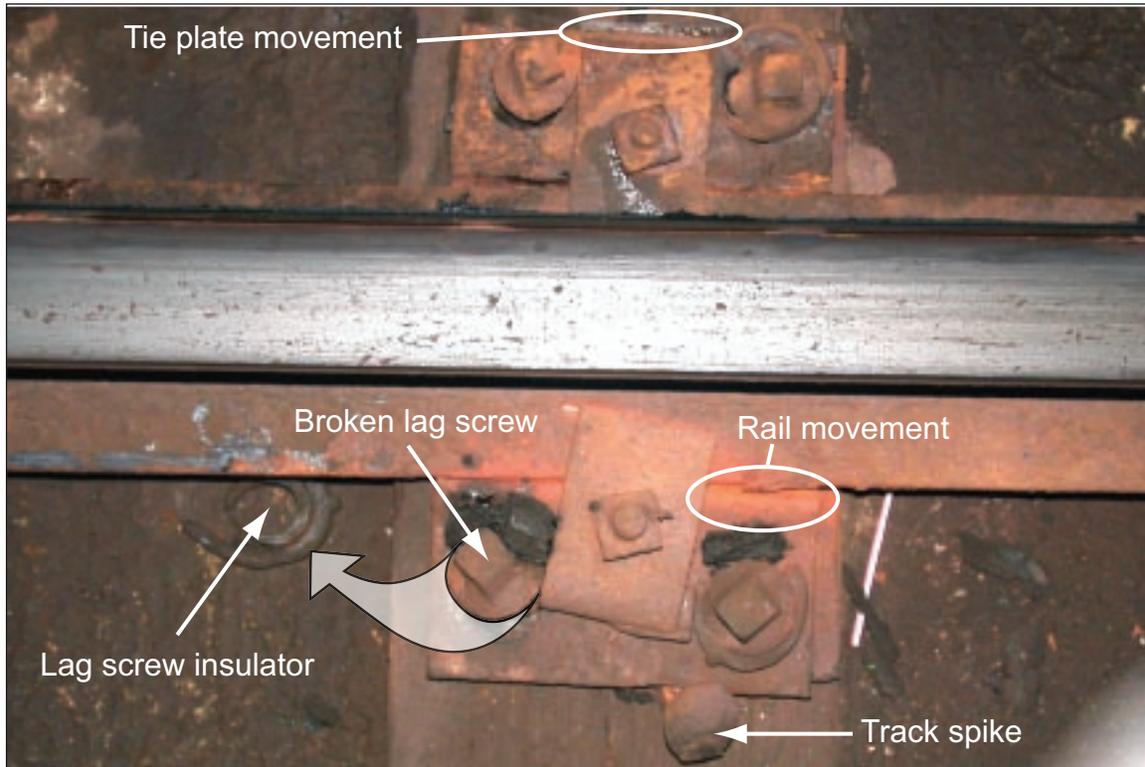
The inspection found that the base of the rail and the rail fastener system (the tie plates, the lag screws, and the spring clips) had corrosion damage. In some areas, track spikes had been added in conjunction with lag screws, and where spring clips or lag screws were missing, track spikes had been used instead.²⁸ There was also evidence of both rail and tie plate movement on the half-ties. (See figure 4.)

Figure 4. Tie plate and rail movement of outside rail near point of derailment. Large white arrow shows displacement of insulator from broken lag screw.

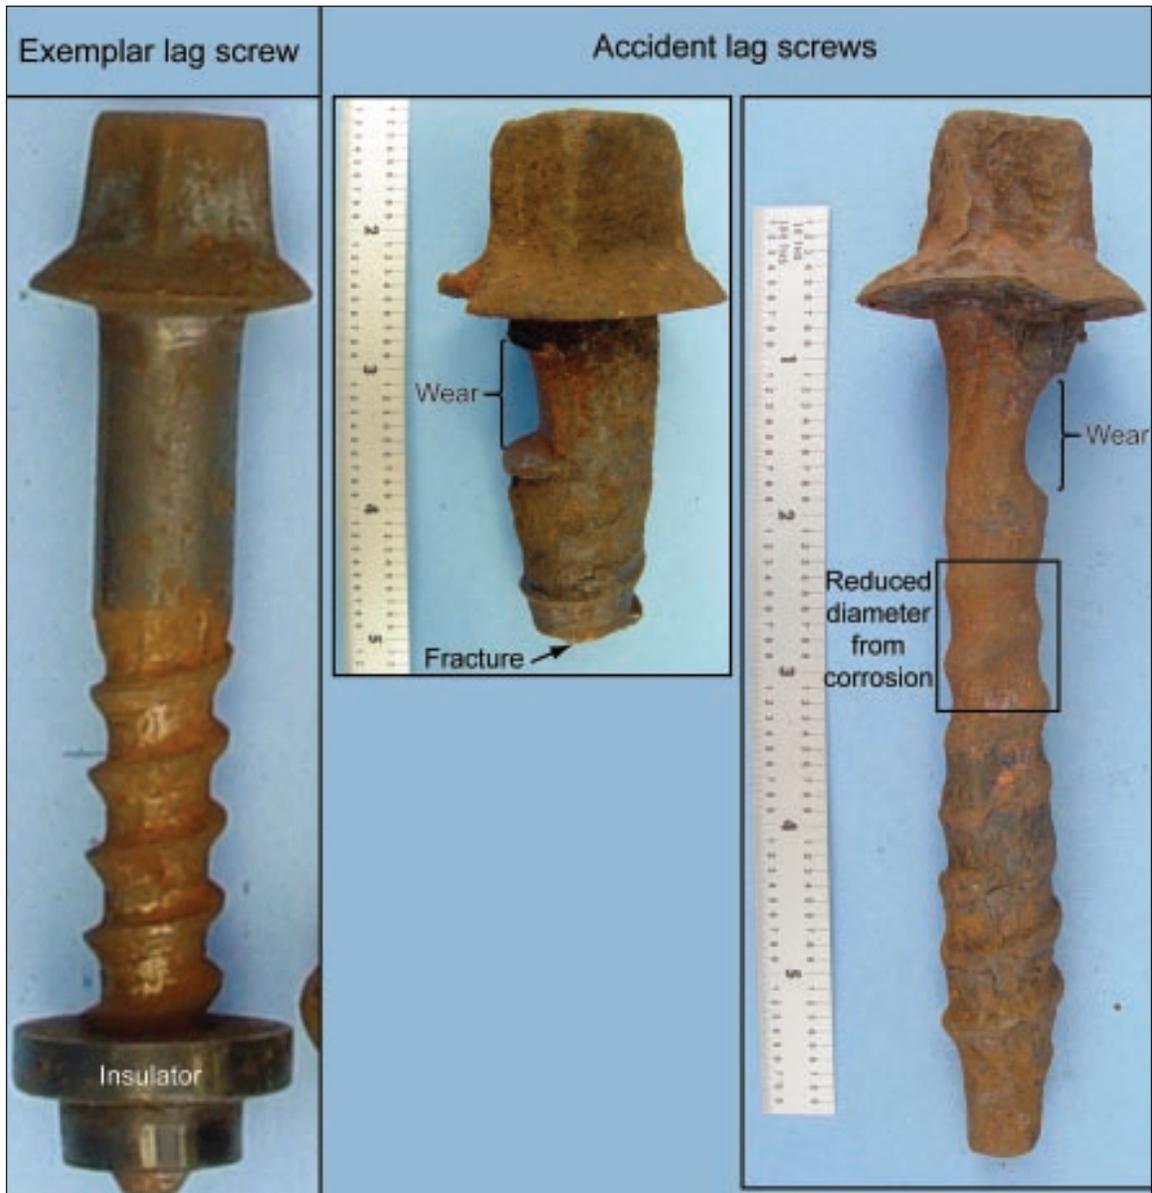
The lag screws, spring clips, tie plates, insulators, and wood tie core samples from the area of the derailment were examined at the Safety Board's Materials Laboratory. All metal components were covered with orange and black oxides. Ten of the 12 lag screws examined had fractured. Each of the 10 lag screws had

significant metal loss due to corrosion and/or wear that caused a reduction in their diameter. Nine of the lag screws fractured in the corroded areas corresponding to the lag screws' upper threads. The fracture on the 10th lag screw occurred in an area of reduced diameter that corresponded to wear from contact with the associated tie plate. Eight of the 12 lag screws had similar reductions in diameter that corresponded to wear from contact with a tie plate. (See figure 5.) Insulators were installed between the lag screws and the tie plates and should have prevented contact between the two.

Figure 5. Damaged lag screws from accident location compared to new exemplar lag screw.

Two of the 10 lag screws had fracture surfaces with a light covering of oxides consistent with a recent fracture. The other eight lag screws had fracture surfaces with a significant covering of dark oxides that obliterated the fine features on the surface, and several of these appeared to have been rubbed consistent with preexisting fractures.
