Collision of Massachusetts Bay Transportation Authority
Train 322 and Track Maintenance Equipment near
Woburn, Massachusetts
January 9, 2007

NTSB/RAR-08/01

Railroad Accident Report

Collision of Massachusetts Bay Transportation Authority Train 322
and Track Maintenance Equipment Near
Woburn, Massachusetts
January 9, 2007

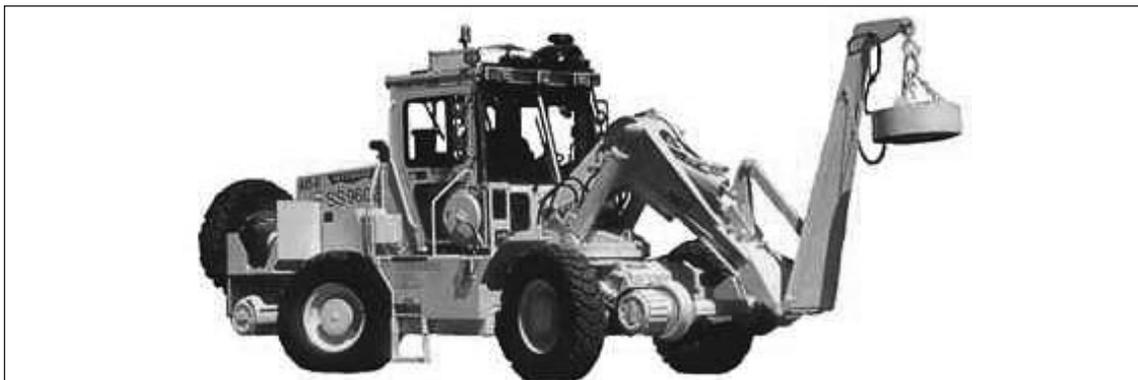
Figure 1. Pettibone Speed Swing 445E.⁴

⁴ The Speed Swing 445E was built by Pettibone. It had four large rubber tractor tires and was equipped with steel wheels that could be lowered onto the rail. The Speed Swing had a hydraulically powered front arm with several different attachments. On the day of the accident, it was equipped for handling cross-ties. The machine weighed 32,217 pounds.

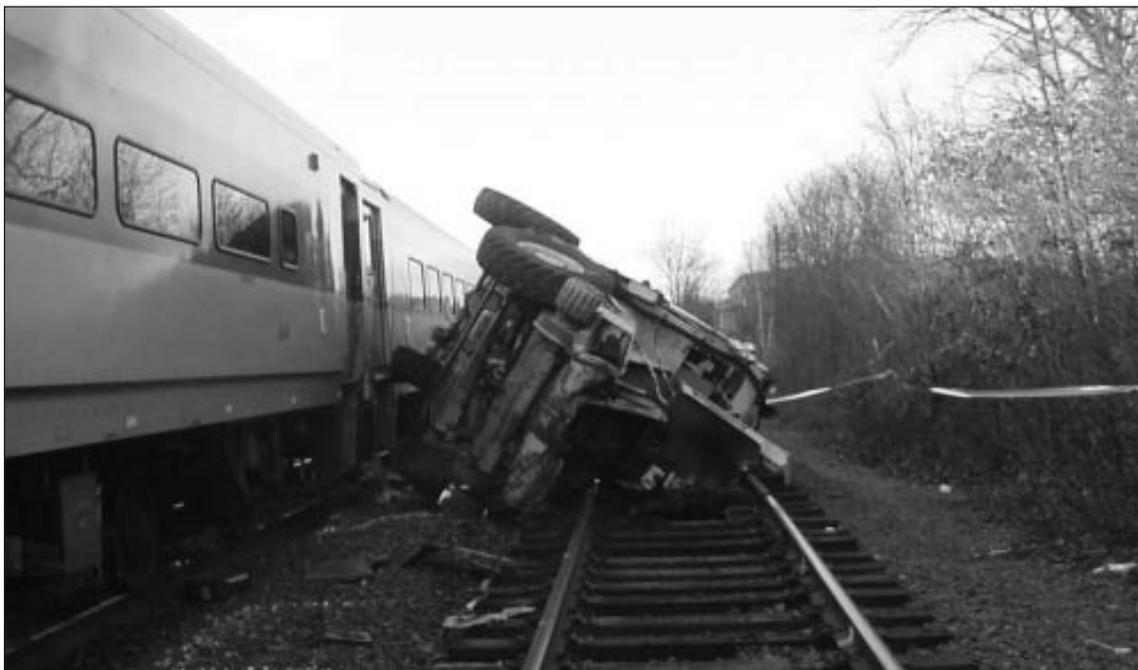
that he had just hit some track equipment. (See figure 3.) Shortly thereafter, an audio recording recorded the train dispatcher saying that she had pulled down (that is, removed) the wrong block.

Figure 3. Damaged track maintenance vehicle.

As a result of the accident, 160 feet of rail, 80 crossties, and 100 tons of ballast had to be replaced. The cost, including labor, was \$15,841. The accident damaged the lead control car and the undercarriage of the train. Repairing the train cost an estimated \$450,000. The track maintenance vehicle was destroyed; replacing it cost \$95,000. The total estimated damage was \$560,841.
