Collision Between Two Massachusetts Bay
Transportation Authority Green Line Trains
Newton, Massachusetts
May 28, 2008

NTSB/RAR-09/02
PB2009-916302

Railroad Accident Report

Abstract: On May 28, 2008, about 5:51 p.m., eastern daylight time, westbound Massachusetts Bay Transportation Authority Green Line train 3667, traveling about 38 mph, struck the rear of westbound Green Line train 3681, which had stopped for a red signal. The accident occurred in Newton, Massachusetts, a suburb of Boston. Each train consisted of two light rail trolley cars and carried two crewmembers—a train operator at the front of the lead car and a trail operator in the second car. The operator of the striking train was killed; the other three crewmembers sustained minor injuries. An estimated 185 to 200 passengers were on the two trains at the time of the collision. Of these, four sustained minor injuries, and one was seriously injured. Total damage was estimated to be about \$8.6 million.

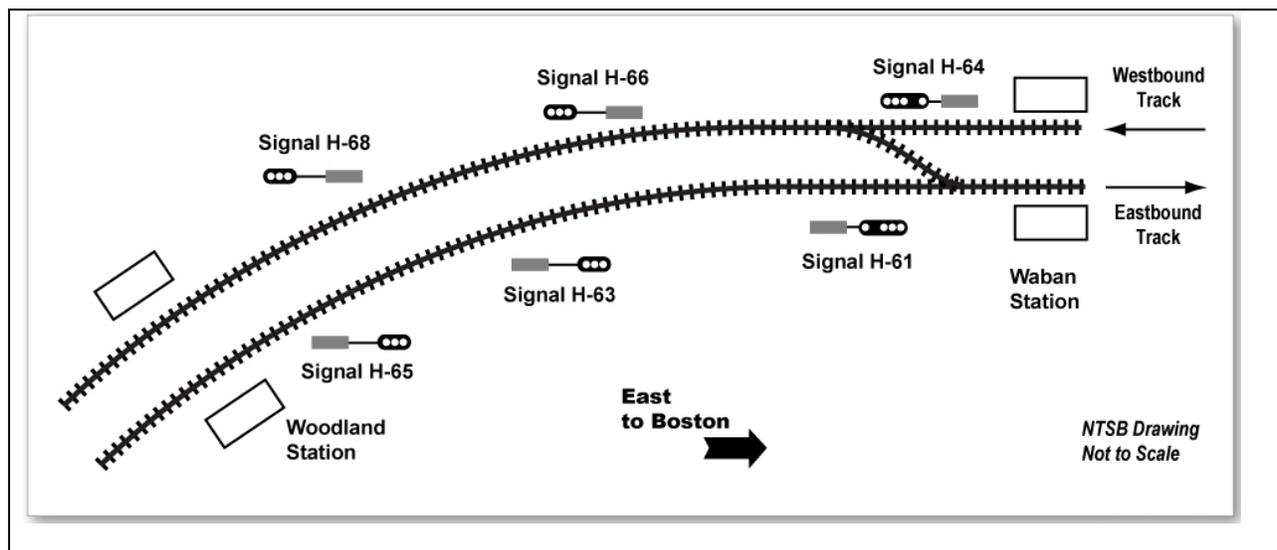
Crewmembers of the struck train reported nothing out of the ordinary during their afternoon run until about 5:50 p.m., when the train operator observed that signal H-66, about 1,666 feet west of Waban station, was displaying a single red aspect. (See figure 3.) MBTA rules state that a train encountering such a signal must stop and hold short of the signal for 1 minute before proceeding at restricted speed not to exceed 10 mph while being prepared to stop short of a car, train, or other obstruction. The operator of the struck train stated that he held his train for the specified time even though the track ahead was clear and he saw no reason for the red signal. The operator told National Transportation Safety Board (NTSB) investigators that he had encountered a red aspect at signal H-66 with the track ahead clear on one of his morning runs on the day of the accident. He stated that at that time he reported the red signal to the Operations Control Center and was told that it had been previously reported; however, there was no MBTA record of a trouble report being filed for the signal at this location.

Figure 3. Signal layout between Waban and Woodland stations on D Branch of MBTA Green Line.

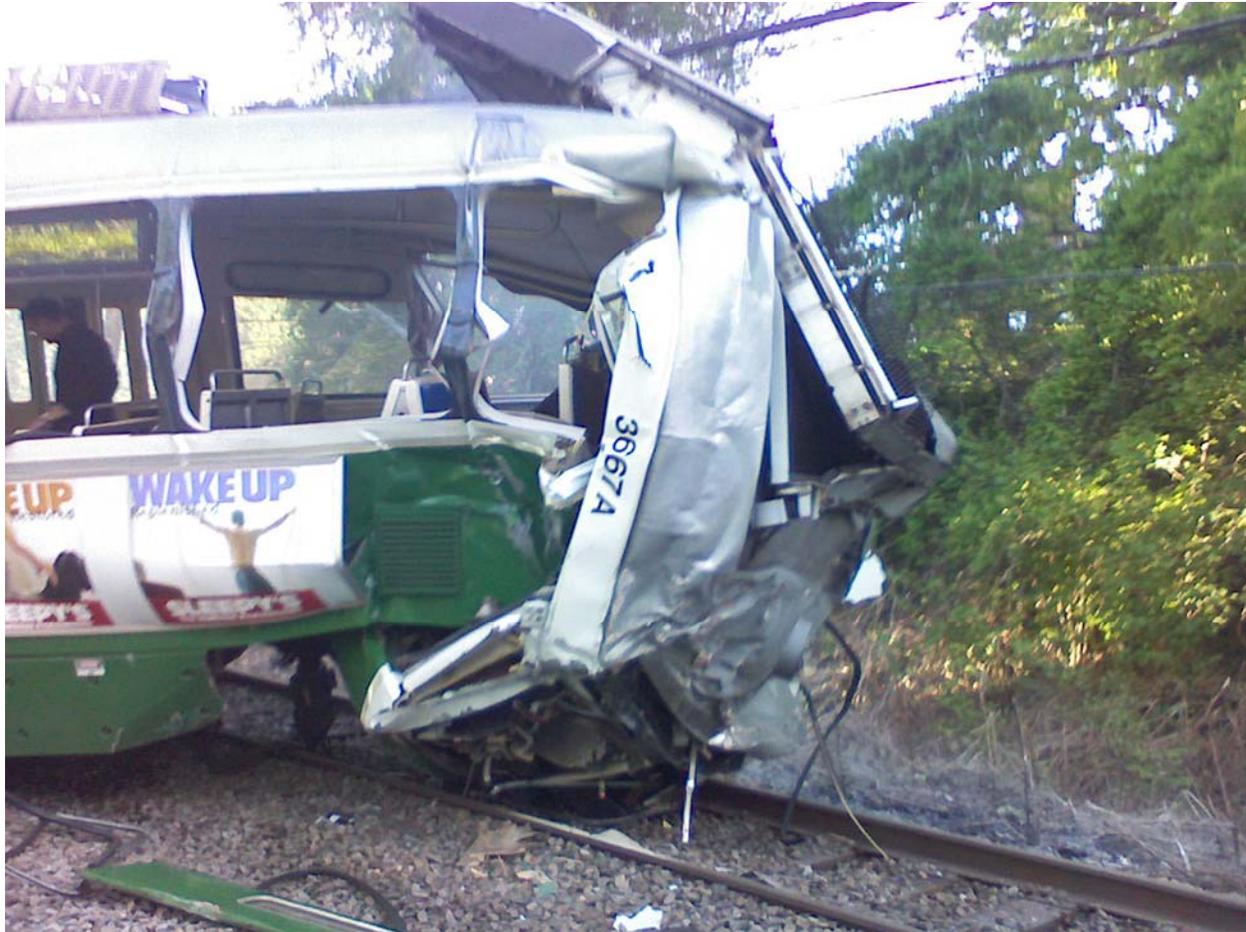
MBTA car 3667, the lead car of the striking train, was destroyed in the accident. It sustained substantial crush damage and also derailed as a result of the collision. (See figure 4.) The second car of the striking train, 3706, sustained minor damage. MBTA car 3703, the second car of the struck train, was severely damaged. The lead car of the struck train, 3681, was derailed with minor damage. The total damage was estimated to be about \$8.6 million.

Figure 4. Crushed lead car of striking train.

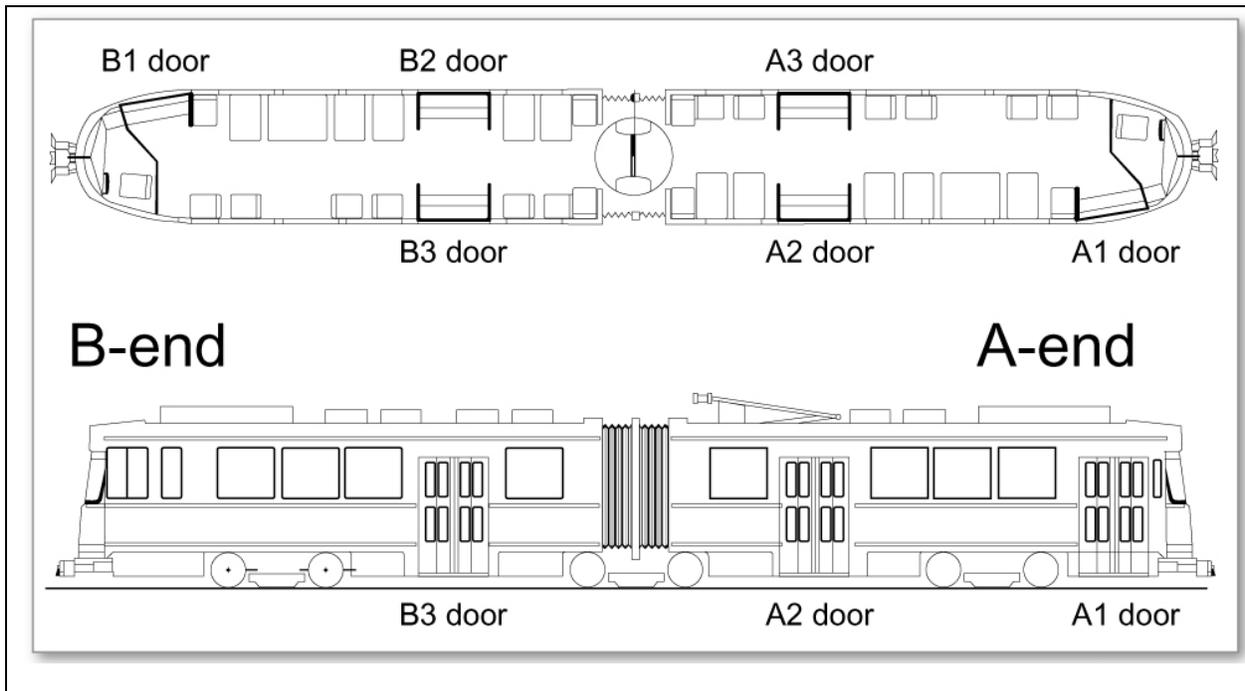
Train 3681 was operating B-end forward. In the A-end (the end that was struck—car 3703), the operator's cab and the A1 door were crushed toward the front of the car body. This crushed area extended from the front of the cab for a distance of 120 inches. The floor began to

buckle upward near the third row (from the rear of the car) of passenger seats. From this point to the rear of the car, the floor sloped downward.

Figure 5. Each train involved in accident consisted of two permanently coupled cars, as shown in drawing. Car 3667 was A-end and lead car of striking train; car 3681 was B-end and lead car of struck train.

The anticlimber⁹ of car 3703 was raised upward and toward the left side (in the direction of travel) of the car. The center of the anticlimber had been moved 13 inches to the left of its normal centerline. The anticlimber's highest point measured 39 1/8 inches above the top of the rail, and the centerline measured 38 7/8 inches above the top of the rail.
