Collision of BNSF Coal Train With the Rear End of Standing
BNSF Maintenance-of-Way Equipment Train
Red Oak, Iowa
April 17, 2011

Accident Report

NTSB/RAR-12/02
PB2012-916302

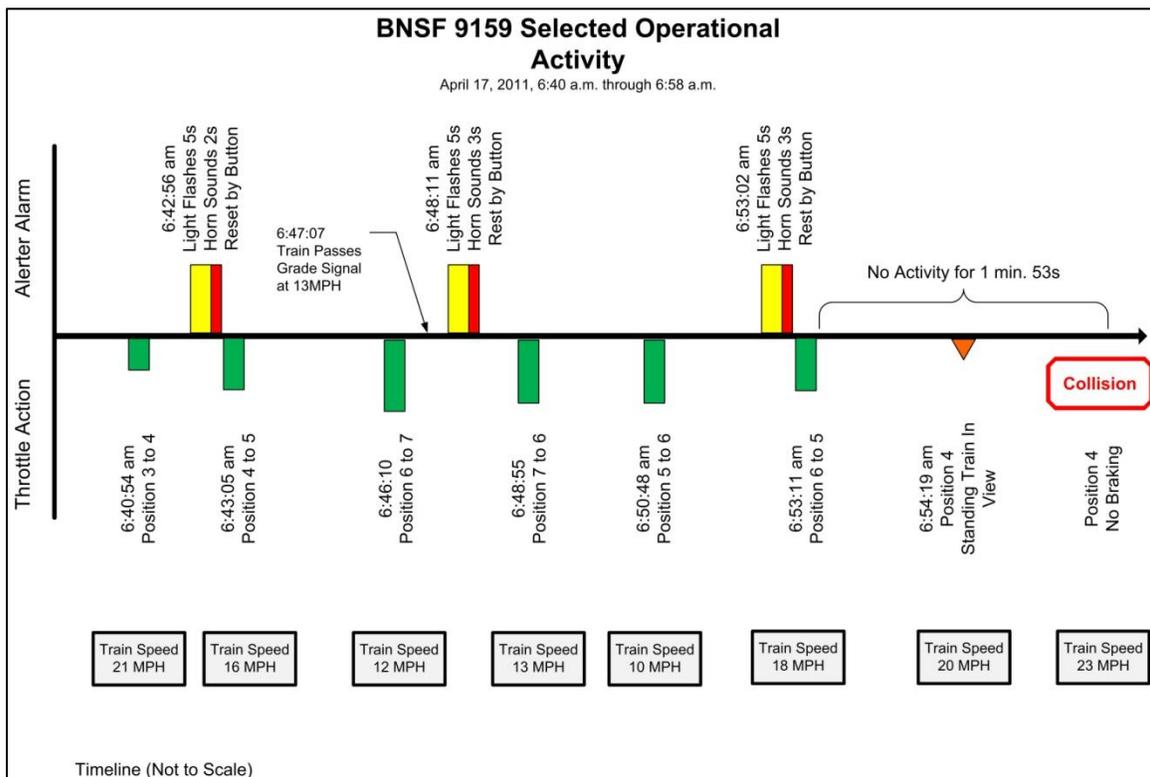
Figure 4 was developed from event recorder data from the striking train’s lead locomotive and shows when the engineer manipulated the controls of the locomotive between CP 4535 and the point of collision. The event recorder data is shown in tabular form at appendix C.

Figure 4. Event recorder data from locomotive of striking train.

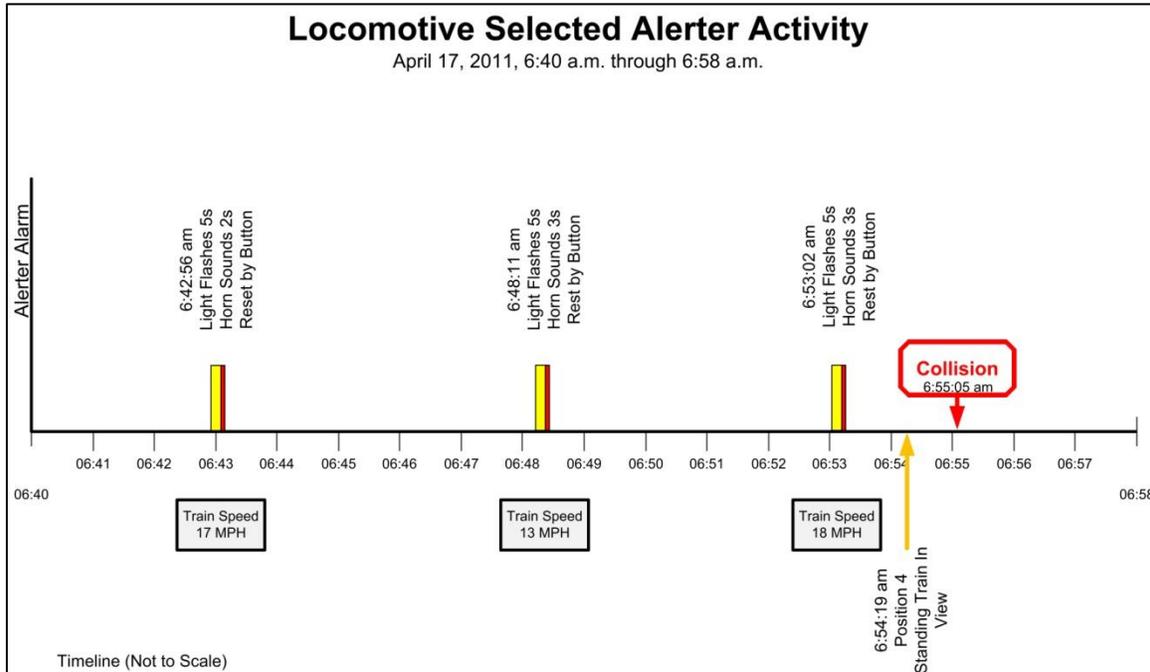
Data from the striking train’s (BNSF 9159) event recorder show that during the 15 minutes prior to the collision, the striking train’s lead locomotive alerter alarmed three times after periods of engineer inactivity and was reset using the alerter reset button after a strobe displayed for 5 seconds and an audible alarm sounded for an additional 2 to 3 seconds. The collision occurred 1 minute 53 seconds after a throttle movement, and the alerter would have been due to alarm in about 7 seconds had the collision not occurred. Figure 5 shows the alerter alarm events that occurred during the last 15 minutes before the collision.

Figure 5. Alerter alarm events from striking train locomotive event recorder during last 15 minutes before collision.

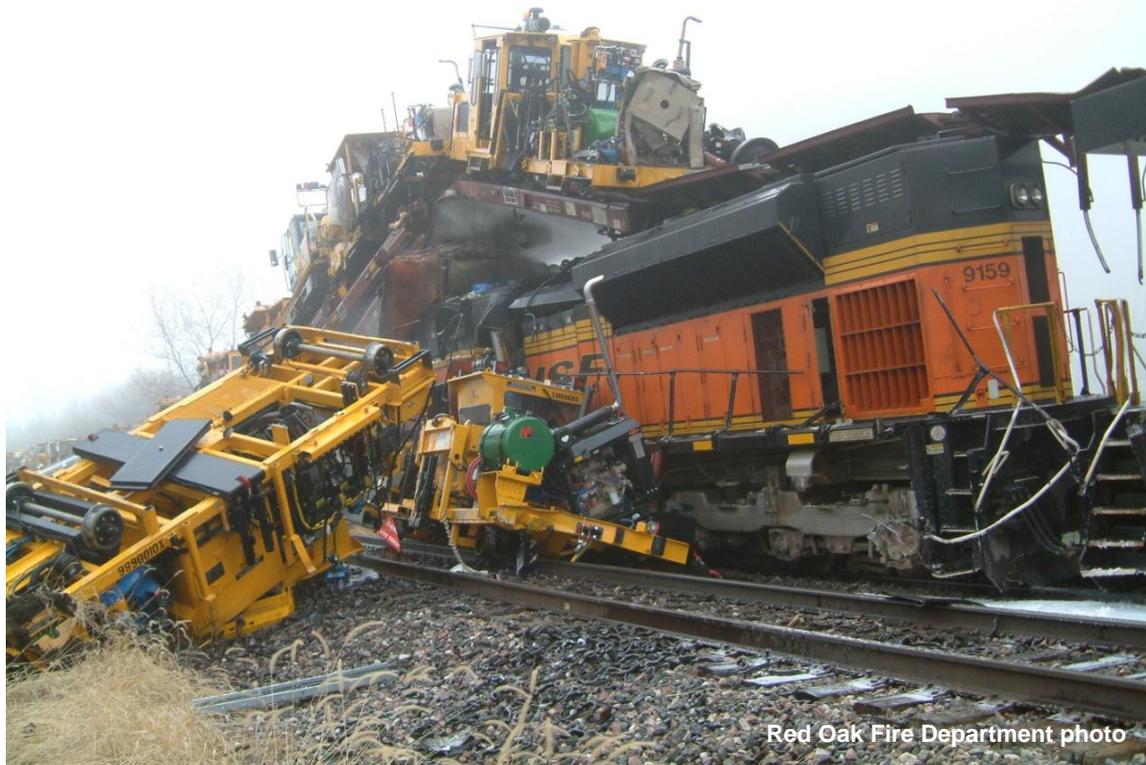
The striking coal train collided with the rear car of the standing MOW equipment train about MP 448.3. The rear car of the MOW equipment train was almost immediately crushed, derailed, and displaced to the north of the track. Several other pieces of derailed equipment came to rest on track one. (See figure 6.) At the same time as the collision, the signal circuit on track one registered a track occupancy indication at the BNSF Network Operations Center (NOC) in Fort Worth, Texas. Based on locomotive event recorder and signal system recorder data, the time of the collision was a few seconds after 6:55 a.m.

Figure 6. Wreckage including lead locomotive of striking train.

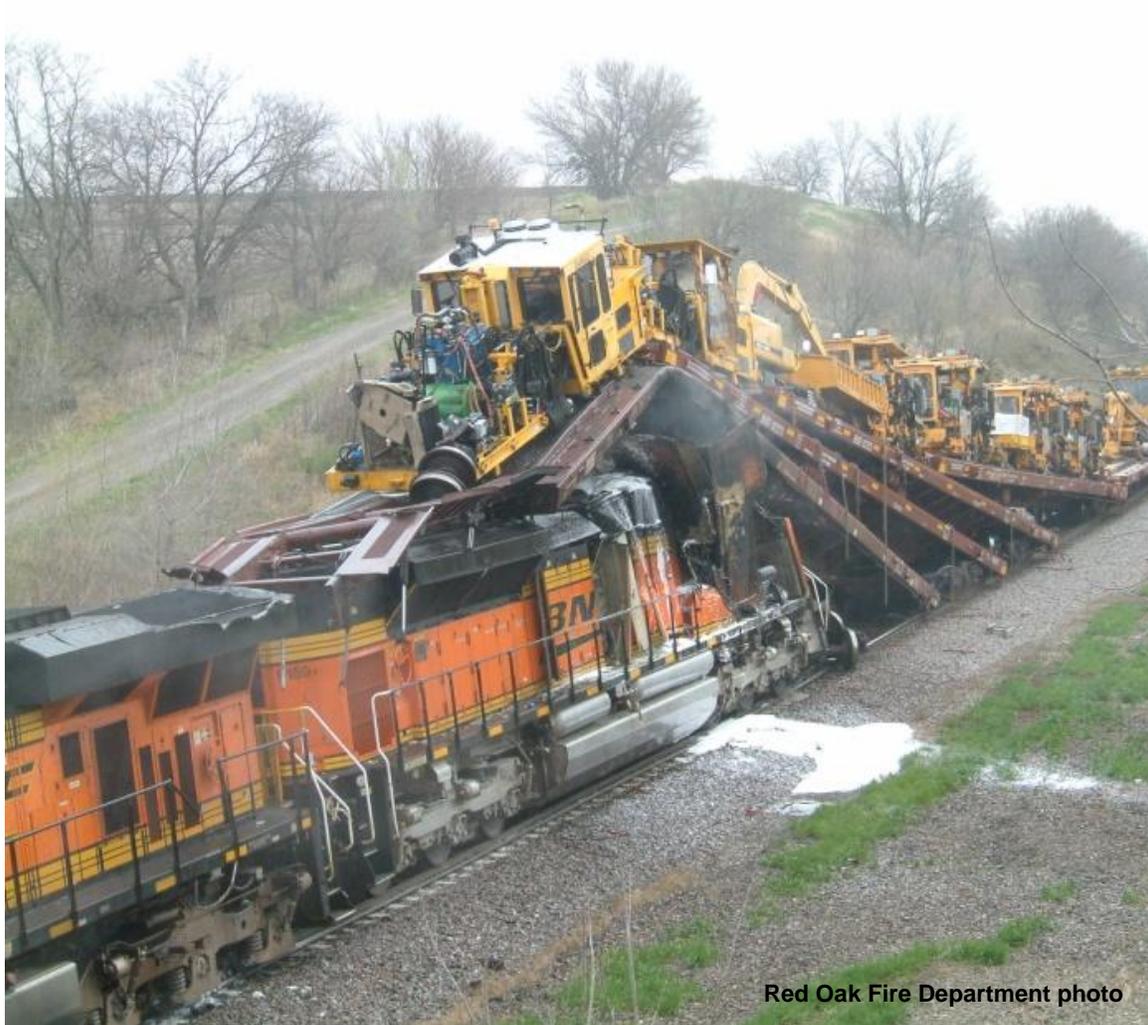
The next four cars (the 29th through the 32nd cars behind the locomotive) were 89-foot-long flatcars loaded with MOW equipment that were derailed and displaced to the north side of track two near the Highway M 37 overpass. (See map in figure 2 and figures 7 and 8.) Much of the cargo on these cars (MOW equipment) broke free from securements and was scattered along the right-of-way.

Figure 7. View of wreckage from highway overpass facing east.

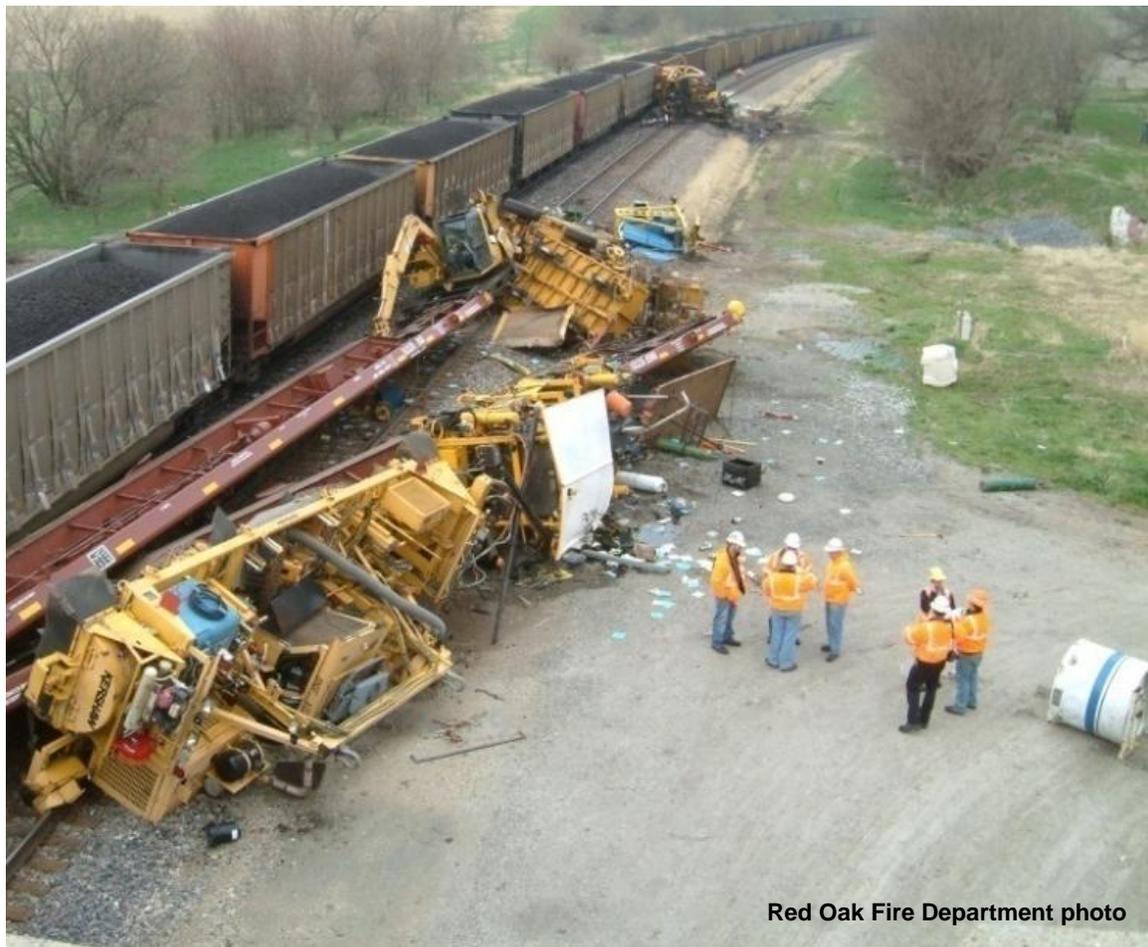
Figure 8. View of wreckage from highway overpass facing west.

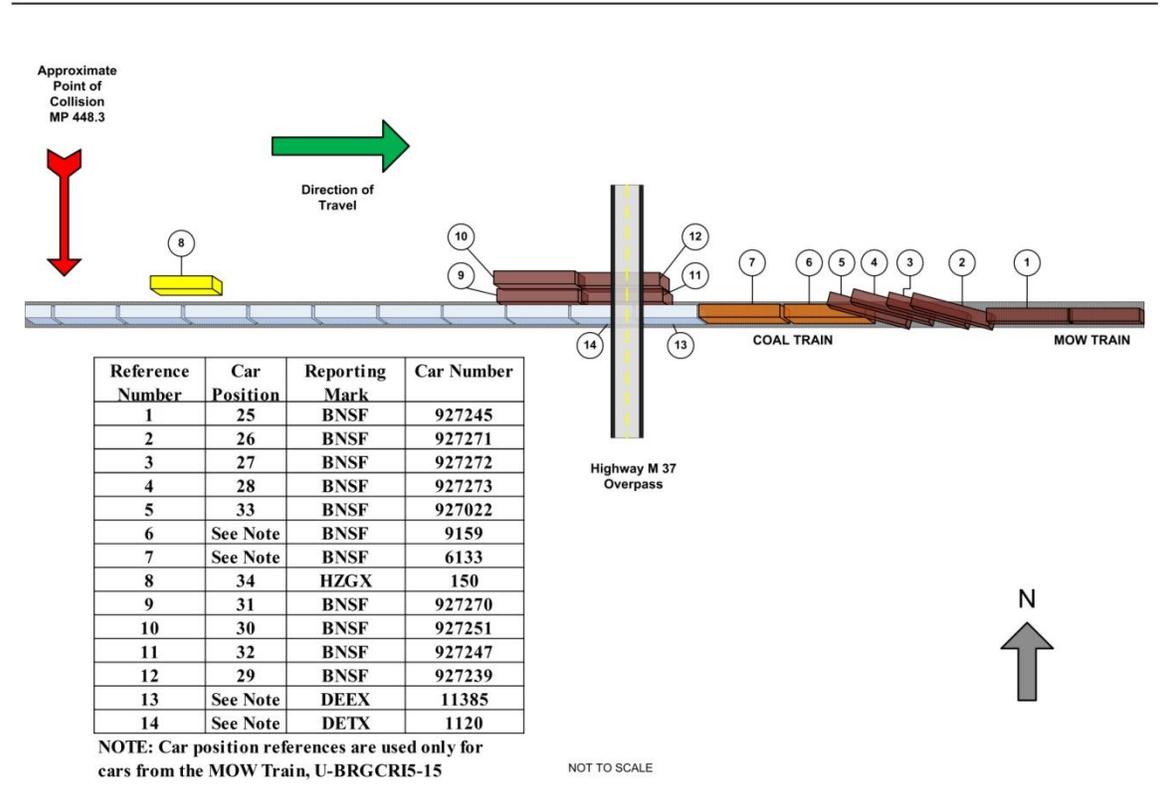
The next three cars (26th through 28th) also were 89-foot-long flatcars that were loaded with MOW equipment. These cars, along with the scorpion flatcar, came to rest lying against each other and overriding each other and leaning against the front end of the lead locomotive of the striking train. (See figure 9.) Trucks, wheel sets, and MOW equipment were scattered along the north and south sides of the tracks.

Figure 9. Wreckage diagram (not to scale).

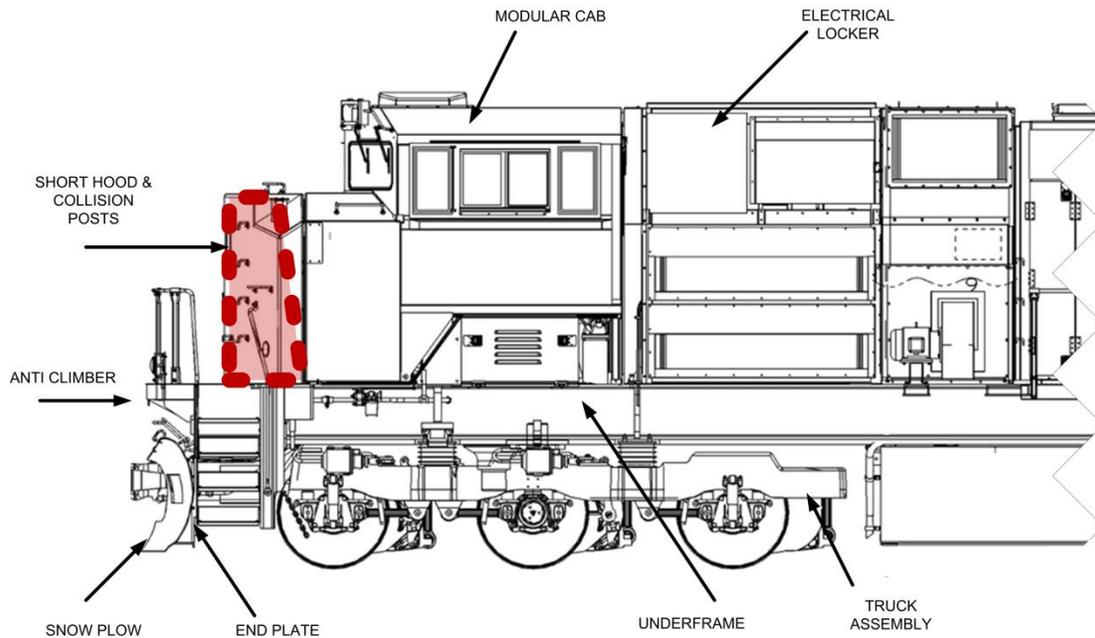
Striking Train. The lead locomotive of the striking coal train, BNSF 9159, sustained extensive frontal damage. (See figure 10.) It derailed, but the unit stayed upright and generally in line with the track. About 16 feet of the front end of BNSF 9159 was compromised as a result of the collision. The short hood and collision posts, normally positioned perpendicular to the deck, were pushed and deflected at an angle of about 35° to 40° in the direction of the cab. The end plate, snow plow, anti-climber,¹¹ short hood, and collision posts were severely damaged and deformed. A major impact area was identified on the front door frame of the operating cab. The frame was found to be split at the top right. The inner doorway, or vestibule, floor area had indications of severe loading and was bent rearward and upward.

Figure 10. Side view of front end of EMD SD70ACe locomotive, the same type of locomotive as striking train lead locomotive, BNSF 9159.

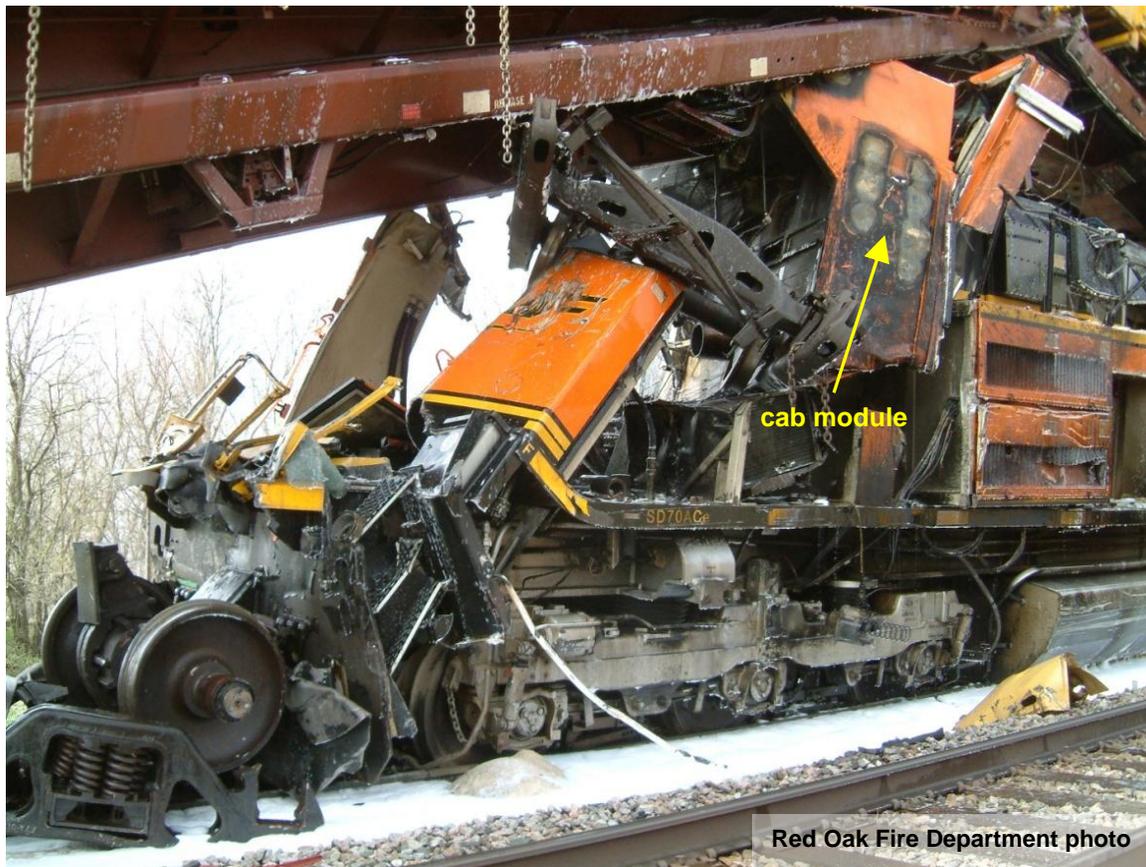
The modular cab of the locomotive sustained a substantial loss of occupied space. The cab was separated from the deck of the locomotive, and the bottom half of the cab rotated up just over 90 degrees. (See figure 11.) The cab was crushed at the rooftop, and the left rear corner of the cab was crushed in. The side walls remained intact to the point of the window line, which is about 4 feet from the roof. The underside of the cab was relatively intact and undamaged. The entire cab had extensive fire exposure and damage.

Figure 11. Upended striking train locomotive (BNSF 9159) modular operating cab.

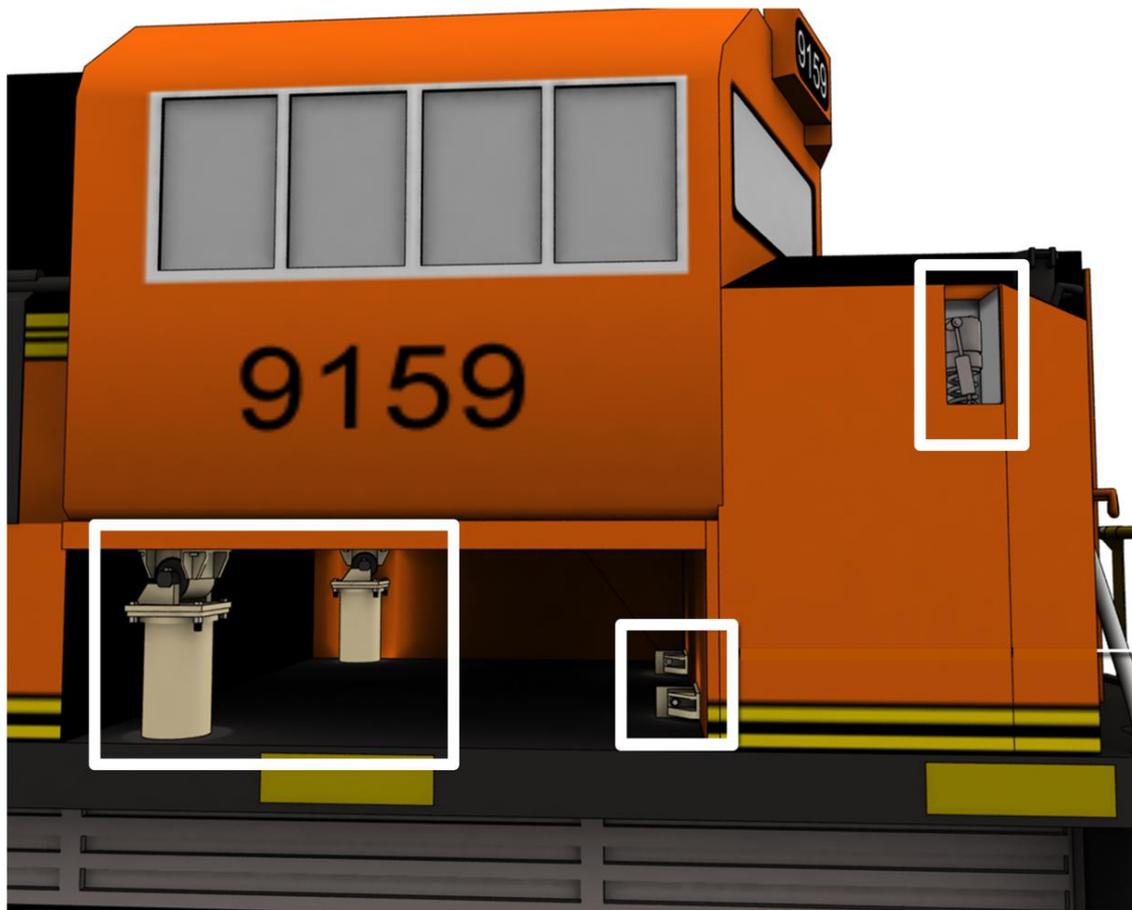
Figure 14. Illustration of EMD SD70Ace locomotive (same type as striking train locomotive) with white boxes indicating the points where the isolated cab attaches to the underframe.

On the underside of the modular cab at its front are two double shear pin joints. This system includes two brackets welded to the top plate and two brackets welded to the underside of the cab floor. These joints are designed as a clearance fit;²¹ a 1-inch-diameter hardened steel pin passes through a wide (2-inch) hole in the deck-mounted bracket. When questioned, EMD stated that this design acted as a loosely coupled fastening system.

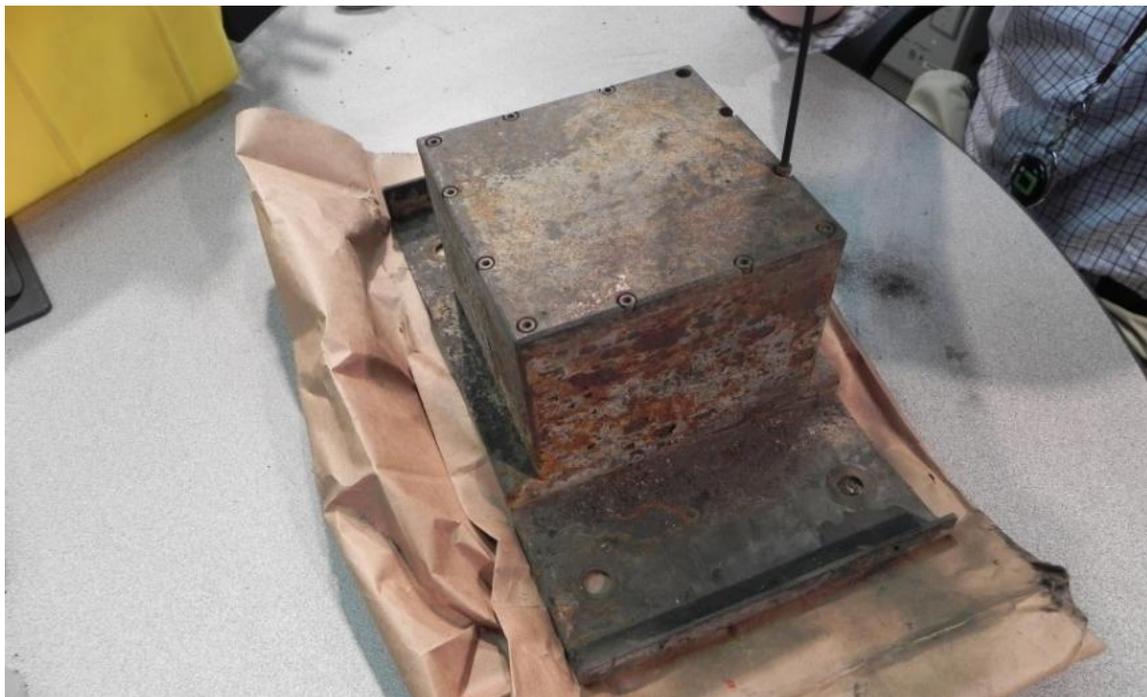
Figure 19. Fire-damaged memory module recovered from BNSF 9159.

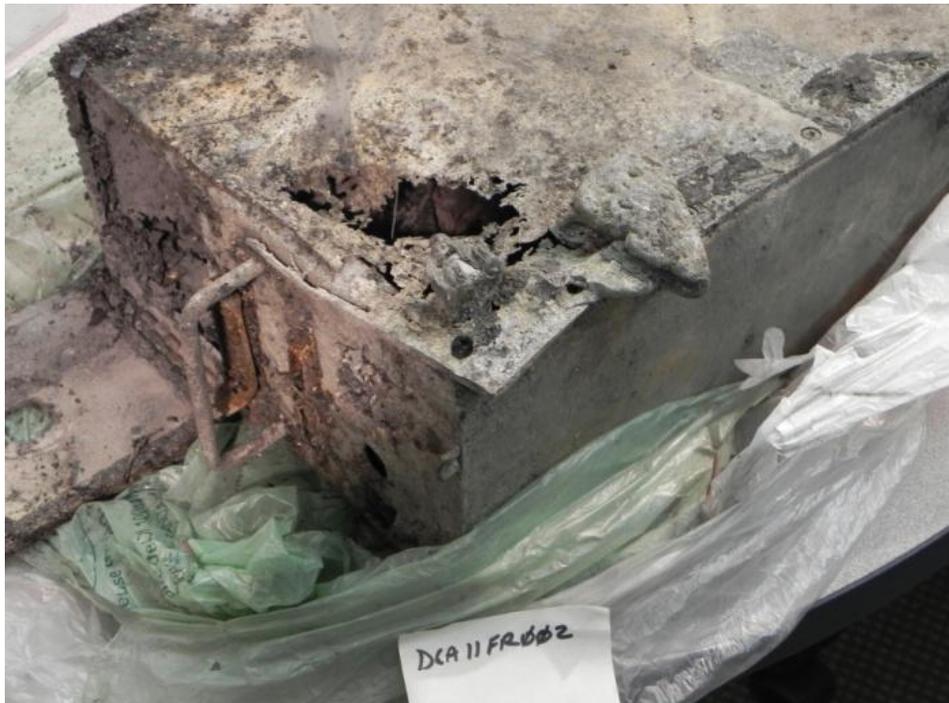
Figure 21. Fire-damaged video recorder hard drive enclosure from BNSF 9159.

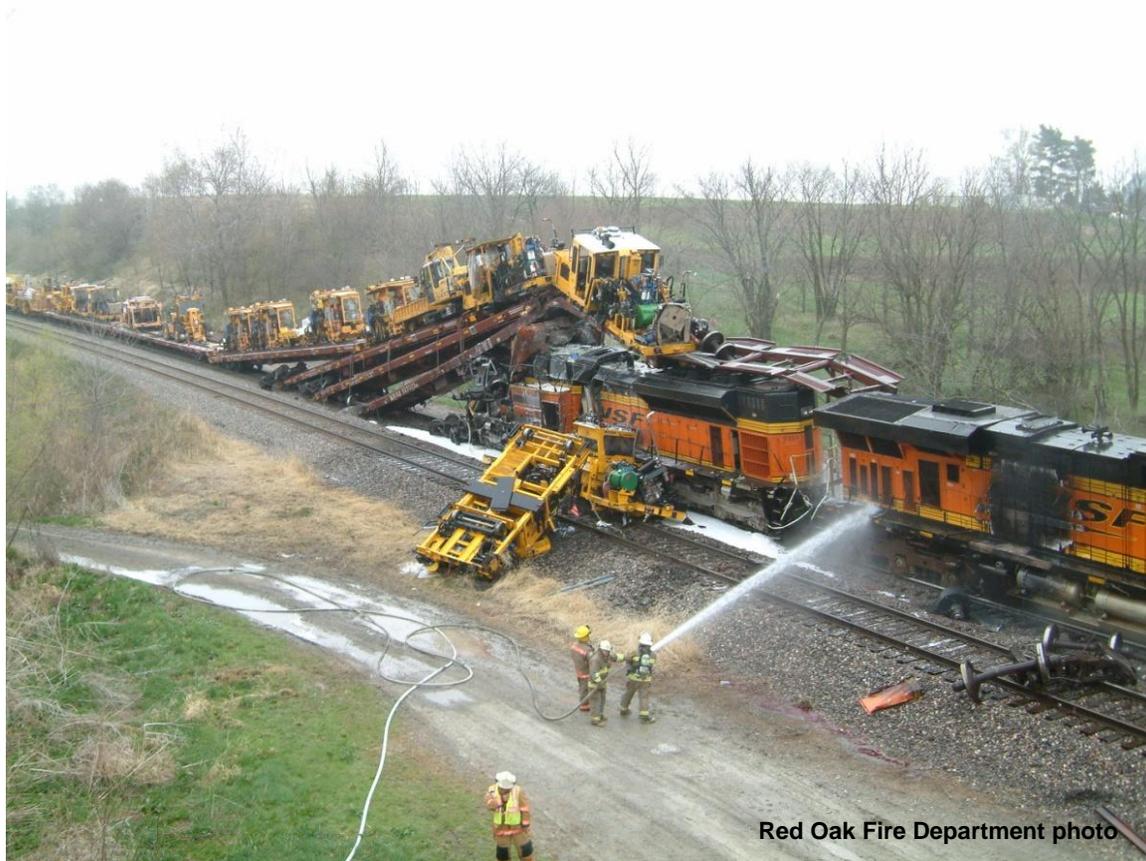
Figure 22. Red Oak Fire Department applying foam after collision.
