Collision of Dakota, Minnesota & Eastern Railroad
Freight Train and 19 Stationary Railcars
Bettendorf, Iowa
July 14, 2009

Accident Summary Report

NTSB/RAR-12/03/SUM
PB2012-916303

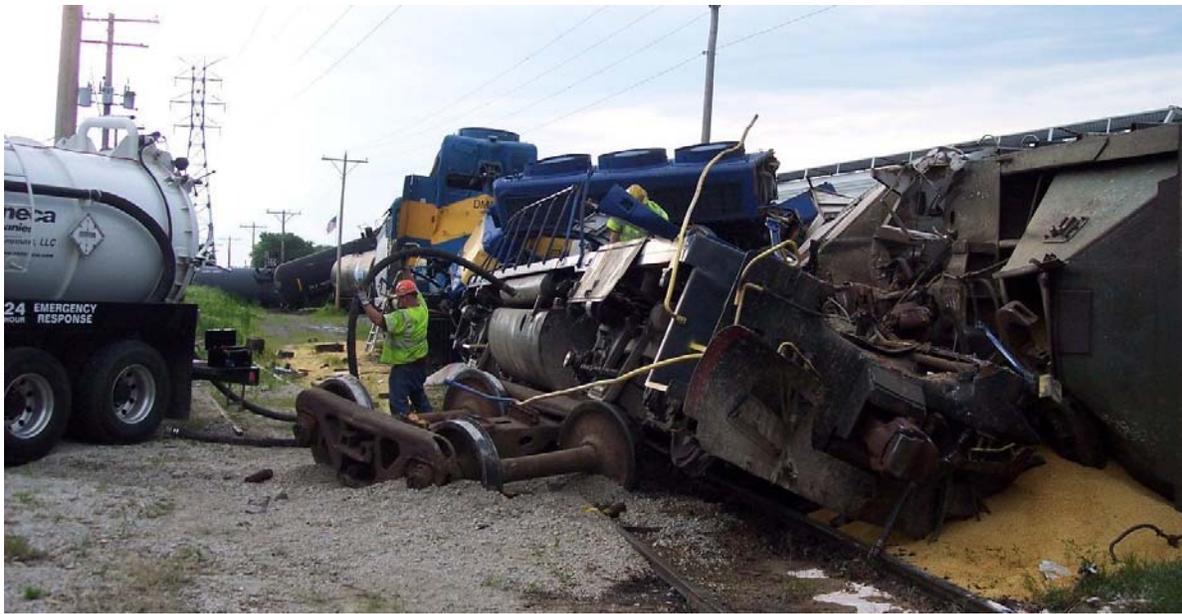
Figure 1. Photograph of damaged lead DME locomotive 4003.

On impact, two locomotives and nine railcars derailed on the DME train. The impact crushed the locomotive cab compartment of the leading locomotive, DME 4003, and sheared it from the top plate. The 4 closest of the 19 railcars on yard track No. 3 also derailed. (See figure 6.)

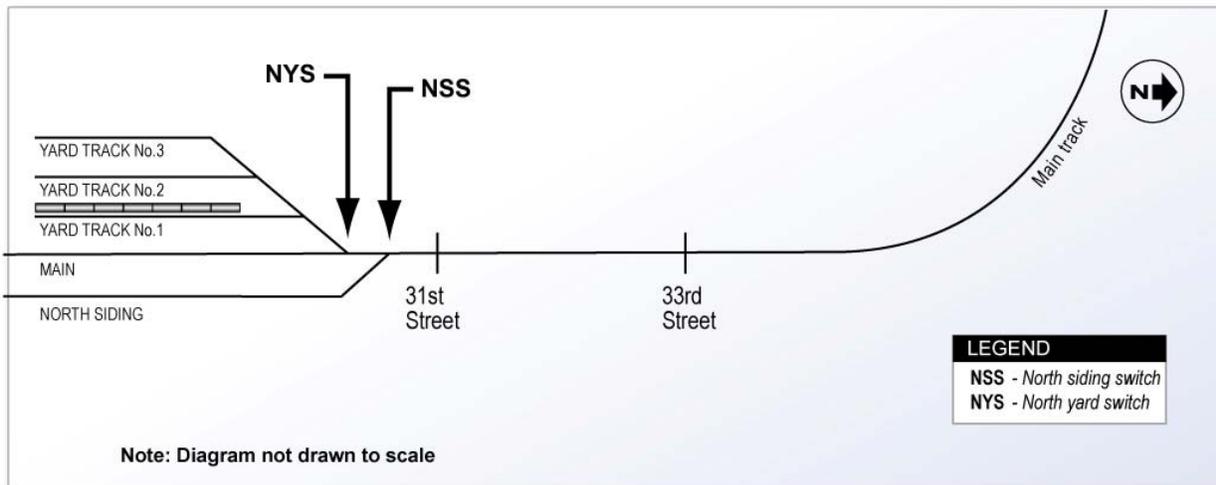
Figure 2: Bettendorf Yard immediately before BNSF local crew placed cars on yard tracks Nos. 2 and 3.

About 1:39 a.m., the crew of the BNSF local placed 20 railcars on yard track No. 2 and 19 railcars on yard track No. 3. The DME dispatcher then instructed the BNSF local engineer to clear the remainder of the train off the main track for a DME train to arrive. The BNSF local engineer requested permission to clear on the north siding. The DME dispatcher authorized the request. The BNSF local moved north about 350 feet with 18 railcars, past the remote-controlled north siding switch and the 31st Street crossing. The engineer successfully lined the remote-controlled north siding switch⁷ and backed the train onto the north siding. (See figure 3.)

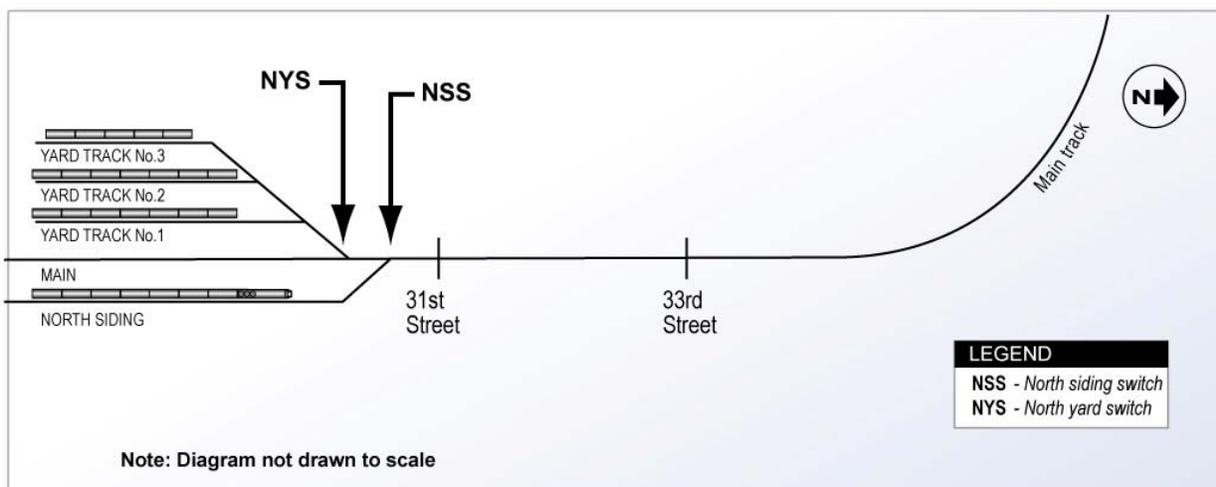
Figure 3. View of Bettendorf Yard after BNSF local cleared onto north siding.

After the BNSF local completed its movement onto the north siding, the remote-controlled north siding switch automatically lined itself back for the main track. However, the north yard hand-operated switch remained lined toward yard track No. 3. In compliance with the *General Code of Operating Rules (GCOR)*⁸ Rule 5.9.2, the BNSF local engineer turned the locomotive's headlight off to avoid adversely affecting the vision of the crew of the oncoming DME train.

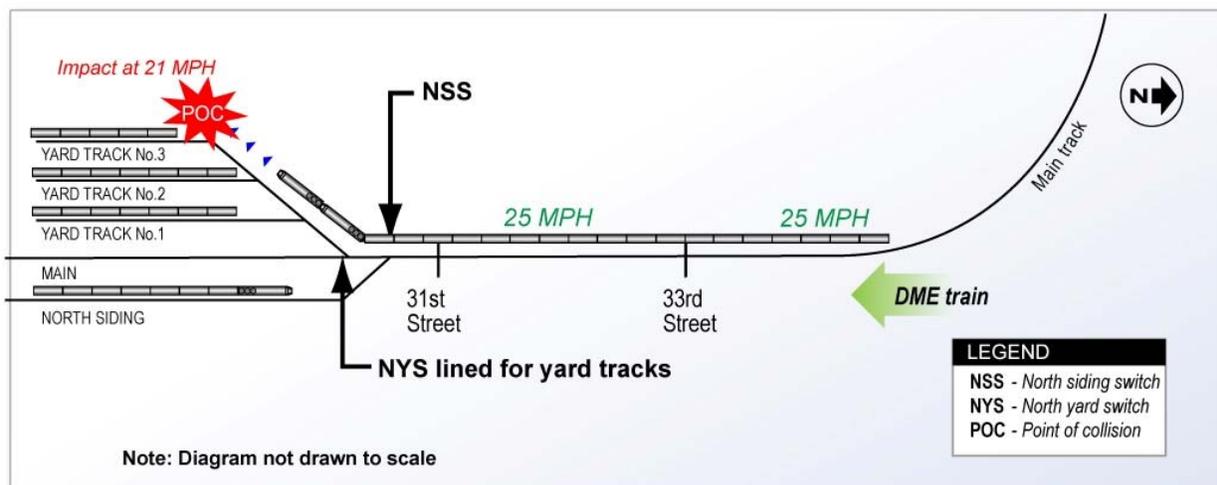
At MP 187.68, the switch position indicator light showed the position of the remote-controlled north siding switch. Postaccident sight-distance testing revealed the switch position indicator light was green and first visible from MP 187.2. Although red reflections from the north yard hand-operated switch position reflector target¹⁰ were visible from 33rd Street, it was not readily identifiable as the target for the north yard hand-operated switch until 31st Street.¹¹ At MP 187.7, the north yard hand-operated switch was incorrectly lined leading into the yard. The DME train entered the yard, traveled 168 feet, and struck 19 stationary cars on track No. 3. (See figure 4.)

Figure 4. Path of DME train as it approached point of collision.

The NTSB concludes that the switch position reflector target for the north yard hand-operated switch did not adequately warn the approaching train of the incorrectly lined main track switch at a sufficient distance for the train to stop in time to prevent the accident.

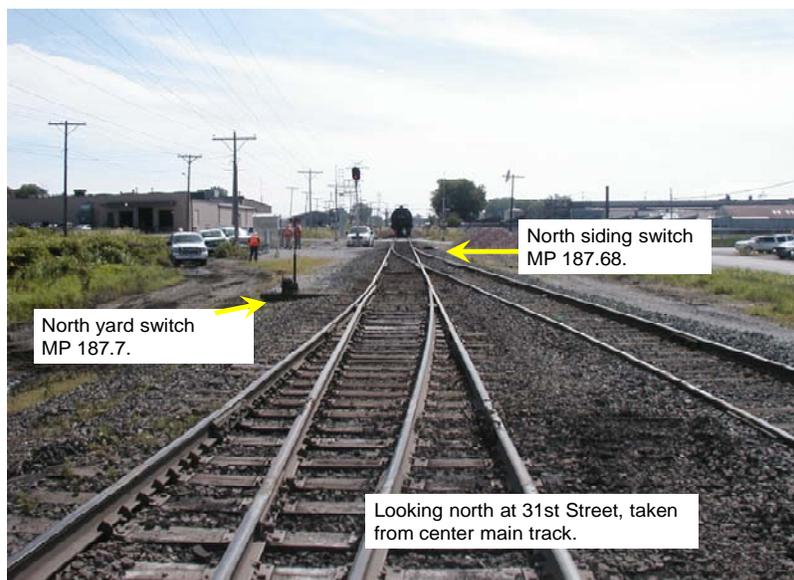
Figure 5. North yard hand-operated switch and remote-controlled north siding switch.

The DME train passed the remote-controlled north siding switch, which was lined in the correct position for main track movement. Then, almost immediately, the train diverted from the main track at the incorrectly lined north yard hand-operated switch.

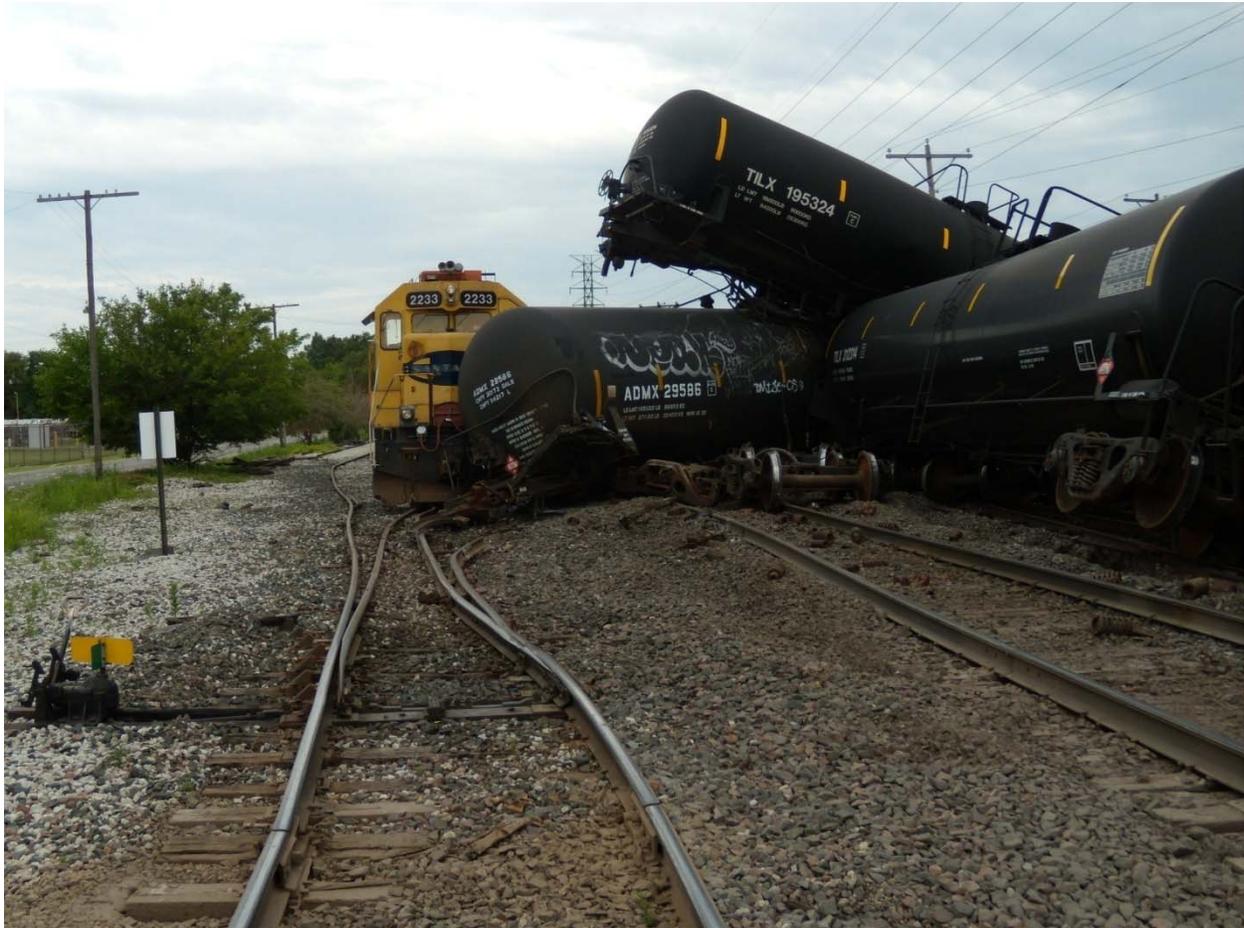
Figure 6. Wreckage of DME tank railcars.

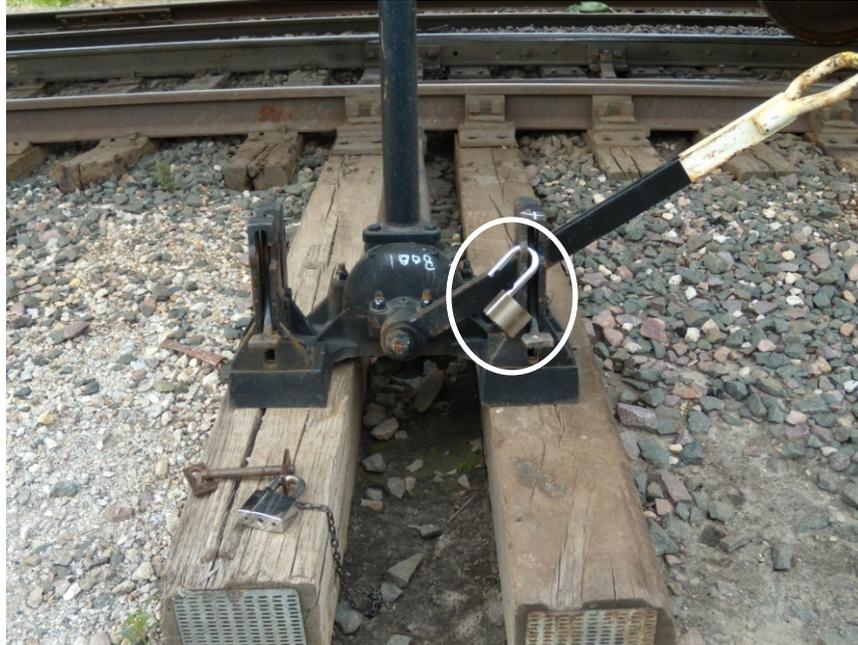
During the postaccident inspection, investigators found that the north yard hand-operated switch was still lined for yard track No. 3, the switch lock was still unlocked, and the switch lock was hanging in the switch locking hasp.¹⁶ (See figure 7.)

The NTSB concludes that had the crew of the BNSF local train relined the north yard hand-operated switch for main track movement before releasing its track warrant authority, as required by operating rules, the accident would not have occurred.

Figure 7. Bettendorf Yard north yard hand-operated switch with unlocked BNSF lock.

The NTSB also recommends that the FRA revise 49 CFR 218.105(d)(1) to require that until the appropriate switch position technology is installed on main track switches in non-signaled territories that are not equipped with positive train control, train crews releasing track authority to the dispatcher must hold job briefings with the dispatcher and clearly convey the position of all main track switches that were used prior to releasing track warrant authority.

The NTSB recommends that CP require both train dispatchers and train crews to document switch positions and to hold job briefings to ensure that all main track switches in non-signaled territories are correctly lined before releasing track warrant authority. Finally, the NTSB recommends that CP require that until appropriate switch position warning technology is installed on main track switches (in non-signaled territory not equipped with positive train control), when a main track switch has been reported relined for a main track, the next train to pass the location approach the switch location at restricted speed. That train crew should then report to the dispatcher that the switch is correctly lined for the main track before trains are allowed to operate at maximum authorized speed.
