Collision of Two Canadian National Railway Freight Trains near Two Harbors, Minnesota September 30, 2010

Accident Summary Report

NTSB/RAR-13/01/SUM
PB2013-104865

Railroad Accident Report

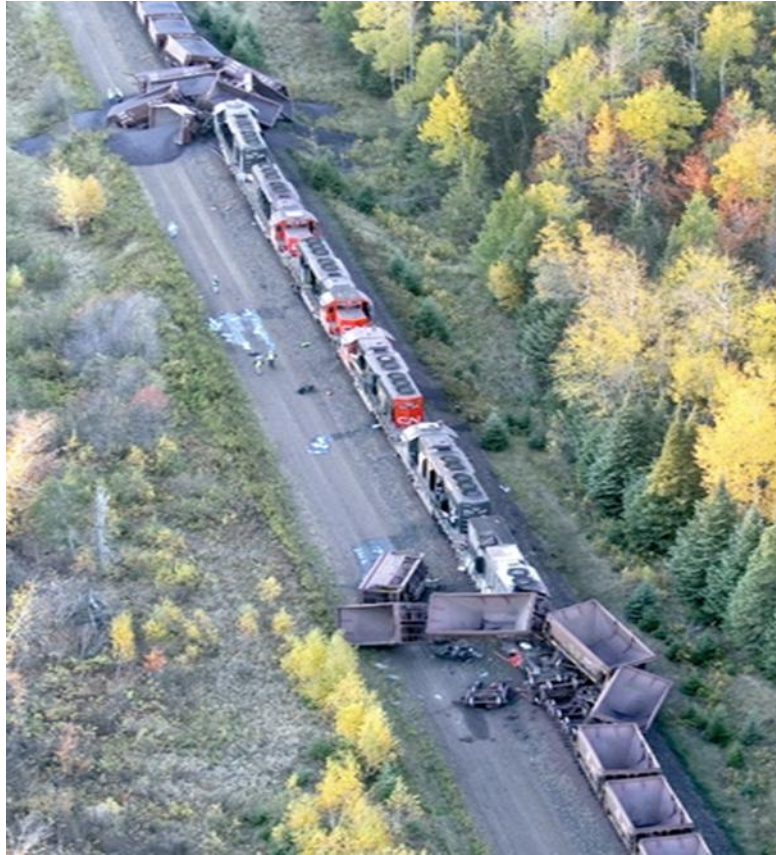
The collision occurred near milepost 13.5 on the Iron Range subdivision of the CN North division near Two Harbors, Minnesota (see figure 1). The estimated property damage was \$8.1 million. At the time of the accident, the sky was clear, and the temperature was about 72°F.

Figure 1. This is an aerial photograph of the train collision.

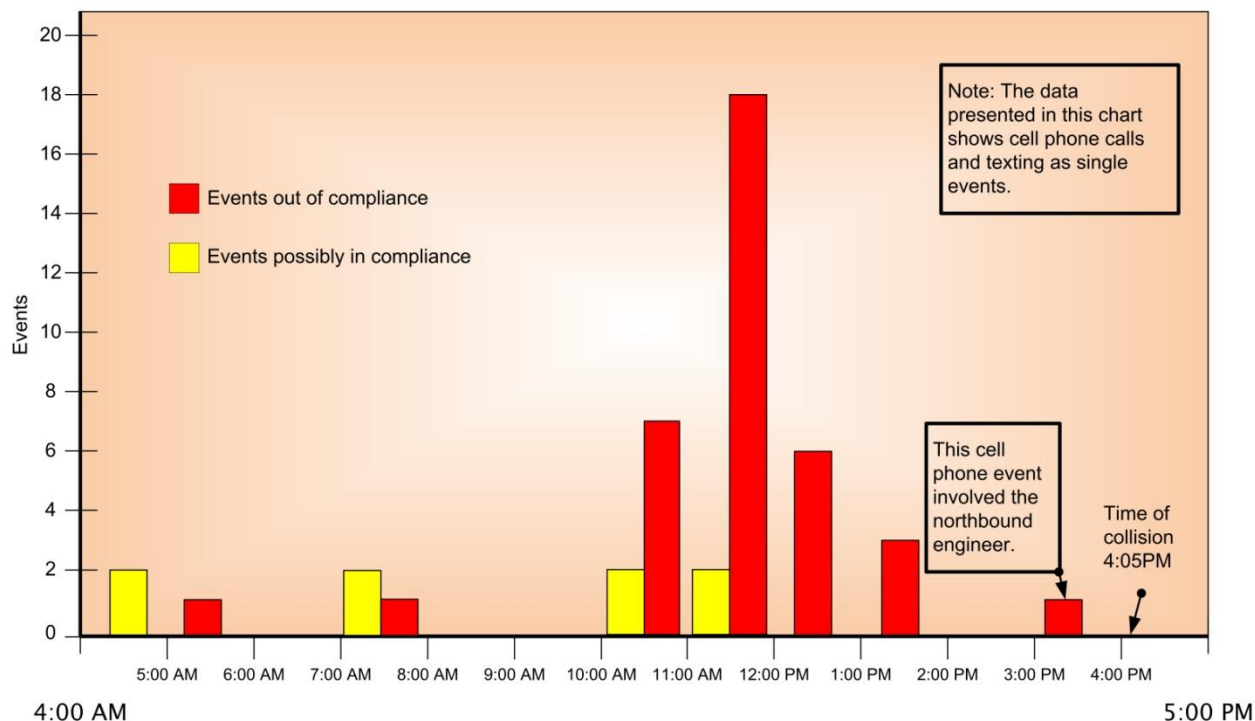
**Two Harbors Northbound & Southbound Train
Cell Phone Use During Work Hours
September 30, 2010**

Figure 4. This graphic shows cell phone use by the southbound and northbound train crews during the accident trip.
