Head-On Collision of Two Union Pacific Railroad
Freight Trains Near Goodwell, Oklahoma
June 24, 2012

NTSB/RAR-13/02
PB2013-107679

Railroad Accident Report

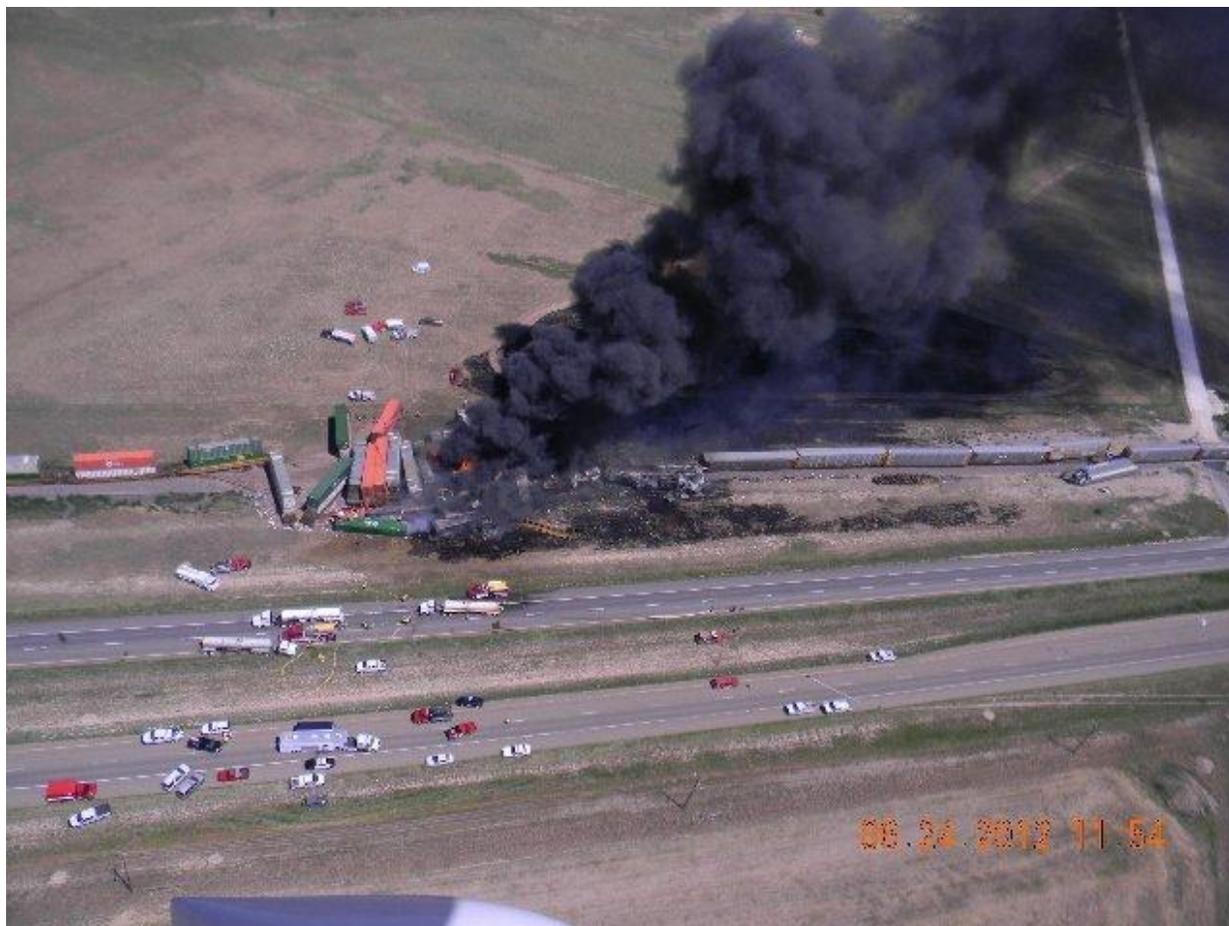
The collision derailed 3 locomotives and 24 cars of the eastbound train and 2 locomotives and 8 cars of the westbound train. The engineer and the conductor of the eastbound train and the engineer of the westbound train were killed. The westbound train conductor jumped to safety. During the collision and derailment, several locomotive fuel tanks ruptured, releasing diesel fuel that ignited and burned. (See figure 2.) Damage was estimated at \$14.8 million.

Figure 2. Aerial view of accident and fire.

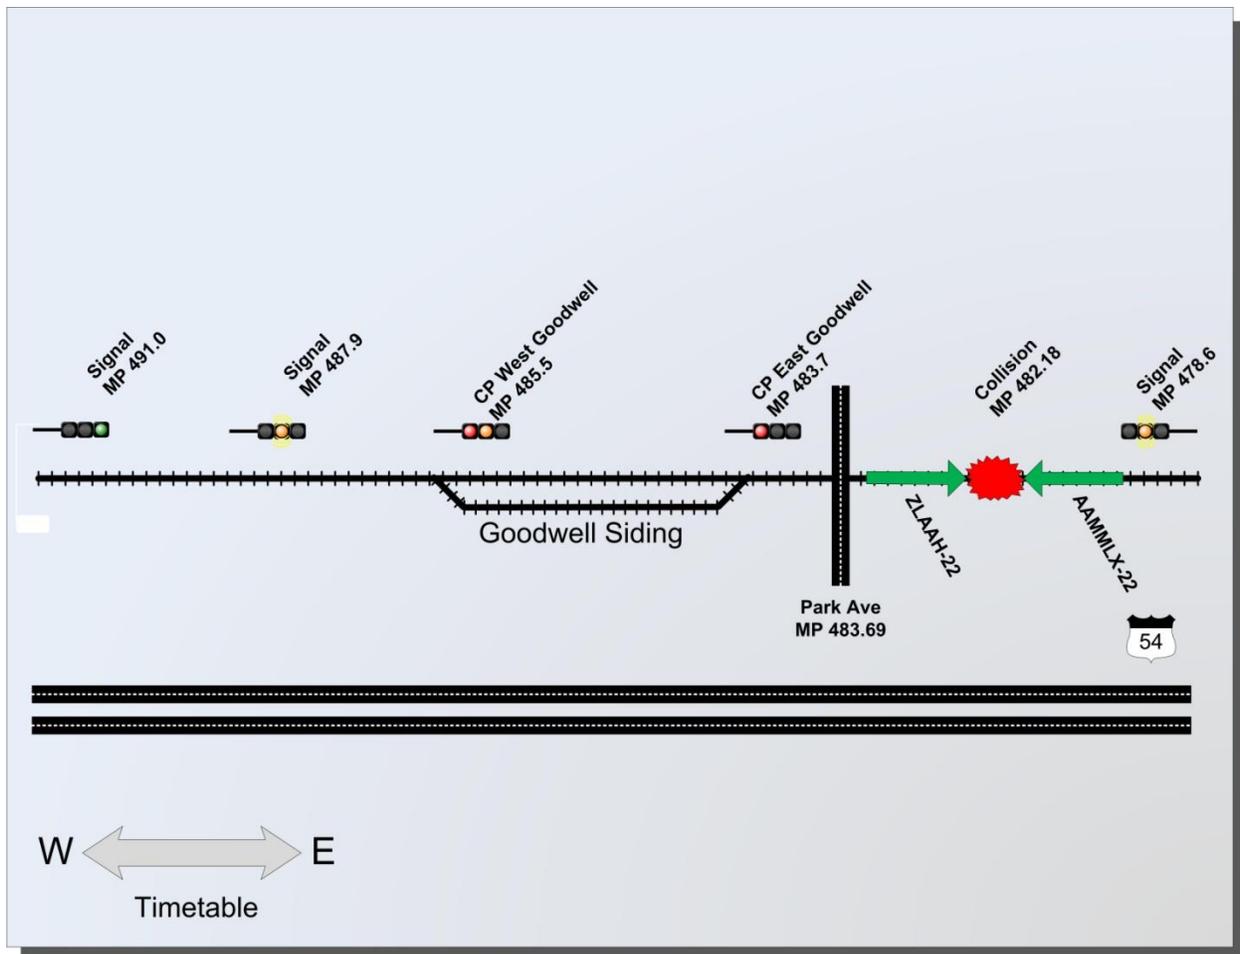
At the time of impact, the eastbound train was traveling at 58 mph, and the westbound train was traveling at 21 mph. The lead locomotives of both trains were found on their sides, with extensive damage, in the field adjacent to the point of collision. Based on the locomotive event recorders on the trailing locomotives of each train and signal and dispatcher recorder data, the time of the collision was 10:02 a.m. Figure 4 shows a track map of the accident area.

Figure 4. Track map of accident area.

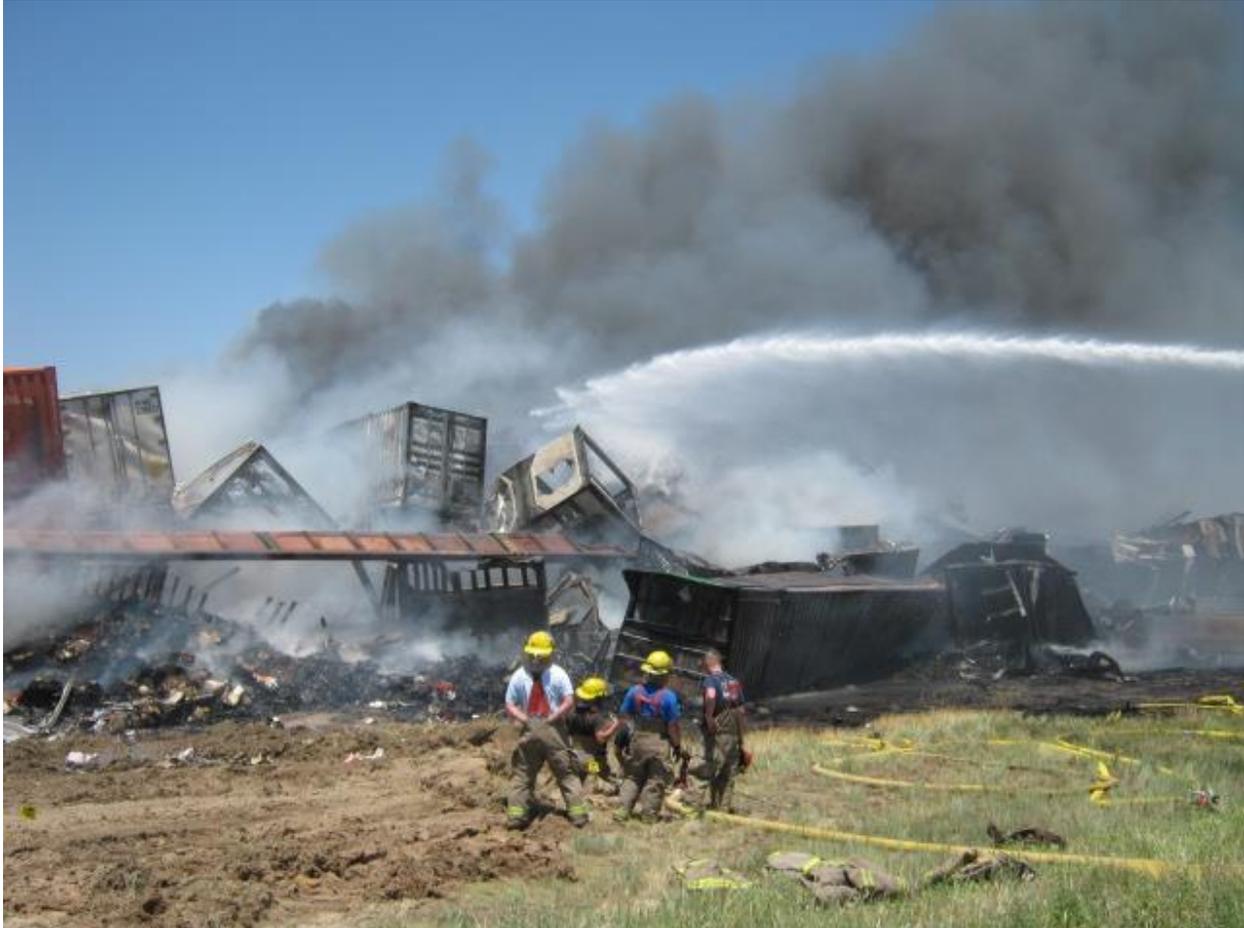
The derailed locomotives and railcars of both trains came to rest as a pile of wreckage and debris near the point of collision. Witnesses told investigators that the wreckage was immediately engulfed in a large fire. The diesel-fueled fire burned for more than 24 hours despite fire suppression efforts that continued throughout the day and into the evening. (See figure 5.)

Figure 5. Suppression of the fire.

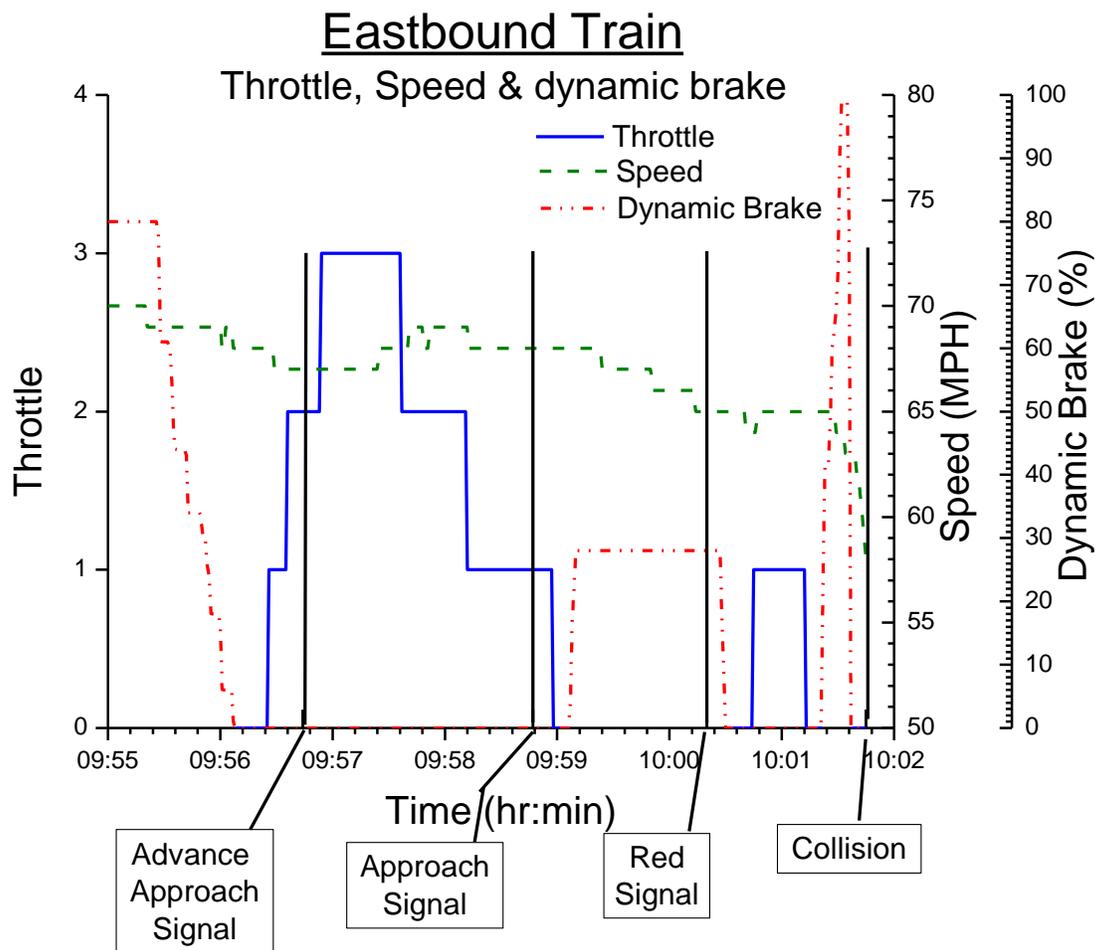
Evidence of the actions of the eastbound train was obtained from the event recorder on the trailing locomotive and the wayside signal logs. The advance approach signal (flashing yellow light) was about 2 miles from the approach signal and about 4 miles from the stop signal at the east end of the Goodwell siding. The advance approach signal required the crew to slow their train to 40 mph. The approach signal (solid yellow light over solid red light) required the crew to proceed at not more than 30 mph and be prepared to stop at the next signal (red light), which was a stop signal. The stop signal required the crew to stop the train. The crew did not comply with any of the three wayside signals; instead, the train was operated past each of the signals at speeds greater than 60 mph, ultimately colliding head-on with the westbound train. (See figure 6.) The investigation revealed that the advance approach, approach, and stop signals were functioning properly and accurately displayed their aspects before the accident.

Figure 6. Eastbound train timeline using event recorder data from trailing locomotive.

The eastbound train engineer did not reduce the train speed in accordance with the two approach signals or stop the train at the third (last) signal—a stop signal—before the collision. Instead, based on the event recorder data, the engineer appeared to make throttle and dynamic brake adjustments that maintained train speed close to the 70 mph limit, as would be expected for a train operating on a clear signal. The conductor did not intervene to slow or stop the train as the wayside signals were not obeyed, as required by UP rules. At the time of the accident, the conductor of the eastbound train had worked for the UP for 9 years. Given his years of experience, it seems unlikely that he saw the advance approach, approach, and stop signals and chose to do nothing to stop the train in time to prevent the collision. It seems much more likely that the conductor failed to observe the three signals during the almost 5 minutes between the advance approach signal and the collision. It appears that he was not engaged in the developing situation as the train neared and proceeded past the advance approach signal. However, detailed evidence that would have been useful to reconstruct and explain the circumstances leading to the accident was limited due to the extensive collision damage and fire: there were no data on crew behavior captured in the event recorder on the lead locomotive, no autopsy results, no toxicology

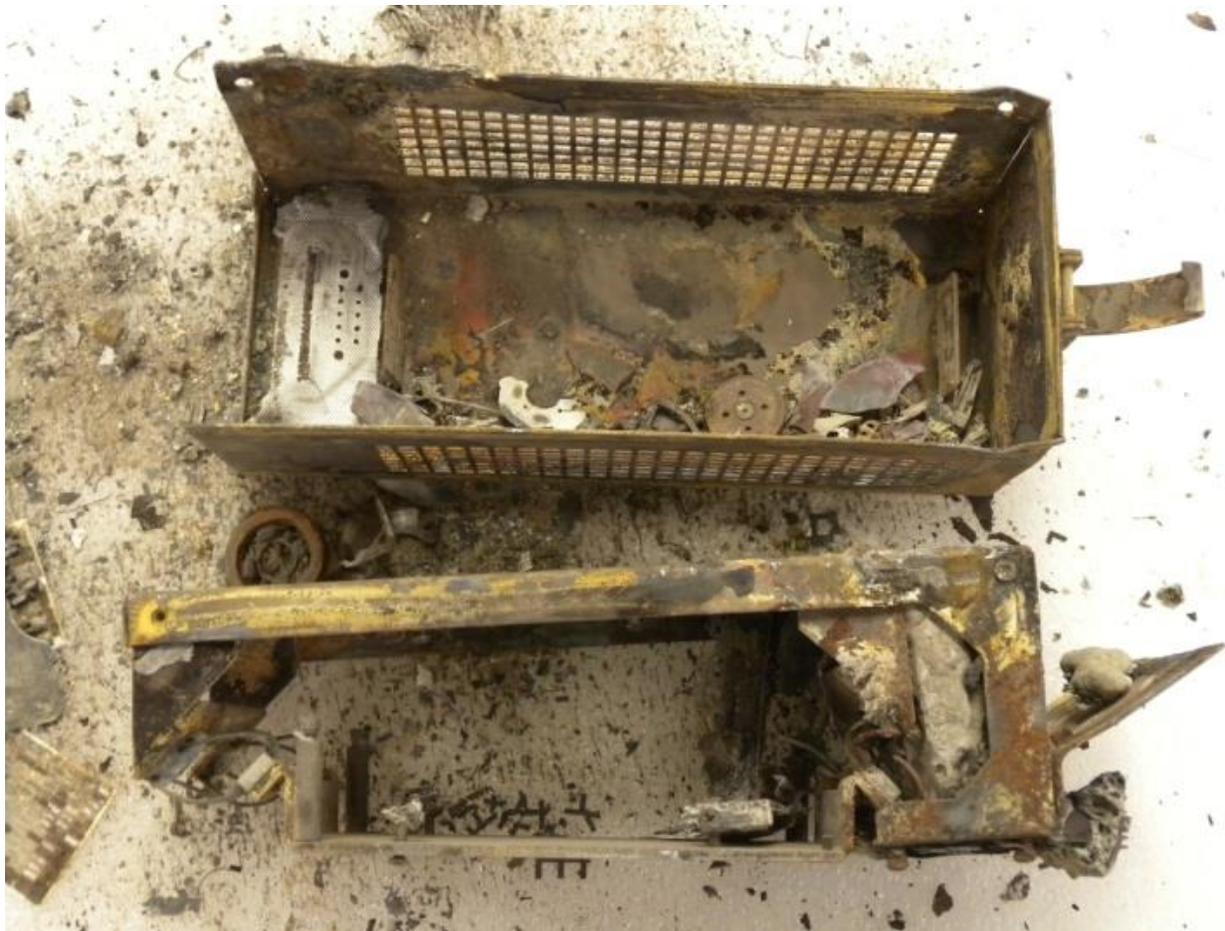
The video recorders on the locomotives in the Goodwell accident were not required by regulation and were not protected from impact or fire. The video recorders from the trailing locomotives of both trains were undamaged and downloaded normally but provided limited information. The video recorder from the lead locomotive on the eastbound train was not recovered. The video recorder from the lead locomotive of the westbound train was severely damaged by fire. The enclosure was opened and inside were unrecognizable burned and broken small pieces of debris, dust, and ash. (See figure 7.)

Figure 7. Interior of video recorder hard drive enclosure from lead locomotive of westbound train.
