Chicago Transit Authority Train Collides with Bumping Post
and Escalator at O'Hare Station
Chicago, Illinois
March 24, 2014

NTSB/RAR-15-01
PB2015-103738

Railroad Accident Report

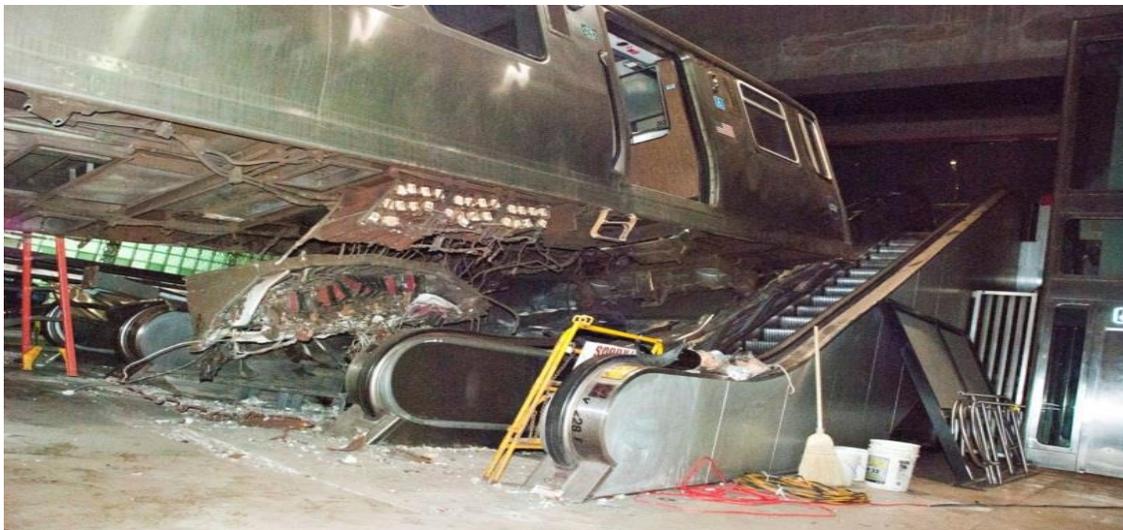
Figure 1. Damaged train No. 141 resting on the escalator.

The lead car struck the bumping post near the end of the track and continued onto the concrete platform and up the escalator. The front truck on the first car were raked out from under the car and remained on the tracks where the concrete platform began. The wreckage under the car and against the concrete platform not only contained the wheels and axles but also the track bumping post structure. Part of the undercar propulsion electronic group was damaged when the car slid over the concrete platform.

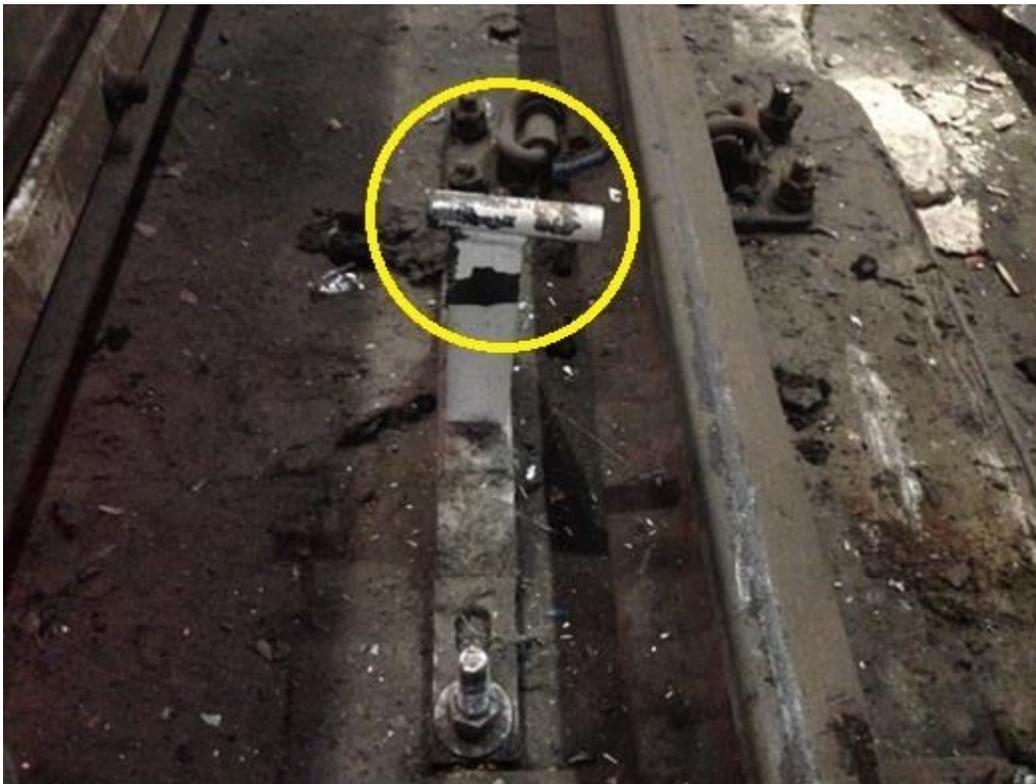
As the train approached the red signal, a speed command to lower the train’s speed to 0 mph automatically went to the operator’s control system. As the train passed the red signal, the track trip mechanically initiated full dynamic and full friction braking on the train.⁶ Meanwhile, the action of the train hitting the track trip woke the train operator. She immediately moved the master controller into the braking position to apply the dynamic and friction brakes. Postaccident data showed the train’s speed was about 23 mph approaching the bumping post. Neither the automatic command nor the train operator’s actions engaged the brakes before the train hit the end of the platform. The track trip at track level had a strike mark on its white paint. (See figure 3.) The switch on the lead car, which would come in contact with the track trip, had signs of white paint transfer.

Figure 3. Strike marks on the track trip's white paint.

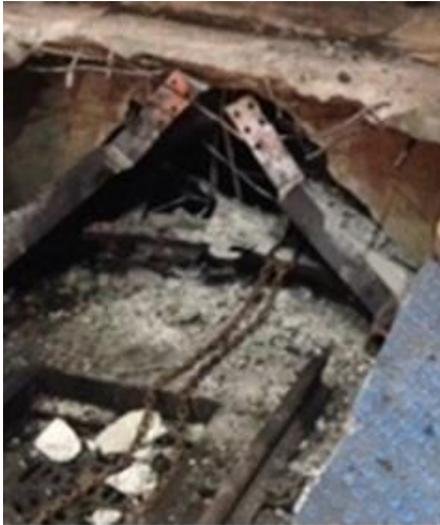
The bumping post near the end of the center pocket track was destroyed by the impact. All three tracks had similar bumping posts before the end of the tracks. (GWE 1985) (Figure 5 shows the destroyed bumping post; Figure 6 shows a similar bumping post installed on track 2.)

Figure 5. Destroyed bumping post.

A postaccident examination of the accident site showed that the bumping post on the center pocket track was installed with the striking face about 13 feet from the end of the rail and 15 feet 6 inches to the concrete platform edge. The distance from the striking face of the bumping post to the end of the frame was 9 feet.

Since the accident, the CTA has installed additional track trips with more distance to the end of the track at the O'Hare Station. They have also decreased the maximum speed to 15 mph on the center pocket track. Further, as explained in the Postaccident Actions section, the CTA found other locations of terminating tracks with suspect stopping distances and are making modifications.

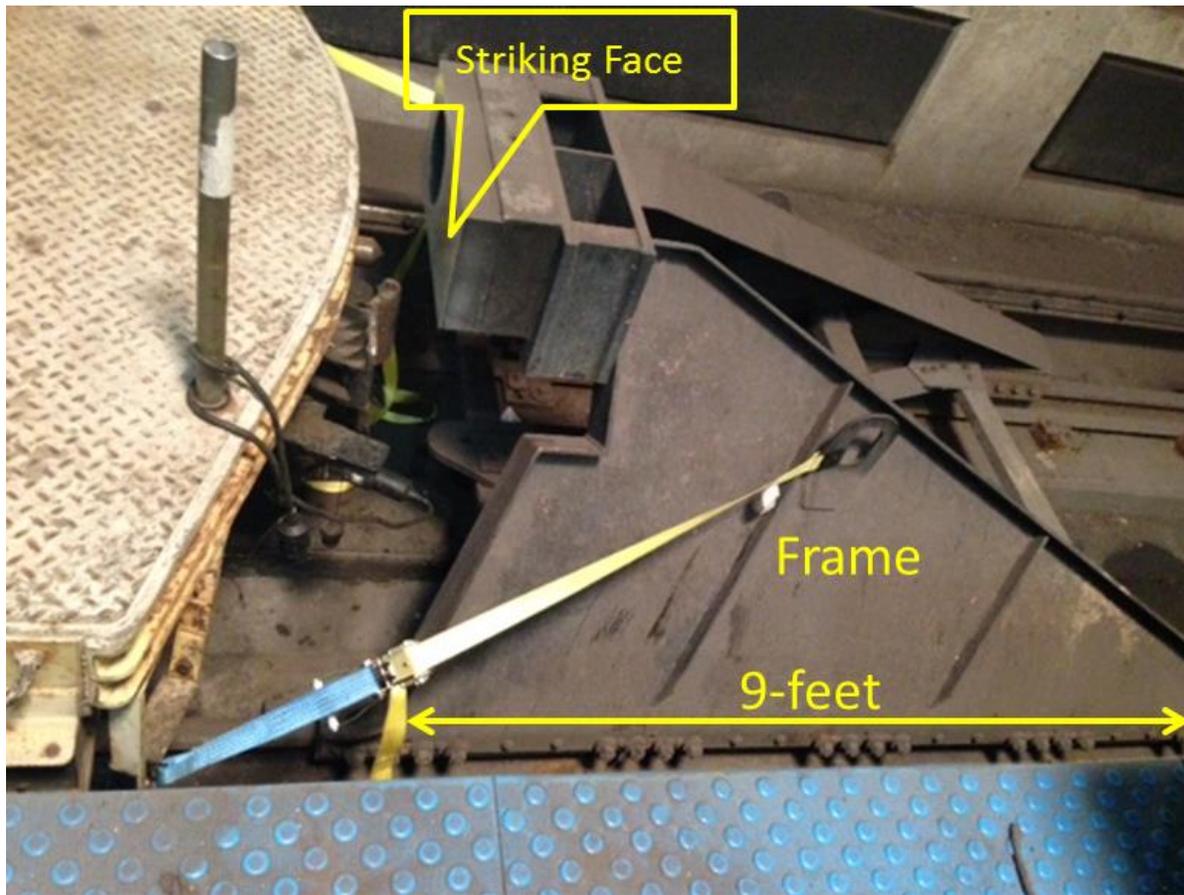
Figure 6. This bumping post is similar to the one destroyed on the center pocket track by the impact.

Original design documents showed the face of the bumping post not to exceed 13 feet from the end of the track for the pocket track. However, the bumping post locations for tracks 1 and 2 are shown as 60 feet \pm .

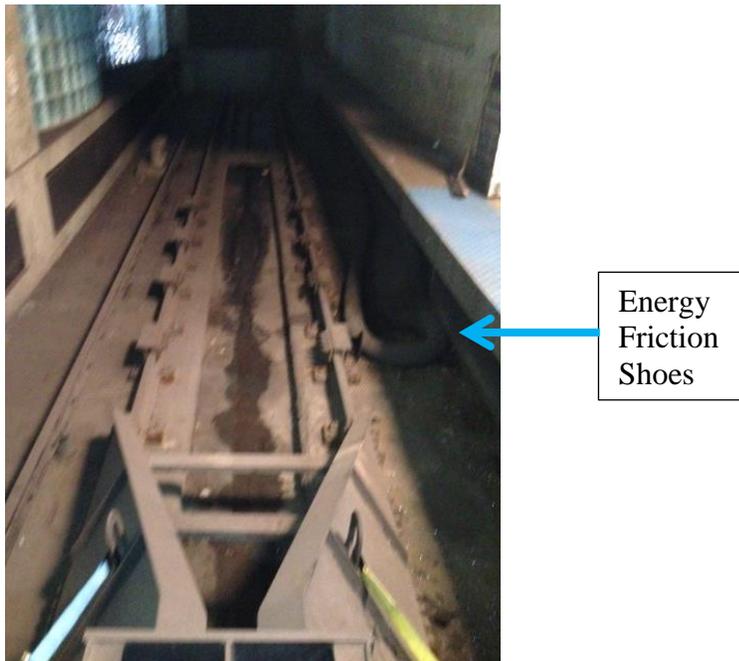
The bumping post specifications included energy friction shoes.⁸ However, NTSB investigators contacted a former project manager associated with the original construction, who recalled that when the bumping post was installed in the center pocket track there was not enough room to add the energy friction shoes on the rail behind the post supports. Because of that, the construction workers tightened the fasteners that attach the bumping post to the center pocket track with more force than they used on the other two tracks. Investigators were unable to find evidence of an analysis that showed tightening the fasteners was the appropriate method for addressing the lack of room and absence of the energy friction shoes. Energy friction shoes were installed on tracks 1 and 2. See figure 7 for a depiction of the friction shoes fastened to the rail on track 2.

Figure 7. Energy friction shoes fastened to the rail on track 2.

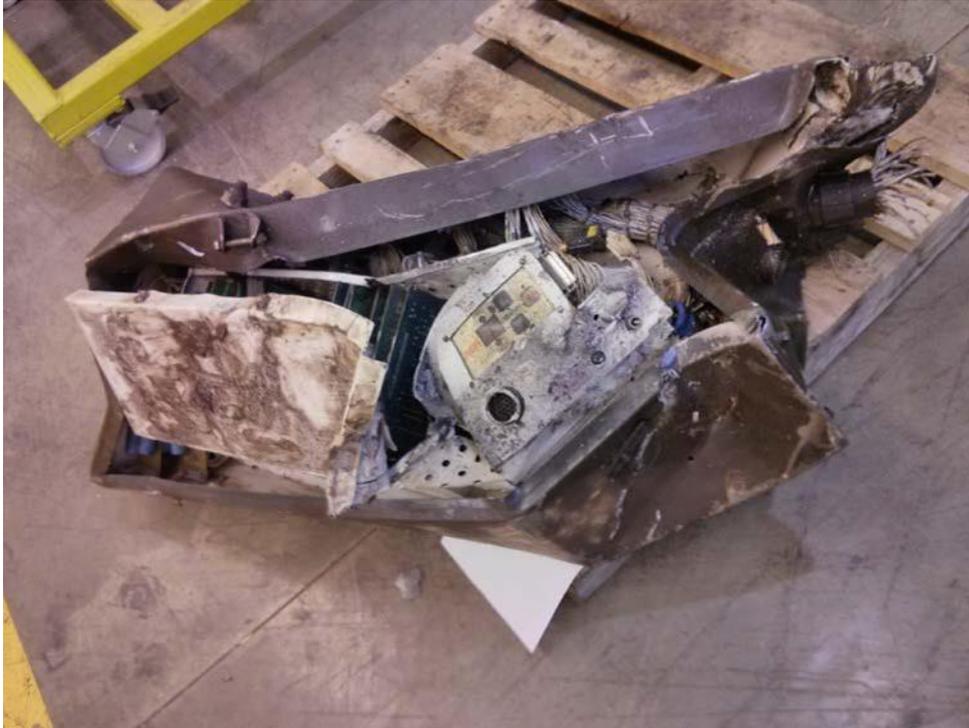
Supervised by NTSB investigators, the undercar propulsion electronic group from car 3061 was removed after the accident and sent to CTA's repair facility in Skokie, Illinois. A qualified electrician removed the propulsion card. (See figure 8.) The visibly undamaged U20 chip was put onto a new card, but no data could be retrieved. The only data that could be recovered was from the trailing cars.

Figure 8. The card rack, which recorded the event data, was within the undercarriage and was damaged in the crash.
