Derailment of Amtrak Passenger Train 188  
Philadelphia, Pennsylvania  
May 12, 2015

**Accident Report**

NTSB/RAR-16/02  
PB2016-103218

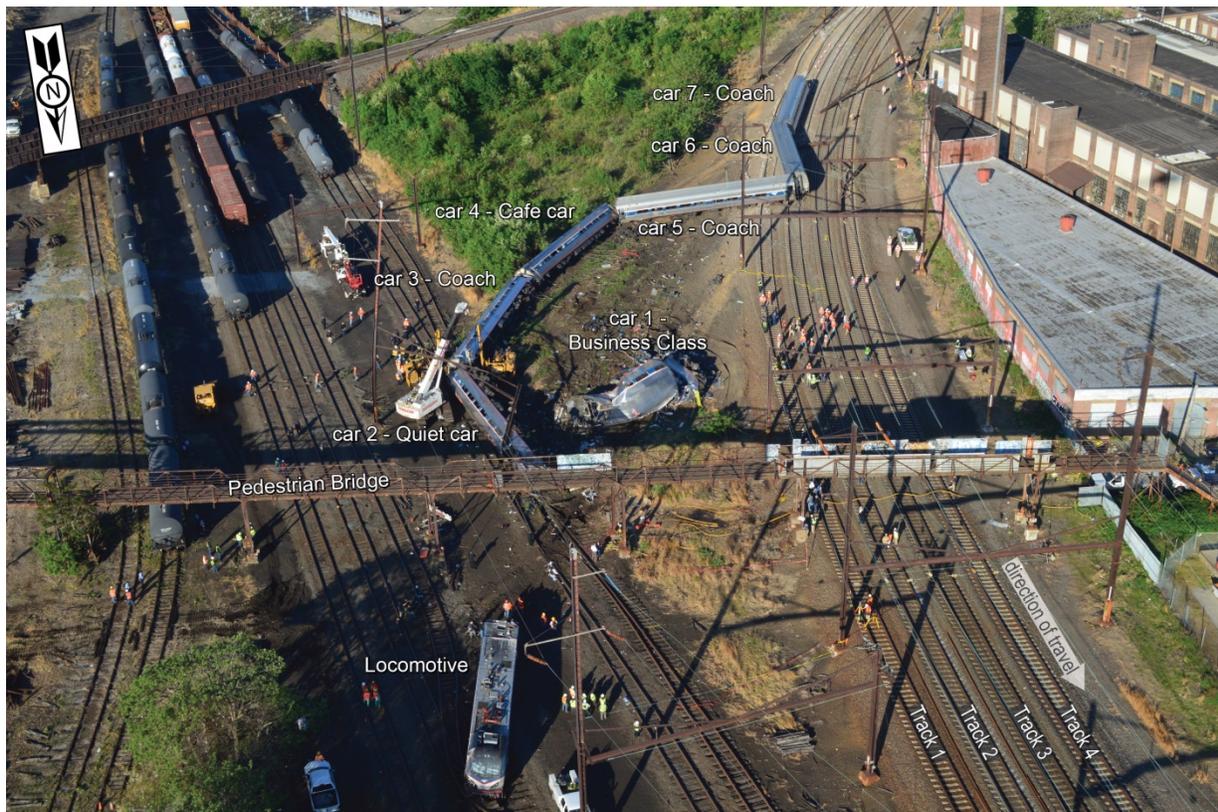
**Figure 1.** Accident scene.

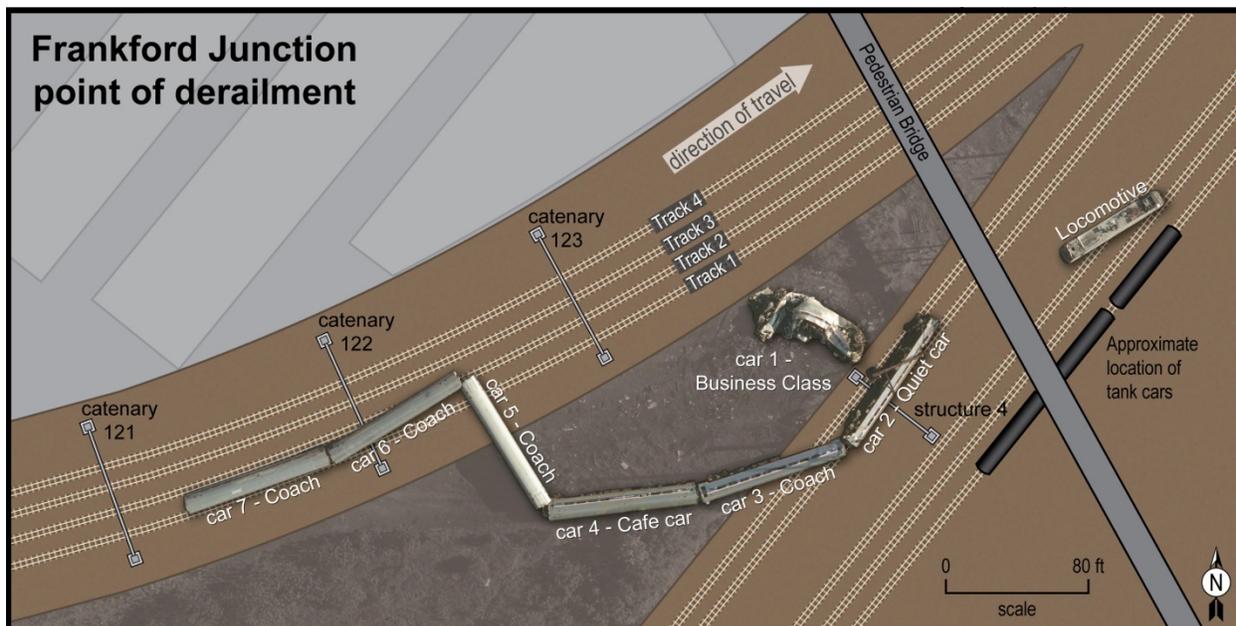
A review of the locomotive forward-facing video showed that the locomotive traveled past—and did not strike—the first catenary support structure, N121. (See figure 6.) After the first passenger car derailed, it struck catenary support structure N121. This support structure completely separated from the remainder of the catenary structure, and the first passenger car was severely damaged, likely from the impact. The second catenary support structure, N122, was struck with enough force to separate it from the rest of the catenary structure and flatten it to the ground. Components of the first passenger car were found beginning at the second support structure N122. As a result of multiple impacts with catenary support structures and subsequent overturning, the structure of the first car was catastrophically compromised. Four of the eight passengers who died were recovered in or near this car.

**Figure 6.** Accident site showing derailed cars, catenary structures locations.

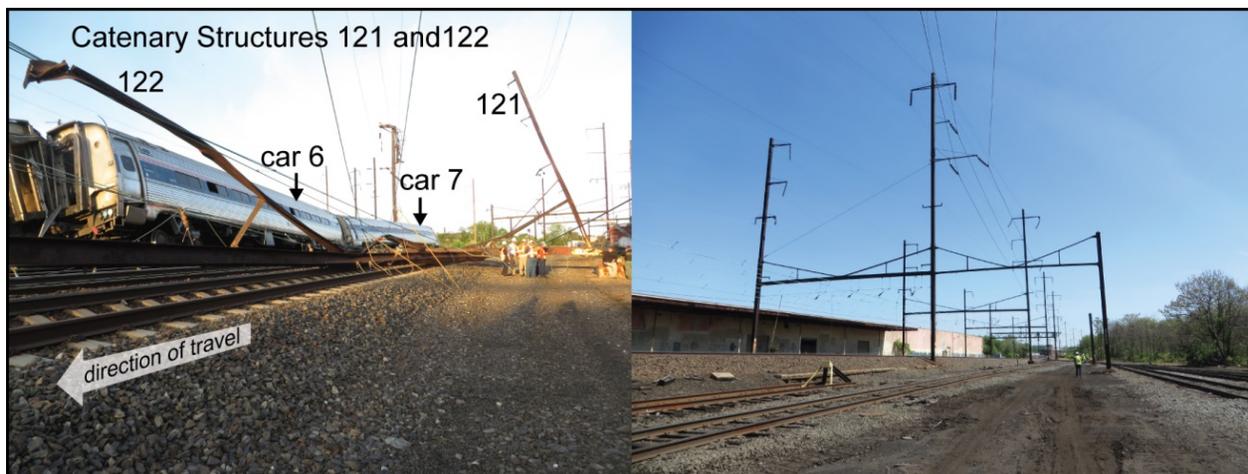
**Figure 7.** Damaged catenary supports (left); example of undamaged catenary supports (right).

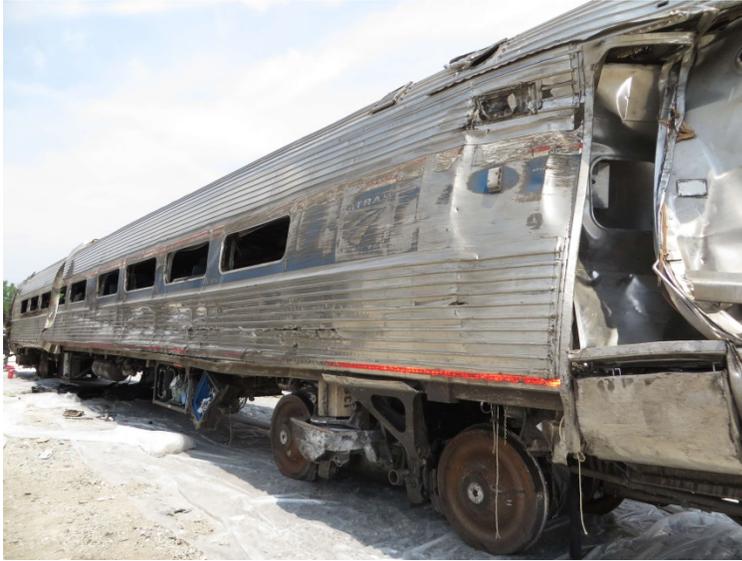
six right-side windows were completely separated from their openings, and three right-side windows were partially dislodged and missing exterior zip strips. On the third car, all nine of the right-side windows were separated from their openings, and there was extensive scraping on the blue decal surrounding the windows. On the fourth car, three right-side windows were completely separated from their openings, and four windows were partially dislodged. The remaining cars in the consist had varying degrees of scraping damage on their right sides (car body and windows).

**Figure 8.** Photograph showing damaged right side of car 3.

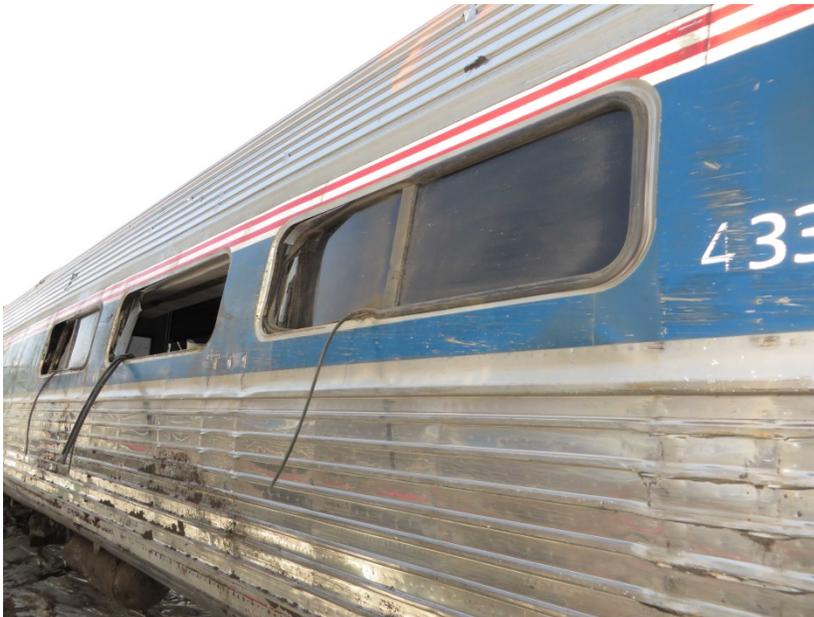
**Figure 9.** Close-up of damaged windows on right side of car 4.

Four of the passengers who died were recovered under or near the third passenger car. Two of these four passengers were partially ejected from window openings and trapped under the third car. Another passenger was found under car 3, and the last was found adjacent to car 3. These two were most likely ejected from the train through window openings after the windows had separated. As previously mentioned, six windows were completely separated from car 2, and all nine of the right-side windows were separated from their openings from car 3. The NTSB concludes that if the passenger car windows had remained intact and secured in the cars, some passengers who died would not have been ejected and would likely have survived the accident.
