RAILROAD ACCIDENT REPORT

PENN CENTRAL COMPANY
COLLISION OF TRAINS
N-48 AND N-49 AT
DARIEN, CONNECTICUT
AUGUST 20, 1969

REPORT NUMBER: NTSB-RAR-70-3

ADOPTED: OCTOBER 14, 1970

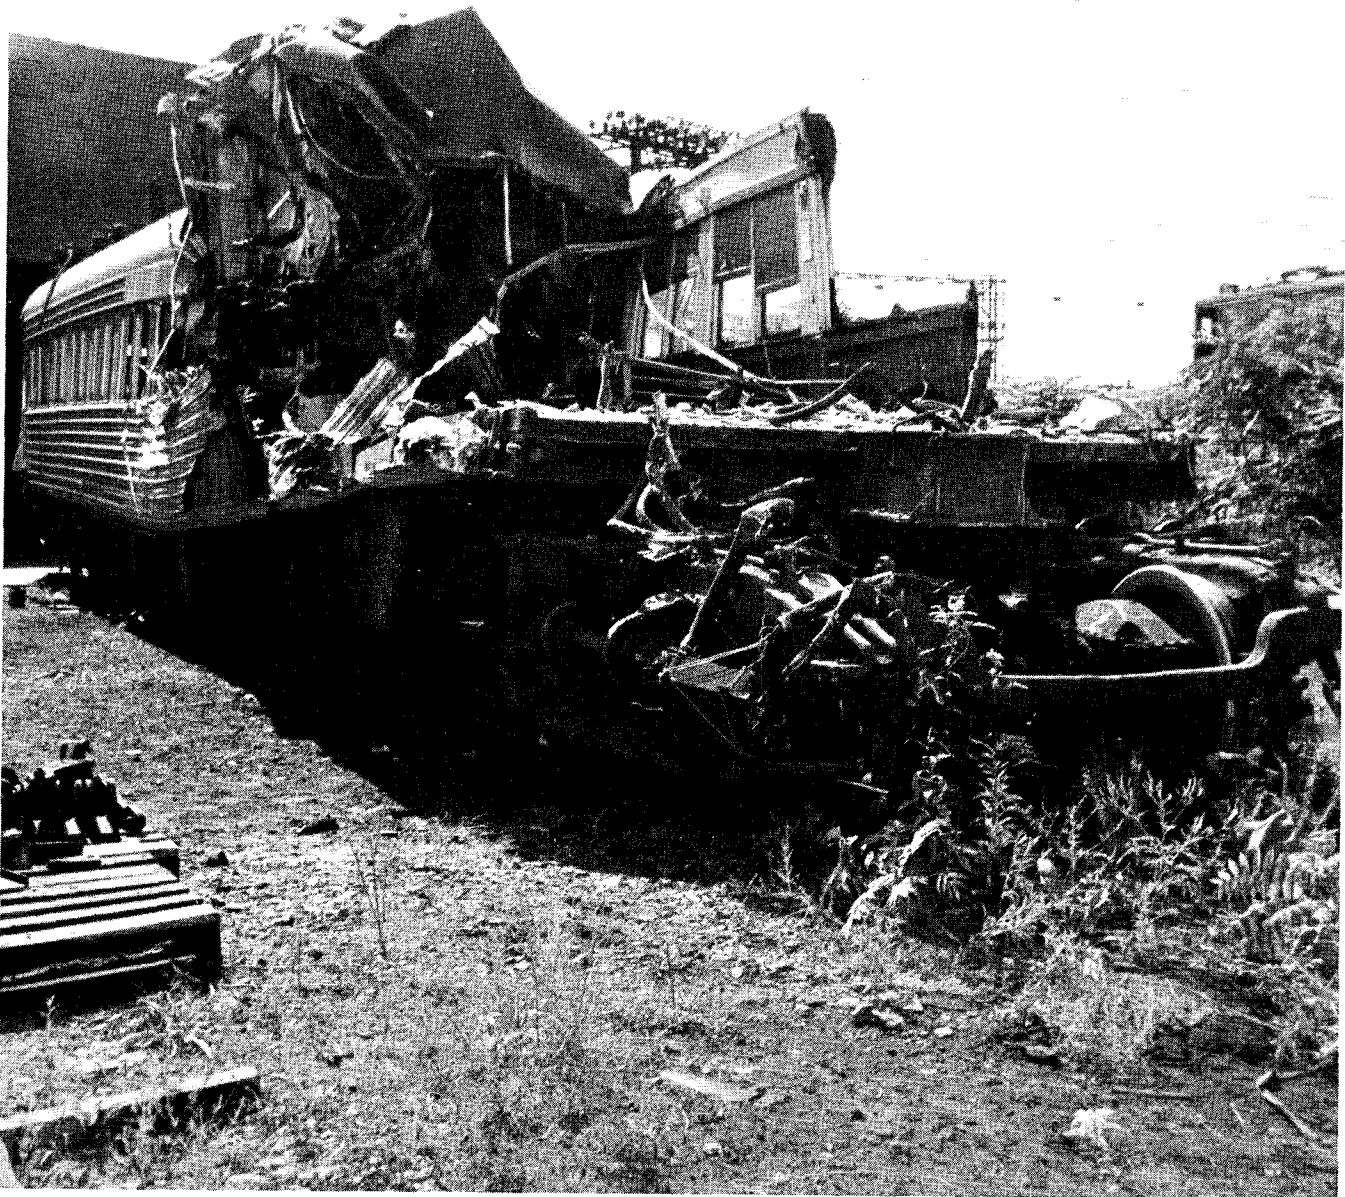
Figure No. 2

Because the leading car of N-49 passed through the superstructure of the leading car of train N-48, almost one-half of the first car of train N-48 was destroyed. The underframe of the first car of N-48 was broken off at the body bolster or at a point about 13 feet from the end of the car. The engineer's compartment, on the front platform on the end of the car was completely destroyed and this entire section of the car was forced approximately 20 feet to the rear. (See Figure 2, page 14.) The underframe of the second car of N-48 buckled and was moderately damaged. The third car was slightly damaged.

Damage to leading car of N-48

The impact caused the body of the leading car of N-49 to break away from the forward truck and to rise upwards. The car body mounted the underframe of the leading car of N-48 and passed partly through the superstructure. The force of the collision caused the leading car of each train to move laterally, the first car of N-49 to the south, and the first car of N-48 to the north. When the cars came to rest, they were side-by-side with the front end of the leading car of N-49 about 30 feet east of the front of the leading car of N-48. The momentum exchange of the impact moved the lighter, three-car train (N-48) backwards from the point of impact about 21 feet, while the heavier train came to a stop after a movement of 21 feet plus the distance of the collapsed superstructure of the first car of N-48, a total distance of about 40 feet. Much of the force of the impact was absorbed by the collapsing structure of the two leading cars, and the full force of the impact was not transmitted to the other cars in the train. This reduced the extent and severity of injuries to the passengers riding in the second and third cars of N-48.

The engineer of N-48 was in the control compartment and a passenger was somewhere in the forward portion of the leading car prior to the accident. The forward half of the car was demolished by the collision. The body of engineer was found in the crushed control compartment, and the body of the passenger in the twisted metal of the damaged portion of the car.

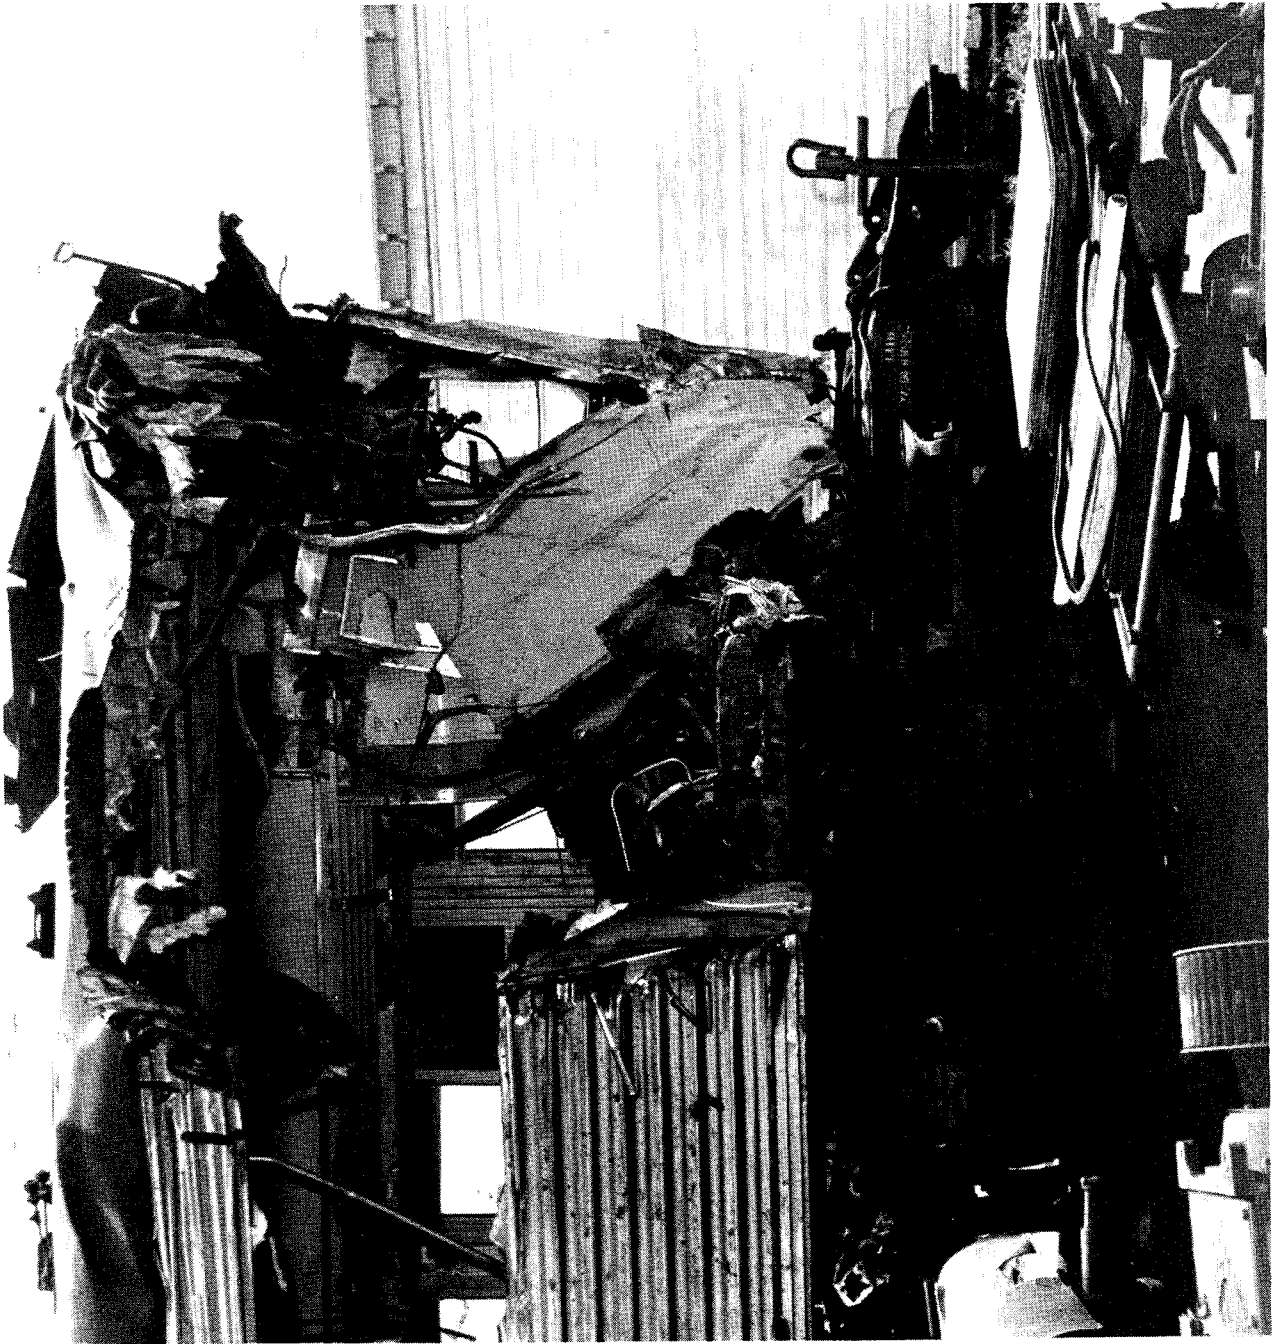
Figure No. 3

Damage to leading car of N-49

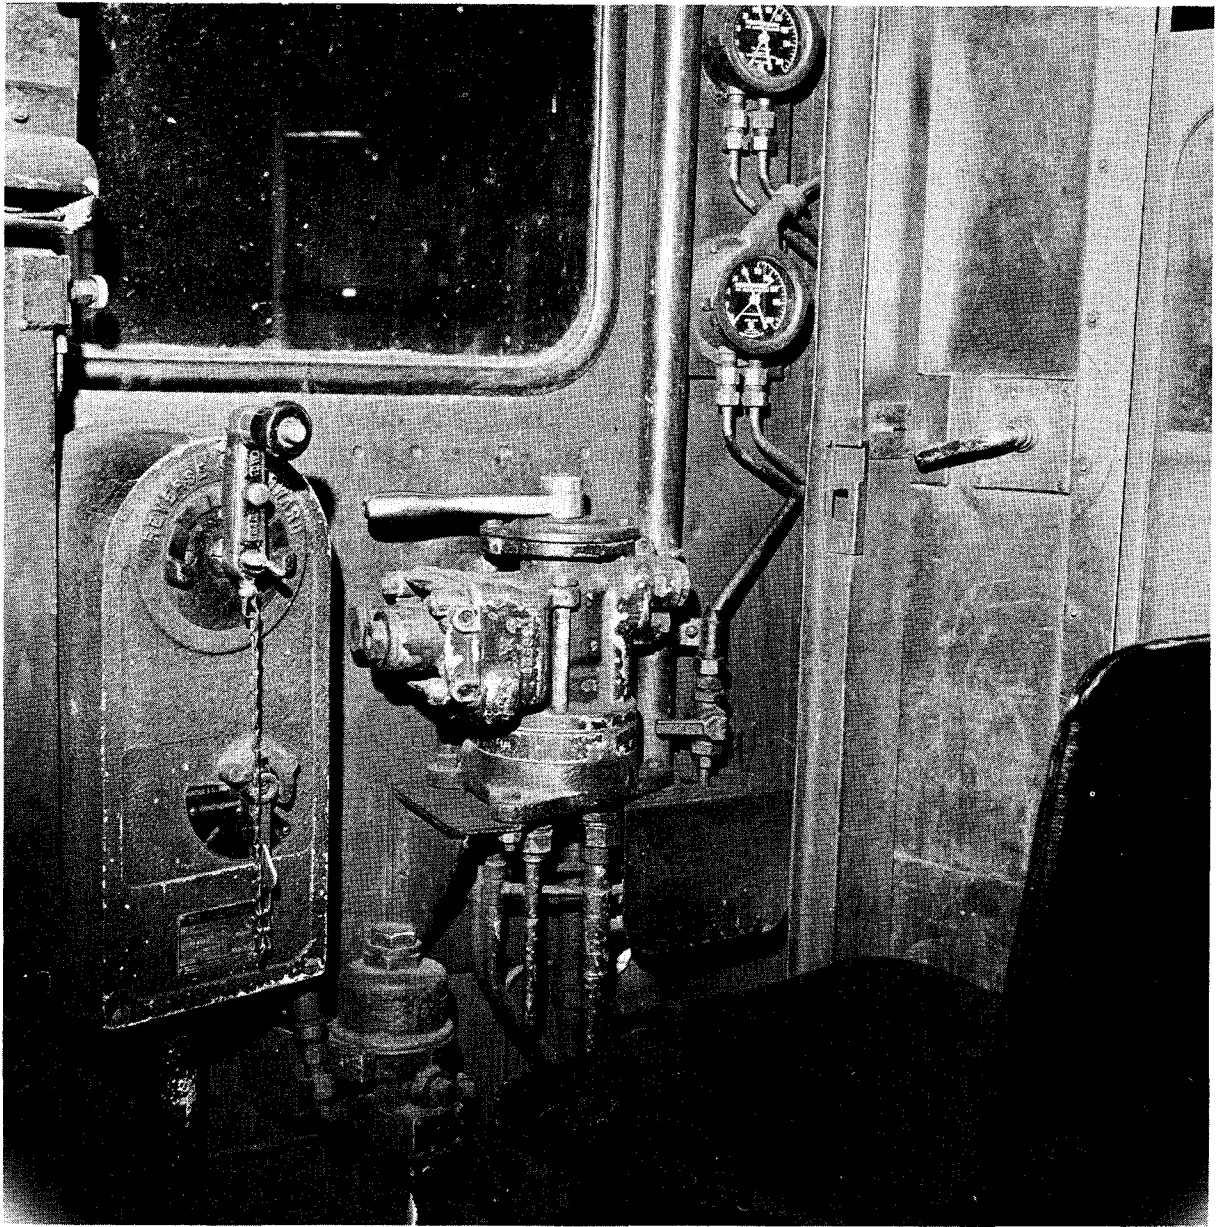
Figure No. 4

Interior view of engineer's operating compartment

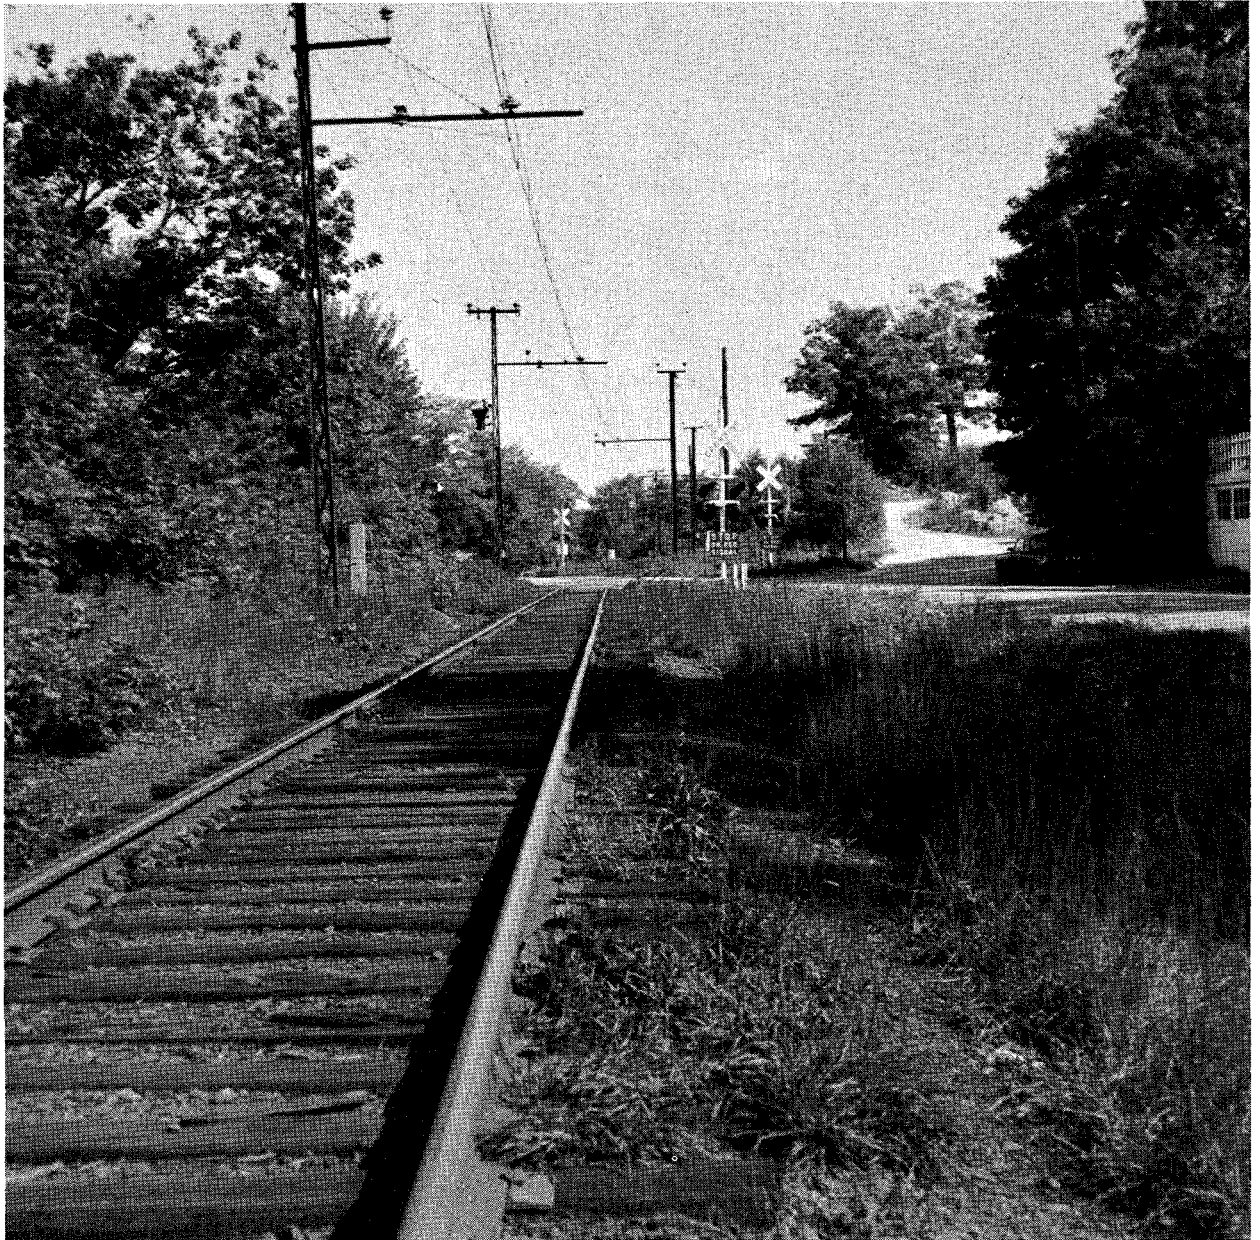
Figure No. 4-6

Hoyt Street crosses the main track from south to north at an angle of about 20° . The center of this crossing is located about 340 feet east of the east siding switch of Dale siding. Another street, which approximately parallels the main line on the south, intersects with the east side of Hoyt Street. This junction is located just south of the railroad crossing. These roads and crossings are surfaced with bituminous material. Apparently due to the angle of the intersection and the additional road intersecting Hoyt Street close to the crossing, four automatic red-flashing light protection devices are provided, one on each corner. Due to the angle of the crossing and the installation of the devices, the red-flashing lights can be more easily seen by persons on the train than those signals protecting roadways crossing the track at right angles. (See Figure 4-6.)

Hoyt Street Crossing as seen by the engineer of an eastbound train after passing Dale siding.
