# RAILROAD ACCIDENT REPORT

DERAILMENT OF AMTRAK TRAIN NO. 1  
WHILE OPERATING ON THE  
ILLINOIS CENTRAL RAILROAD NEAR  
SALEM, ILLINOIS

June 10, 1971

REPORT NUMBER. NTSB-RAR-72-5

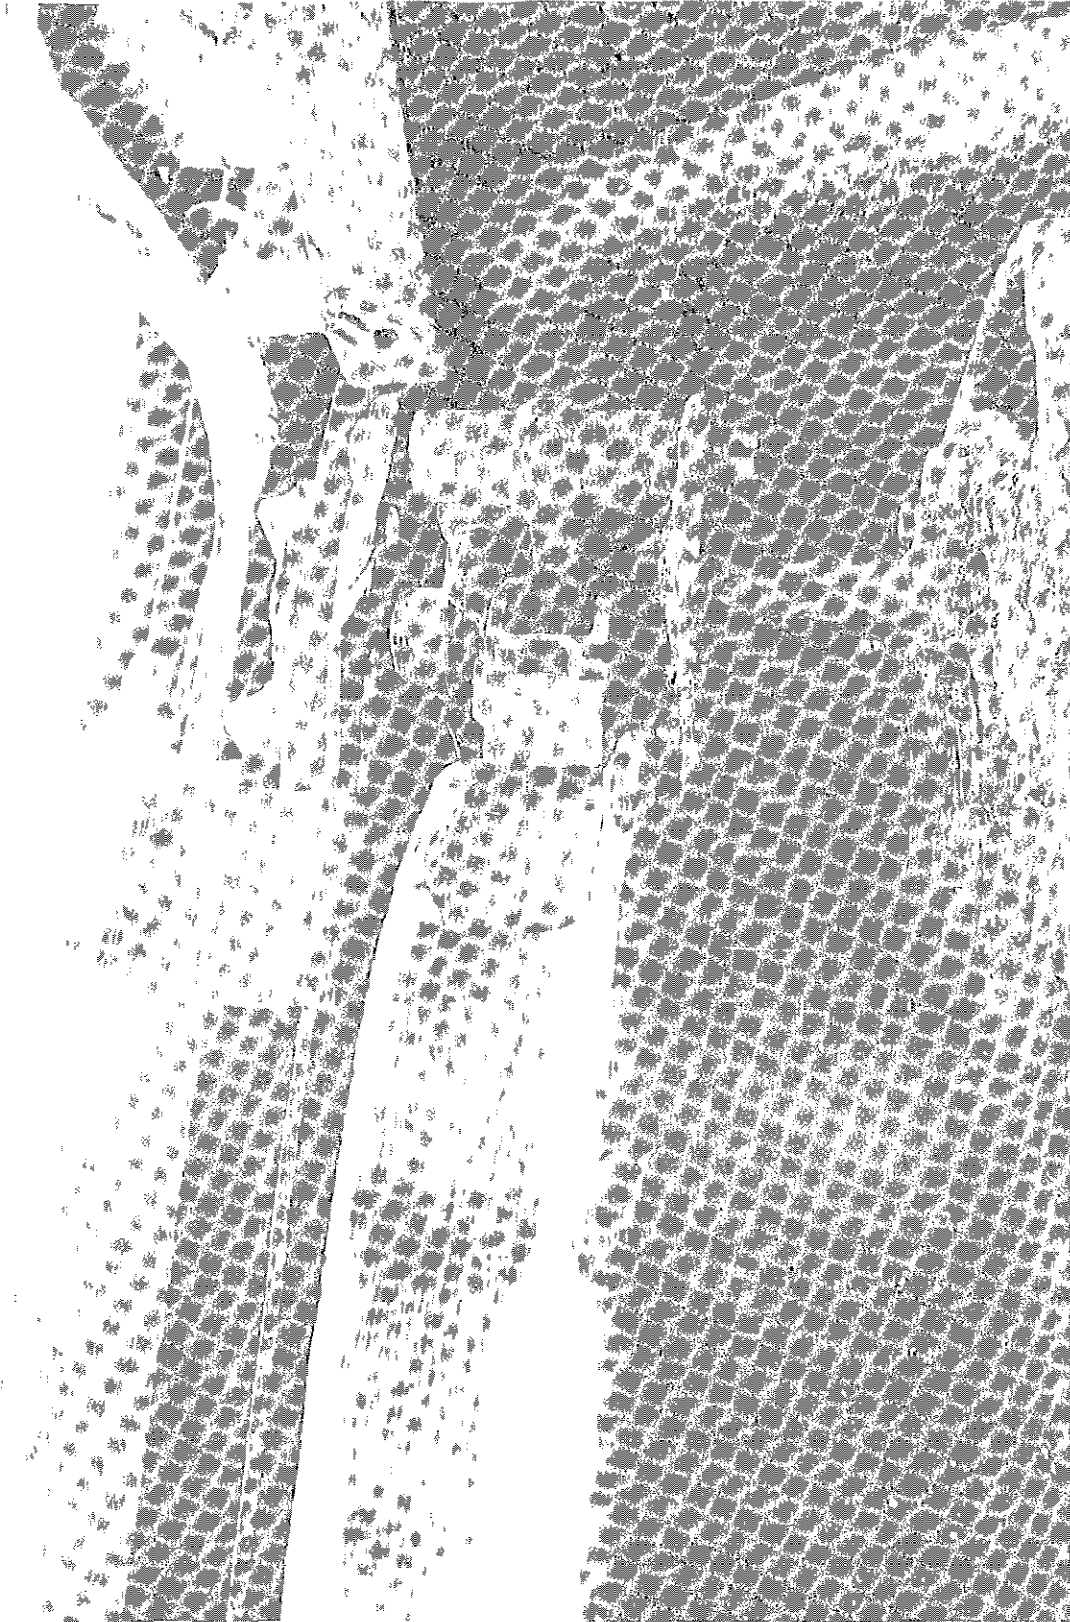
Figure 7 —Slid-Flat Spot on Locomotive Wheel as Observed at Scene of Accident.  
Gear Case has been Removed.

The rear truck of unit 4031 remained attached to the unit when it was turned over on its side. Both of the leading wheels of this truck had flat spots about 10-3/4 inches in length. These flat spots had produced a false flange on the outside edge of the tread. (See Figure 7.) The fact that there were no other flat spots on the wheels indicated that the wheels had not turned after locking. When the gearcase cover was removed, no broken gear teeth or other defects in the gears were found which would have caused the wheels to lock.

When the armature on the traction motor seized, the direct connection between the pinion gear on the armature and the ring gear on the axle caused the wheels to stop turning. The friction between the sliding wheels and the rail soon wore away the tread of the wheels at the point of contact. The absence of other flat spots on these wheels indicates that once the wheels began to slide, they remained in a fixed position.

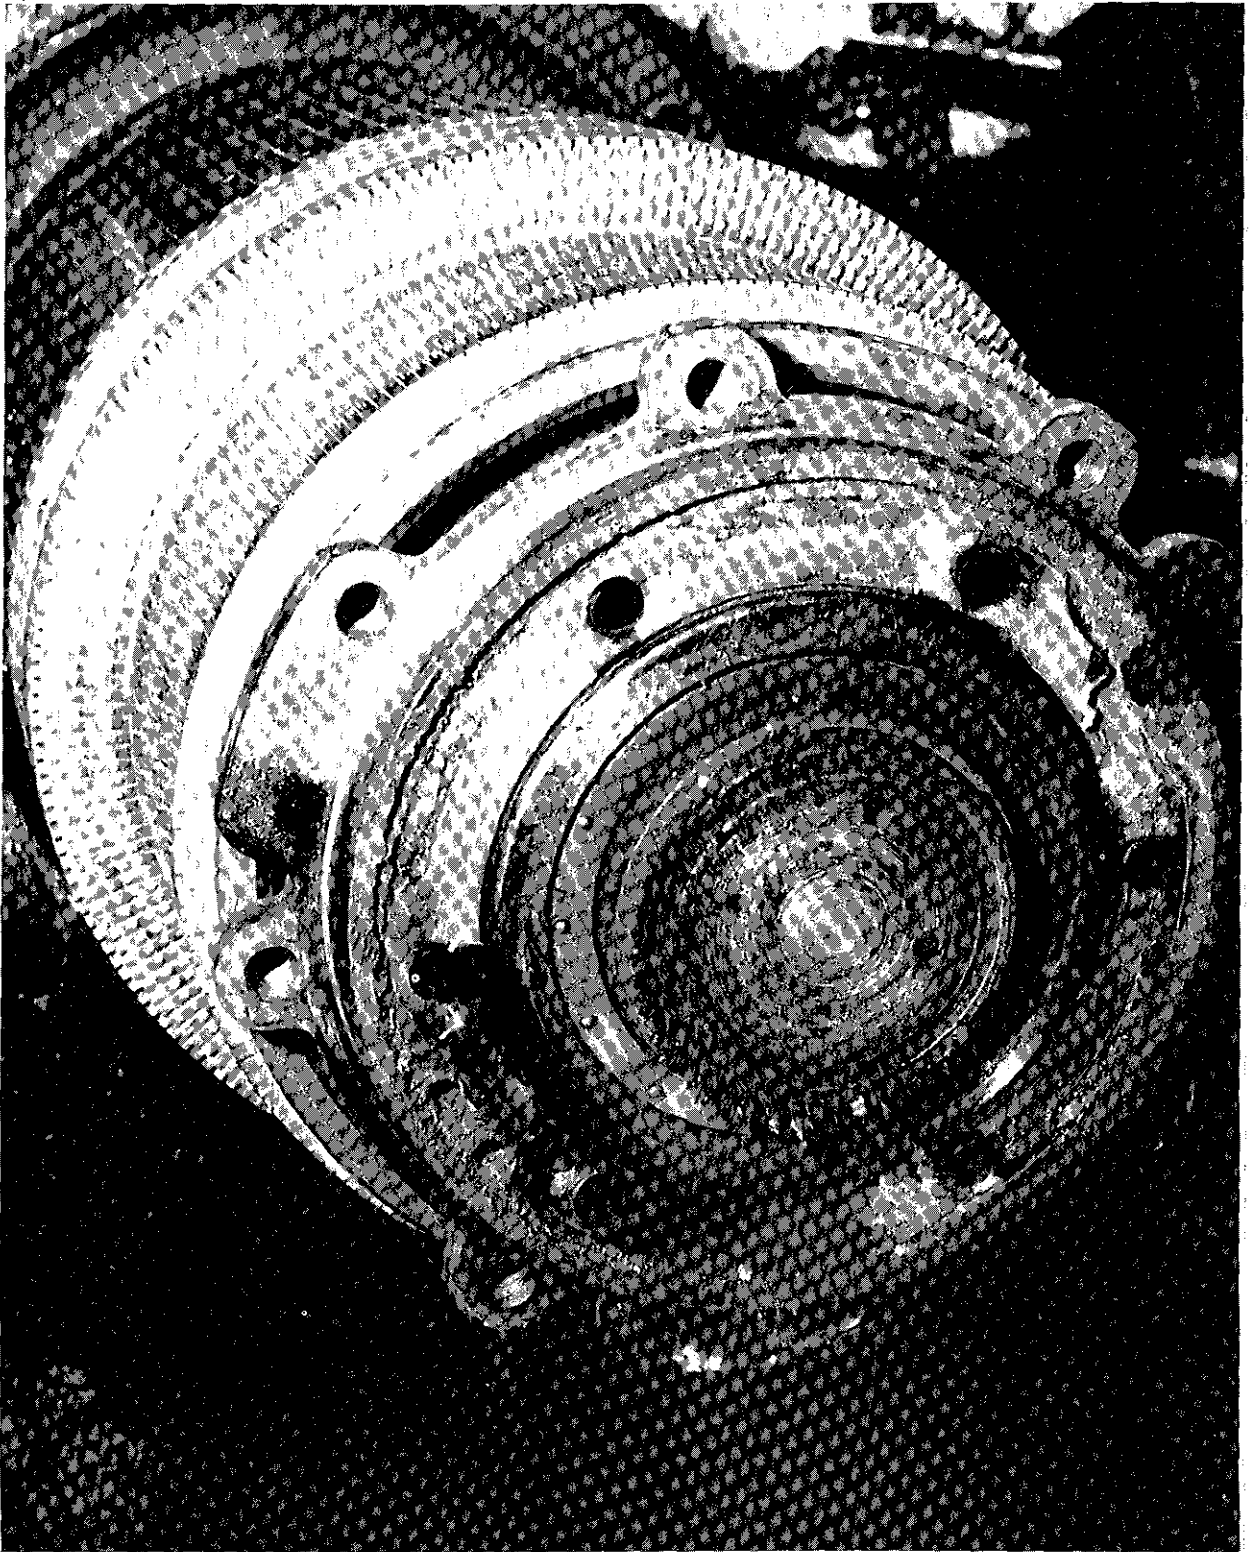
**Figure 9 – Damaged Commutator End Bearing**

The armature was removed from the motor and disassembled. The commutator end roller bearing was damaged by heat and the grease was charred. (See Figure 9.) The pinion end roller bearing was damaged by heat. The steel rollers were flattened, grooved, and discolored. The inner and outer races were damaged. (See Figure 10.)

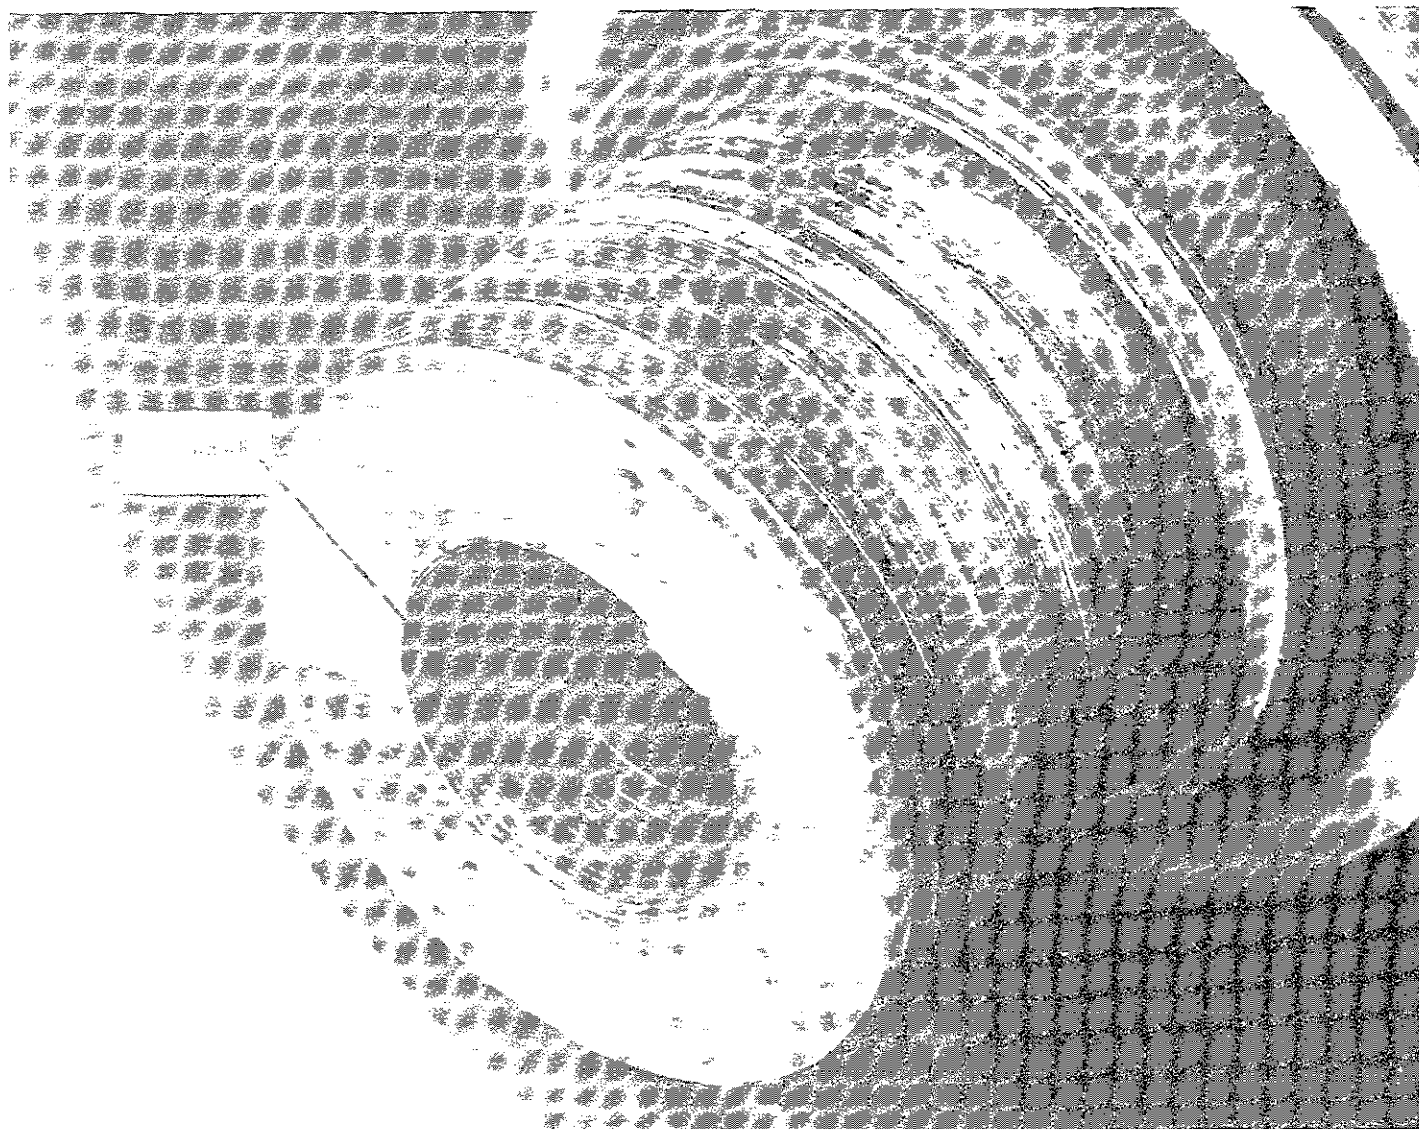
of the armature shaft indicated no distress from movement of the locking screws.<sup>4</sup>

Figure 11.—Commutator End of Armature Shaft showing markings made by set Screws with no Evidence of Set Screws moving on Face of Shaft.

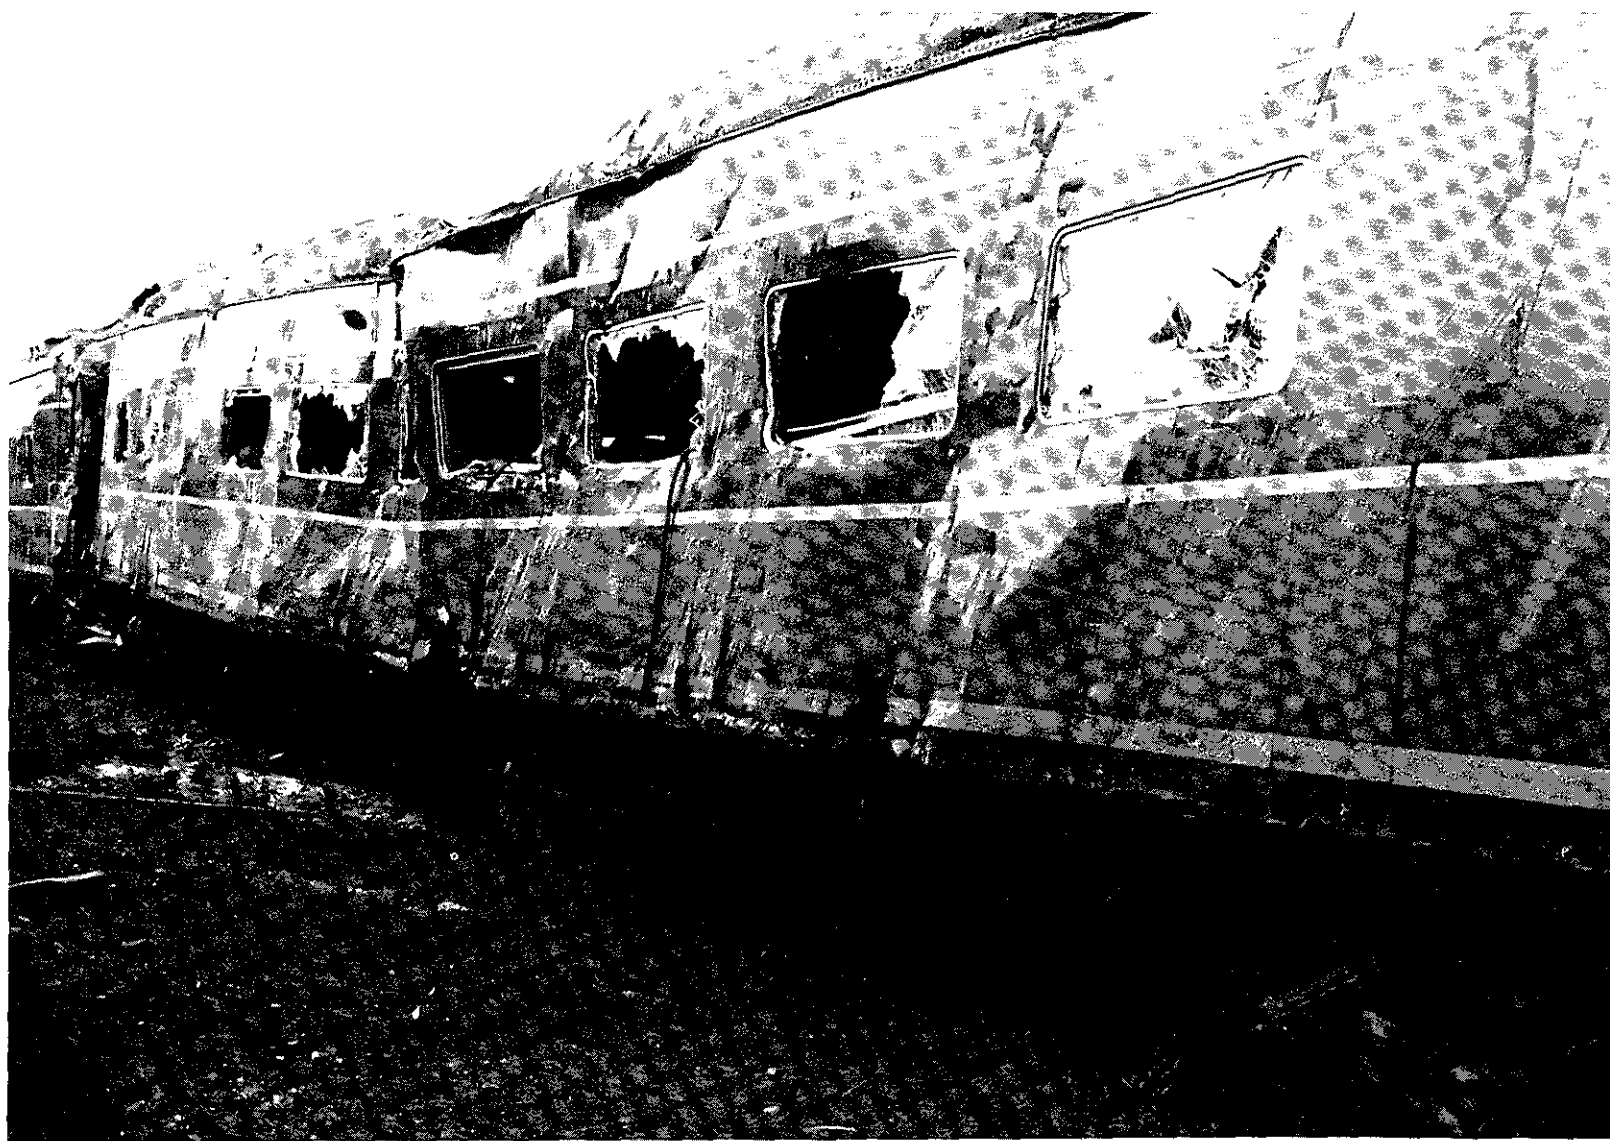
The cause of six of the eleven fatalities was the ejection of passengers through the large side windows which broke when the cars overturned. The other fatalities were caused by passengers being ejected from the end of the car, or being struck by a cross tie, or being hurled against the inside of the car. A total of 163 passengers and employees were injured when impacted against injury-producing surfaces inside the cars.

Figure 12.—Large observation type windows broken out when car 2616 overturned. Note outward distortion of broken glass in two nearest windows. The broken out windows became the floor of the passenger compartment as the car slid to a stop. At least one or as many as three passengers were ejected through these holes and were fatally injured.

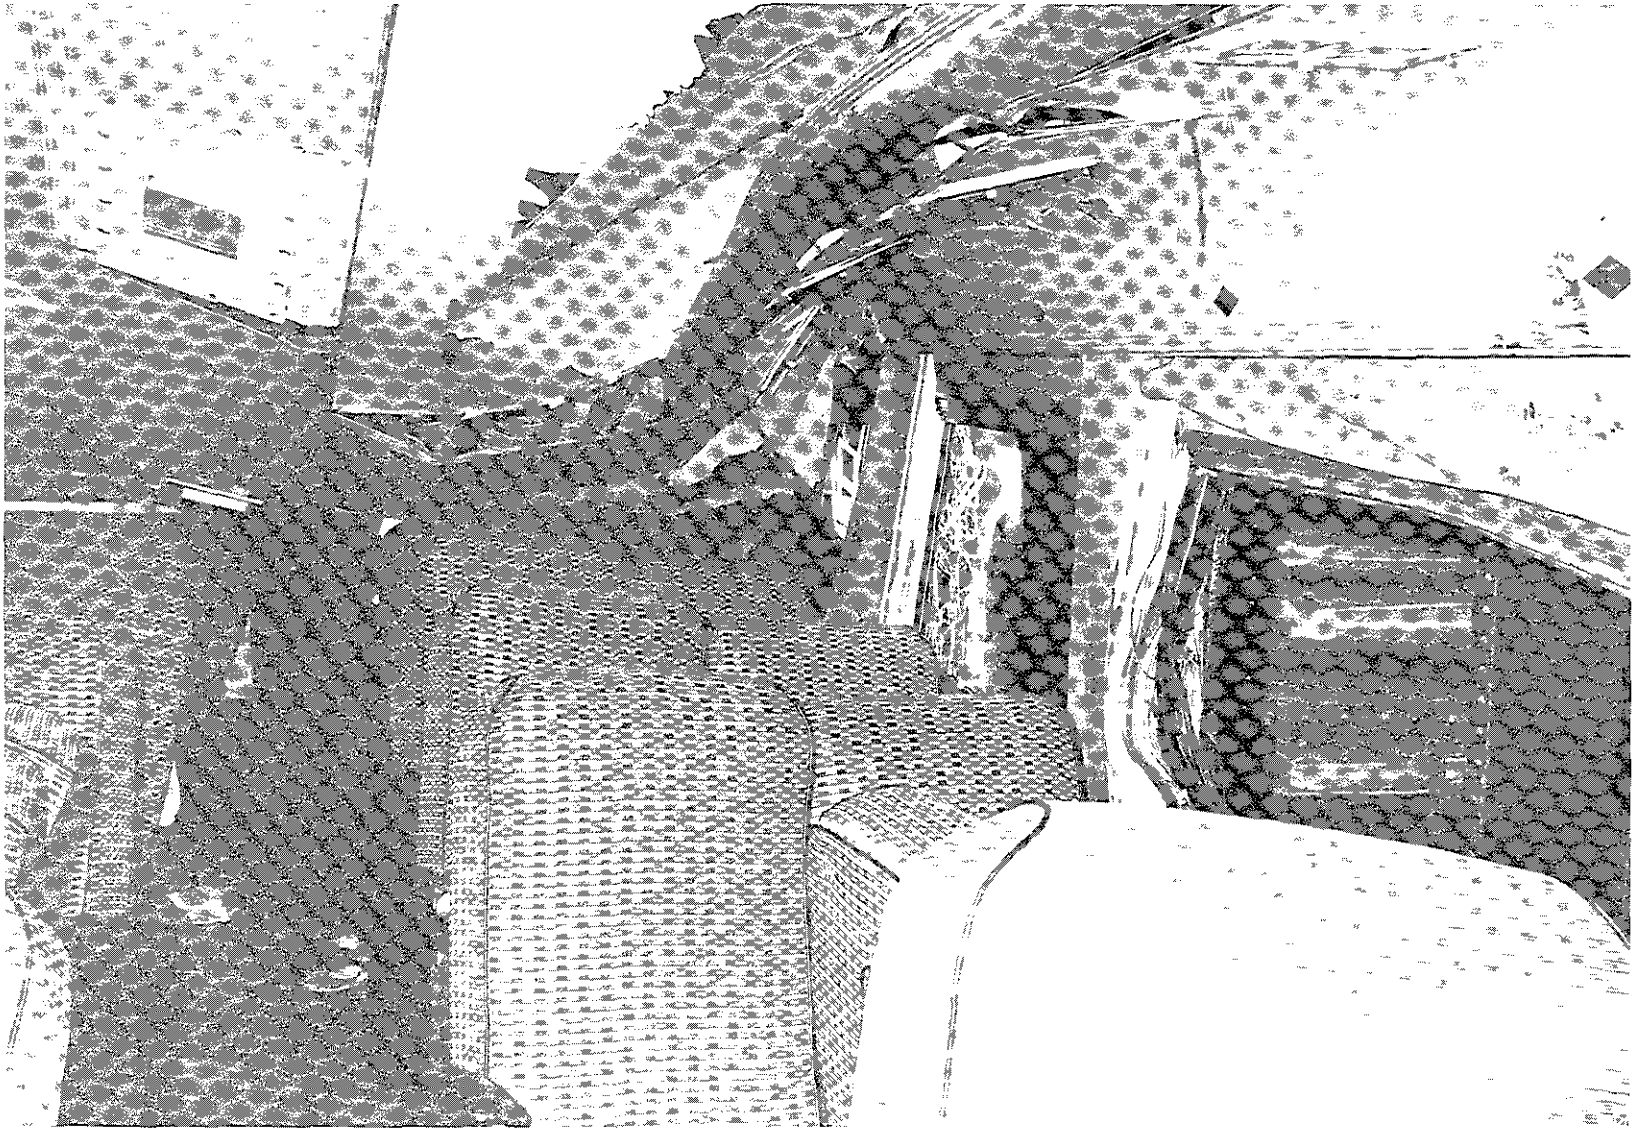
Figure 13.—Separation of metal ceiling which produces sharp edges.

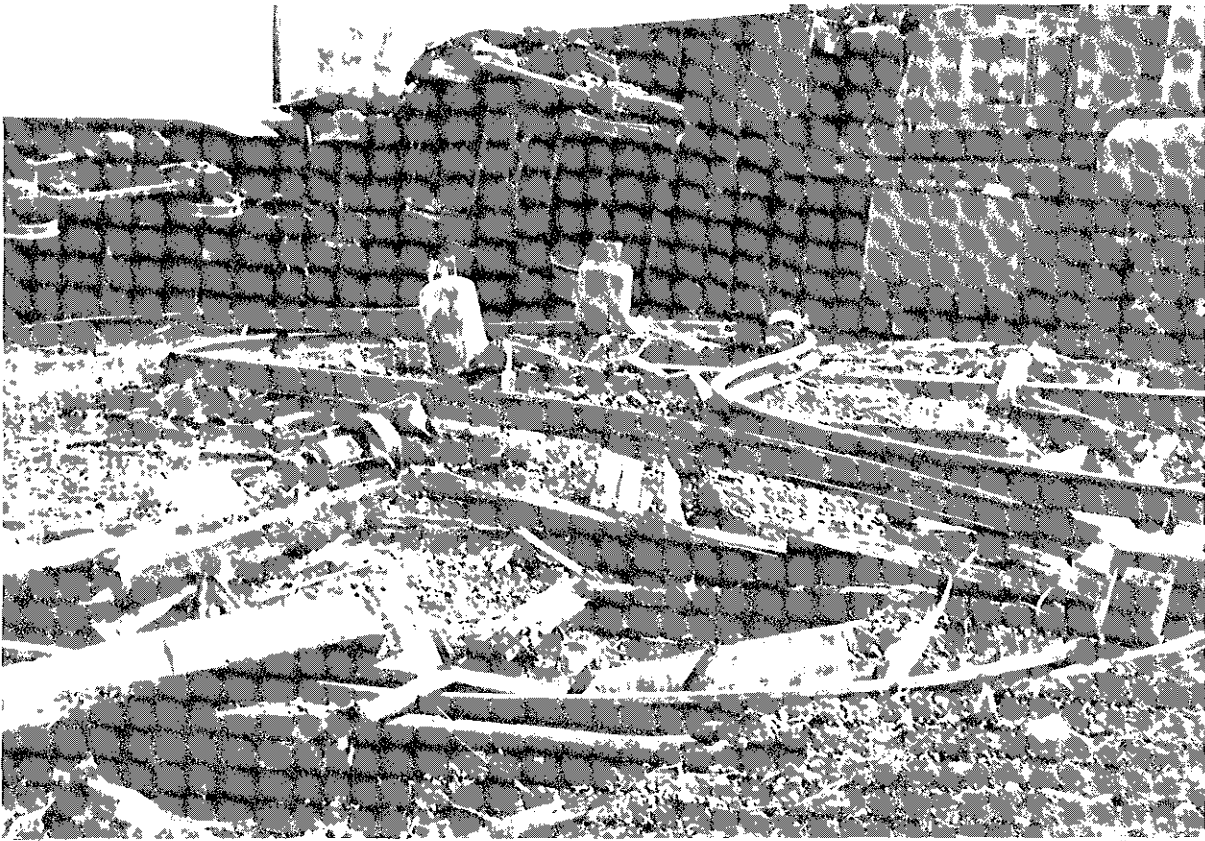
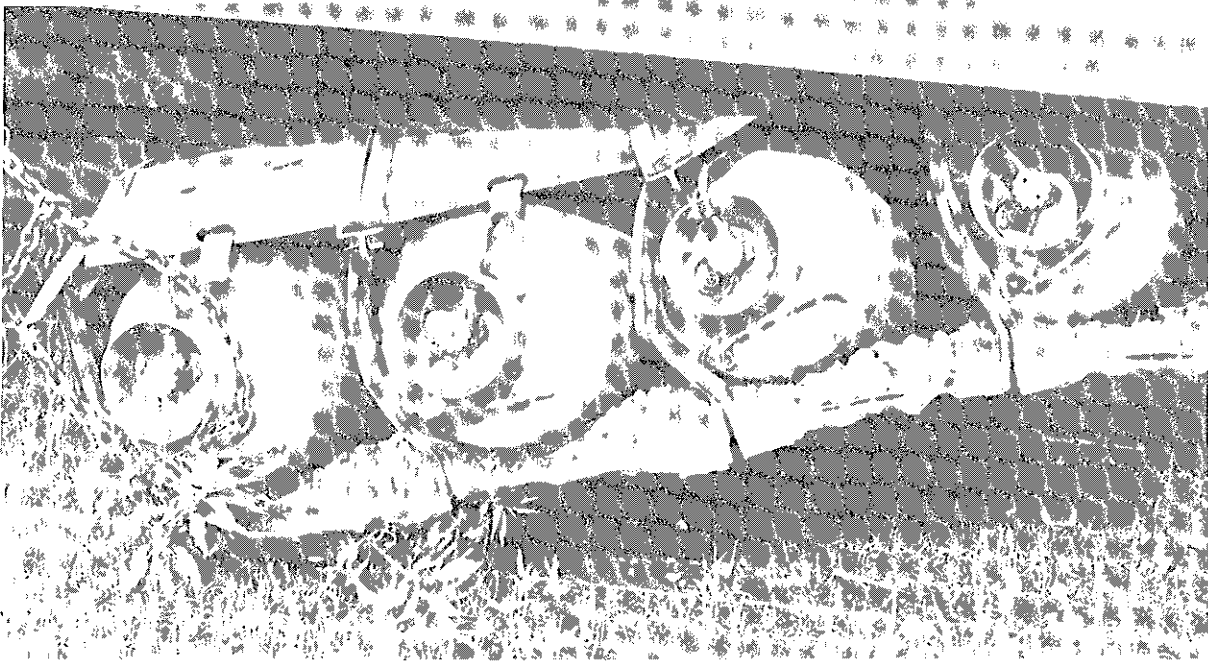
Figure 15 –Views of Damaged Propane Cylinders

The first six cars were demolished. Their sides were bent and torn, their underframes were damaged, and the roofs of several of the cars were smashed downwards. Most of the windows on the sides of the cars which were in contact with the ground were smashed. Many of the seats in the coaches had rotated and some were torn loose from the floor. Unsecured furniture in the coaches, particularly in the dining cars, was thrown around the interior of the cars. Broken rails from the track penetrated several cars. In one case, a rail was driven up through the floor in the seat area and in another case a rail penetrated the toilet area. (See Figure 6.) Propane tanks on some cars were torn loose and were scattered on the ground, whereas the fittings of others were torn loose. The propane, however, did not ignite.

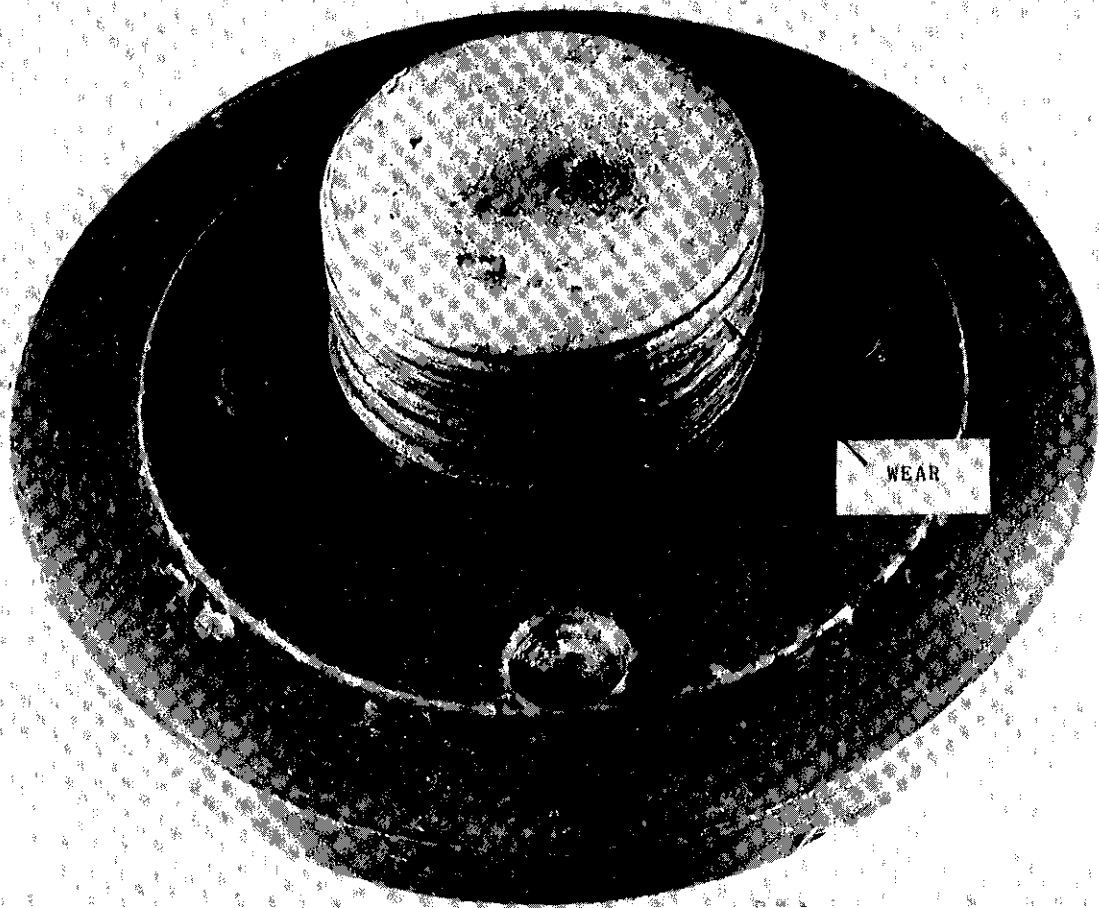
**Photograph 1D —Inner Face of Locking Plate Showing worn threads and  
Lack of wear on outer edge where Plate should Contact H-Ring.**

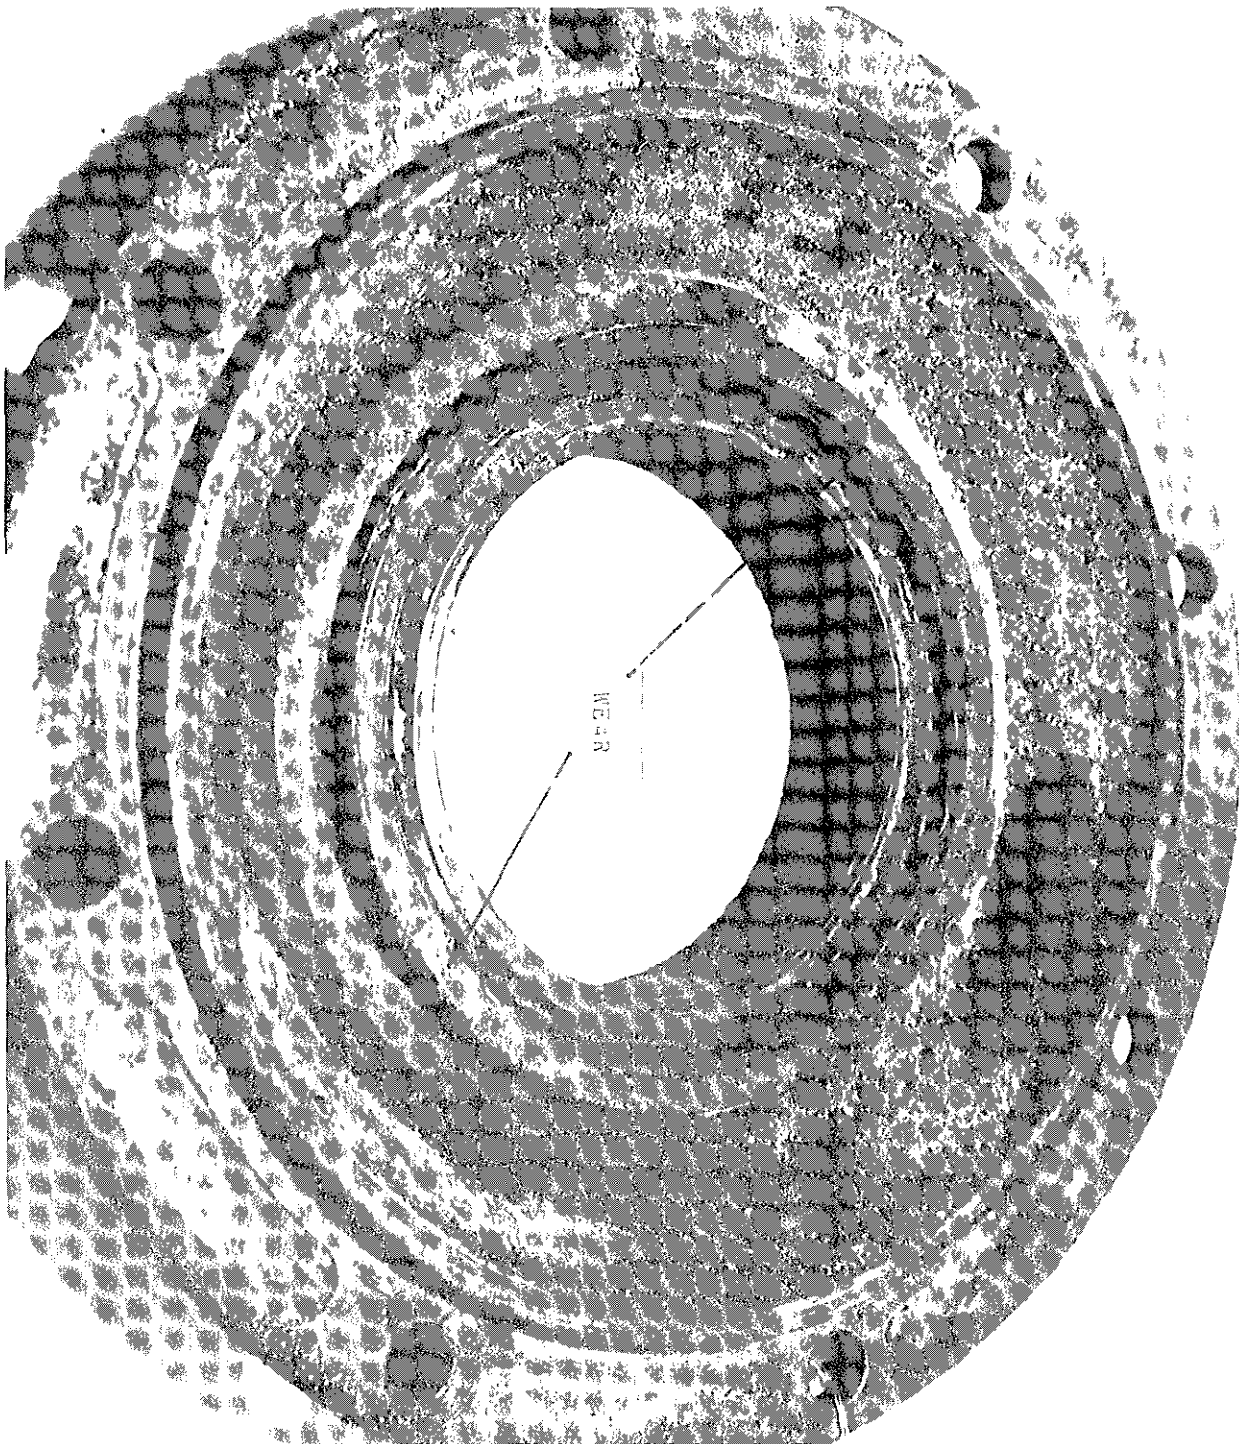
Photograph 2D.—Pinion Bearing End Cover Showing Excessive Wear from Contacting  
Outer Oil Thrower

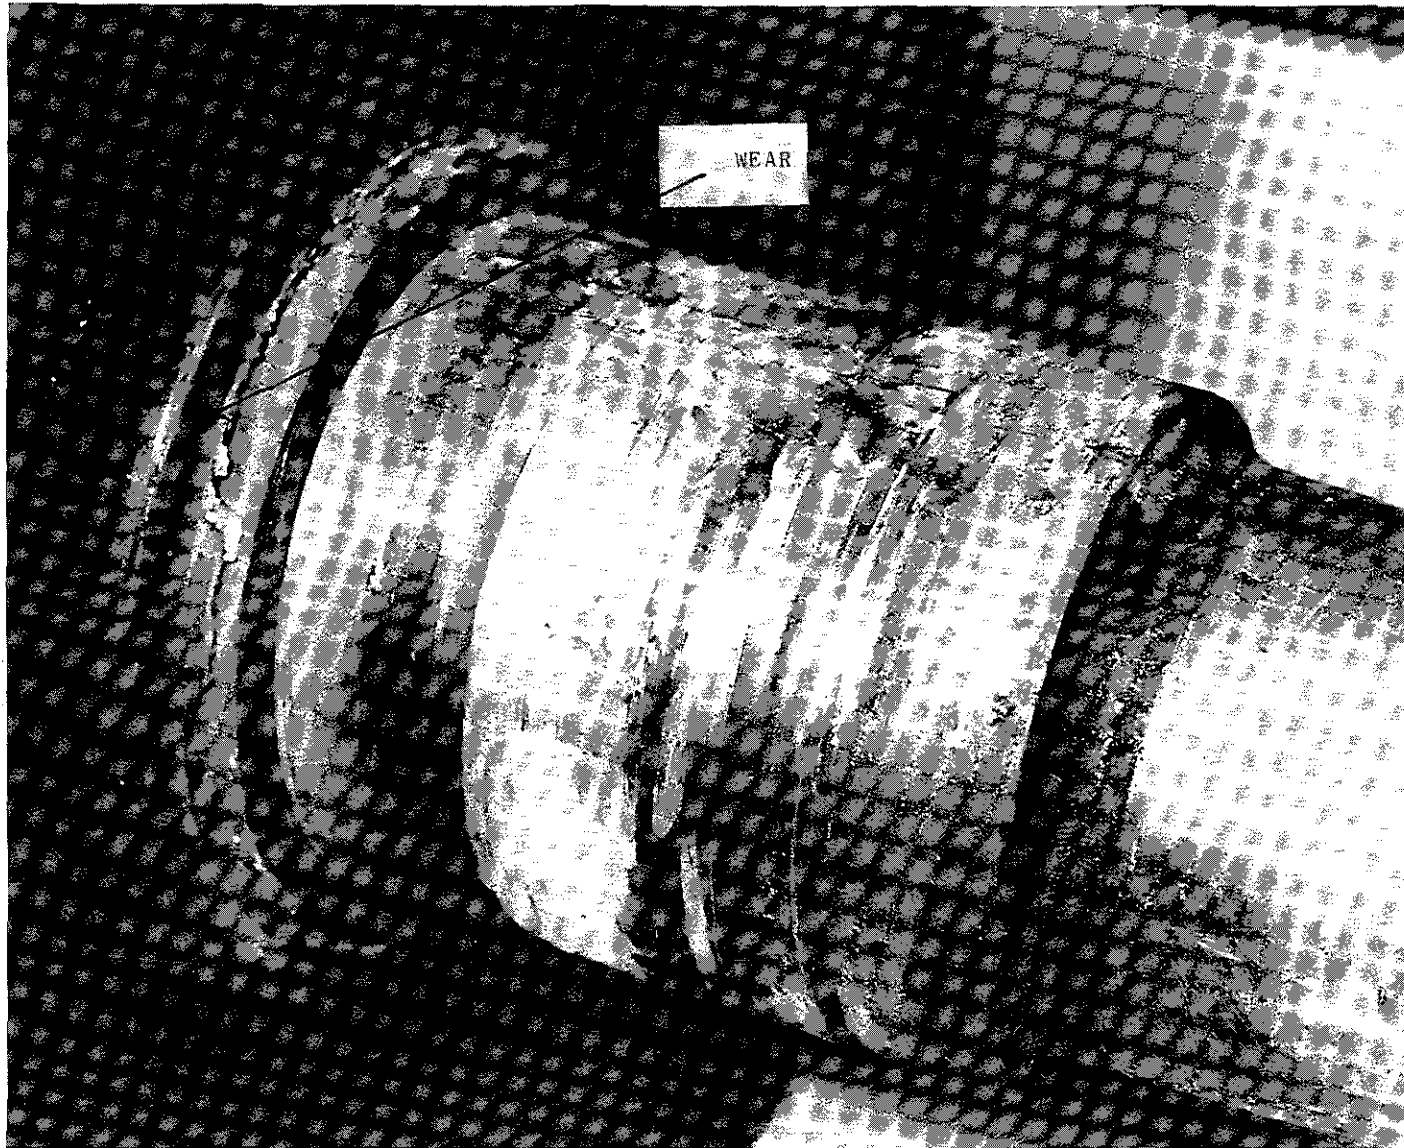
Photograph 3D.—Pinion End of Armature with Bearing Removed, Note Excessive Wear on Oil Thrower

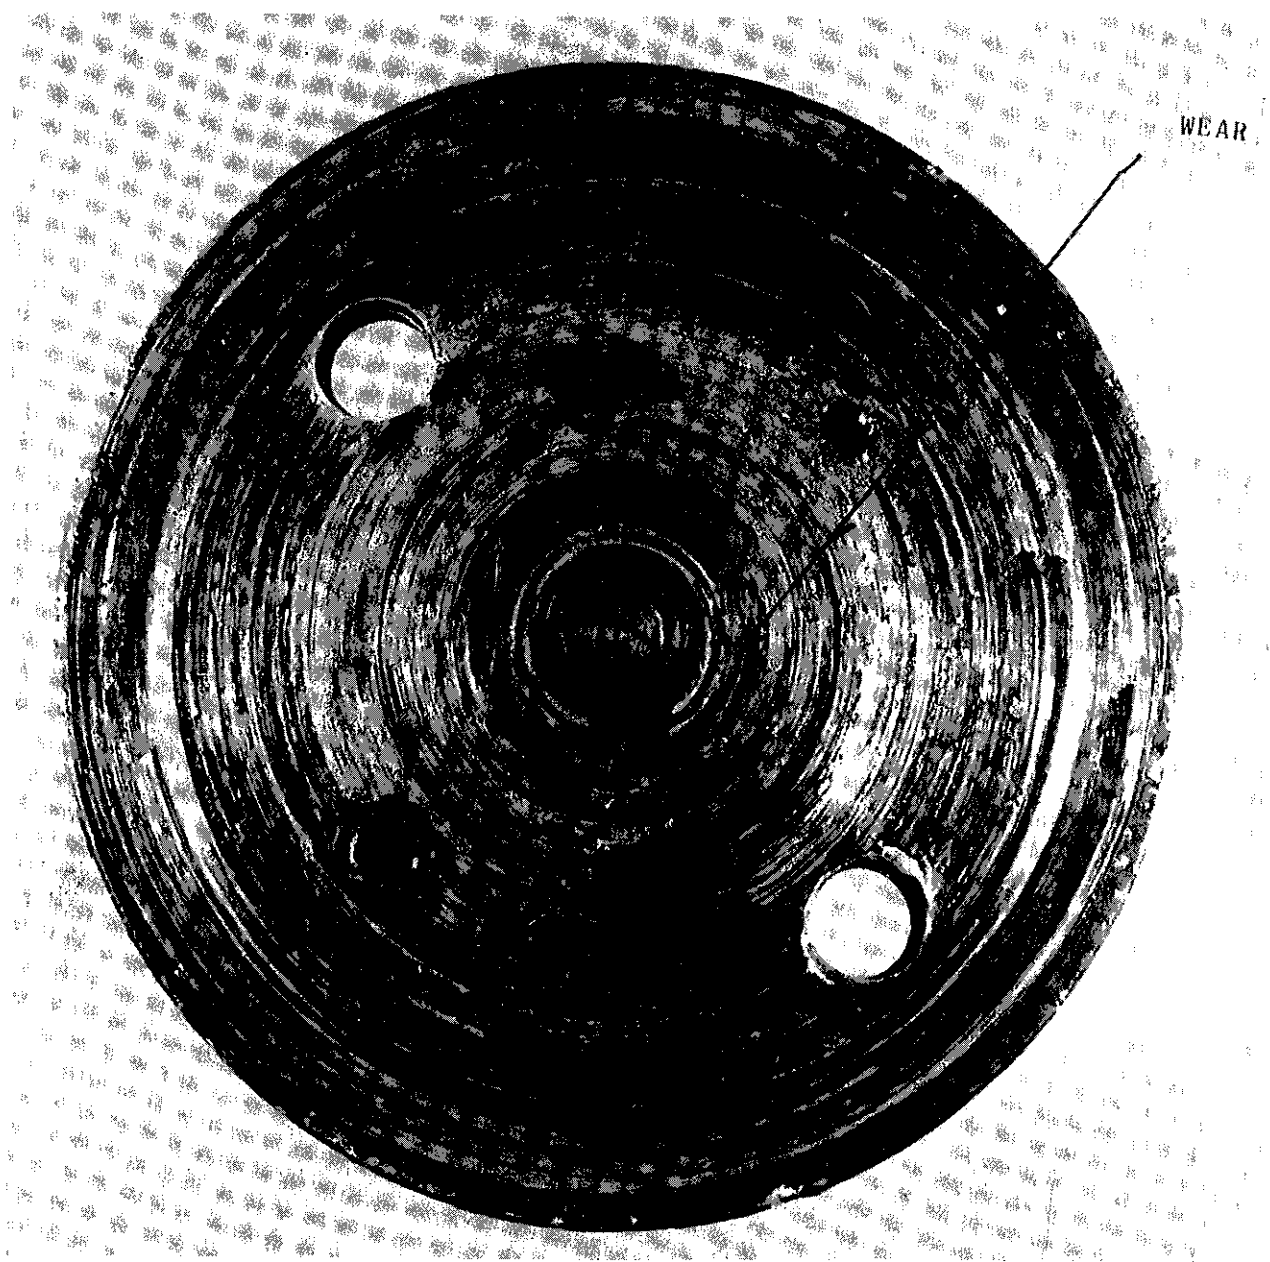
**Photograph 5D.—Outside Surface of Locking Plate showing Wear due to Plate Contacting the Commutator Bearing End Cap.**
