# RAILROAD ACCIDENT REPORT

COLLISION OF  
ILLINOIS CENTRAL GULF RAILROAD  
COMMUTER TRAINS,  
CHICAGO, ILLINOIS  
OCTOBER 30, 1972

NATIONAL TRANSPORTATION SAFETY BOARD  
Washington, D.C. 20591  
REPORT NUMBER: NTSB-RAR-73-5

ADOPTED: JUNE 28, 1973

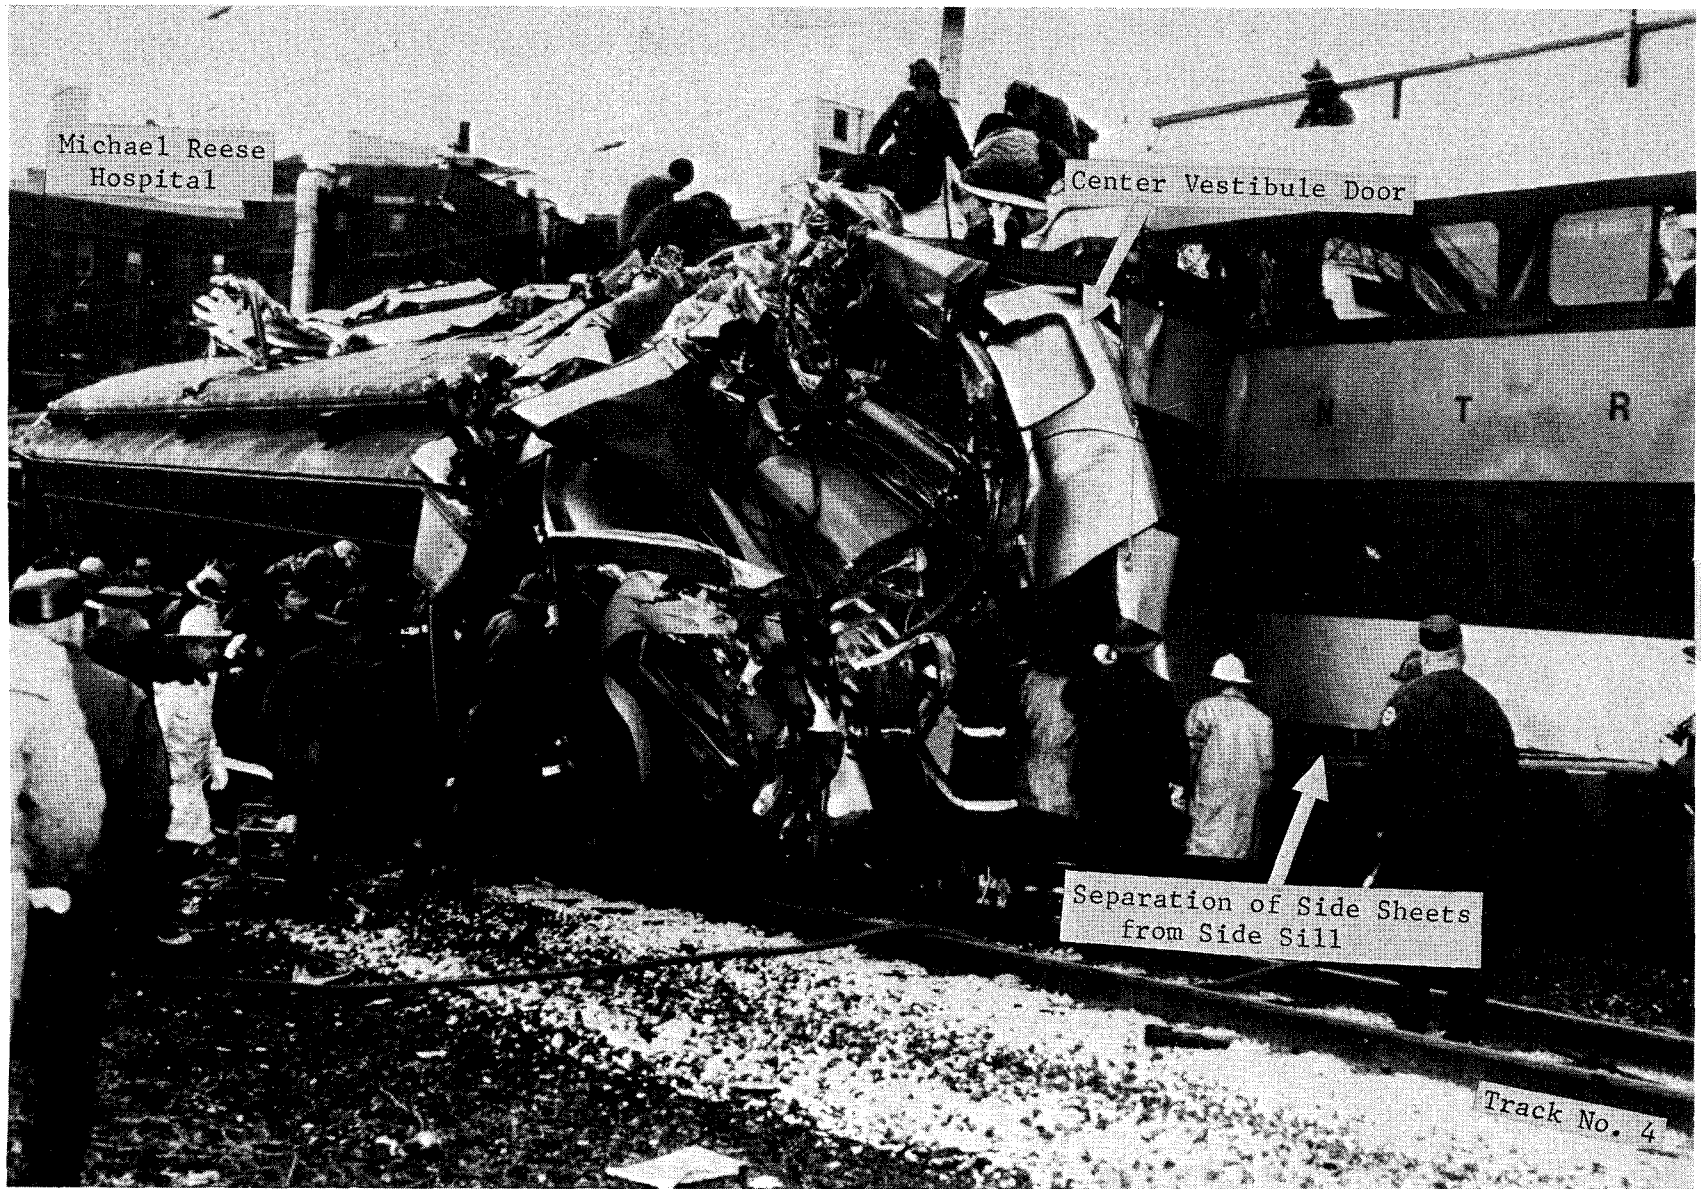
Figure 2. Trains After Collision.

The collision. The leading coupler of the first car of train 720 was broken off by the impact, and the car overrode the underframe of the rear car of 416. The first car of 720 then sheared off the collision posts on the rear car of 416, veered slightly to the right, and moved through the passenger section. (See Figure 2.) The lead truck on 720's first car was thrown from under the car and came to rest along the east side of the track. The rear truck was derailed and came to rest against the rear truck of the Highliner car.

Train damage. The rear half of the last car of train 416 was demolished. The end of the car and most of the right side were sheared off at floor level. A portion of the left side and several seats on the upper level remained intact. All lower-level seats were destroyed. The underframe of the car was not buckled, and the three other cars of 416 received only minor damage and were returned to service.

The first 10 feet of the lead car of train 720 was demolished. The center sills and couplers on several of the other cars of the train were broken, and these cars sustained sufficient damage to prevent prompt return to service.

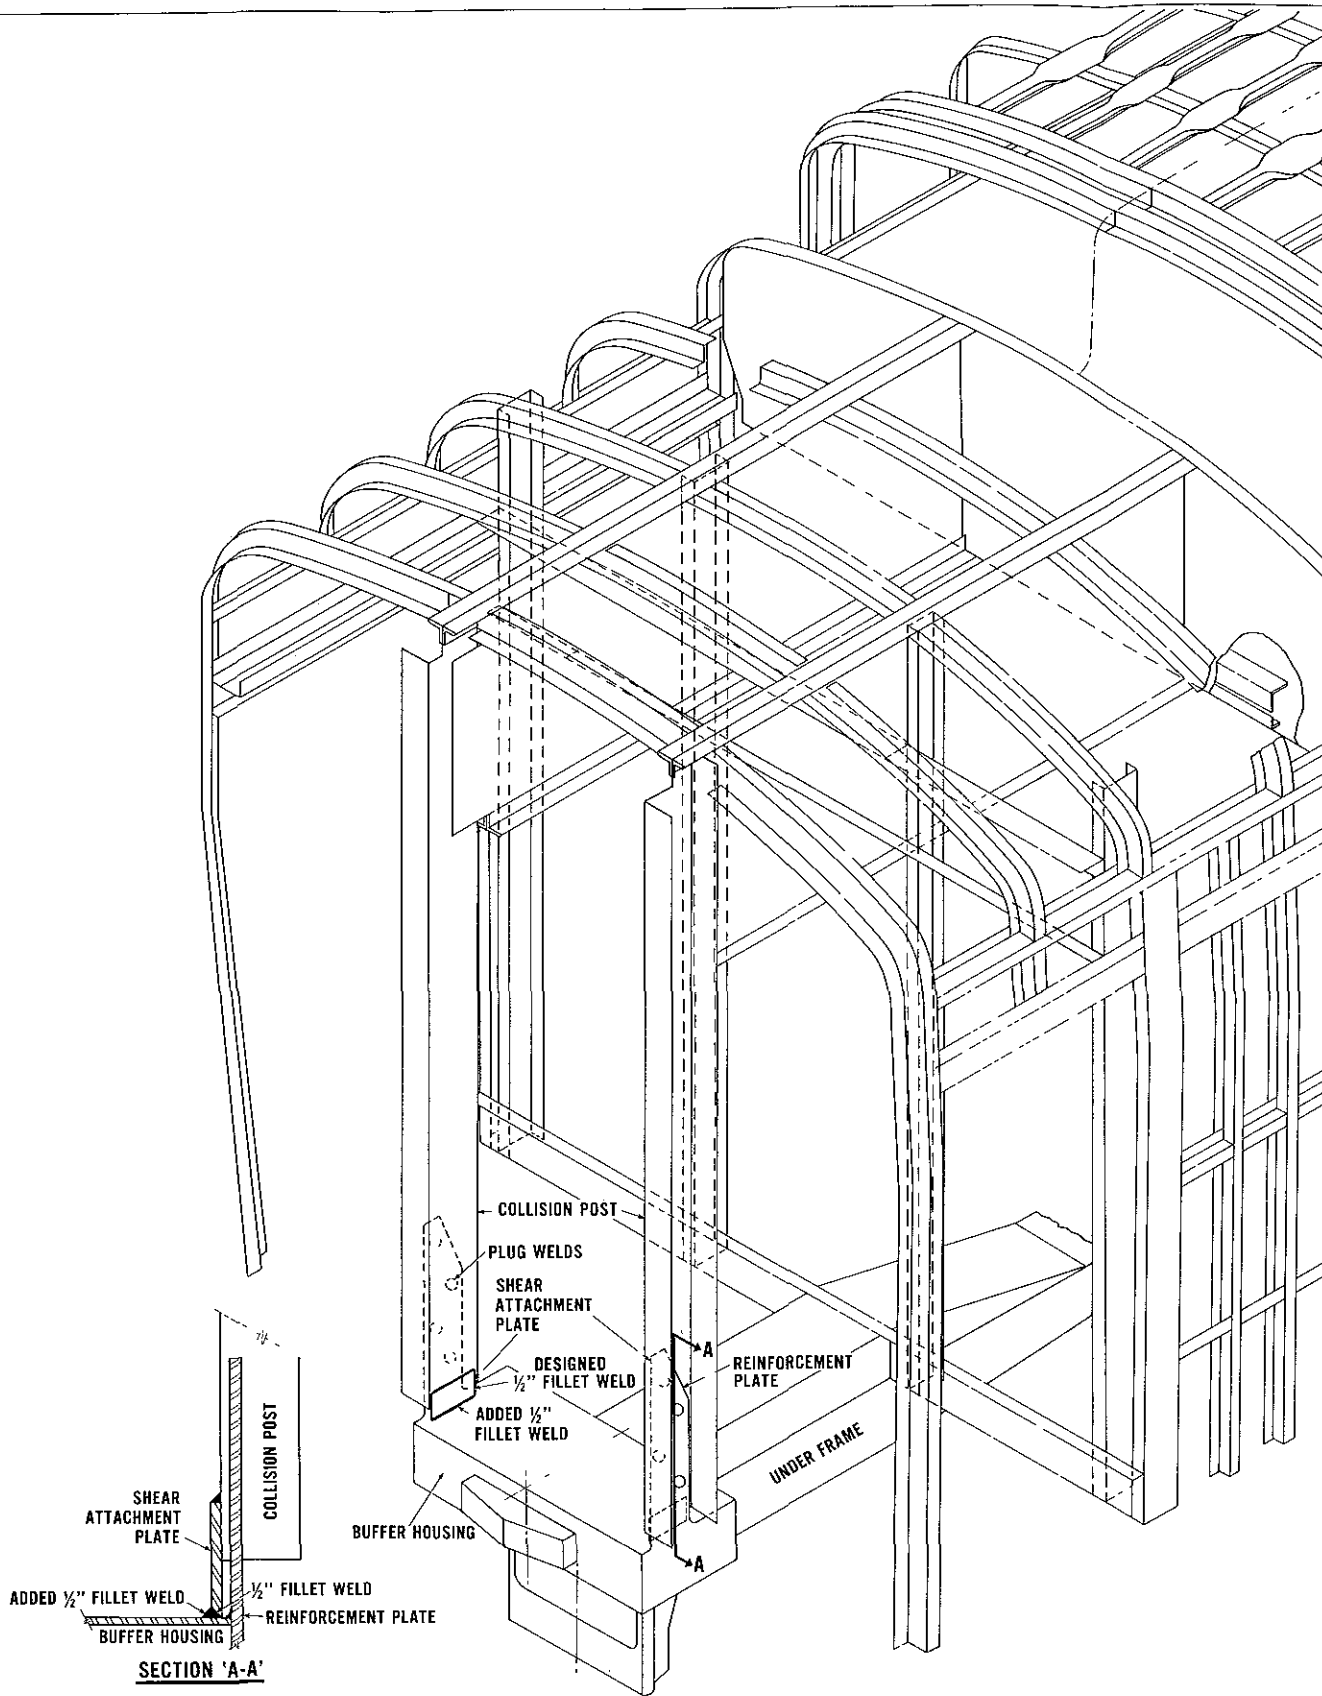
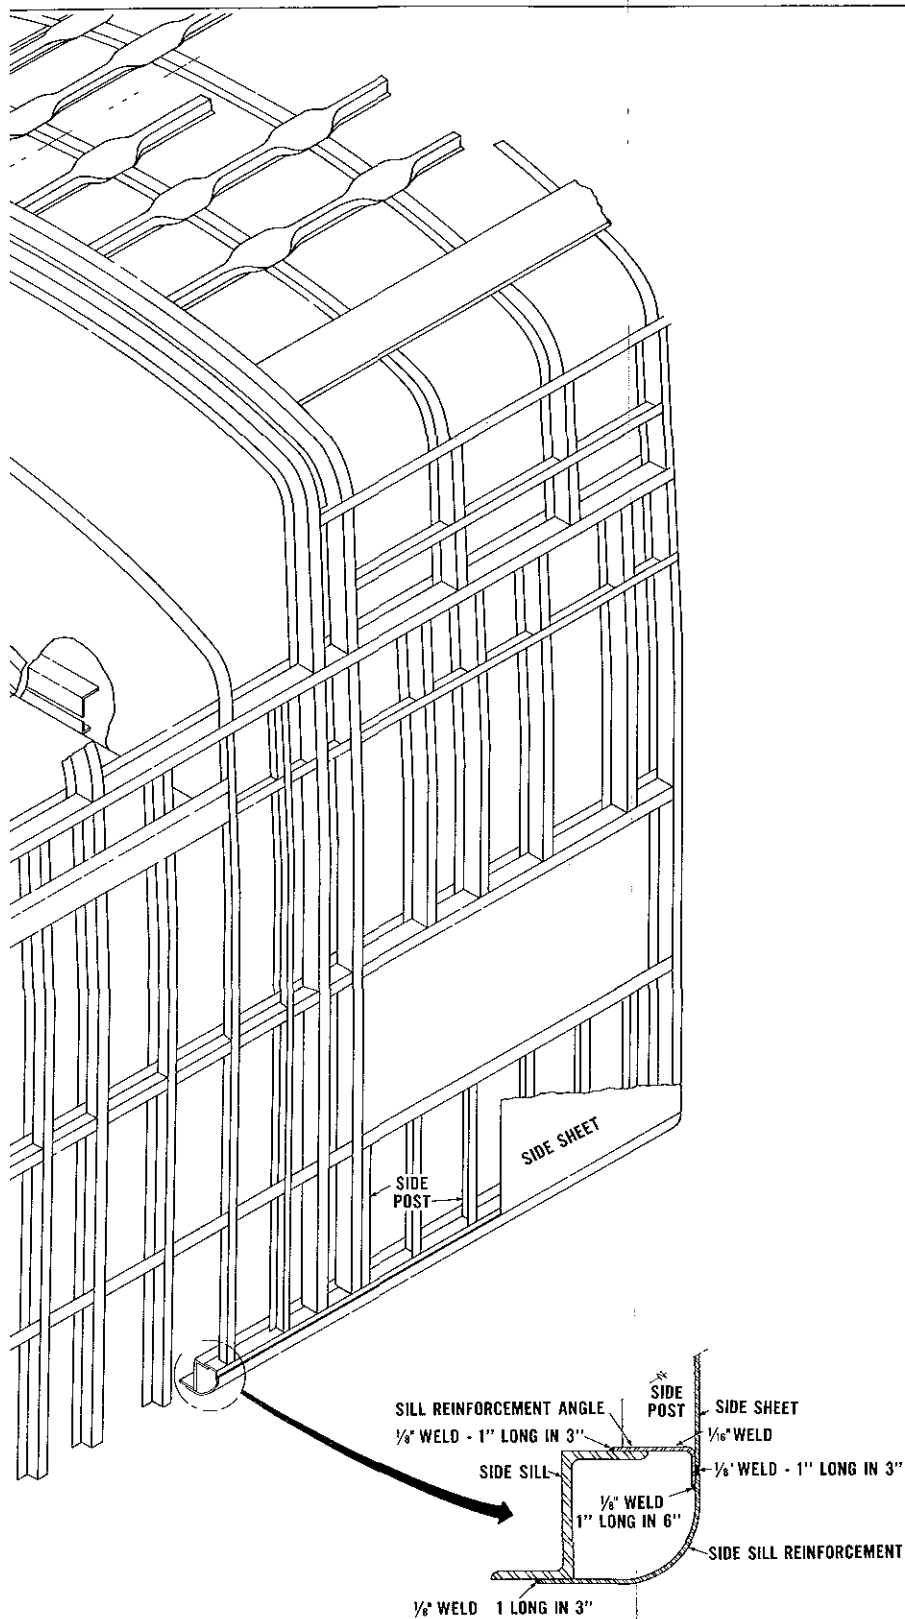
FIGURE 5

CAB END STRUCTURE  
I.C.G. HIGH LINER

Train equipment. The collision posts of the Highliner car struck by 720 failed in the weld which attached the shear attachment plate to the underframe. Tests disclosed incomplete fusion between the plate and about 75 percent of the weld. The bottom edge of the plate was bevelled to permit the weld to penetrate through the plate to the underframe from one side. However, the bevel of the shear attachment plate extended only five-sixteenths of an inch into the plate, instead of the full one-half inch as designed. An additional 1/2-inch fillet weld which had been applied adjacent to the original weld failed in the parent materials of the underframe and shear plate. The plug welds which attached the reinforcing plate to the collision posts were fused incompletely. Further description of the design and failures of the collision posts can be found in Appendix G, which contains an interim recommendation made by the Safety Board to the FRA on April 25, 1973.

Some of the side posts on the rear car were sheared off through the welds which attached the posts to the sill reinforcing angle. Other posts were sheared off above the welds and were bent outward, which contributed to the failure of the sill reinforcing angle. Many of the intermittent welds which attached the sill reinforcing angle to the side sill broke in the welds and thus permitted the sill reinforcing angle to be torn from the side sill for about one-half of the damaged area. The intermittent welds which attached the bottom of the side sheets to the sill reinforcing angle broke and allowed the side sheets to separate. (See Figure 5.)
