**REAR-END COLLISION OF TWO
SOUTHERN PACIFIC TRANSPORTATION COMPANY
FREIGHT TRAINS**

INDIO, CALIFORNIA

JUNE 25, 1973

REPORT NUMBER: NTSB-RAR-74-1

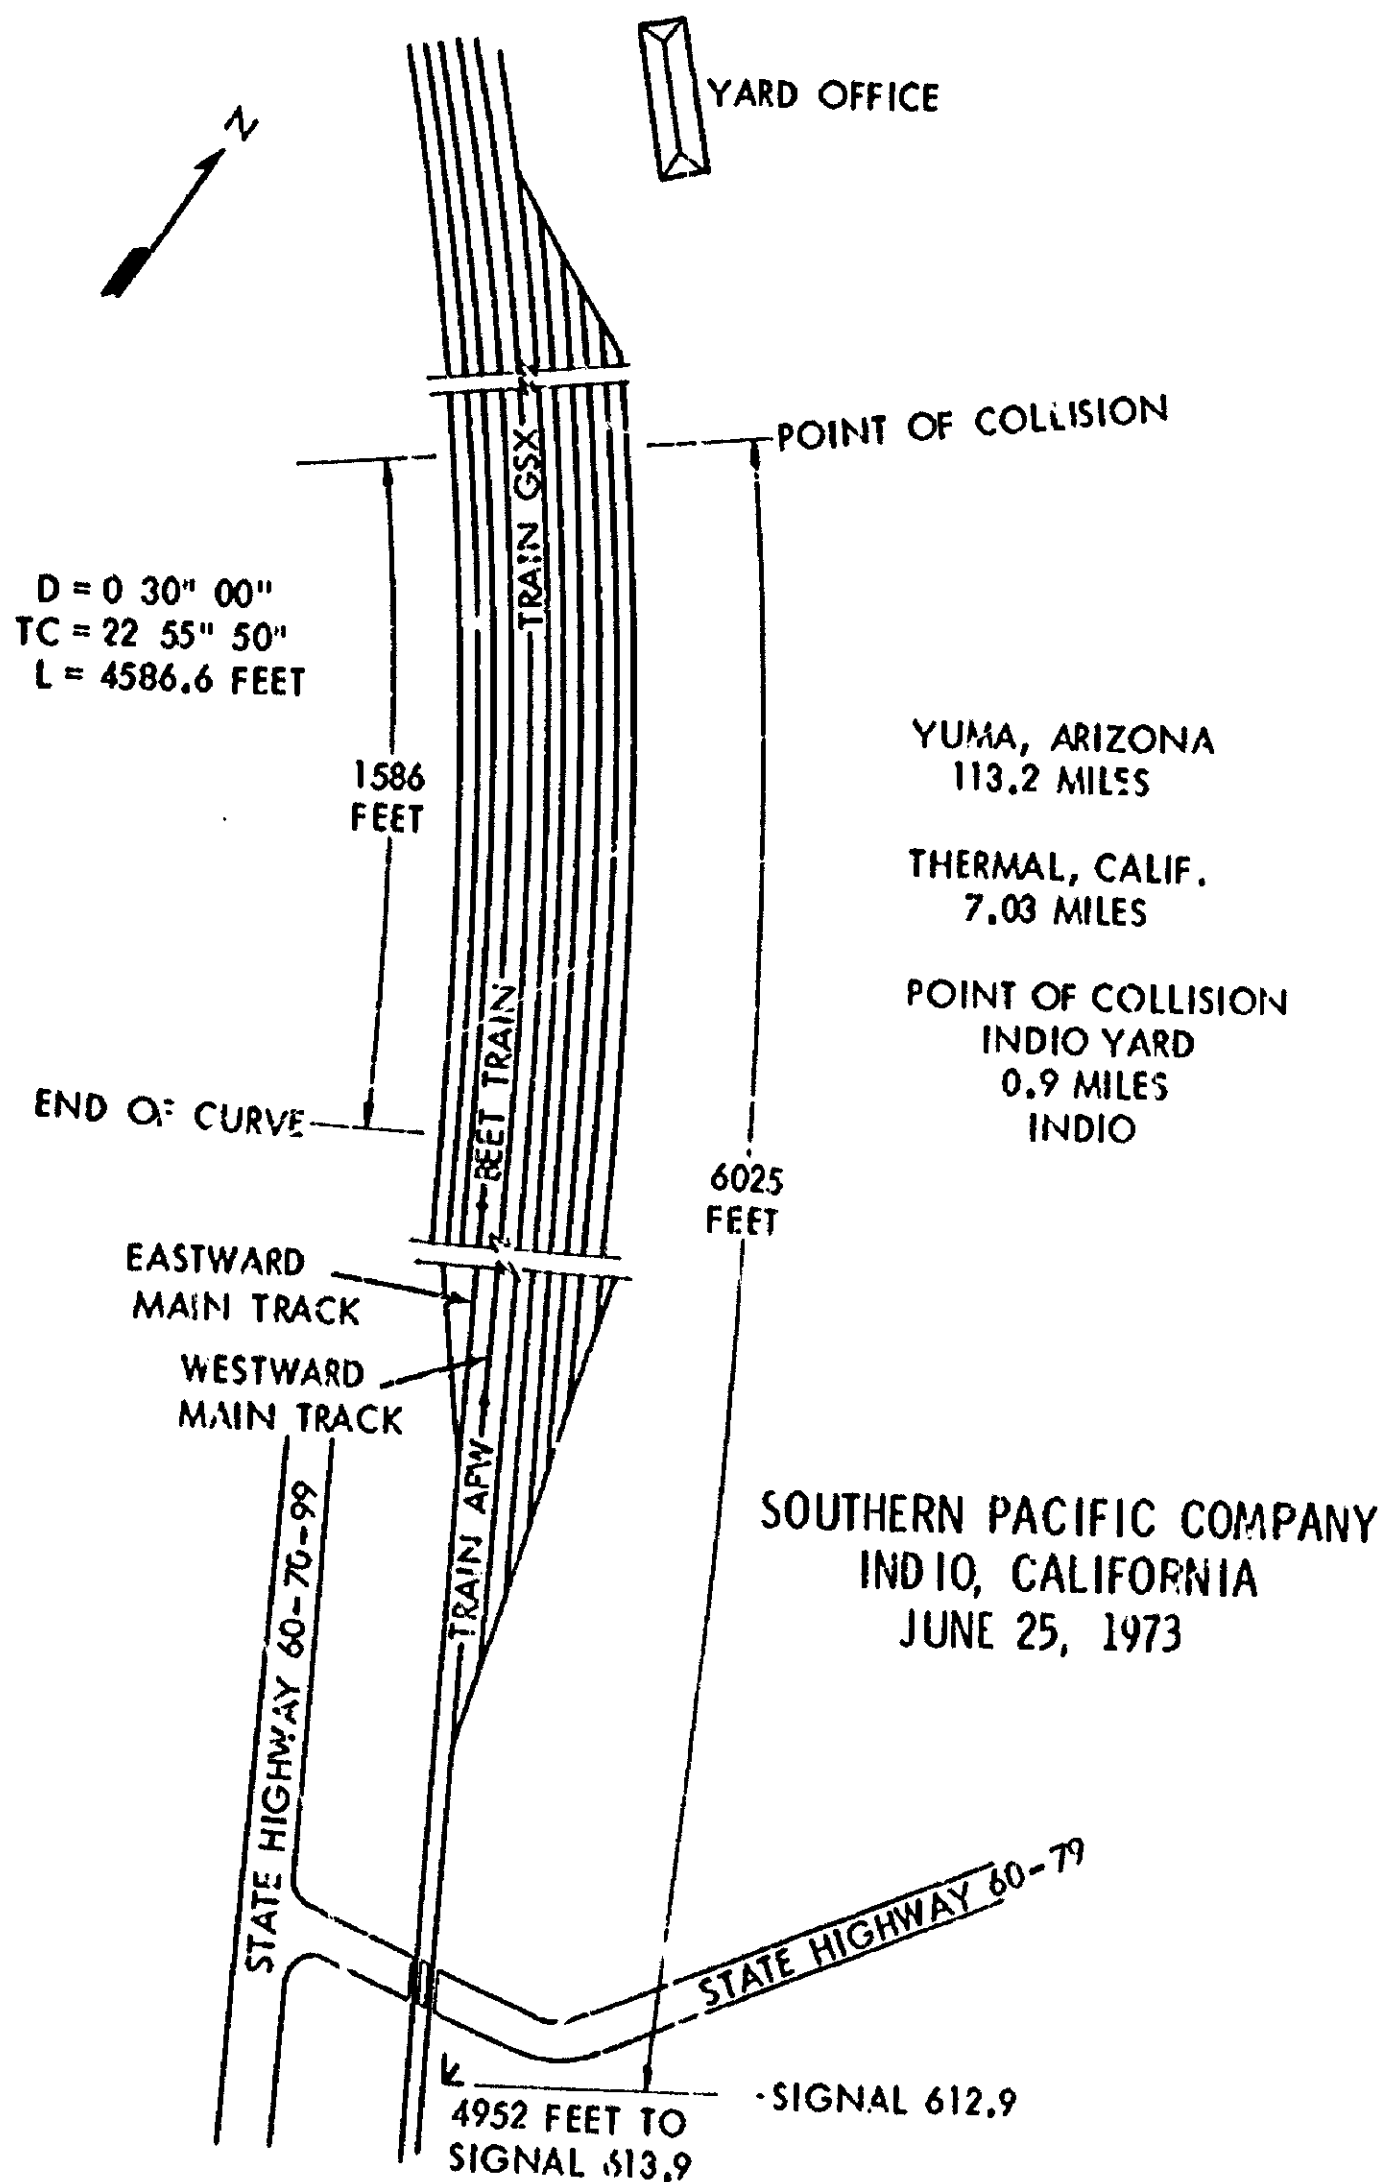
Figure 1. Accident site.

on each side. Westbound trains approached Indio on straight tracks until they reached a point 4,439 feet west of signal 612.9. From this point, they traversed a 0° 30' curve to the left for a distance of 4,586 feet. Westbound trains approaching the collision point on the westbound main track ascended a 0.2-percent grade. A yard office was located along the north side of the yard about 2,680 feet west of the collision point. (See Figure 1.)
