COLLISION OF PENN CENTRAL FREIGHT TRAIN  
OV-8 WITH AN OPEN DRAWBRIDGE  
CLEVELAND, OHIO  
MAY 8, 1974,

REPORT NUMBER: NTSB RAR-75-3.

ADOPTED: MARCH 26, 1975

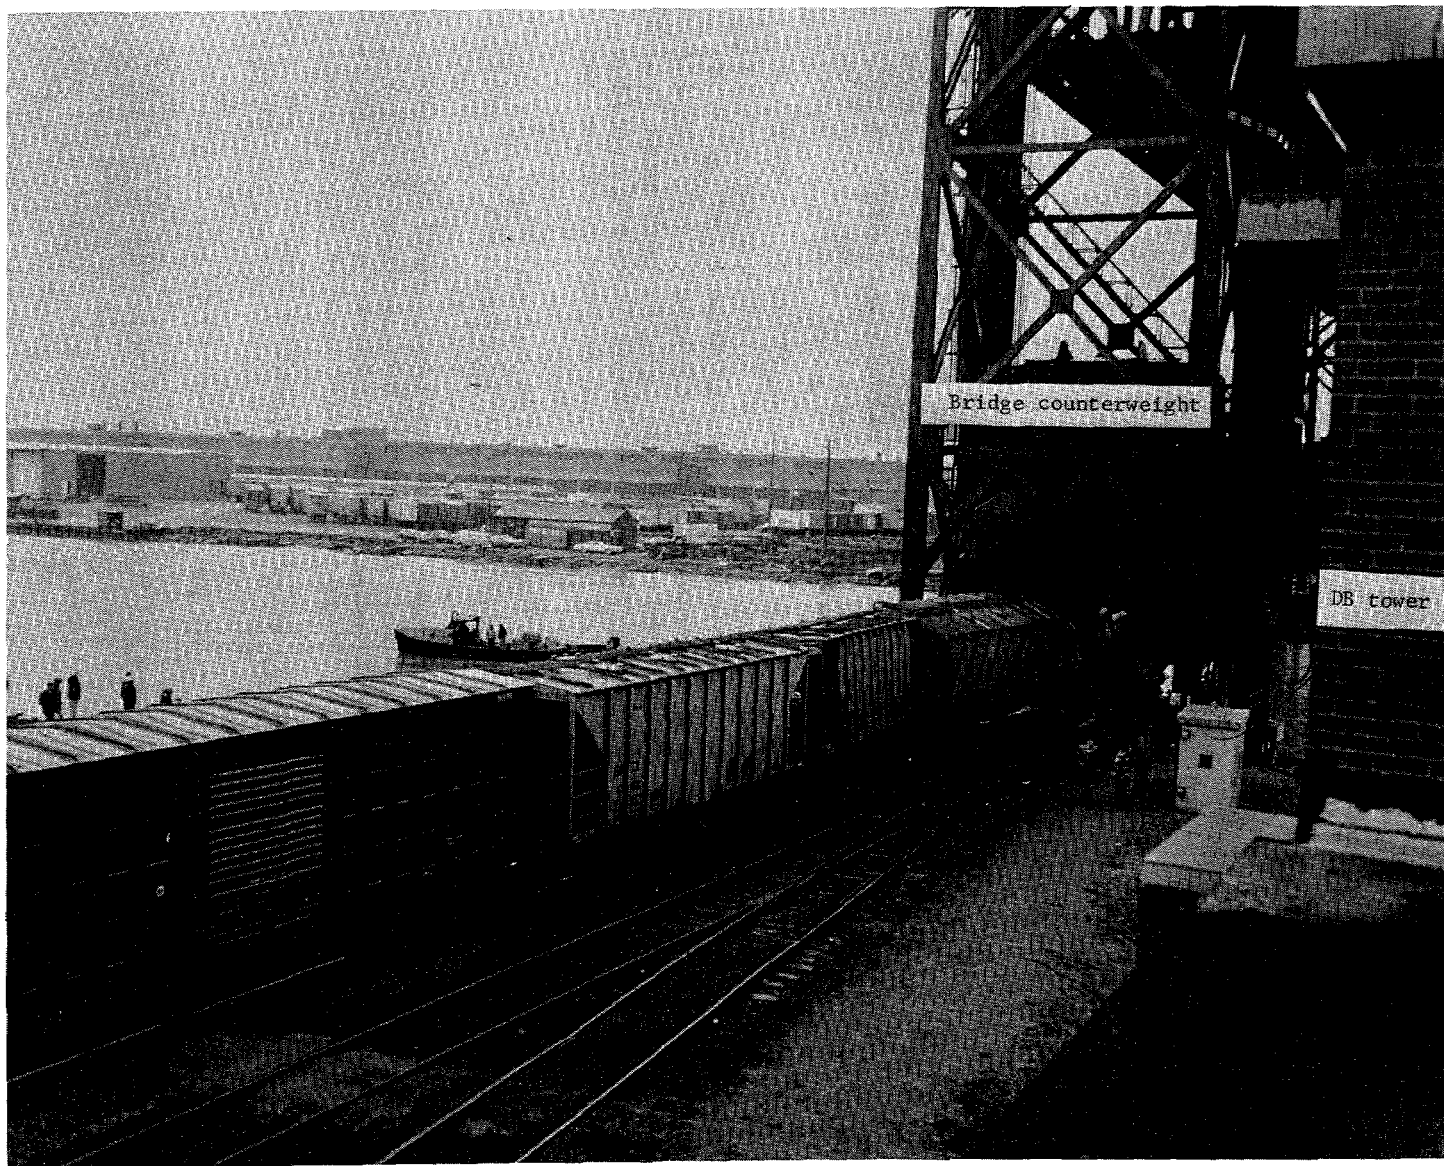
Following that conversation, the DB operator remembered that a U.S. Corps of Engineers' boat had been awaiting passage through the bridge channel since 3:20 a.m., and he immediately opened the bridge. When the bridge was raised, the bridge counterweight was within 5 feet of the track. At 3:56 a.m., train OV-8 collided with the bridge counterweight. (See Figure 1.)

Figure 1. View of wreckage looking east toward Cleveland and the Cuyahoga River.

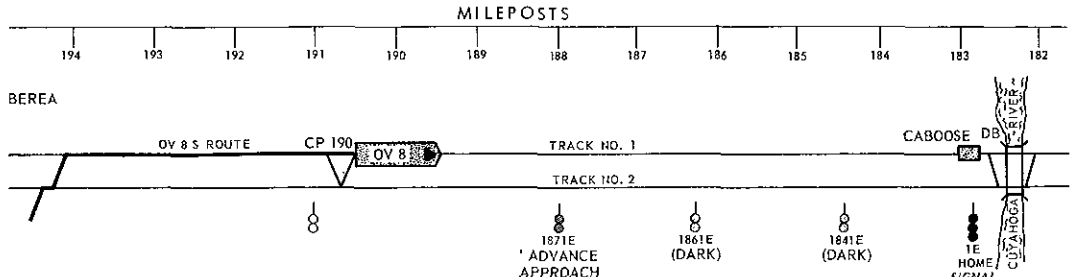
FIG 3-A (TIME=3:43 A.M.) (LIGHT ENGINE RETURNING TO CABOOSE)

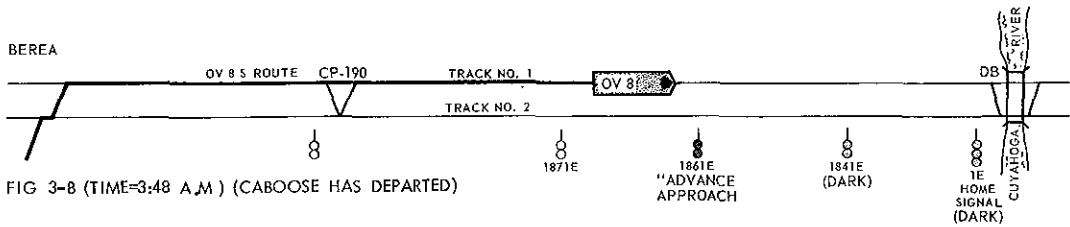
FIG 3-B (TIME=3:48 A.M.) (CABOOSE HAS DEPARTED)

From CP-190 to the collision, OV-8 averaged 33.3 mph. At this speed, the light engine and caboose had cleared the DB tower when the engineer of OV-8 was first able to see signal 1861E. The time was about 3:48 a.m. The position of OV-8 and the signal indications are shown in Figure 3-B. Thus, the engineer could have concluded that the traffic conditions ahead of him were improving since he had observed two "advance approach" signals in succession.

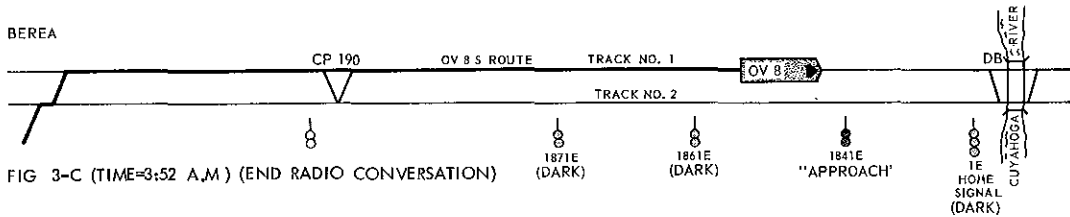
FIG 3-C (TIME=3:52 A.M.) (END RADIO CONVERSATION)

About 3:52 a.m., the radio conversation between the engineer and the DB operator took place, which indicated the route was clear ahead. Figure 3-C shows the position of OV-8 and the signal indication at that time. The "approach" indication of signal 1841E would suggest to the engineer that the home signal was not yet displayed for the route; however, in view of a message that says "all clear ahead of you..." and "you can highball right along," an engineer could reasonably conclude that the route ahead would improve, unless a broken rail or some other obstruction unknown to the DB operator existed.

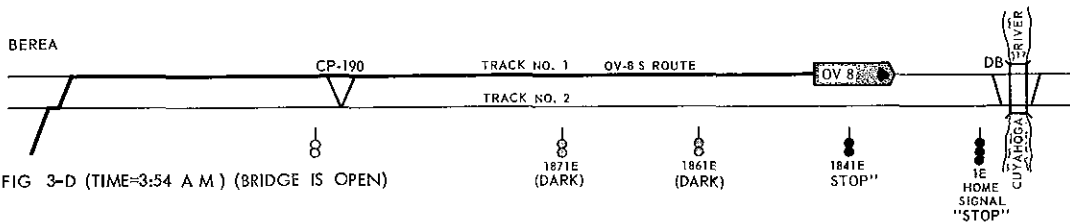
FIG 3-D (TIME=3:54 A.M.) (BRIDGE IS OPEN)

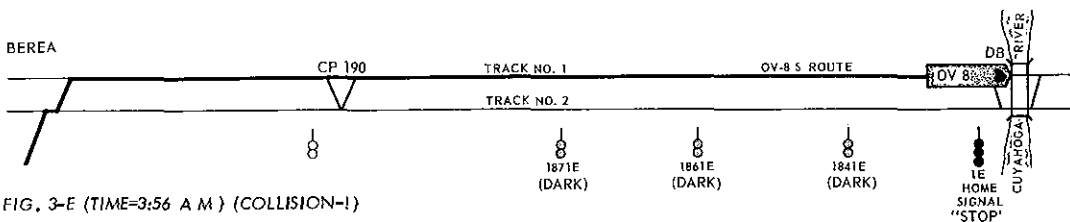
FIG. 3-E (TIME=3:56 A.M.) (COLLISION-1)
