1. Report No. NTSB-RAR-76-7		2. Government Accession No.		3. Recipient's Catalog No.	
4. Title and Subtitle Railroad Accident Report -- Collision of Penn Central Transportation Company- Operated Passenger Trains Number 132, 944, and 939, Near Wilmington, Delaware, October 17, 1975				5. Report Date June 16, 1976

COLLISION OF PENN CENTRAL TRANSPORTATION COMPANY-
OPERATED PASSENGER TRAINS NUMBERS 132, 944, AND 939,
NEAR WILMINGTON, DELAWARE, OCTOBER 17, 1975

REPORT NUMBER: NTSB-RAR-76-7

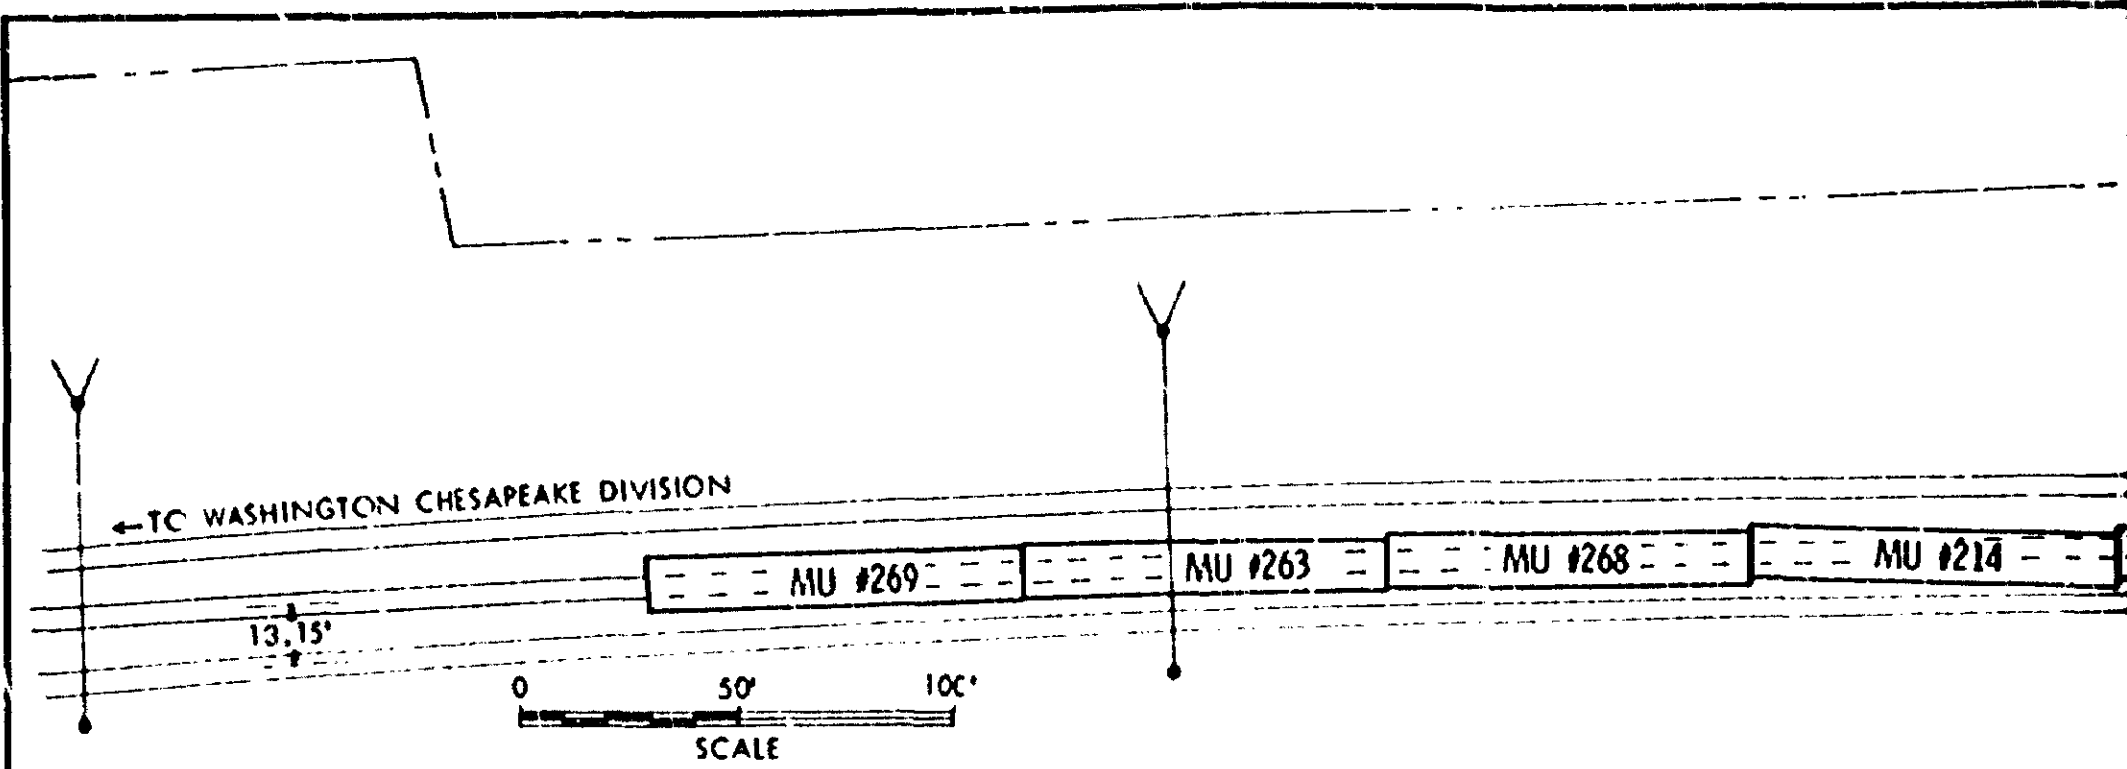
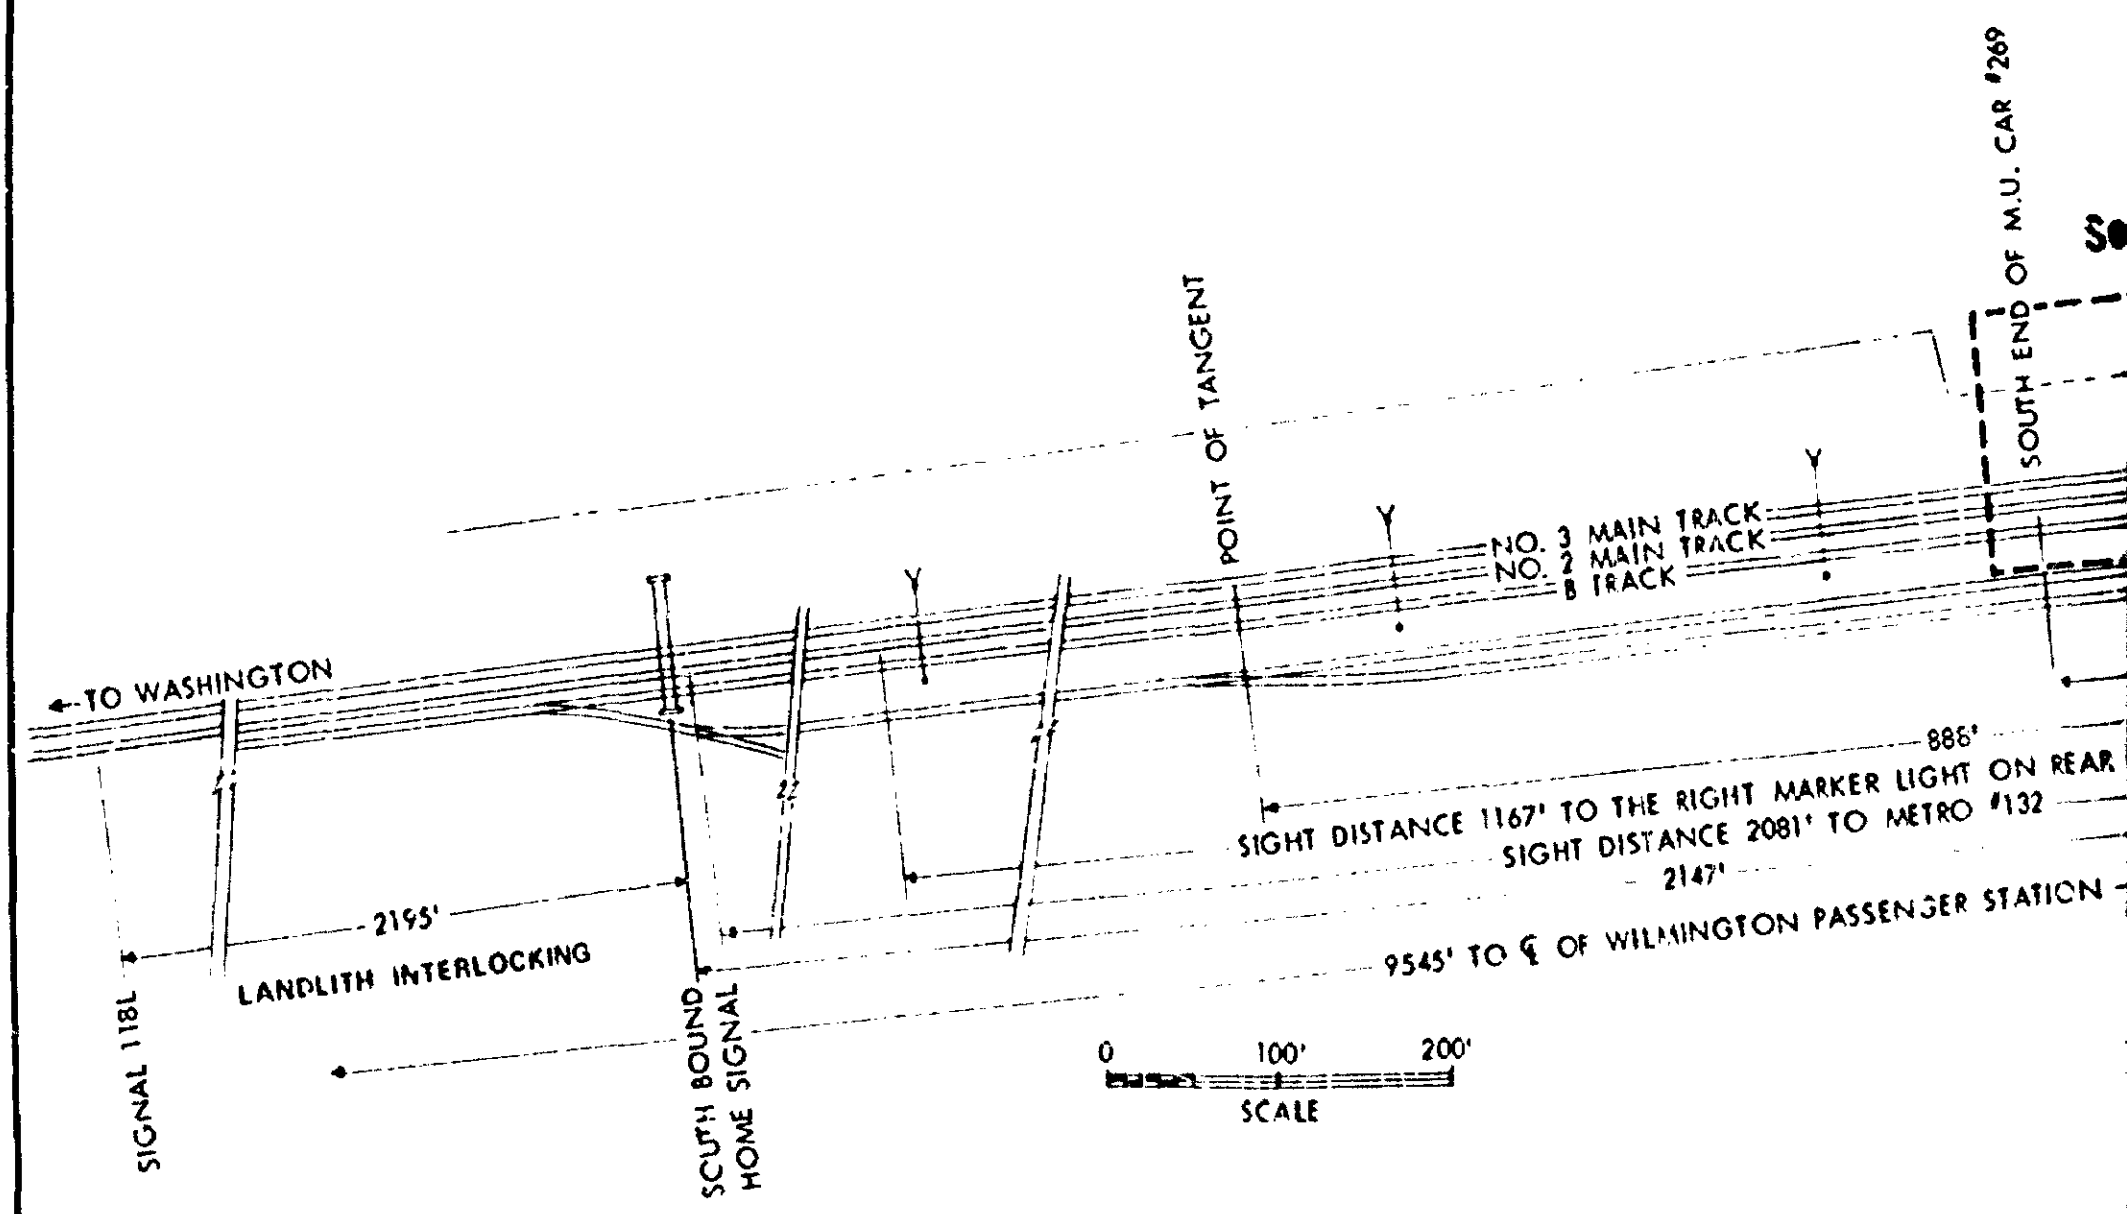
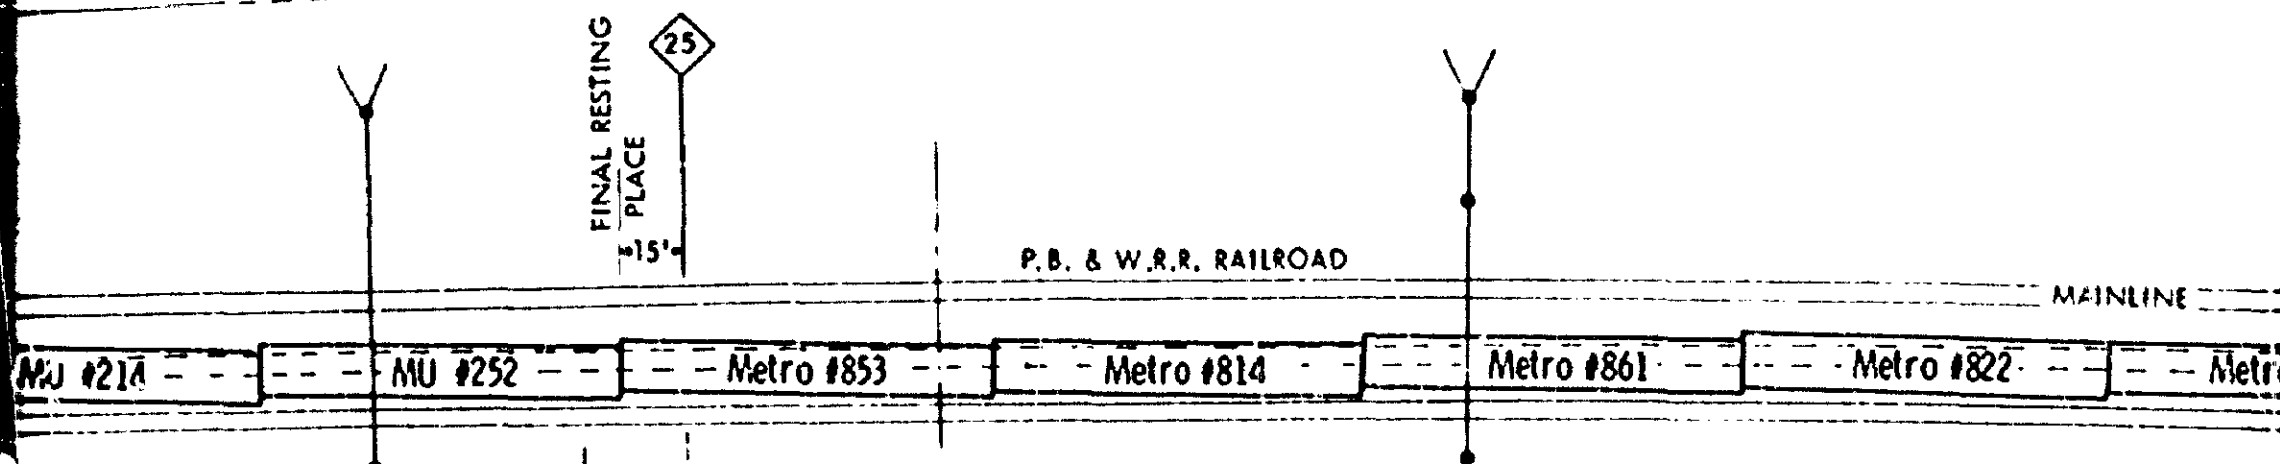
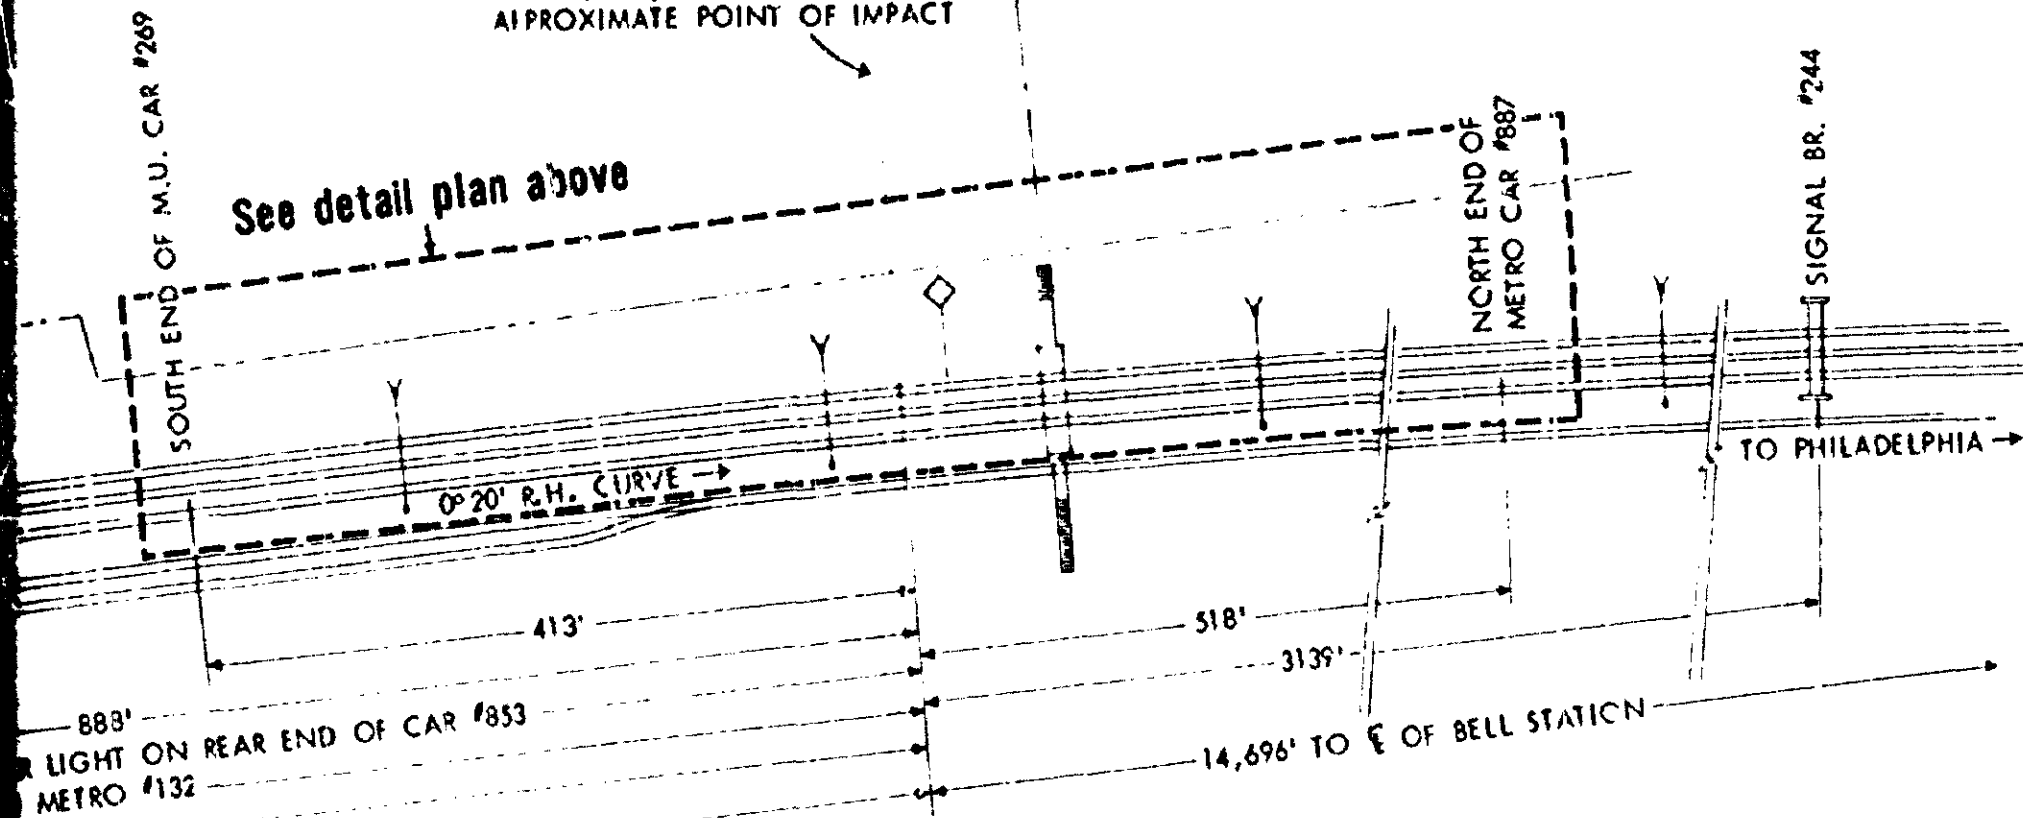
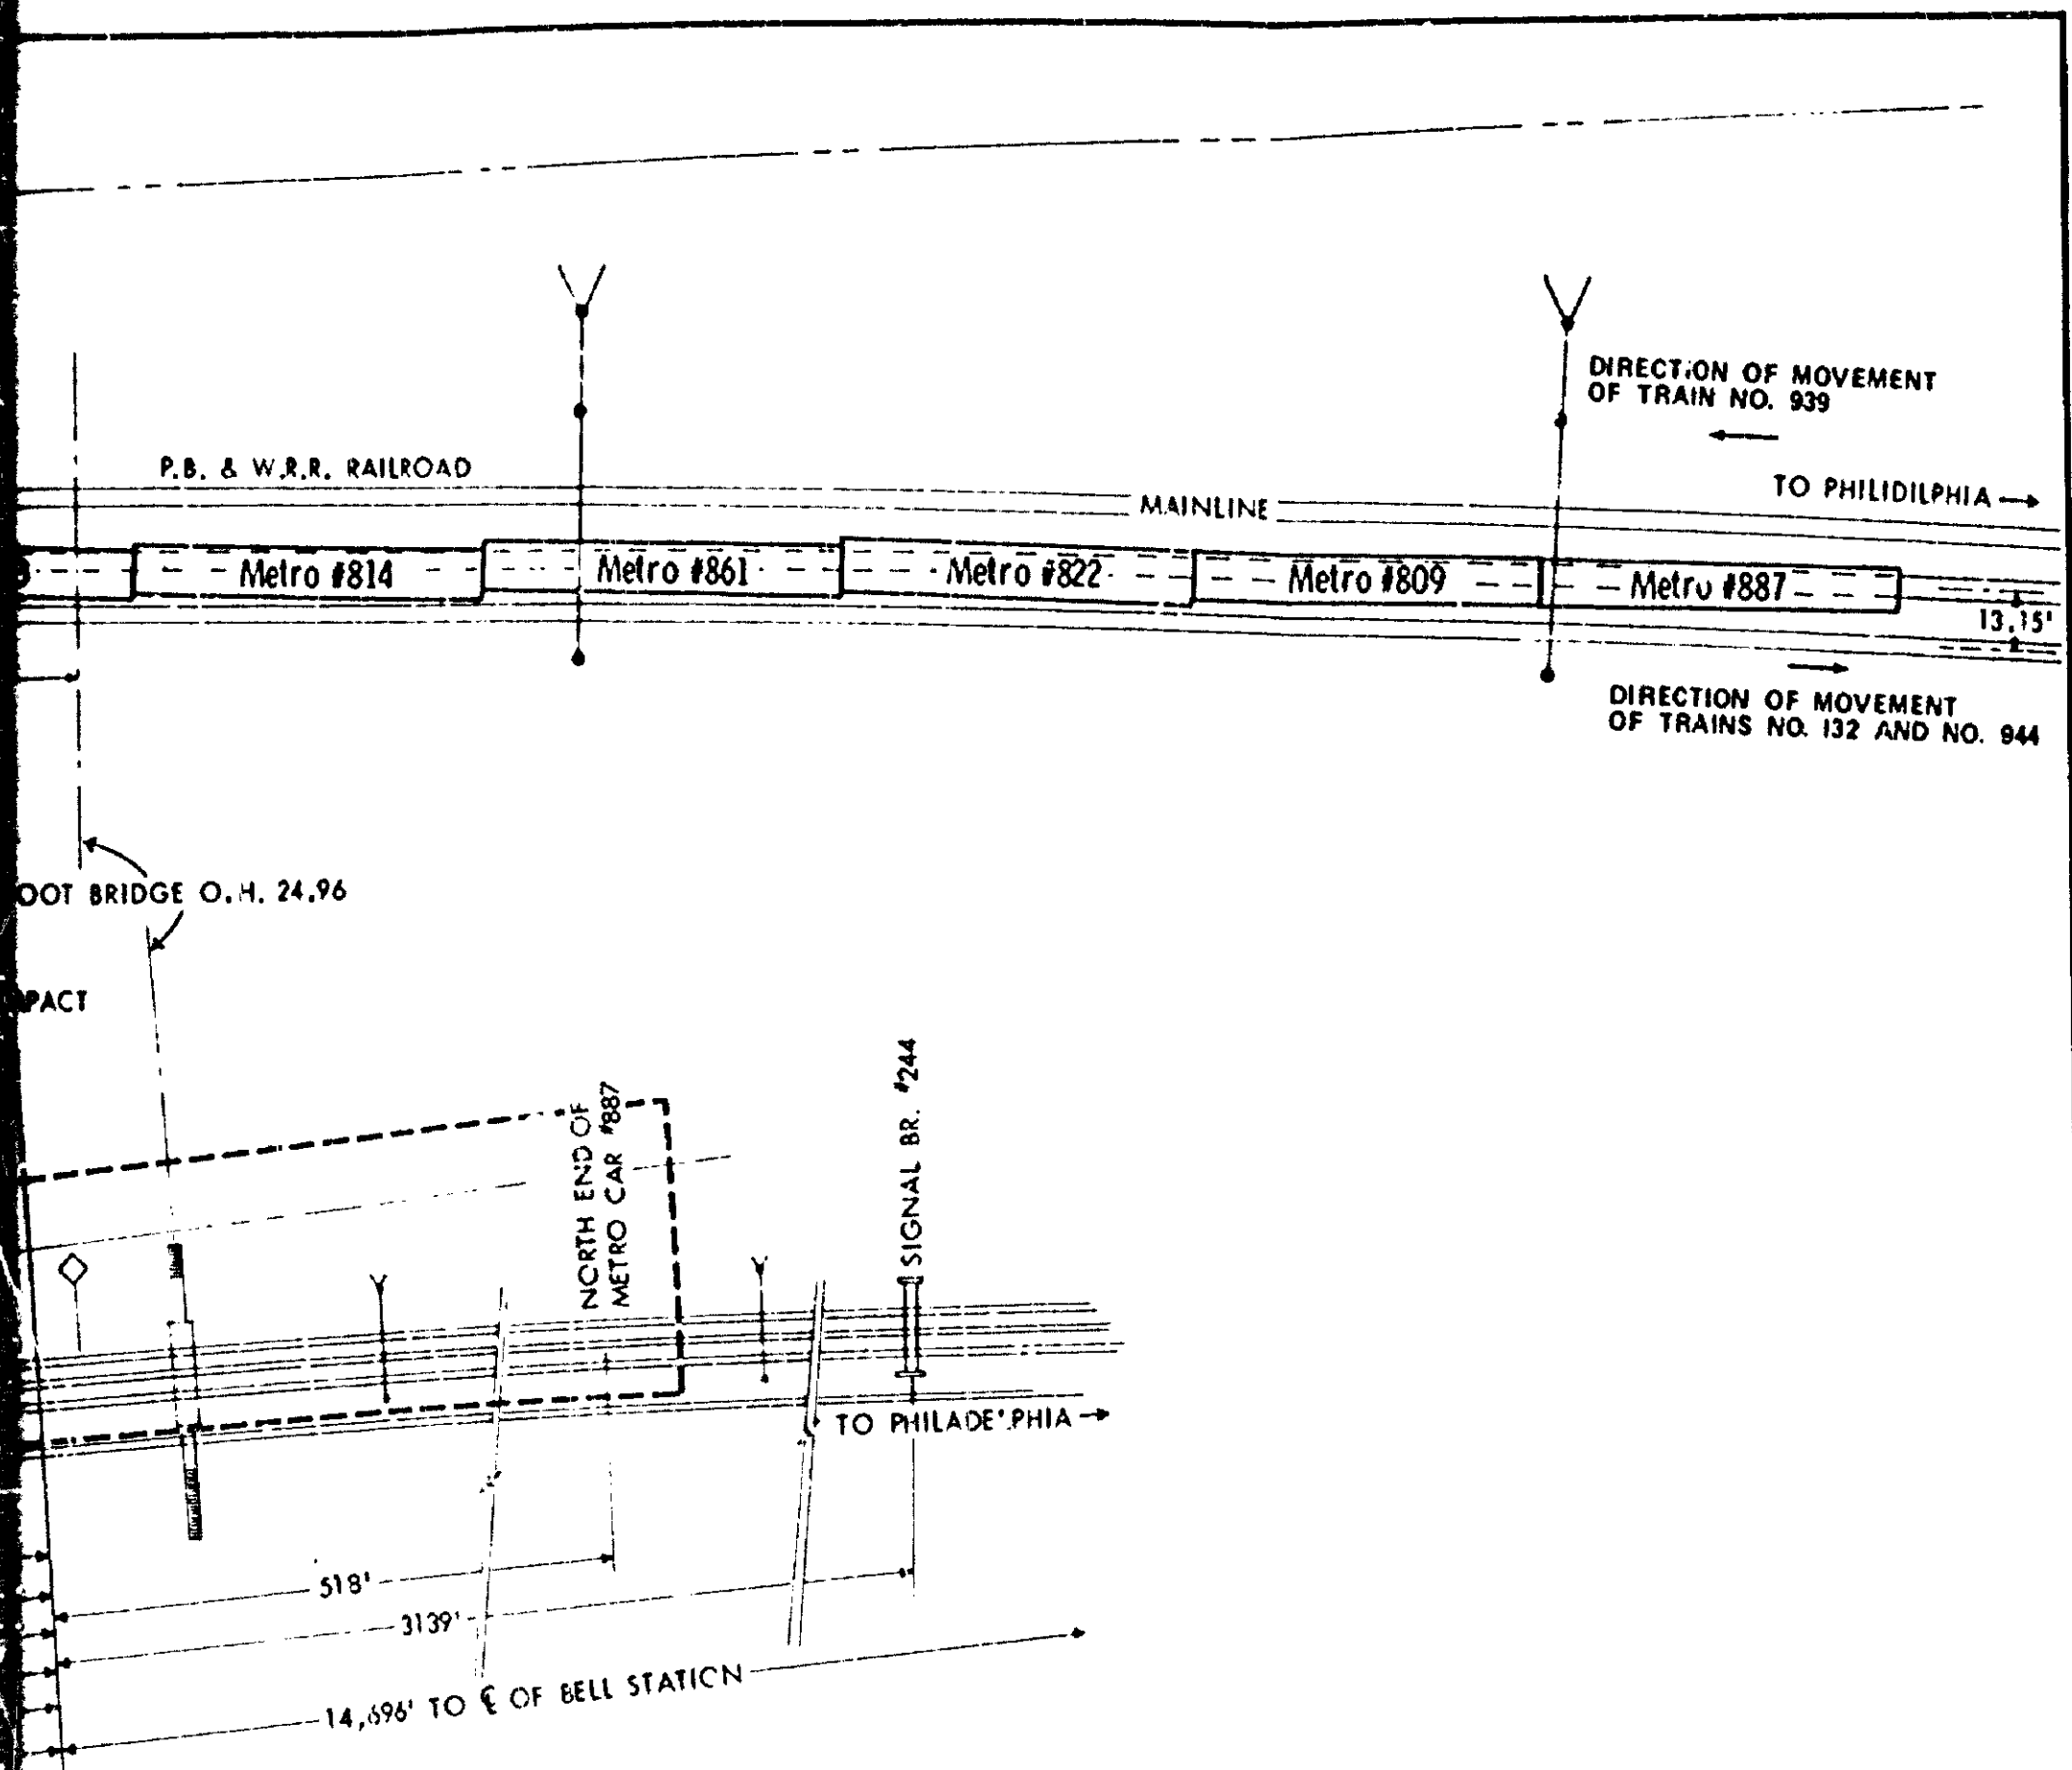
FIGURE 1
ACCIDENT SITE
METRO #132 AND MU #944

The trains collided on No. 2 main track of Penn Central's Northeast Corridor Region, Chesapeake Division, 23 feet south of MP 25. The railroad consisted of three tracks -- "B" track, No. 2 main track, and No. 3 main track. (See Figure 1.) No. 2 was used predominantly for northbound traffic and No. 3 was used predominantly for southbound traffic. South of MP 25, No. 2 track was on a 0.37-percent descending grade and on a 0° 20' curve to the right.

The trains collided about 2,082 feet north of the interlocking limits of Landlith Interlocking, which was controlled remotely from Wilmington Station, and about 4,277 feet north of Signal 118L, which was the last signal passed by No. 944.

APPROXIMATE POINT OF IMPACT

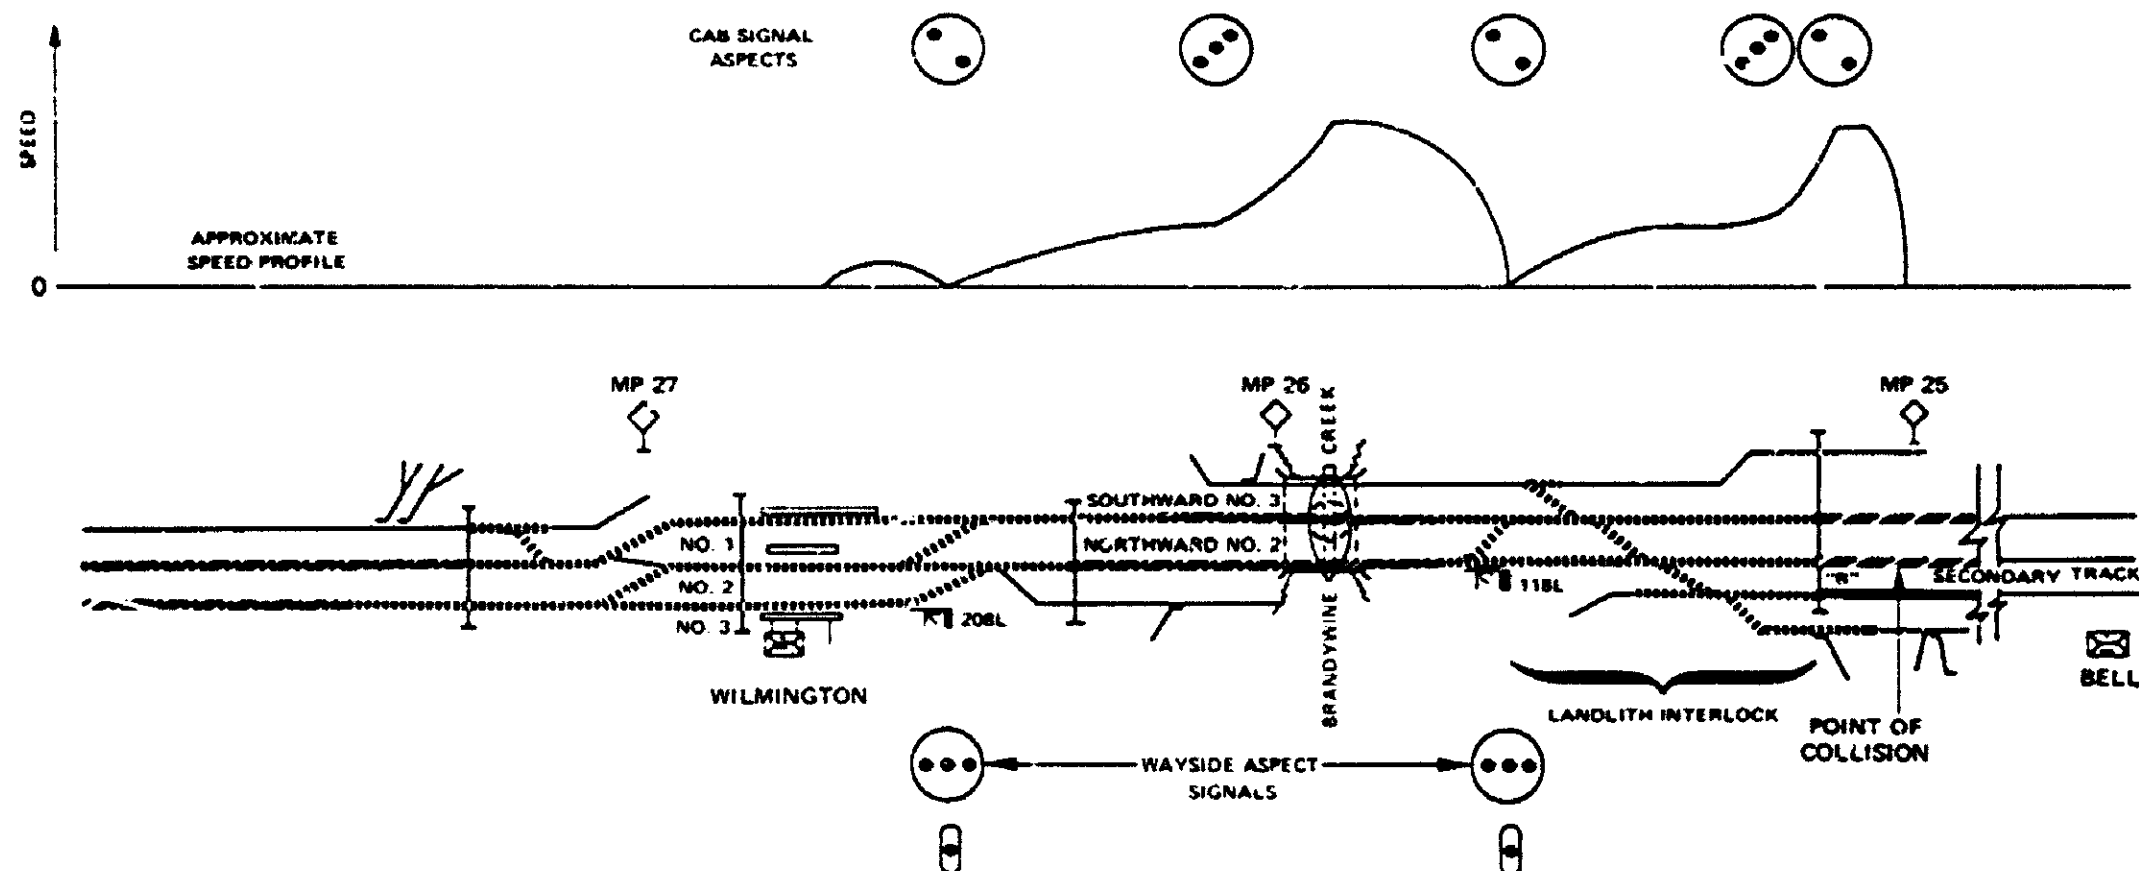
FIGURE 2

TRACK PLAN VIEW MP 27 TO MP 25
INDICATING INTERLOCKING LAYOUT,
SIGNAL LOCATIONS AND SPEED
PROFILE. LIMITS OF APPLICABLE
RULES ARE INDICATED.

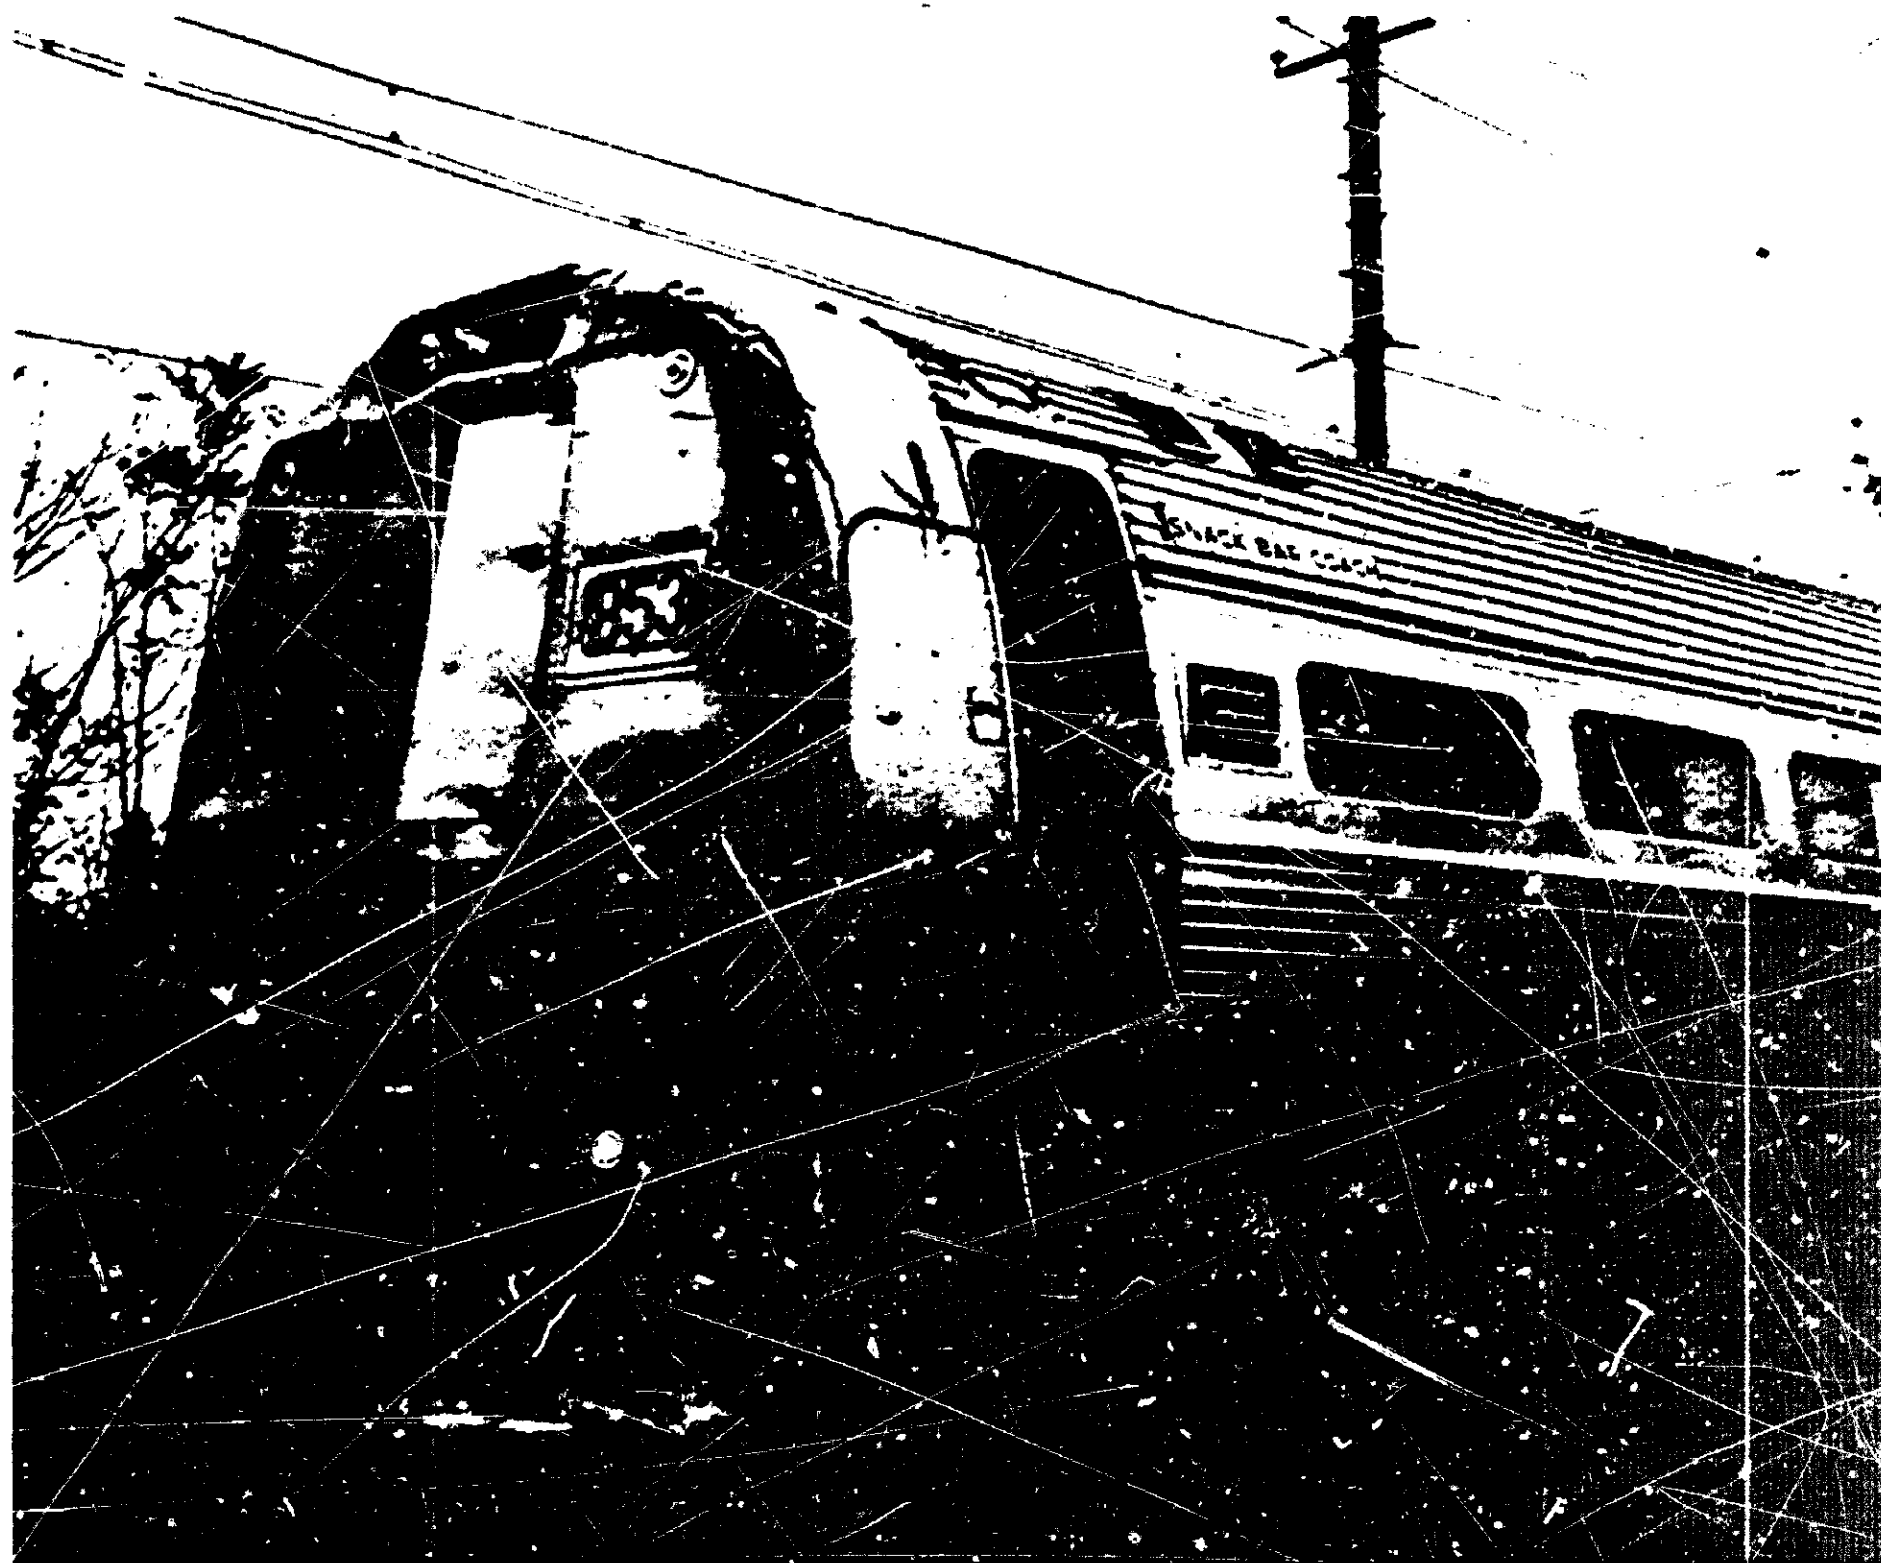
Figure 3. Last car of No. 132.

Train No. 132 was not damaged as extensively as No. 944; the lead car on No. 944 had not penetrated the control or coach compartments on the last car of No. 132. (See Figures 3 and 4.)

Penn Central examined the cars to determine why the trailing car of train No. 132 was damaged less severely than the lead car of train No. 944. Their report stated: "...couplers on the two types of equipment differ and are not compatible.

"On impact, the striking Silverliner cars deflected downwards as couplers passed permitting the draft sill of the Silverliner to enter the striker opening of the Metroliner. This in turn allowed the end sill and

buffer structure of the Metroliner to contact and shear the Silverliner collision post, resulting in collapsing of the vestibule of the Silverliner. Since the buffer of the Metroliner was pushing the end structure of the Silverliner away from its own striker, the contact between the end sheets of the Silverliner and the Metroliner was minimized, resulting in minimal damage to the Metroliner end."
