NATIONAL TRANSPORTATION SAFETY BOARD

RAILROAD ACCIDENT REPORT

SIDE COLLISION OF
SOUTHERN RAILWAY COMPANY
TRAINS NOS. 1 AND 152
SPENCER, NORTH CAROLINA
OCTOBER 8, 1977

REPORT NUMBER: NTSB-RAR-78-3

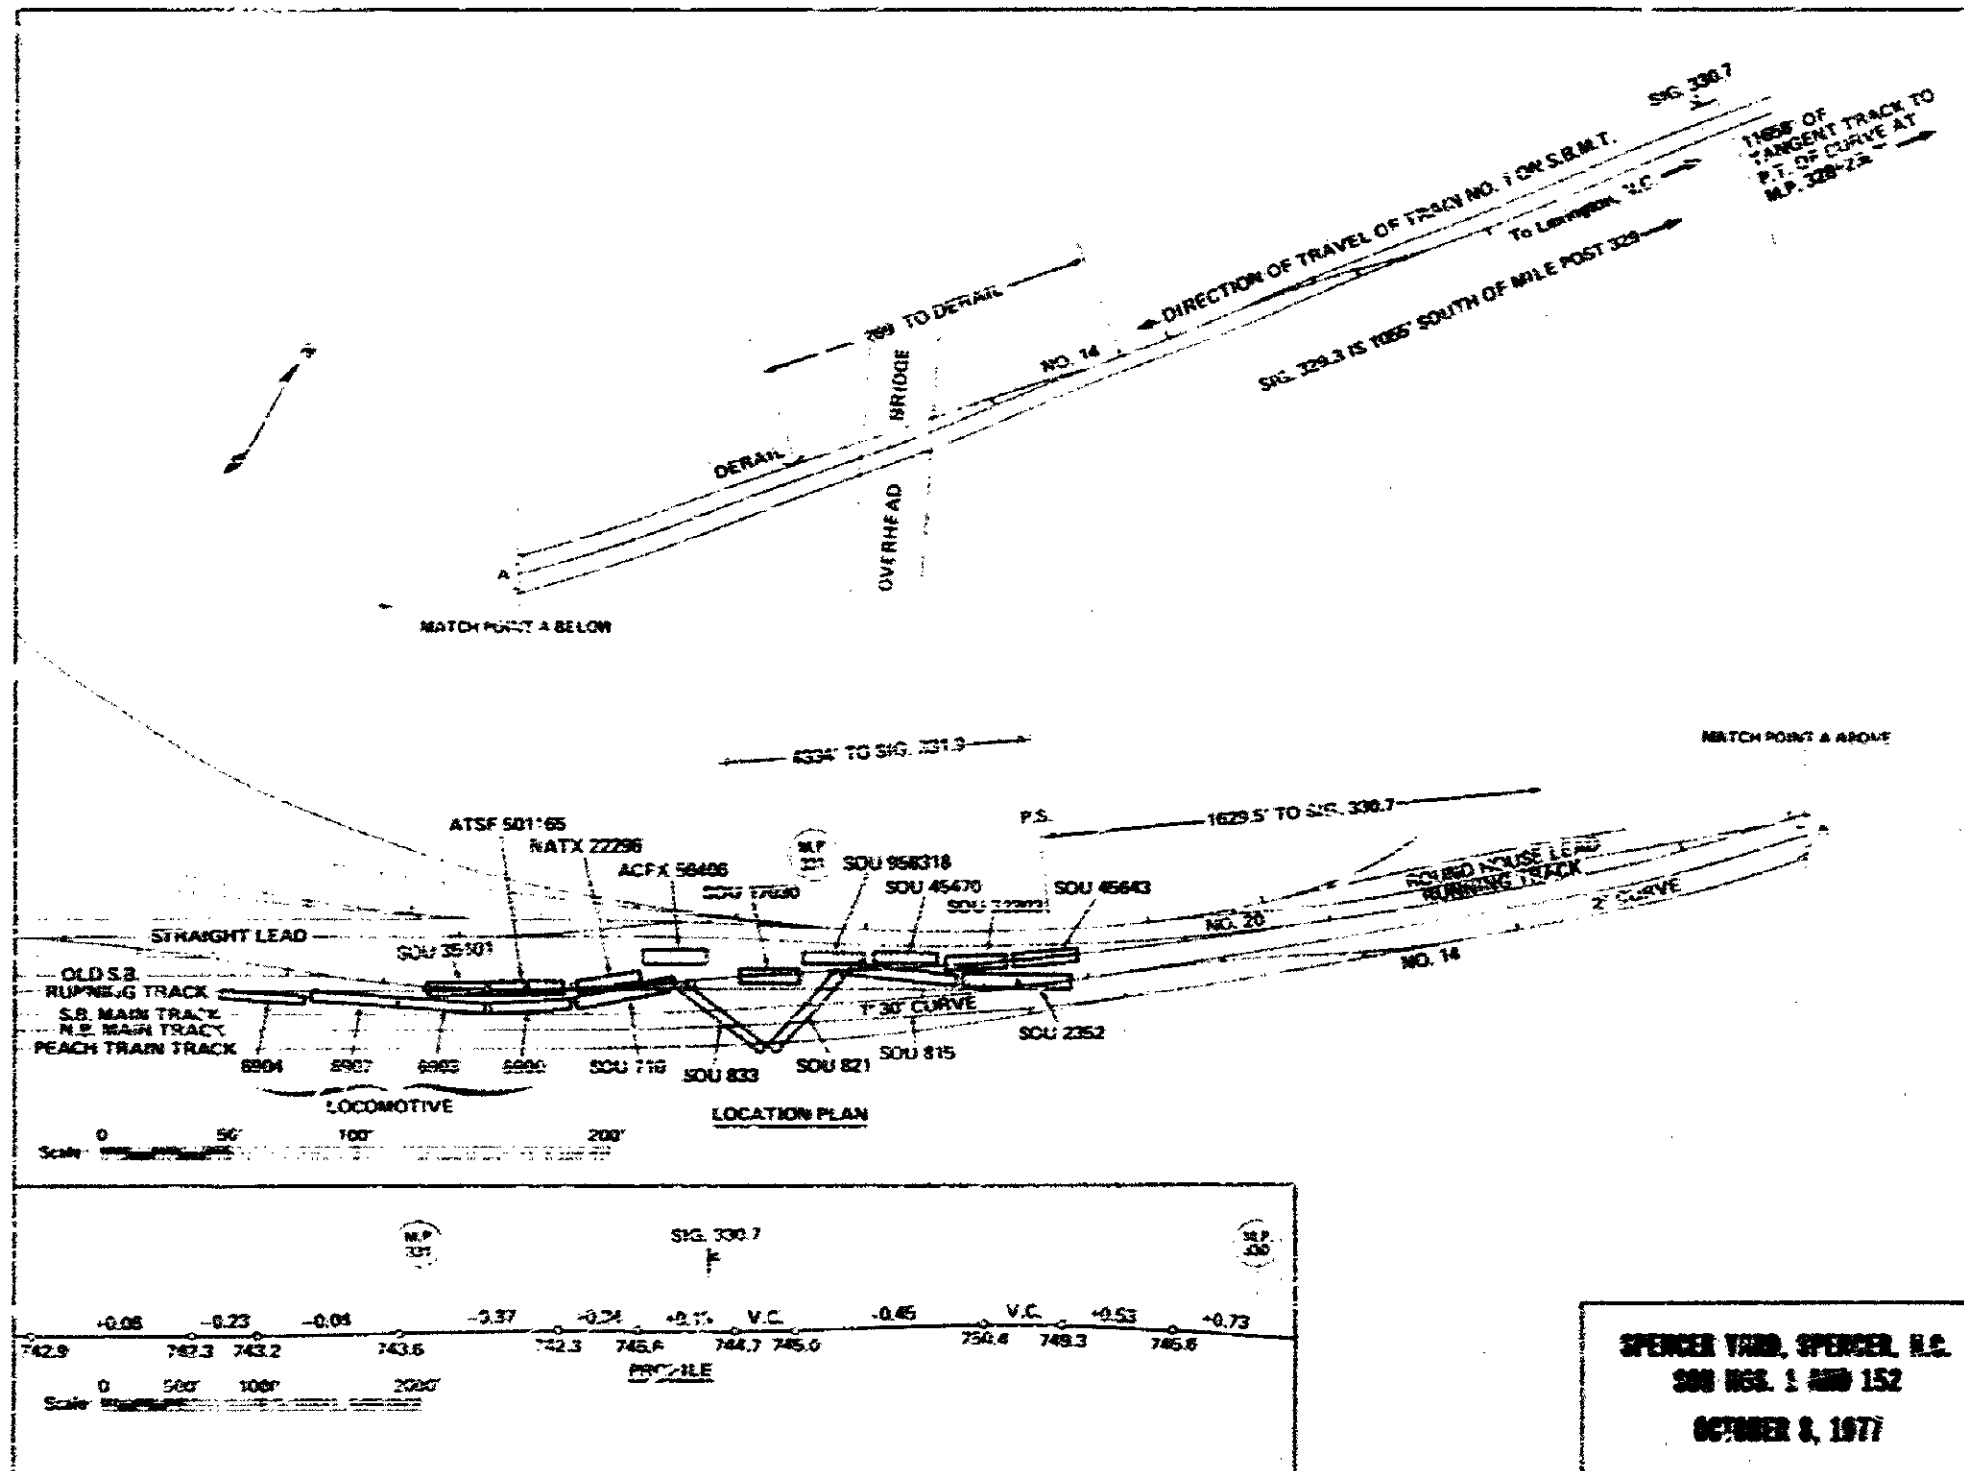
Figure 1. Accident site.

Shortly after The Crescent passed signal 330.7, it entered the north switch of the crossover and was routed from the main track to the running track in the Spencer Yard where it collided with the freight cars of train No. 152.

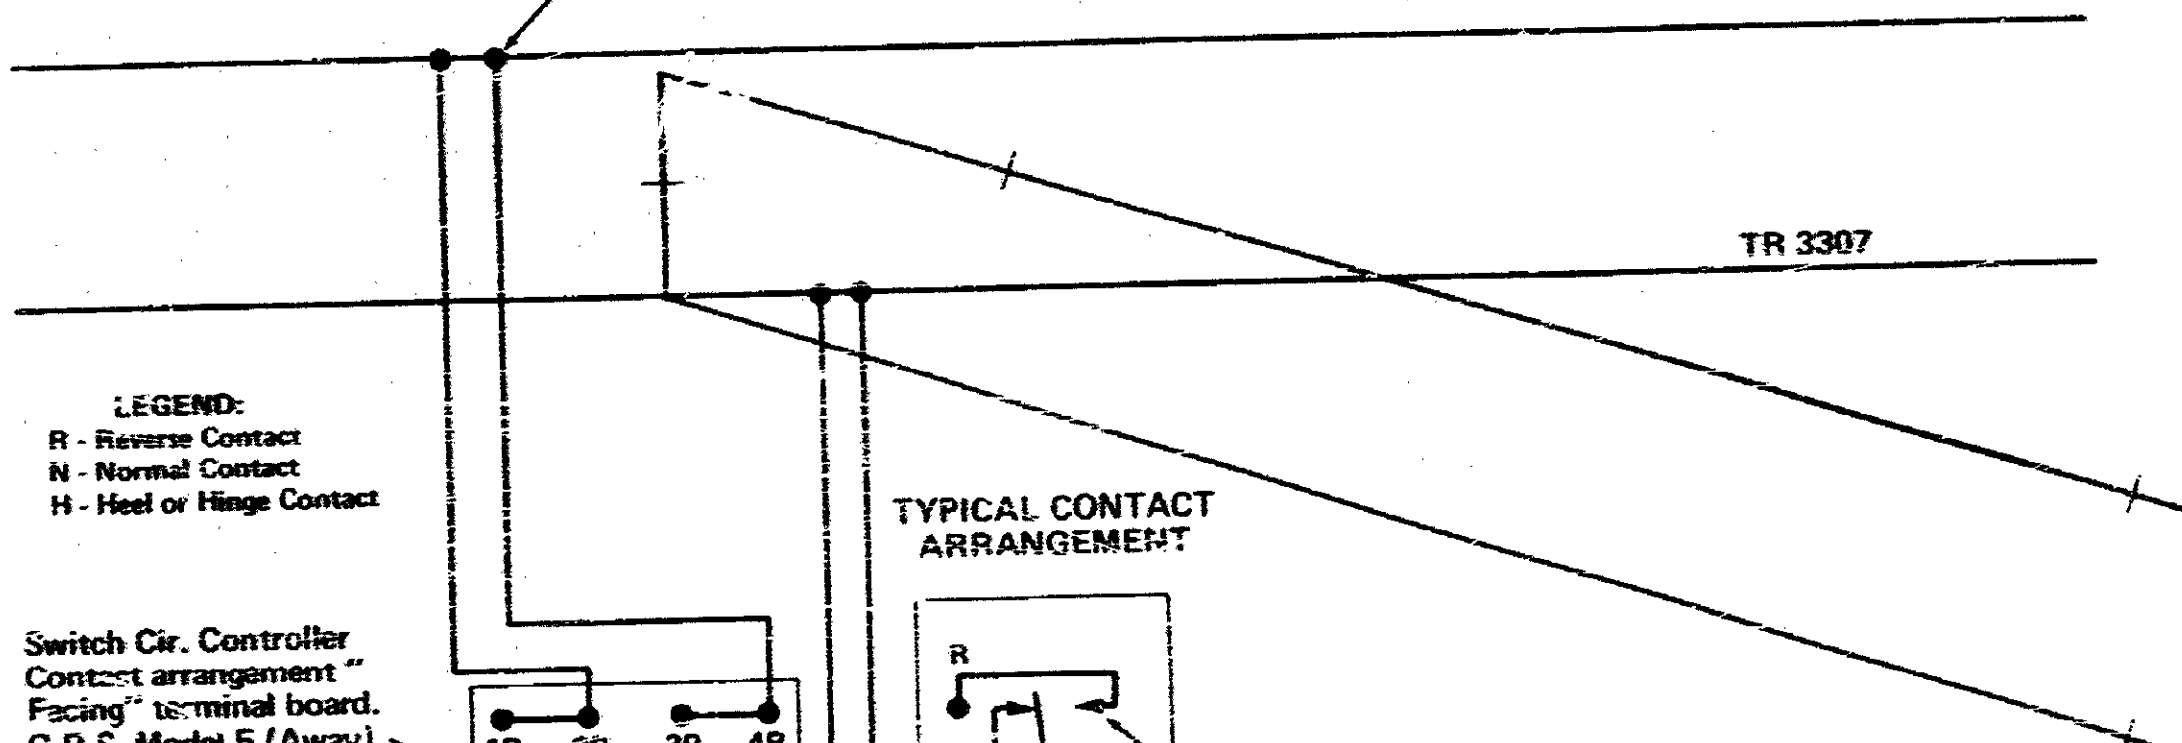
Rail Connector replaced after track forces accidently broke connection on Saturday, Oct. 8, 1977

Switch Cir. Controller Contact arrangement "Facing" terminal board. G.R.S. Model 5 (Away)
 When switch is 1/4 inch off normal to full reverse, 1H closes to 1R, 2H closes to 2R, 3H closes to 3R and 4H closes to 4R. Note jumpers from 1R to 2R, 3R to 4R, 1H to 2H and 3H to 4H.

NOTE: The wire arrangement shown above is "EXACT" as existed at time of investigation, Oct. 12, 1977. Southern Railway, North end of "Old Spencer Depot" Crossover, 1629 feet south of ABS Signal 330.7. Switch Circuit Controller Contacts 1, 2 and 3 failed to shunt TR 3307 with switch in 1/4 inch off normal to full reverse switch position. Eastern Division - Eastern Lines.
