RAILROAD ACCIDENT REPORT

**HEAD-ON COLLISION BETWEEN
AMTRAK TRAIN NO. 82 AND
SEABOARD COAST LINE EXTRA 2771 SOUTH
LAKEVIEW, NORTH CAROLINA
APRIL 2, 1980**

NTSB-RAR-80-8

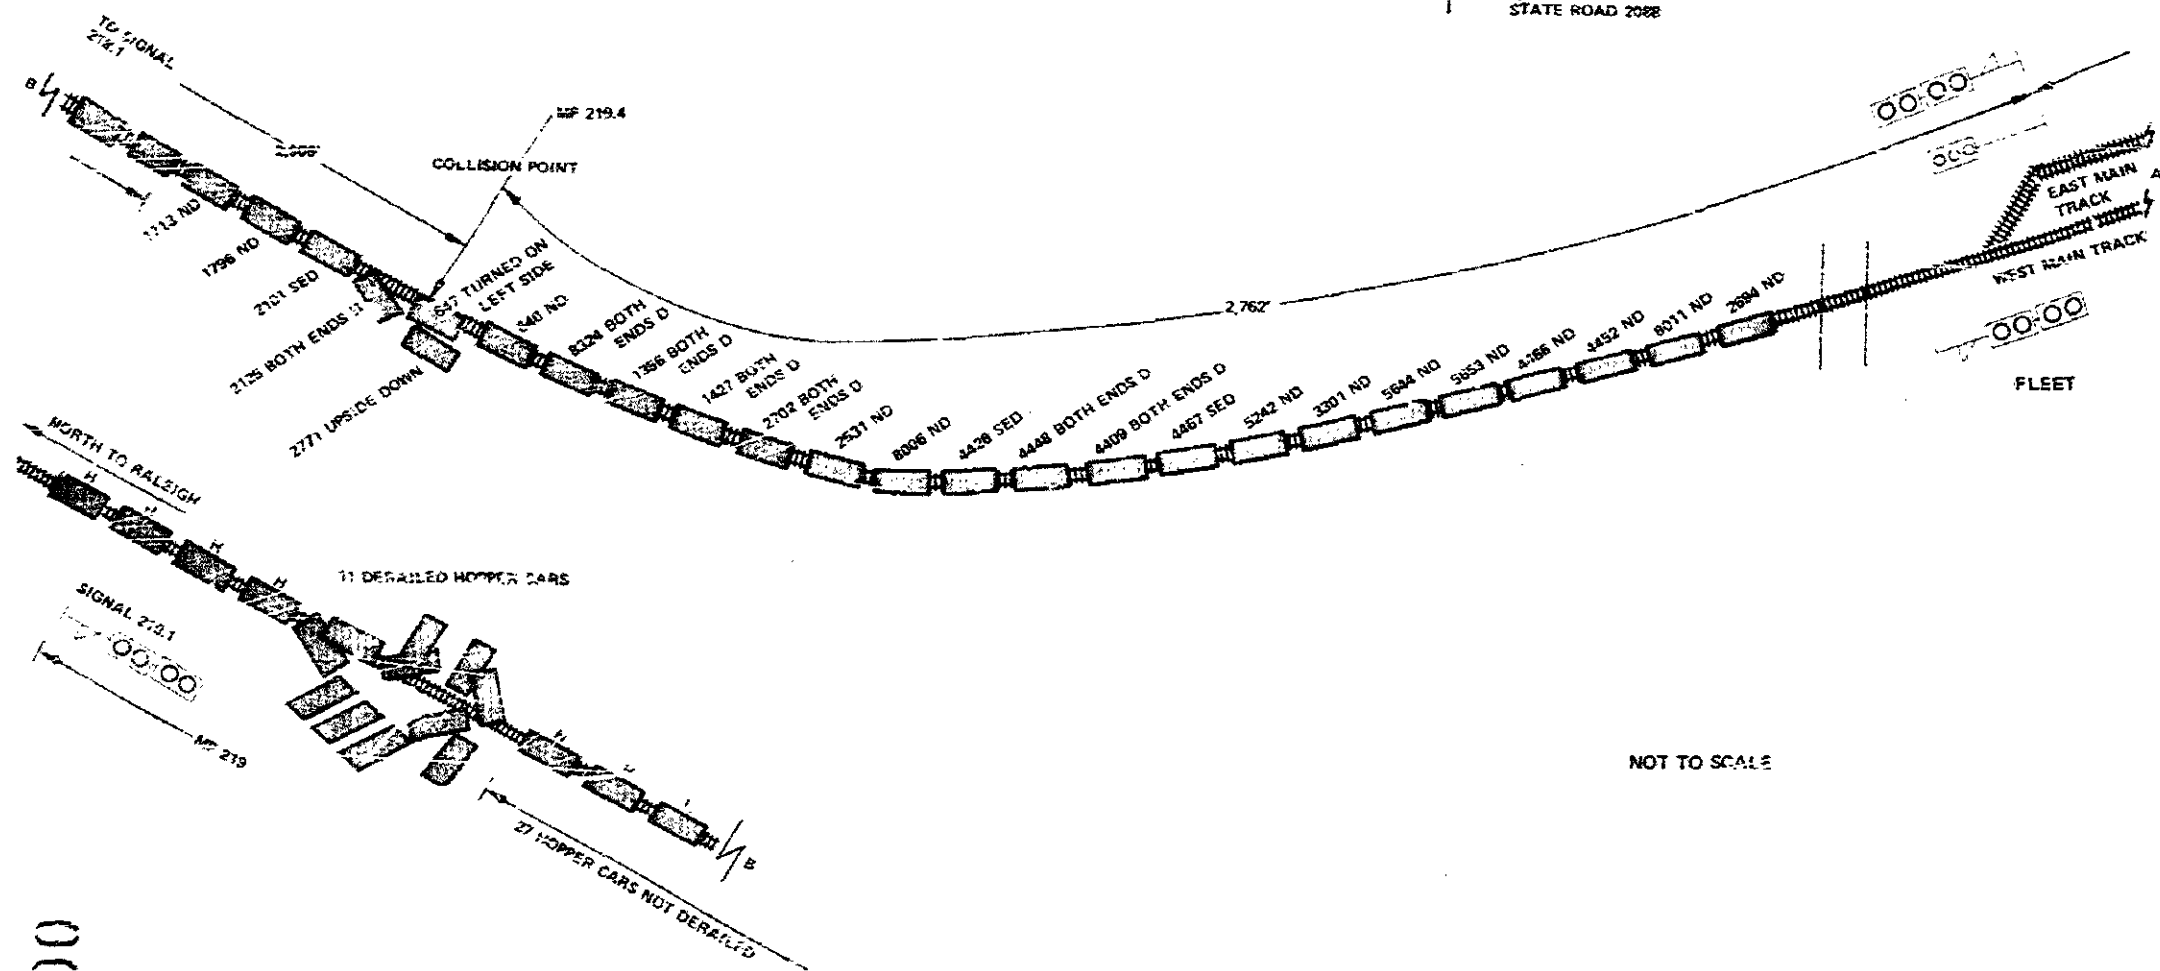
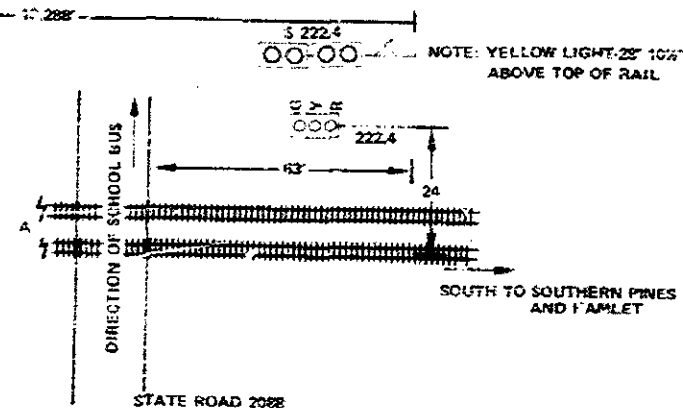
Figure 2.--Derailment site of Train No. 82 and Extra 2771 South.

Just before the engineer sighted the home signal at Fleet Interlocking, he made a brake application to reduce the train's speed for another 50-mph restricted speed curve just north of Fleet. When the train was about 250 feet from the interlocking home signal at Fleet, the engineer saw the "red" aspect through the fog. About the same time, the fireman returned to the operating compartment, and he also saw the "red" aspect, which he called to the engineer as "stop." The engineer repeated the aspect "stop," but he did not immediately put the train's brakes into emergency. The engineer was trying to decide whether to stop the train with a full service brake application and pass the stop signal or to put the train's brakes into emergency and attempt to stop sooner. When he recognized that the track switch was aligned for a southbound train to enter the east track, he put the train's brakes into emergency without hesitating. The train began to decelerate as it passed the "stop" signal, ran through the switch, and moved into the 3° 15' curve to the right, north of Fleet Interlocking. As the train continued northward, the engineer looked across the curve and saw the headlight of an approaching locomotive. He grabbed the radio handset and yelled, "Stop that freight train, I got past the switch at Fleet." The fireman immediately left the operating cab and stepped off the west side of the locomotive without falling, about 250 feet from the impact site. The engineer left the cab and jumped from the east side of the locomotive, about 100 feet from the impact site. The engineer testified that, when he recovered from his fall, he was adjacent to the second unit of train No. 82. (See figure 2.)
