RAILROAD ACCIDENT REPORT

**HEAD-END COLLISION OF
AMTRAK PASSENGER TRAIN NO. 74
AND CONRAIL TRAIN OPSE-7
DOBBS FERRY, NEW YORK
NOVEMBER 7, 1980**

NTSB-RAR-81-4

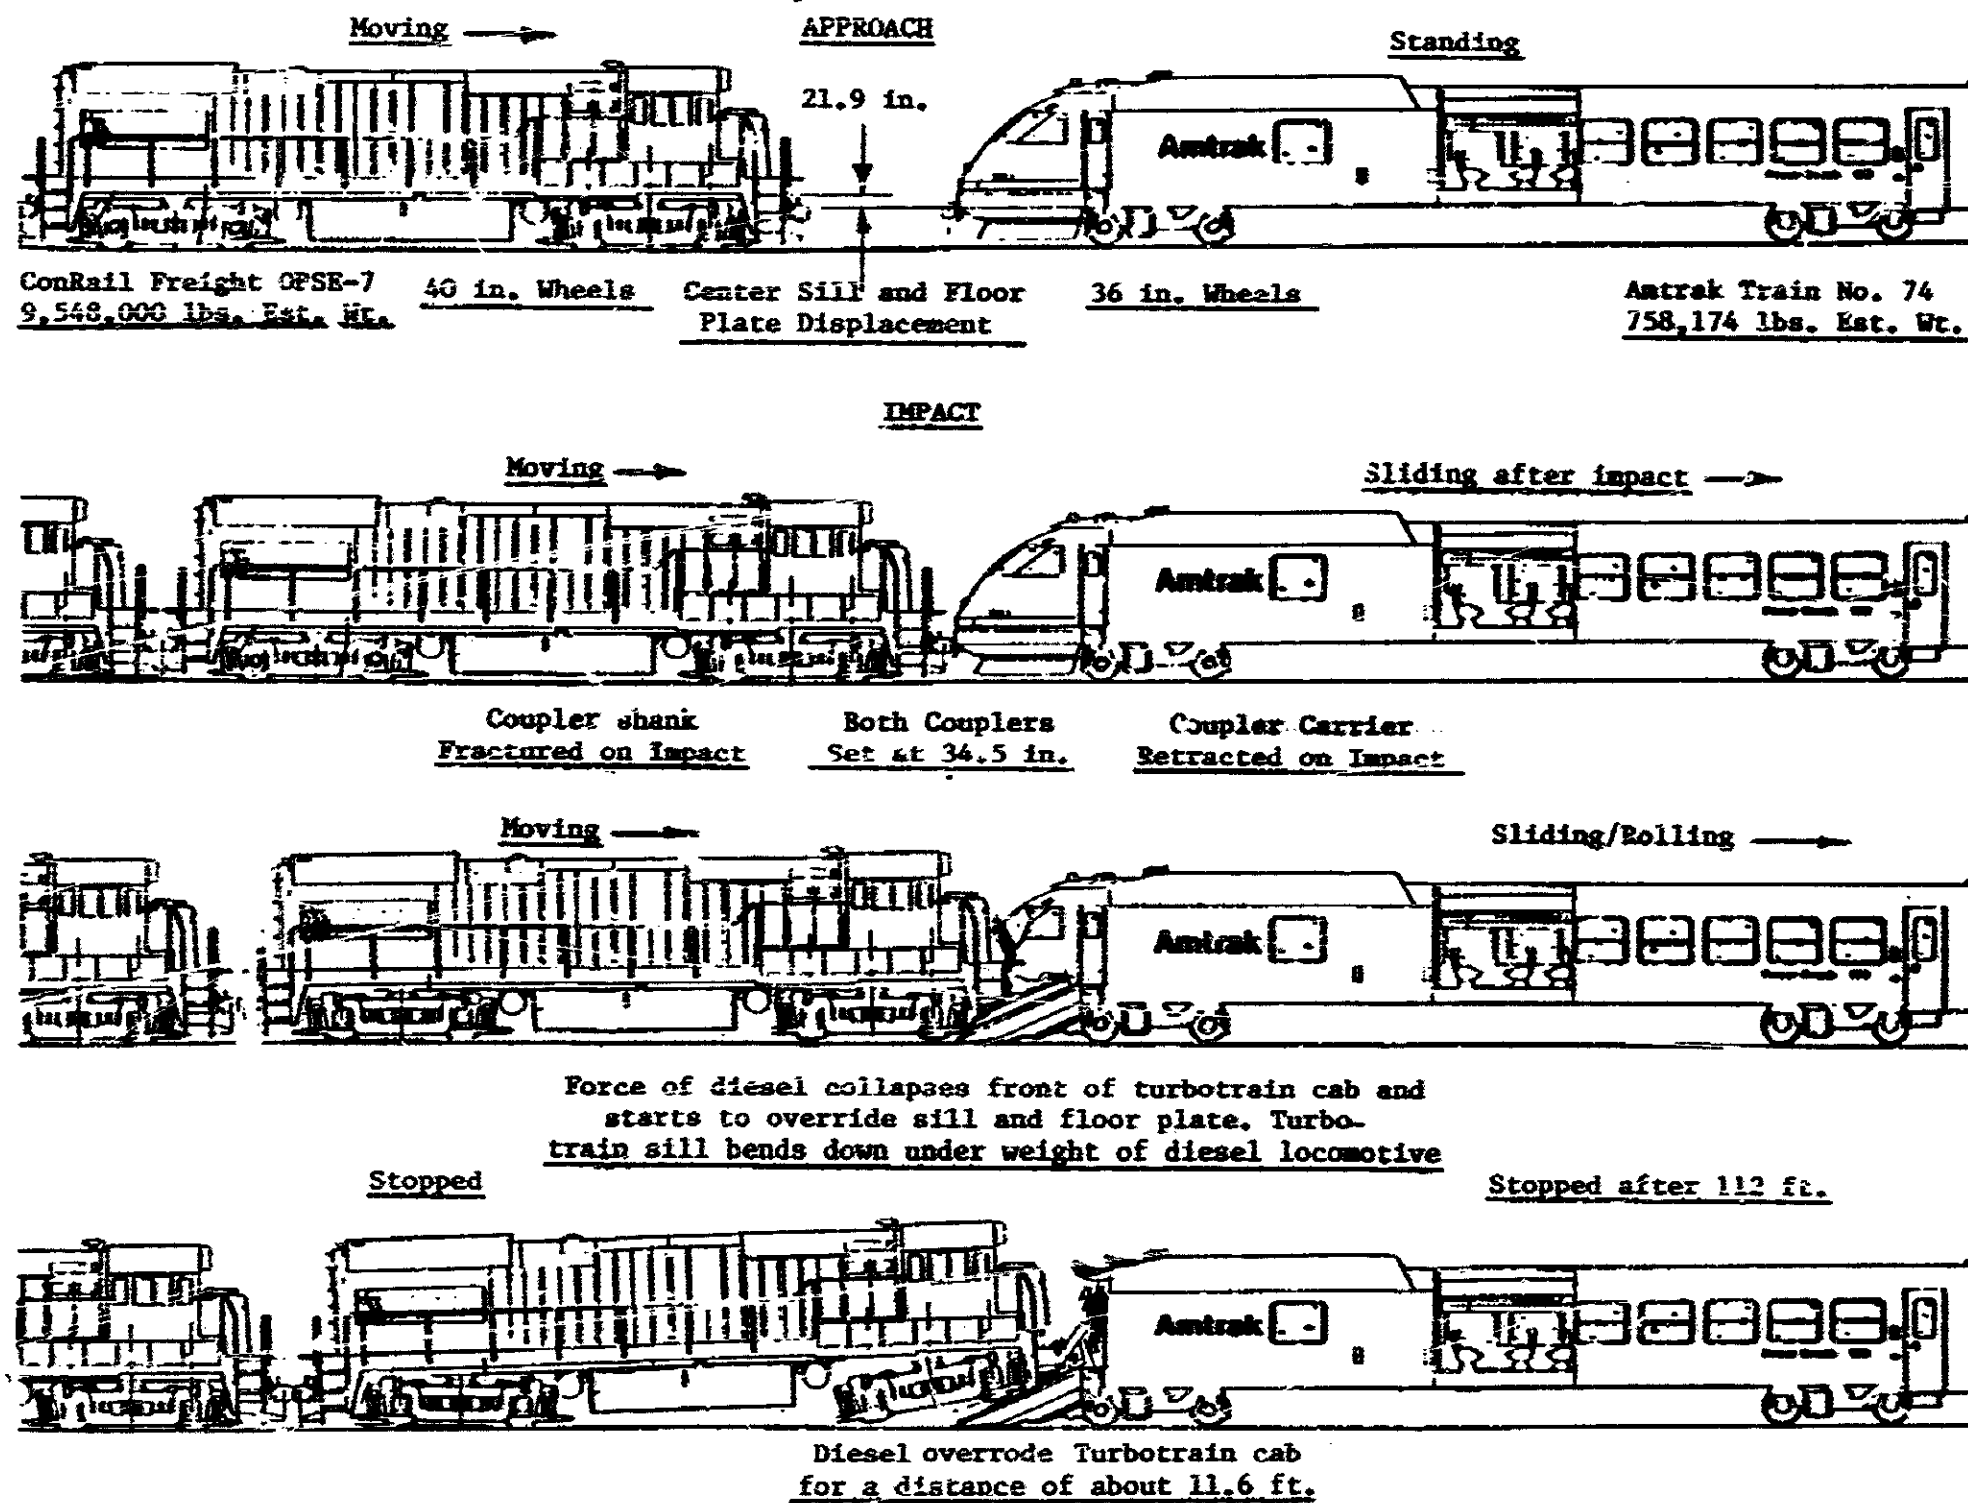
Figure 2.—Diagram of impact of OPSE-7 and No. 74.

Moments later, OPSE-7 collided with standing train No. 74 at about 10 mph. The impact derailed the lead unit of OPSE-7 and pushed train No. 74 rearward about 112 feet, derailling the lead power car (see figure 2) and the following three passenger cars. (See figure 3.) Electrical power to the four tracks was shut off after a crewmember boarded the cab of the rear power car and used the radio to request that the power be shut off because of the collision and because passengers were getting onto the tracks. An employee of a restaurant adjacent to the accident site immediately called the Dobbs Ferry Police Department. Within 3 minutes after the accident, emergency forces began to arrive at the accident site.

Damage to OPSE-7 was limited to the derailed lead locomotive unit. The front end coupler was broken and the front deck, handrails, and side steps were bent, torn, and twisted. The short hood was forward and it was crushed inward.

The operating cab of the power club car of train No. 74 was destroyed because of the 10-mph impact. All floor or deck mounted equipment was torn or sheared off. The other cars in the train sustained minor structural damage.

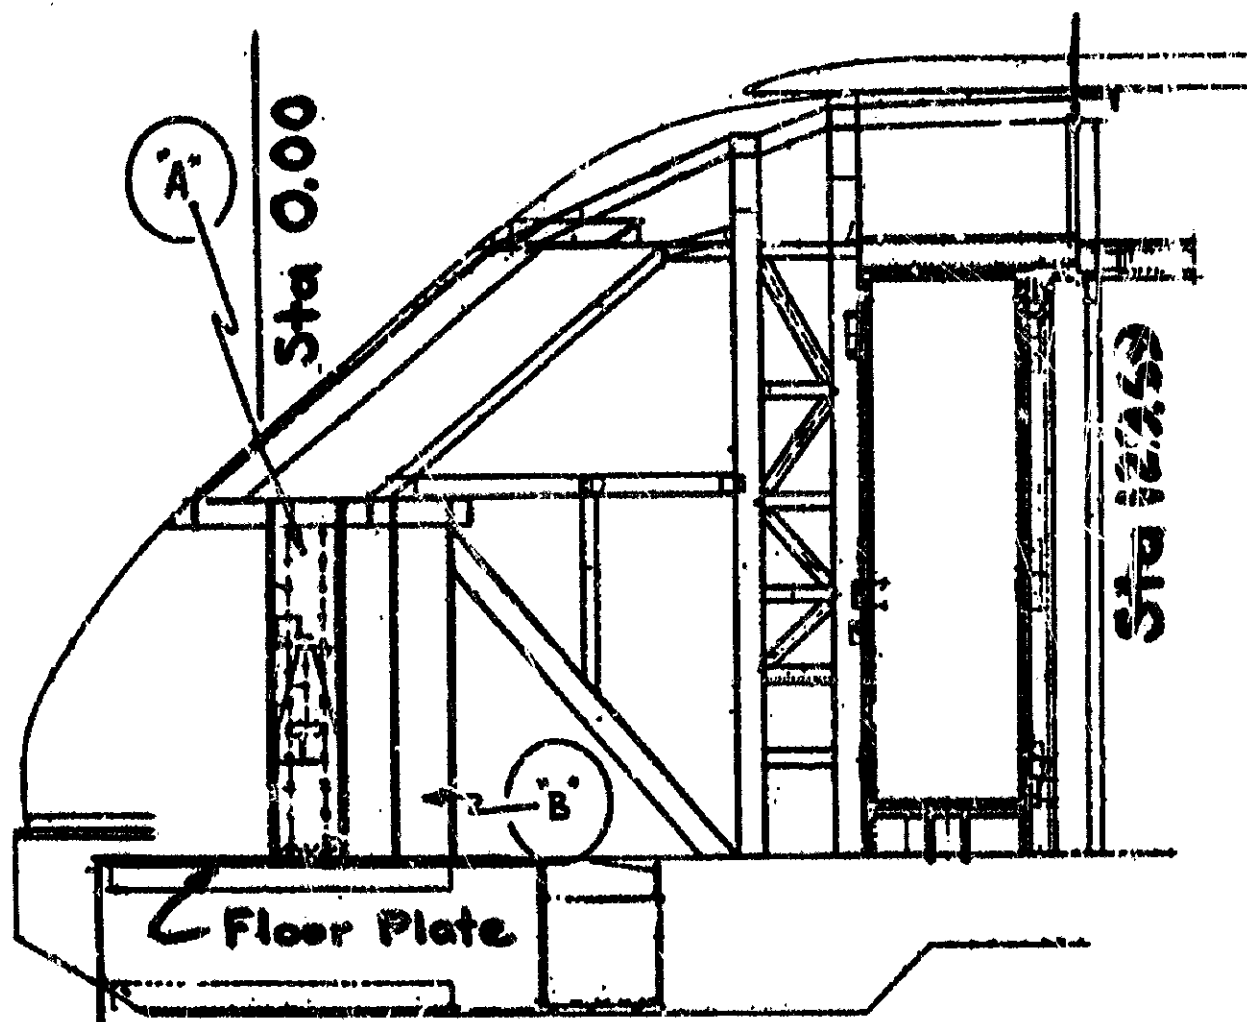
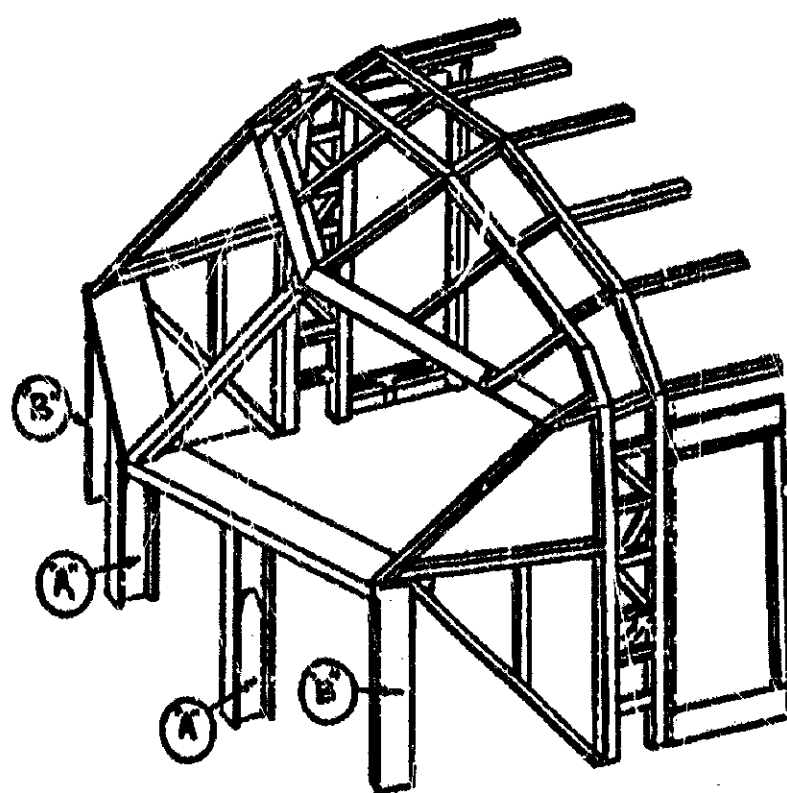
Figure 4. -- Structural design of the engineman's cab front (turbotrains).

The operating cab of the power car had two 10-inch I-beam forward posts, identified by Amtrak as collision posts, (see figure 4 item "A"), welded to the floor. One end of the angled supports (item "B") was welded to the I-beams and the other end was welded to the floor. The forward posts (item "A") were tested in a mock-up configuration to meet the AAR specifications Nos. C-75 through -84, revised 1967. (See appendix H.) The height of the sill and floor plate on the power club car was 45.67 inches above the top of the rail.

"A" = Collision Posts (Center)
 "B" = Collision Posts (Side)

Train No. 74 had traveled approximately 4 miles east of OW when it stopped. Two vertical I-beams were located at the forward end of the power car at Body STA. 0:00. (See figure 4.) These I-beams, identified as collision posts, had failed at the base welds and were pushed rearward about 7 feet. Outboard angled supports which were tied laterally to the vertical I-beams by welded steel structural members had failed at the floor attachment and had torn the floor material. The attaching welds had not failed. These posts were also pushed rearward about 75 inches. The car frame was bent downward until the forward section of the frame contacted the rail. The front AAR type E-coupler, mounted in a retractable coupler box, was found in the retracted position. The two pin-type locks which secured the coupler carrier in the extended position were found undamaged but pushed rearward to an angle of about 60° on both sides. The structural metal of the coupler carrier and the lock pin guides were bent and deformed. The lock pin retracting mechanism was severely bent and damaged. All exterior metal and fiberglass skin panels were destroyed to about 112 inches from the front. All four of the third-rail contact shoes were severely damaged.

Since the sill section and floor plate of train No. 74 were 21.9 inches lower than the sill and floor of the freight locomotive unit of OPSE-7, the operating cab of the power car was not survivable in this accident. Penetration of the power car at this height above the floor plate insured failure of the cab's forward structure.

Although the I-beam forward posts of the power car were intended to be collision posts, they failed to provide any protection since they were torn loose and pushed rearward even in a relatively low speed collision. In the test mockup that was performed on the collision posts before they were installed in the power car, the collision posts were welded to an I-beam before the test loading was applied. (See appendix H.) The actual installation of these collision posts differed from the testing because they were welded only to the much thinner floor plate. In this accident, the collision posts tore loose from the floor plate, or tore the floor plate metal. It is evident that modern passenger equipment, such as that used on train No. 74, will always sustain extensive damage in a collision with conventional locomotives because of the incompatibility of the rigid frames; its frame being approximately 21 inches lower than standard railroad equipment. Apparently, this matchup was not considered when the turboliner equipment was adopted for use on American railroads.

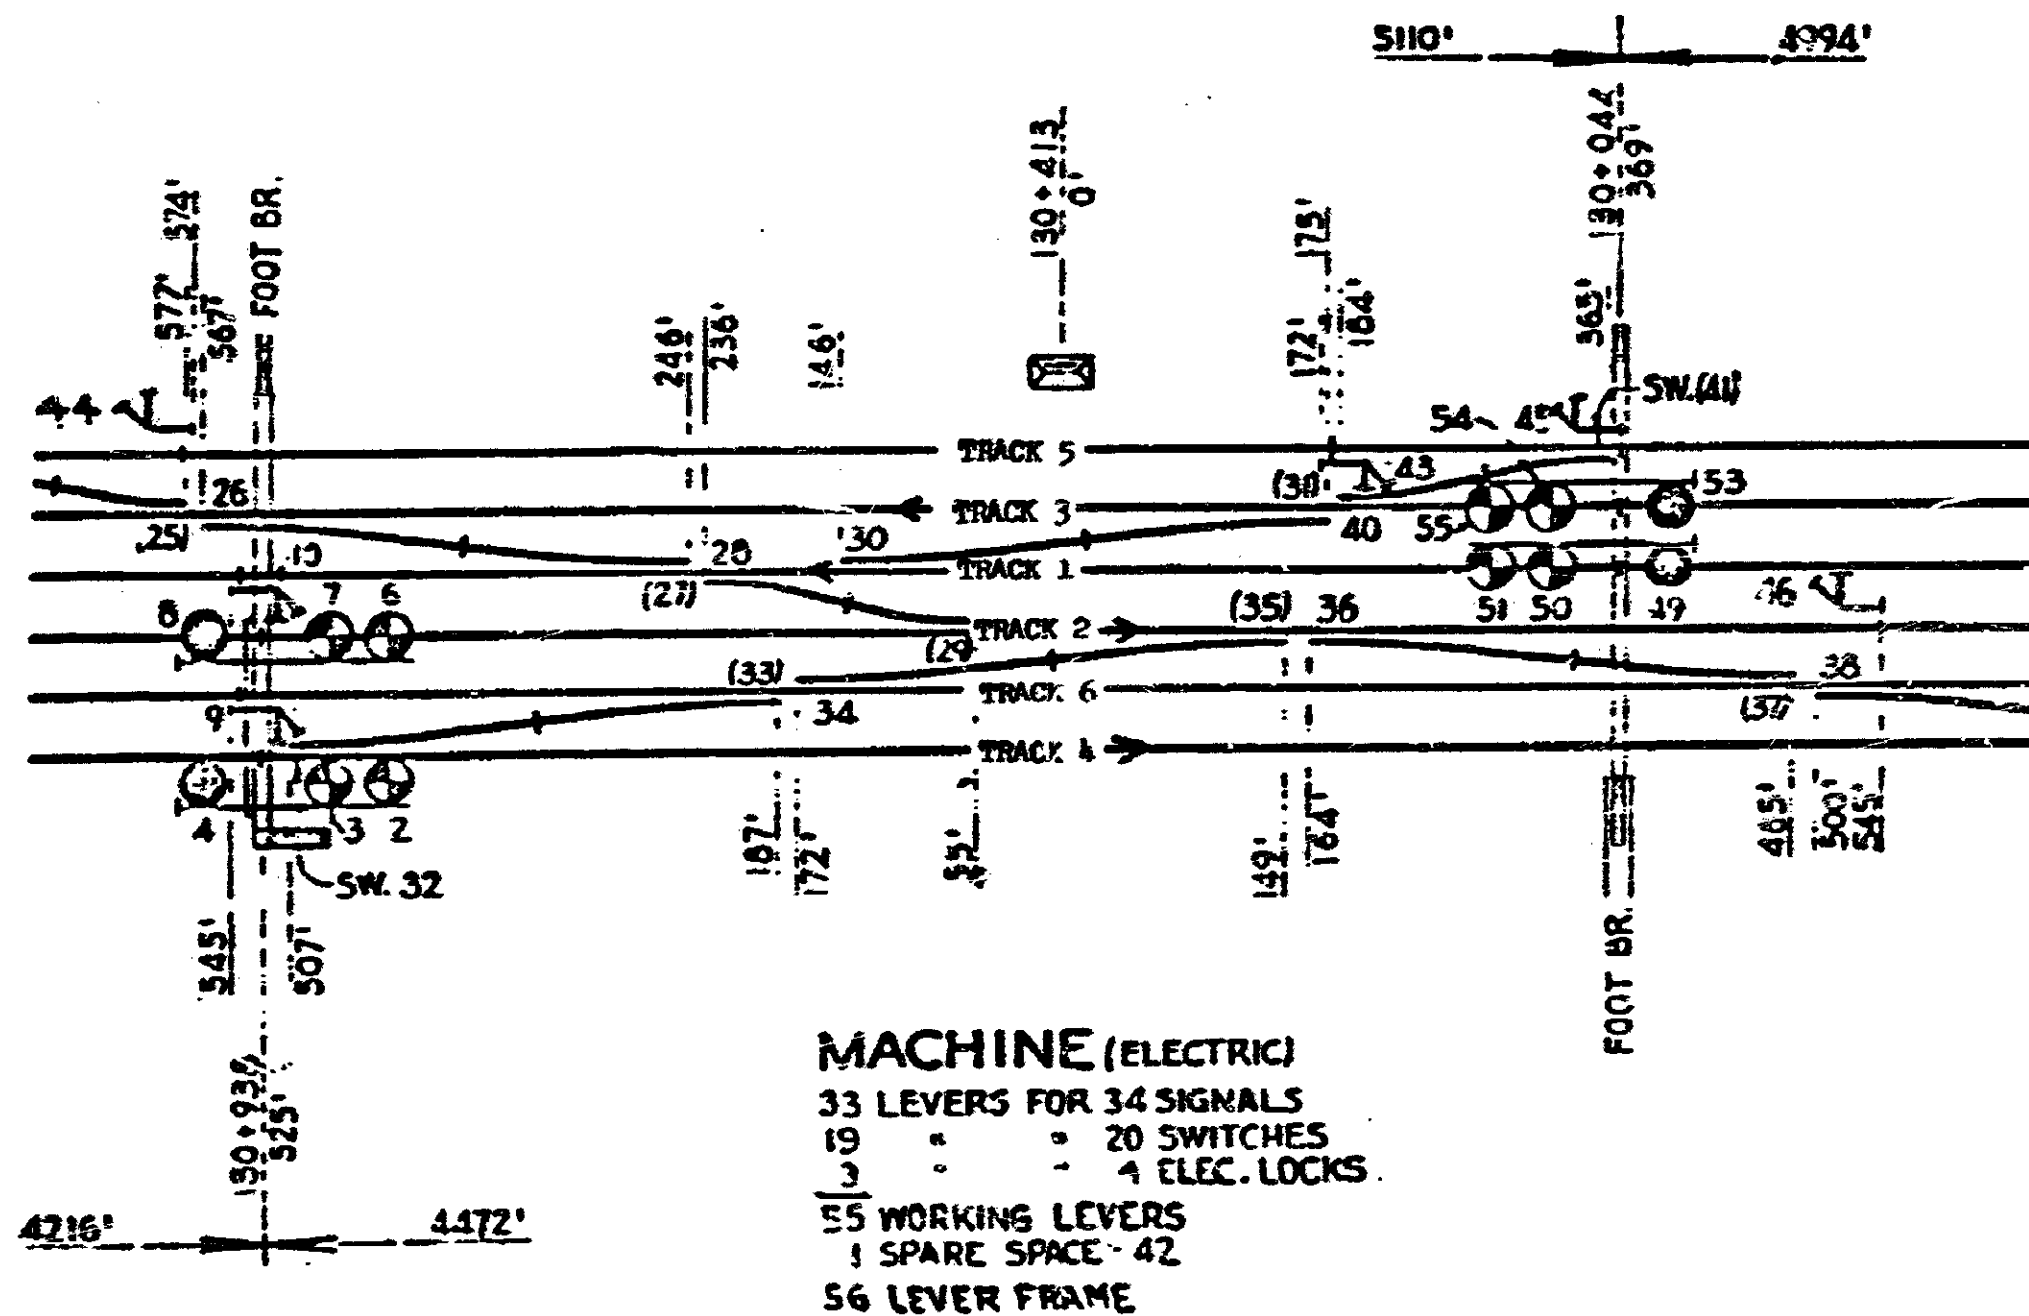
Figure 2.— OW interlocking.

On the eastward signal mast for track No. 2 at OW interlocking, there was a fixture for a flashing letter "O", a train order signal; however, the signal had been electrically disconnected. A bracket for attaching a yellow flag or light, also a train order signal, to the tower building at OW was not accessible to the operator because the storm windows were nailed shut.

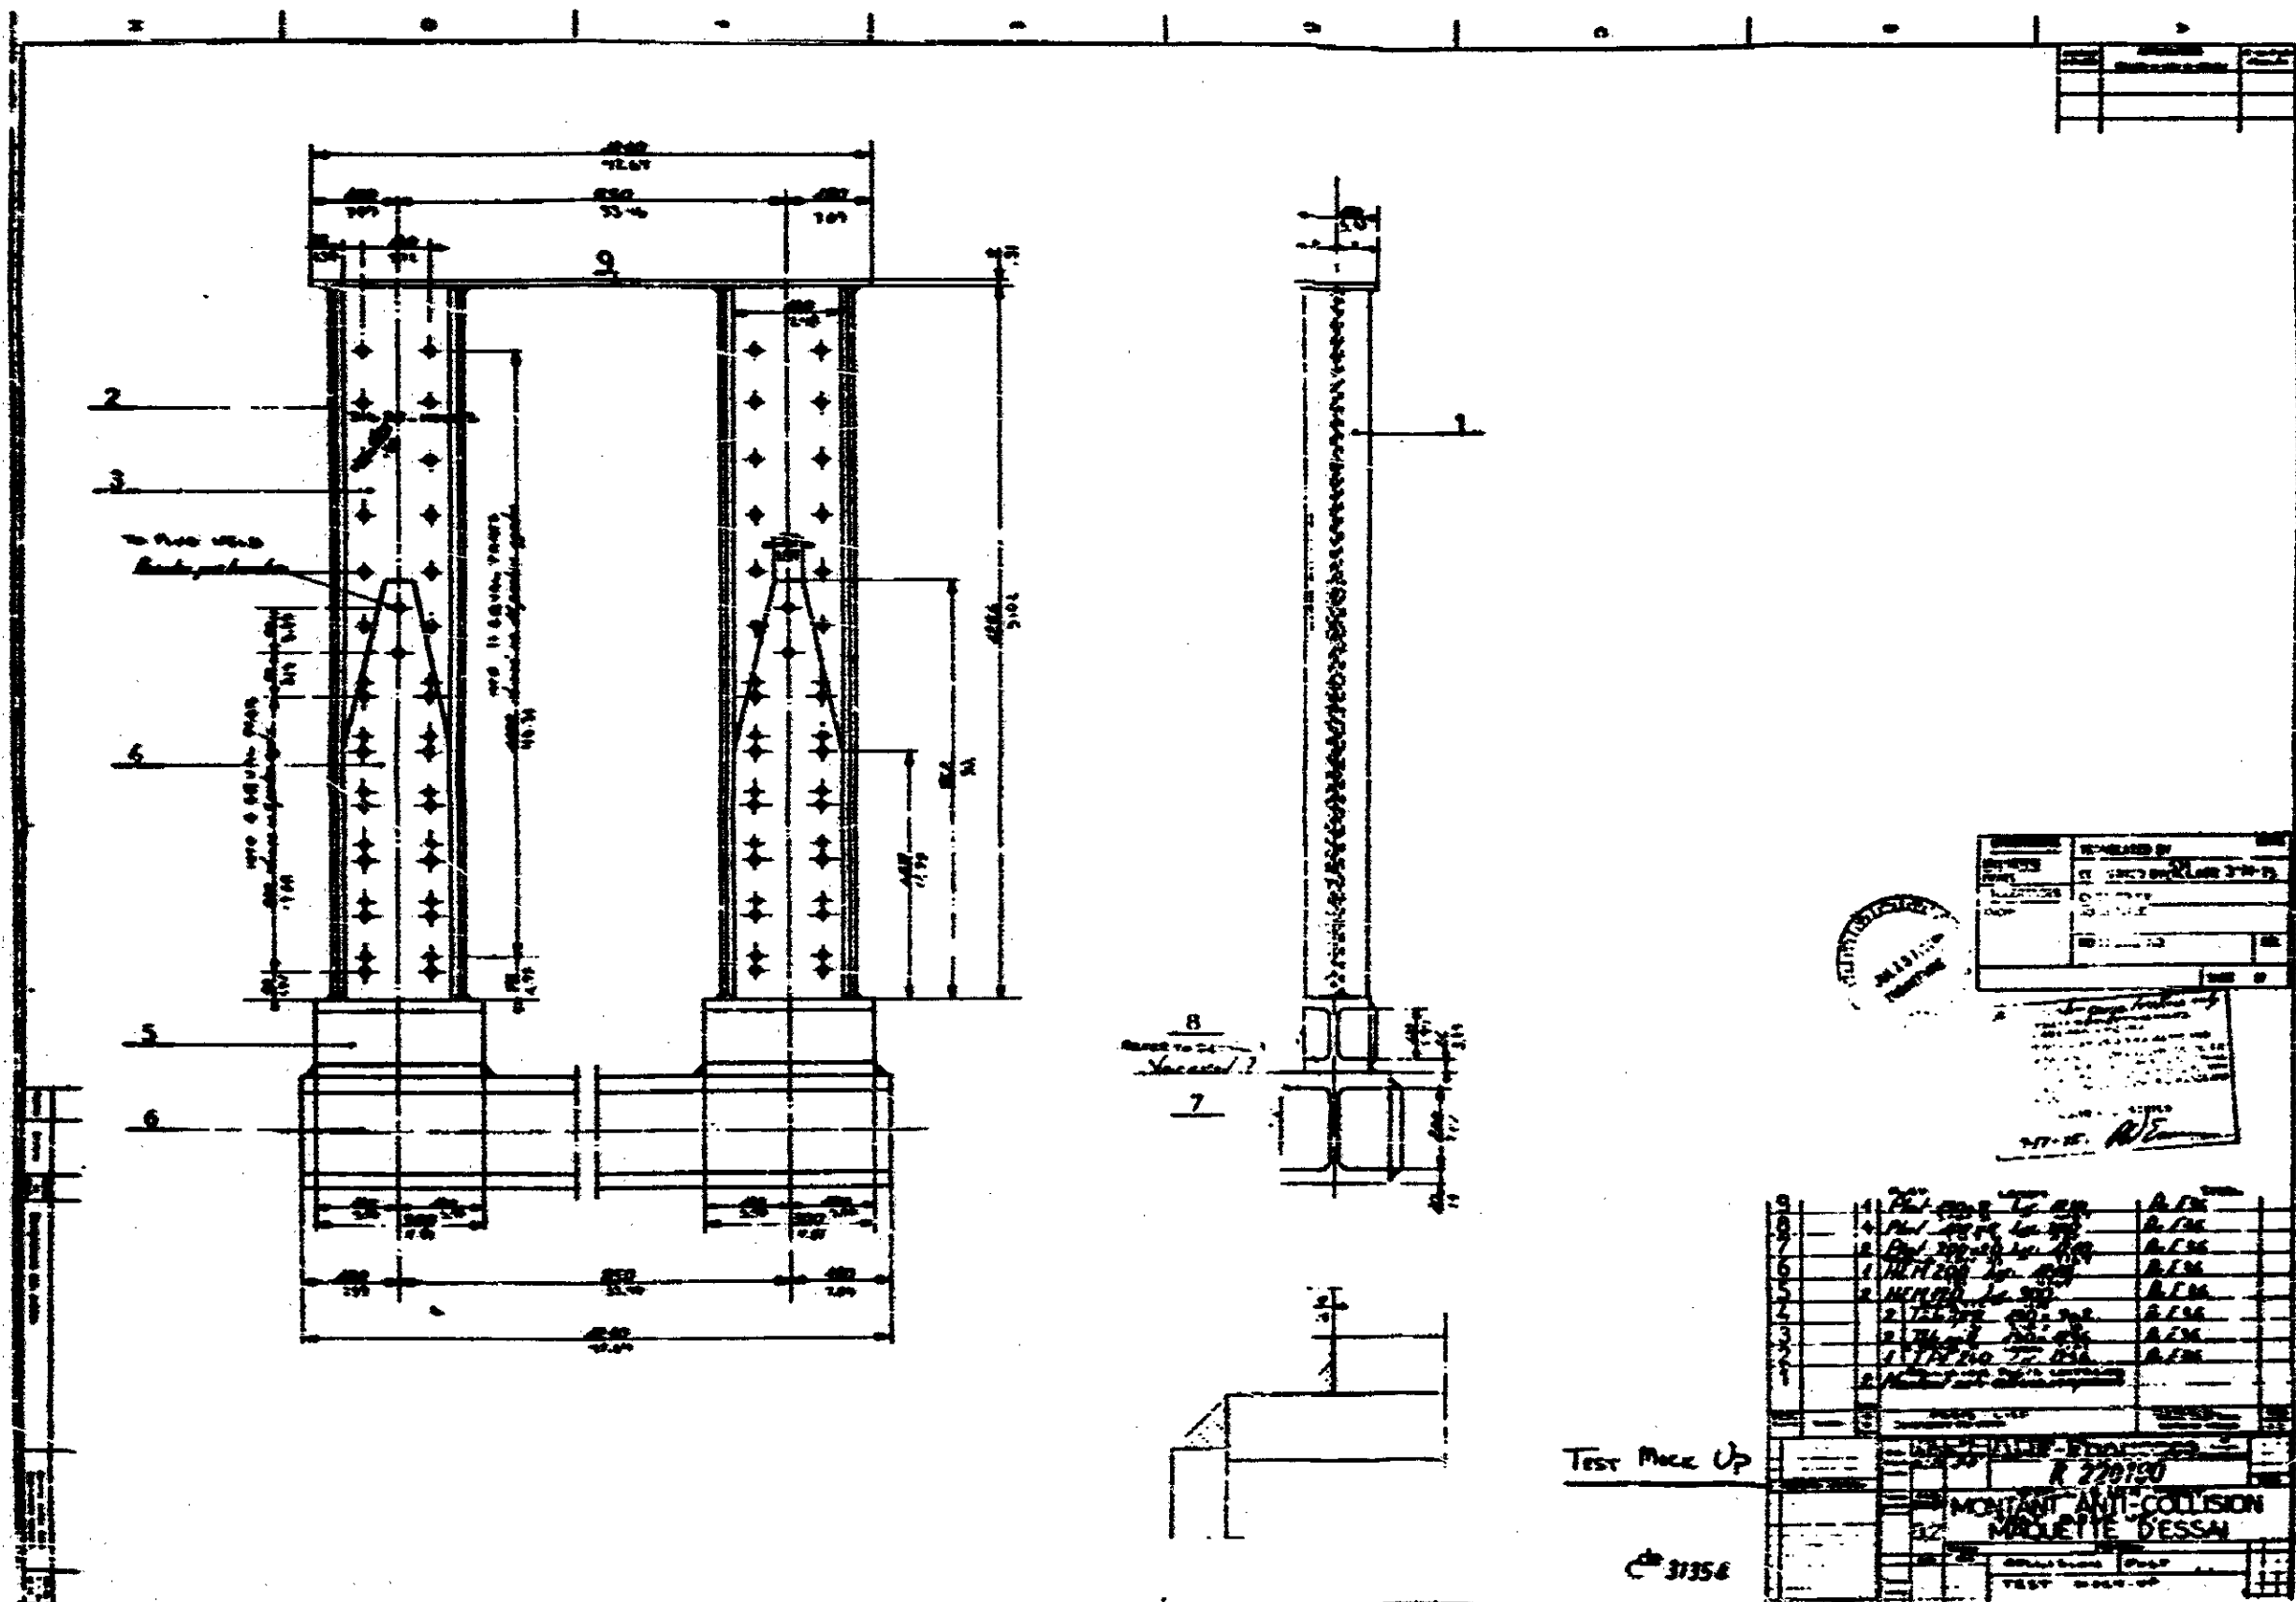
Test Mock Up

A 150K load was applied 18" above lower attachment with no failure.

A 300K load was applied at the base with no failure.
