NATIONAL TRANSPORTATION SAFETY BOARD

RAILROAD ACCIDENT REPORT

**DERAILMENT OF
AMTRAK PASSENGER TRAIN NO. 21
ON THE ILLINOIS CENTRAL GULF RAILROAD
SPRINGFIELD, ILLINOIS
OCTOBER 30, 1980**

NTSB-PAR-81-5

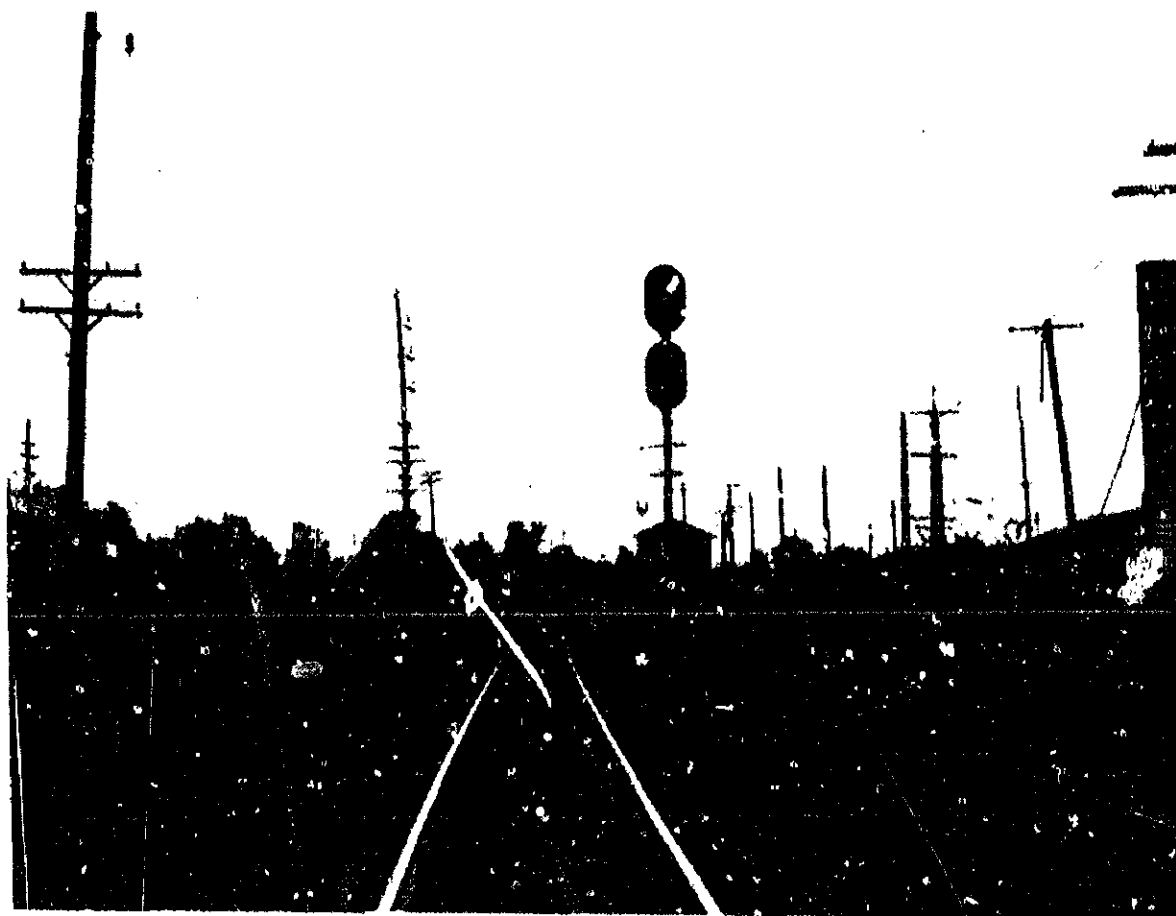
Figure 1.--View from southbound train approaching the home signal and tower at Iles. Iles Avenue crossing is beyond the tower.

The most critical event that preceded the accident was the failure of No. 21's engineer and fireman to observe and comprehend the aspect displayed by the home signal at Iles Tower. This aspect should have indicated to them the route their train was to take at K. C. Junction. Had the signal displayed a green-over-red "clear" aspect to take the straight route, as they supposed, they could pass through K. C. Junction as fast as 79 mph. However, if the signal displayed a yellow-over-green "approach limited" aspect, the train's speed would have to be reduced to 10 mph to permit entering the turnout to track No. 2.

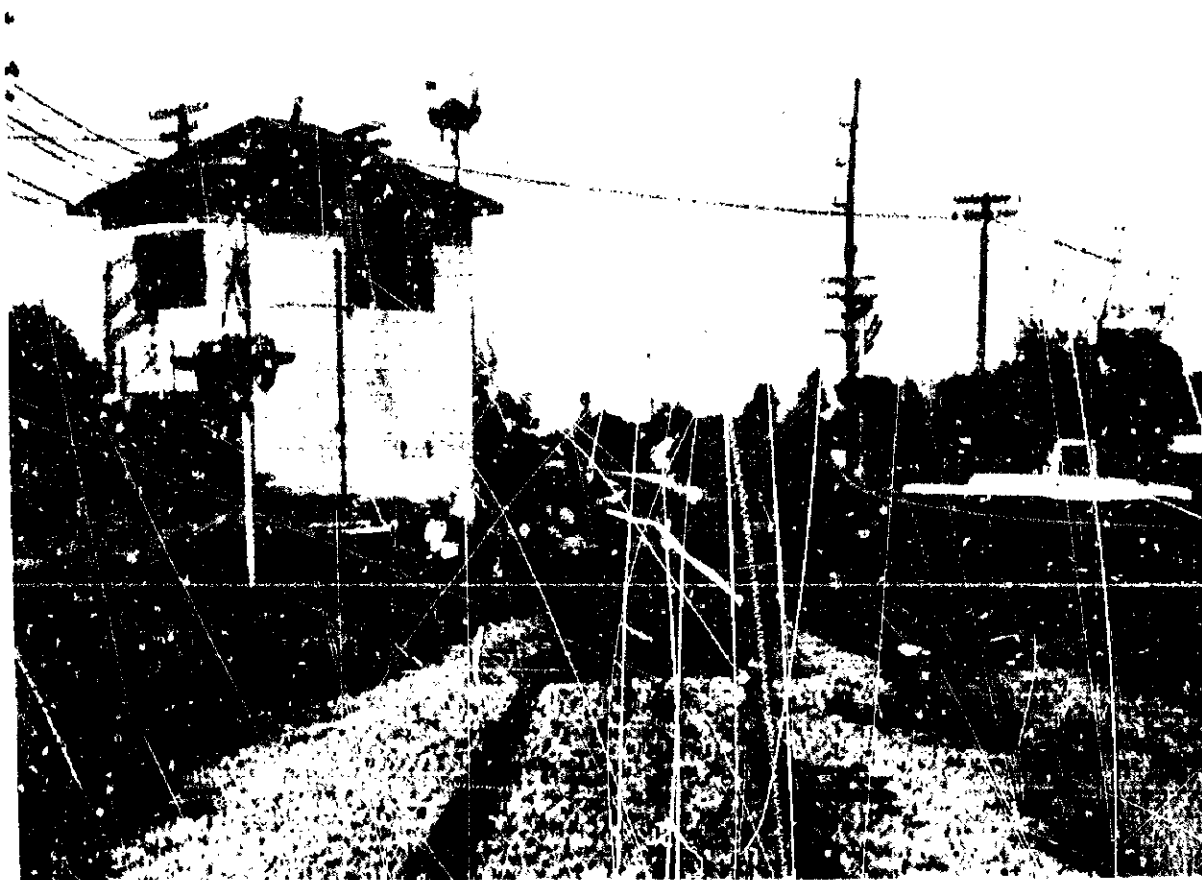
On October 31, 1980, Safety Board investigators observed traffic over the Iles Avenue crossing between 8:00 p.m. and 9:00 p.m. During this period, the flow of vehicles was virtually constant in both directions with traffic frequently stopping on the crossing due to congestion at intersections east and west of the crossing. Subsequent observations revealed that many motorists ignored the flashers and bell as well as the warning whistles of trains approaching the crossing. (See figure 2.)

Figure 2.--Alton Division main track viewed facing north, showing southbound approach to N&W crossing and Iles Tower. Iles Avenue crossing is in the foreground.

16. Removal of the gates and realignment of the street tended to increase the hazardous nature of the Iles Avenue crossing and contributed to the potential distraction of southbound ICG engineers who needed to be concentrating on the signal aspects displayed at that location.

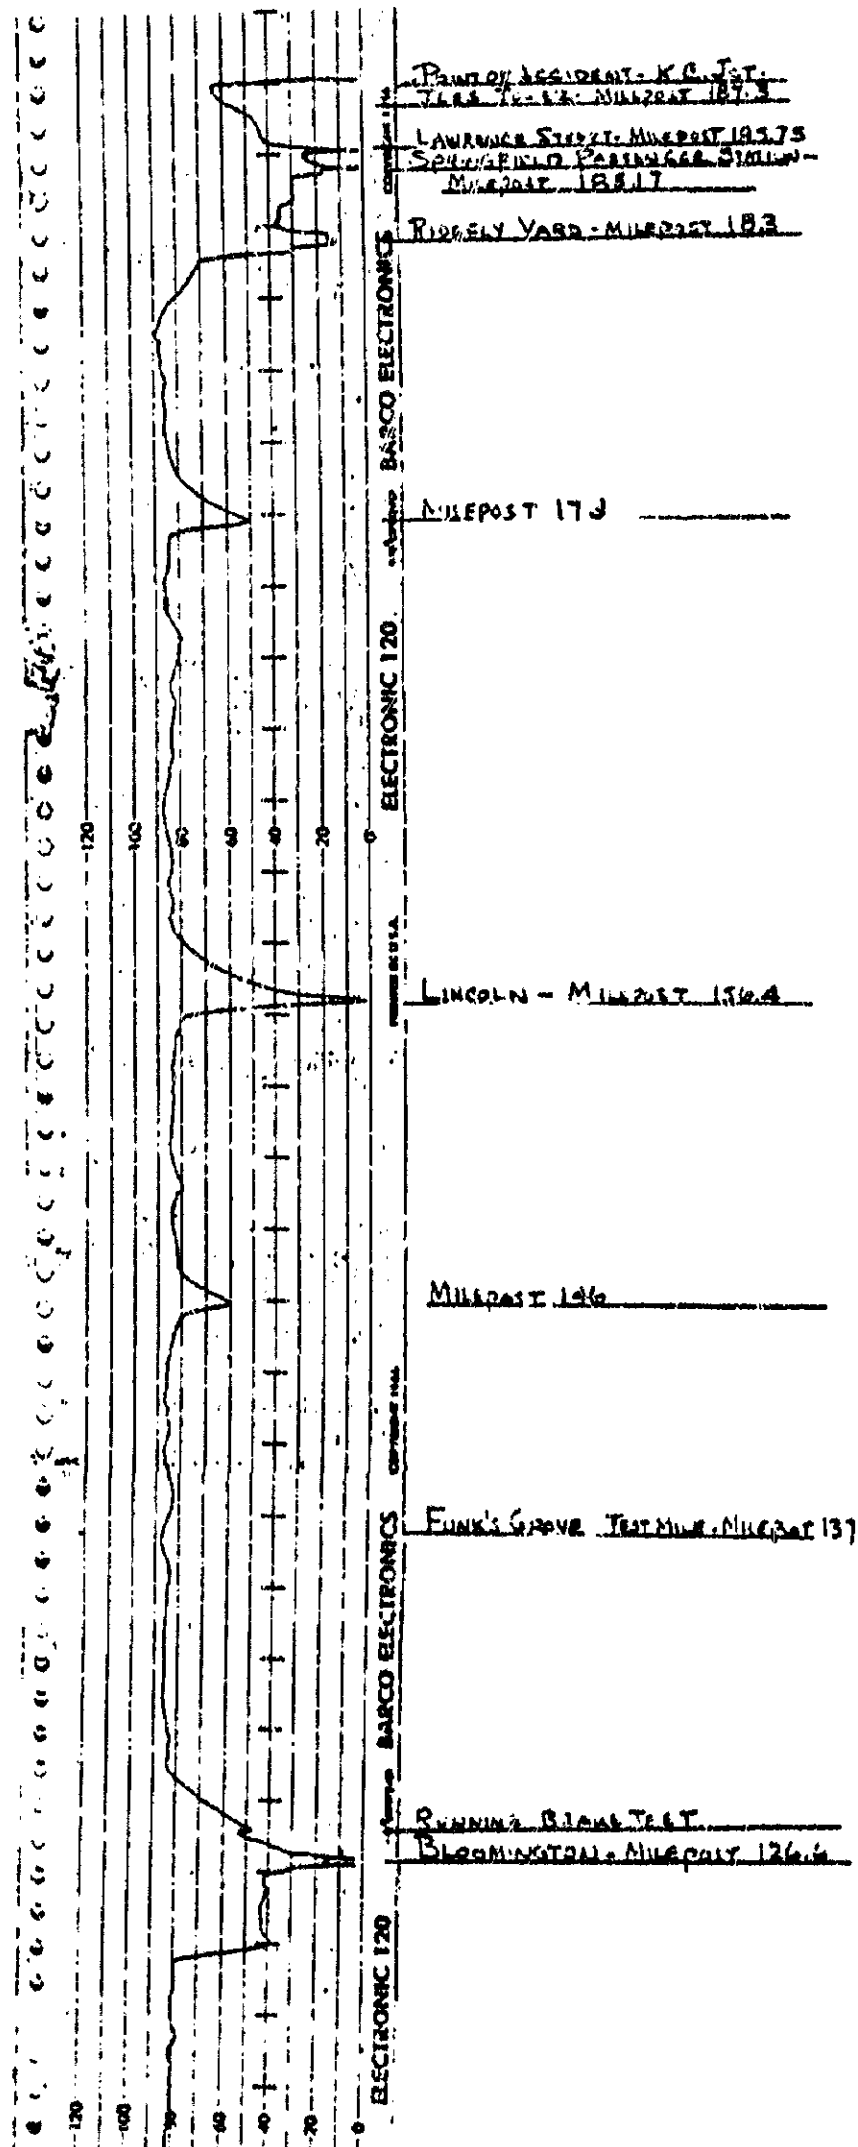
LOCOMOTIVE SPEED RECORDER TAPE REMOVED FROM AMTRAK NO. 21

Following the accident, the speed recorder and speed indicator were calibrated on the basis of an actual wheel diameter of 39.31 inches. It was disclosed that speed was recorded at a rate 2 mph greater than actual speed up to 70 mph; 1 mph greater than actual speed from 80 to 95 mph; and at the correct rate at 100 mph. It was also found that speed was indicated at a rate of 1 to 1 1/2 mph slower than actual speed at virtually all speeds. When the train was traveling at an actual speed of 80 mph, the needle of the speed indicator would be at 79 mph and the speed being recorded on the tape would be 81 mph.
