RAILROAD ACCIDENT REPORT

**DERAILMENT OF AMTRAK TRAIN NO. 97
ON SEABOARD COAST LINE RAILROAD TRACK
LOCHLOOSA, FLORIDA
MAY 26, 1981**

NTSB-RAR-81-9

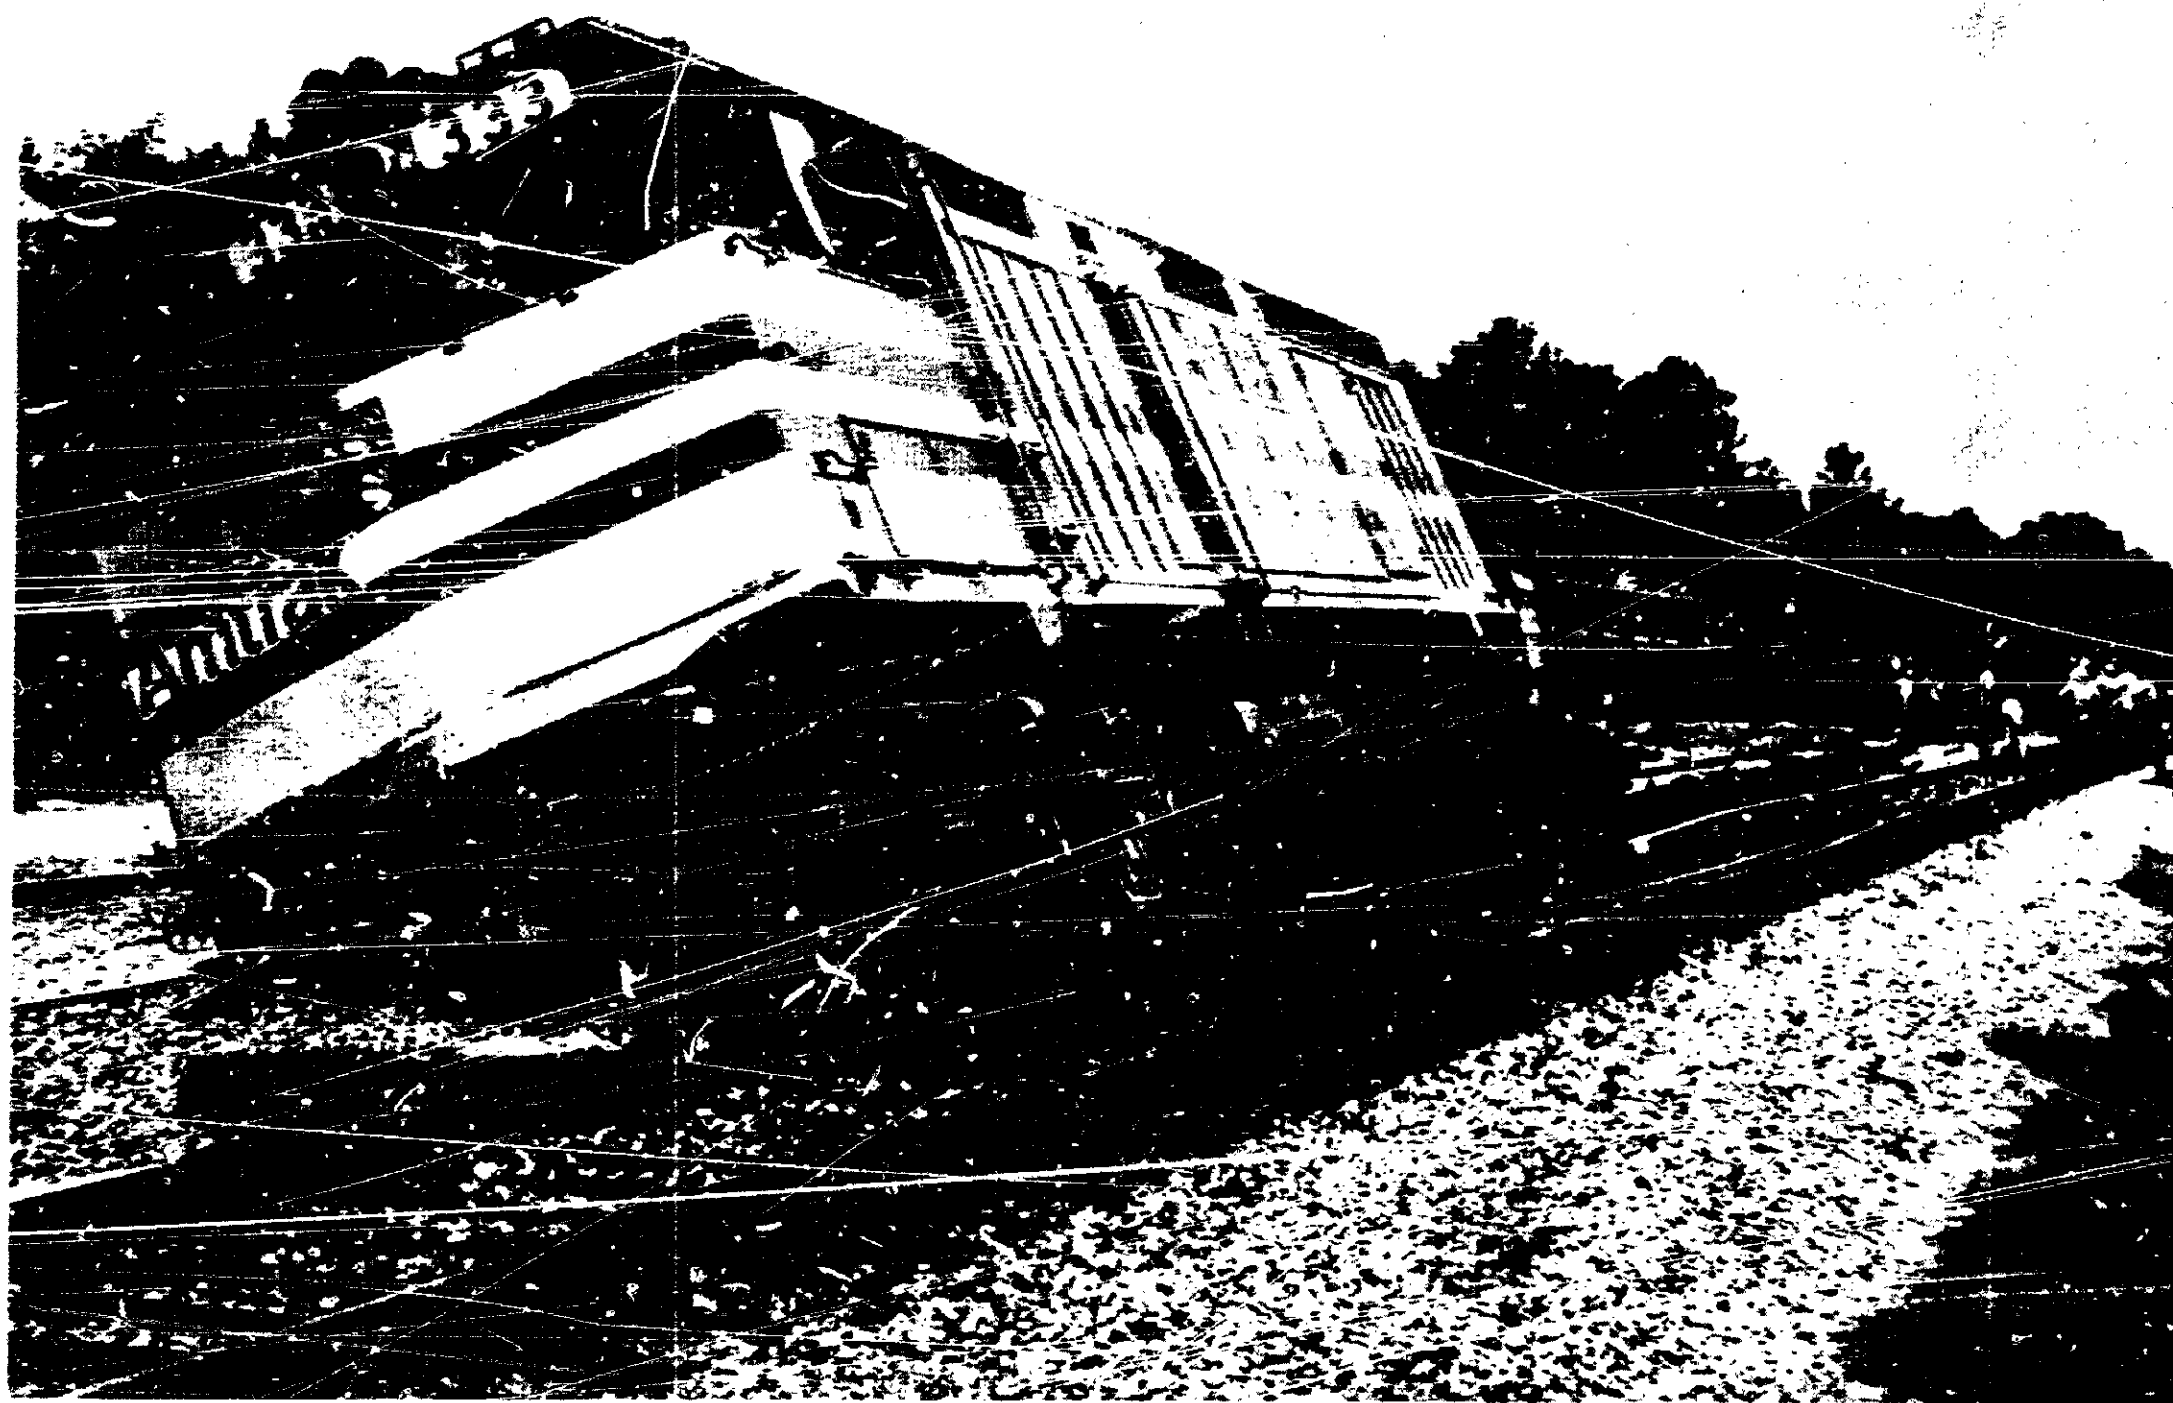
As the train accelerated, the home signal for the north switch of the Lochloosa siding continued to display a "clear" aspect. When the train was about 250 feet from the right-hand facing point switch, the engineer observed that the west switch point was not properly closed against the rail as needed for the main track route indicated by the signal aspect. He immediately instructed the fireman to brace himself and initiated an emergency application of the train's air brakes with the automatic brake valve. The train was moving at a recorded 78 mph. (See appendix C.) When the locomotive passed through the improperly aligned switch, it derailed to the right between two tracks and remained upright. The cars in the train followed the locomotive and derailed, but they also remained upright, coupled, and approximately in line with the track structure. There was no fire. (See figure 1.)

Figure 1.—Derailed locomotive and cars of train No. 97.

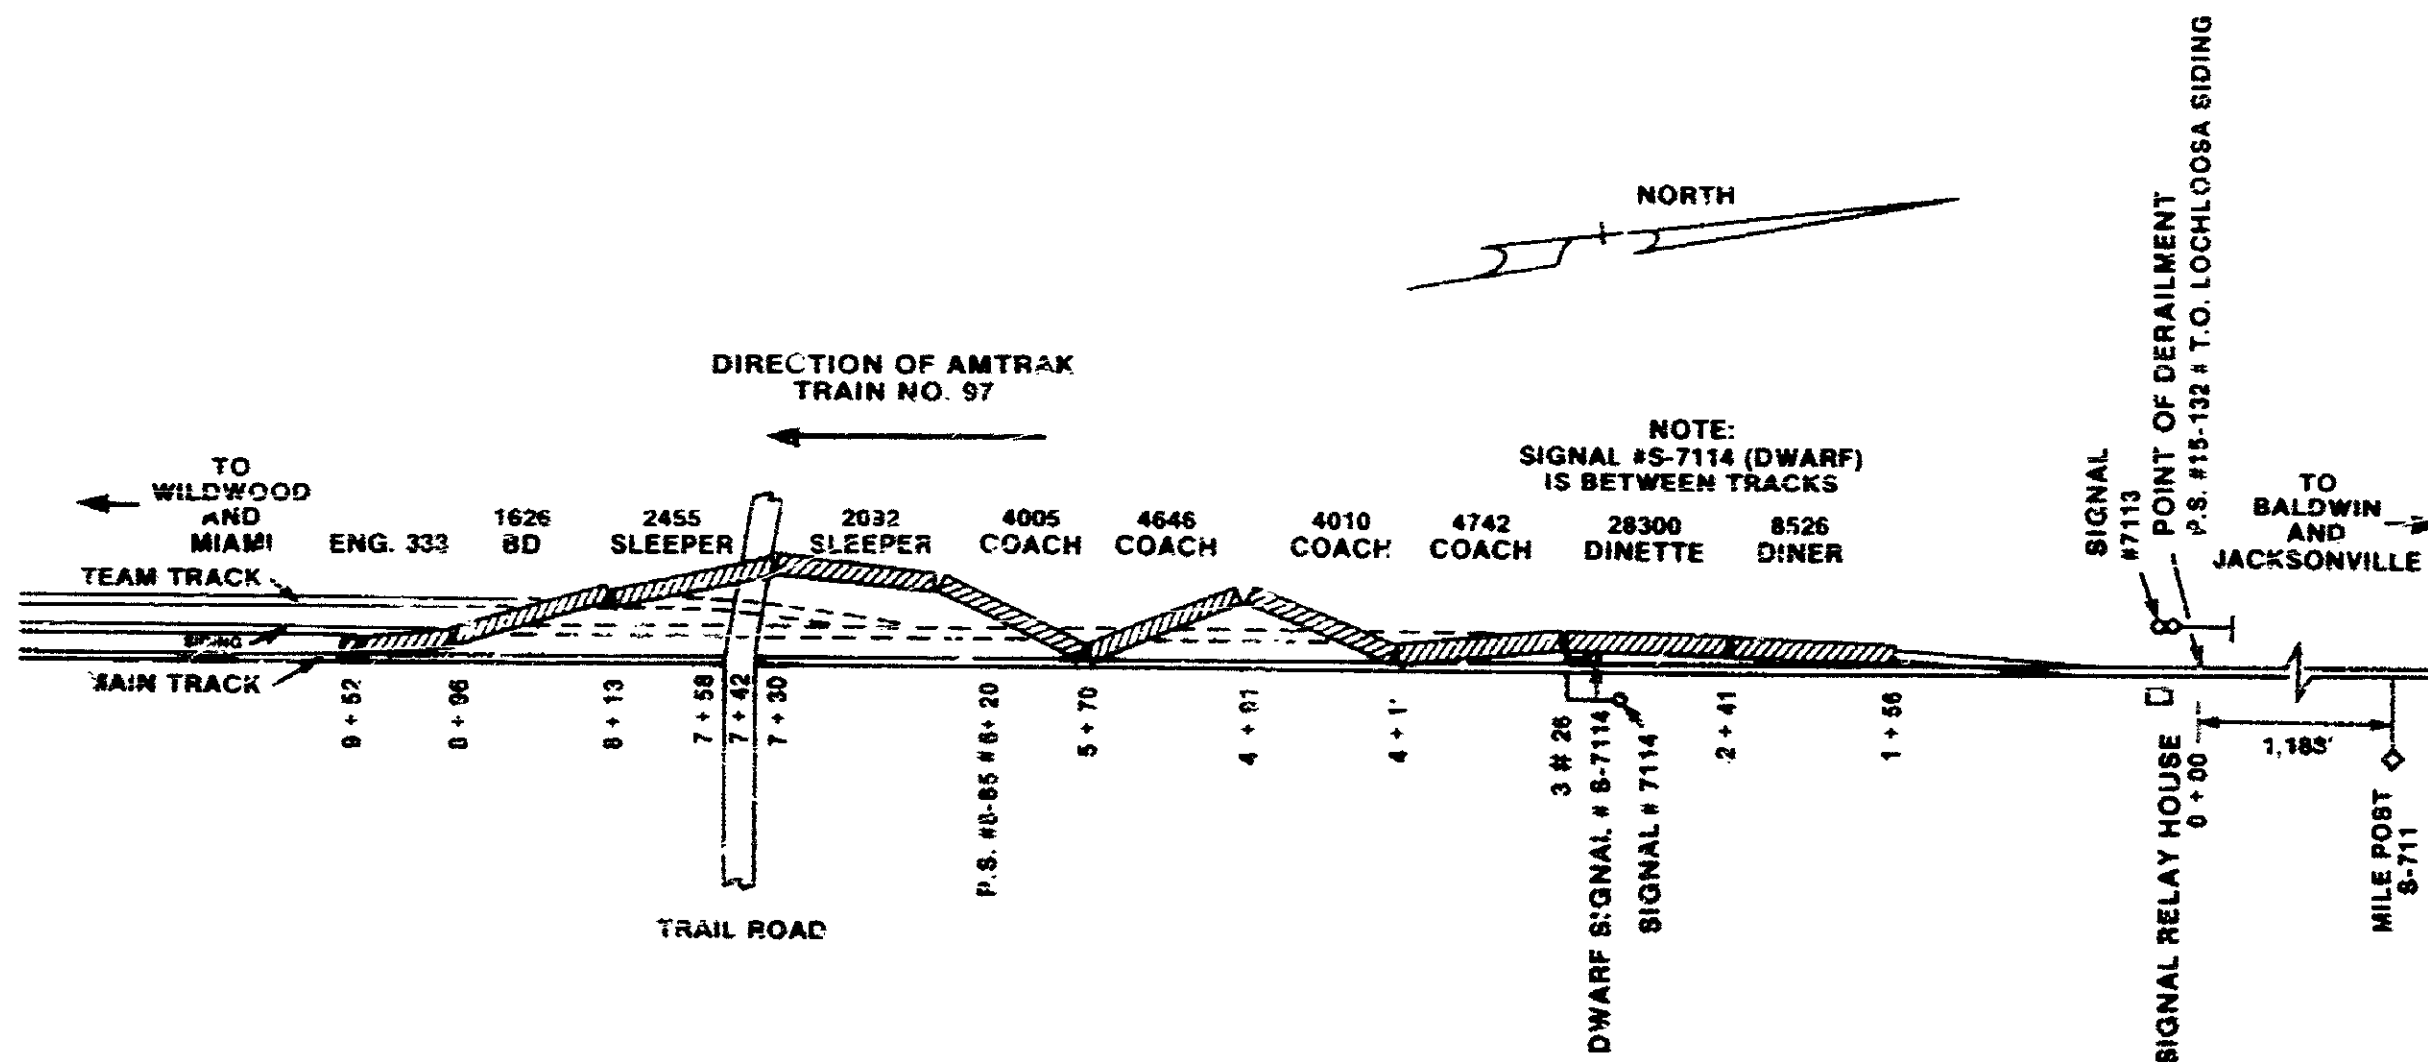
The entire consist of train No. 97 derailed except for the wheels on the trailing truck of the last car, but the train remained upright. (See figure 2.) The locomotive sustained damage to the trucks, fuel tank, and snowplow pilot. The locomotive's trailing truck became disengaged from the car body during the derailment. Damage incurred by the cars was limited to trucks and equipment under the car bodies, except for the fourth and fifth cars which sustained cornerpost damage when they began to jackknife before stopping.

Figure 2.--Plan view of accident site.
