RAILROAD ACCIDENT REPORT

REAR-END COLLISION OF
NEW YORK CITY TRANSIT AUTHORITY
SUBWAY TRAINS 142NL AND 132NL
BROOKLYN, NEW YORK
JULY 3, 1981

NTSB-RAR-82-2

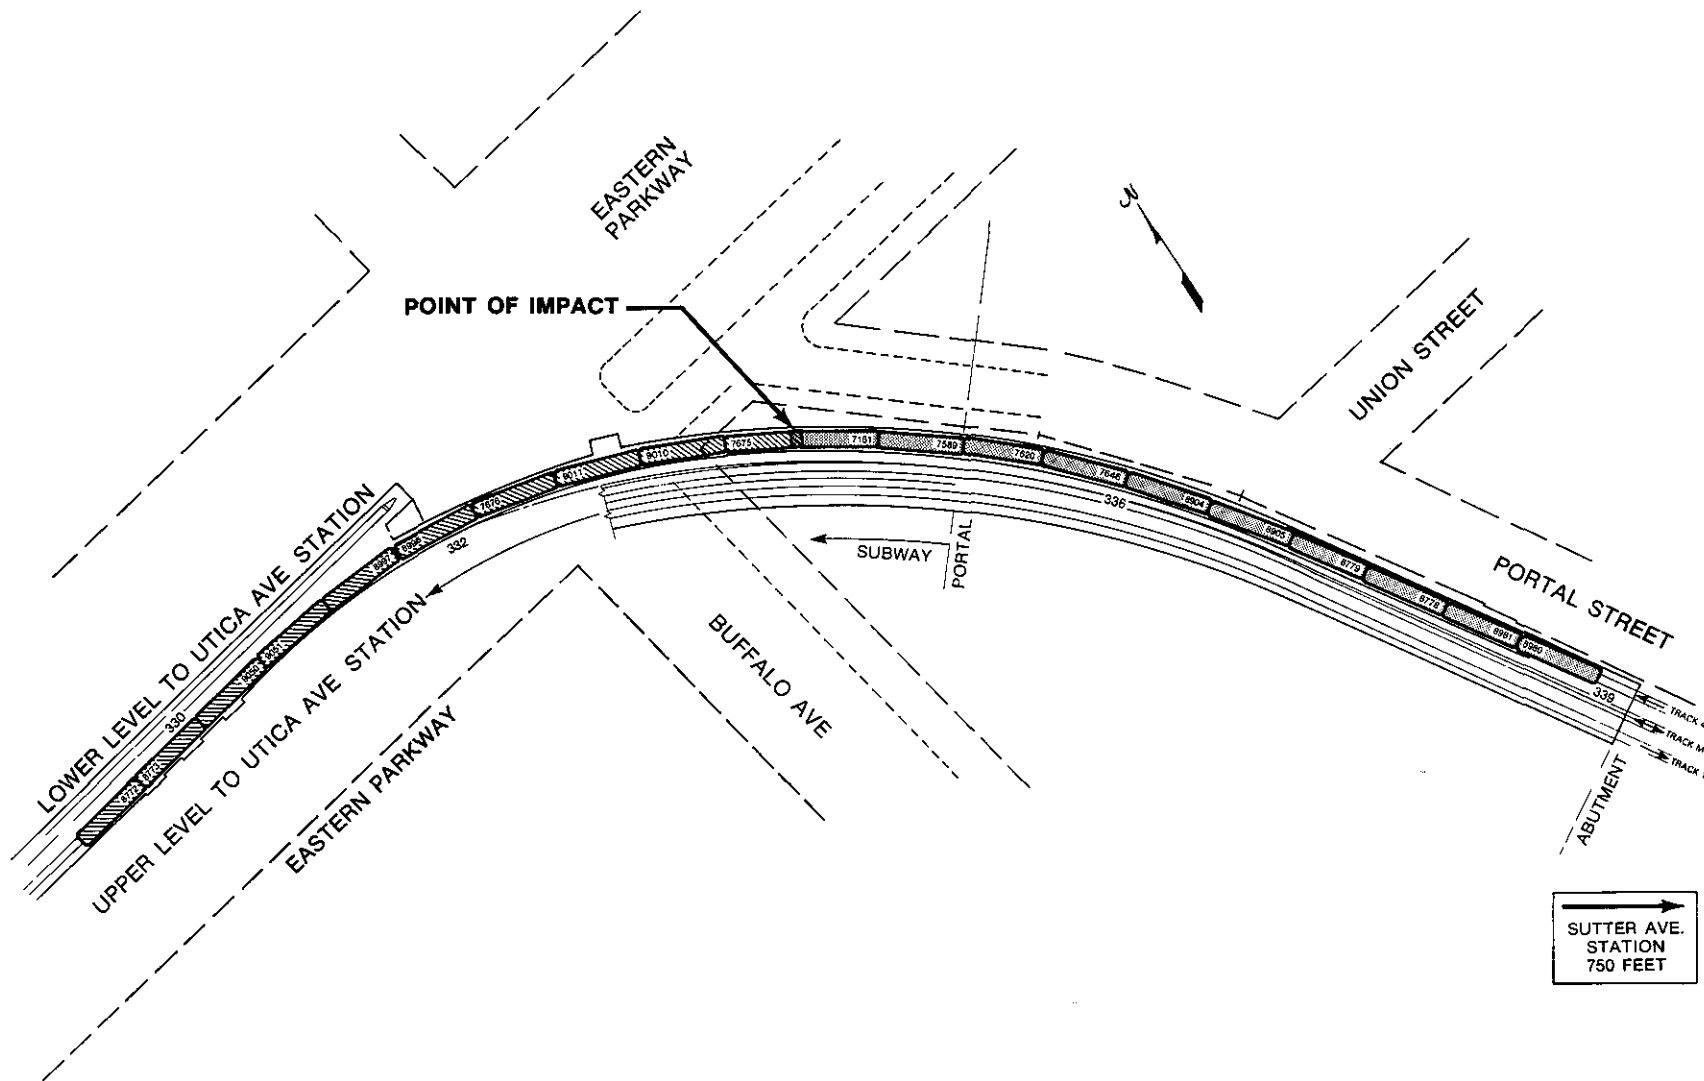
Figure 2.--Plan view of accident site.

The motorman could see the rear of train 122NL ahead, which was also stopped. The rear of train 132NL was 88 feet inside the tunnel entrance. The command center train dispatcher broadcast on the radio at 1:37 p.m., "Hello motormen all trains, 122NL, 132NL, stop and stay in stations where you are please, we have signal trouble until further notice." At 1:41 p.m., the trainmaster at the command center announced by radio:

The New Lots extension is on an elevated structure that extends from New Lots Avenue to the portal of the subway tunnel 1,100 feet north of the Sutter Avenue Station. There are six stations in the 2 1/3 miles from the New Lots Avenue Station to the tunnel portal. A northbound train leaving the Sutter Avenue Station descends from the elevated structure and while approaching the tunnel portal enters a 9°52' right-hand curve, and then enters the tunnel on a 9°22' left-hand curve. The collision occurred in the tunnel on the 9°22' left-hand curve. (See figure 2.)

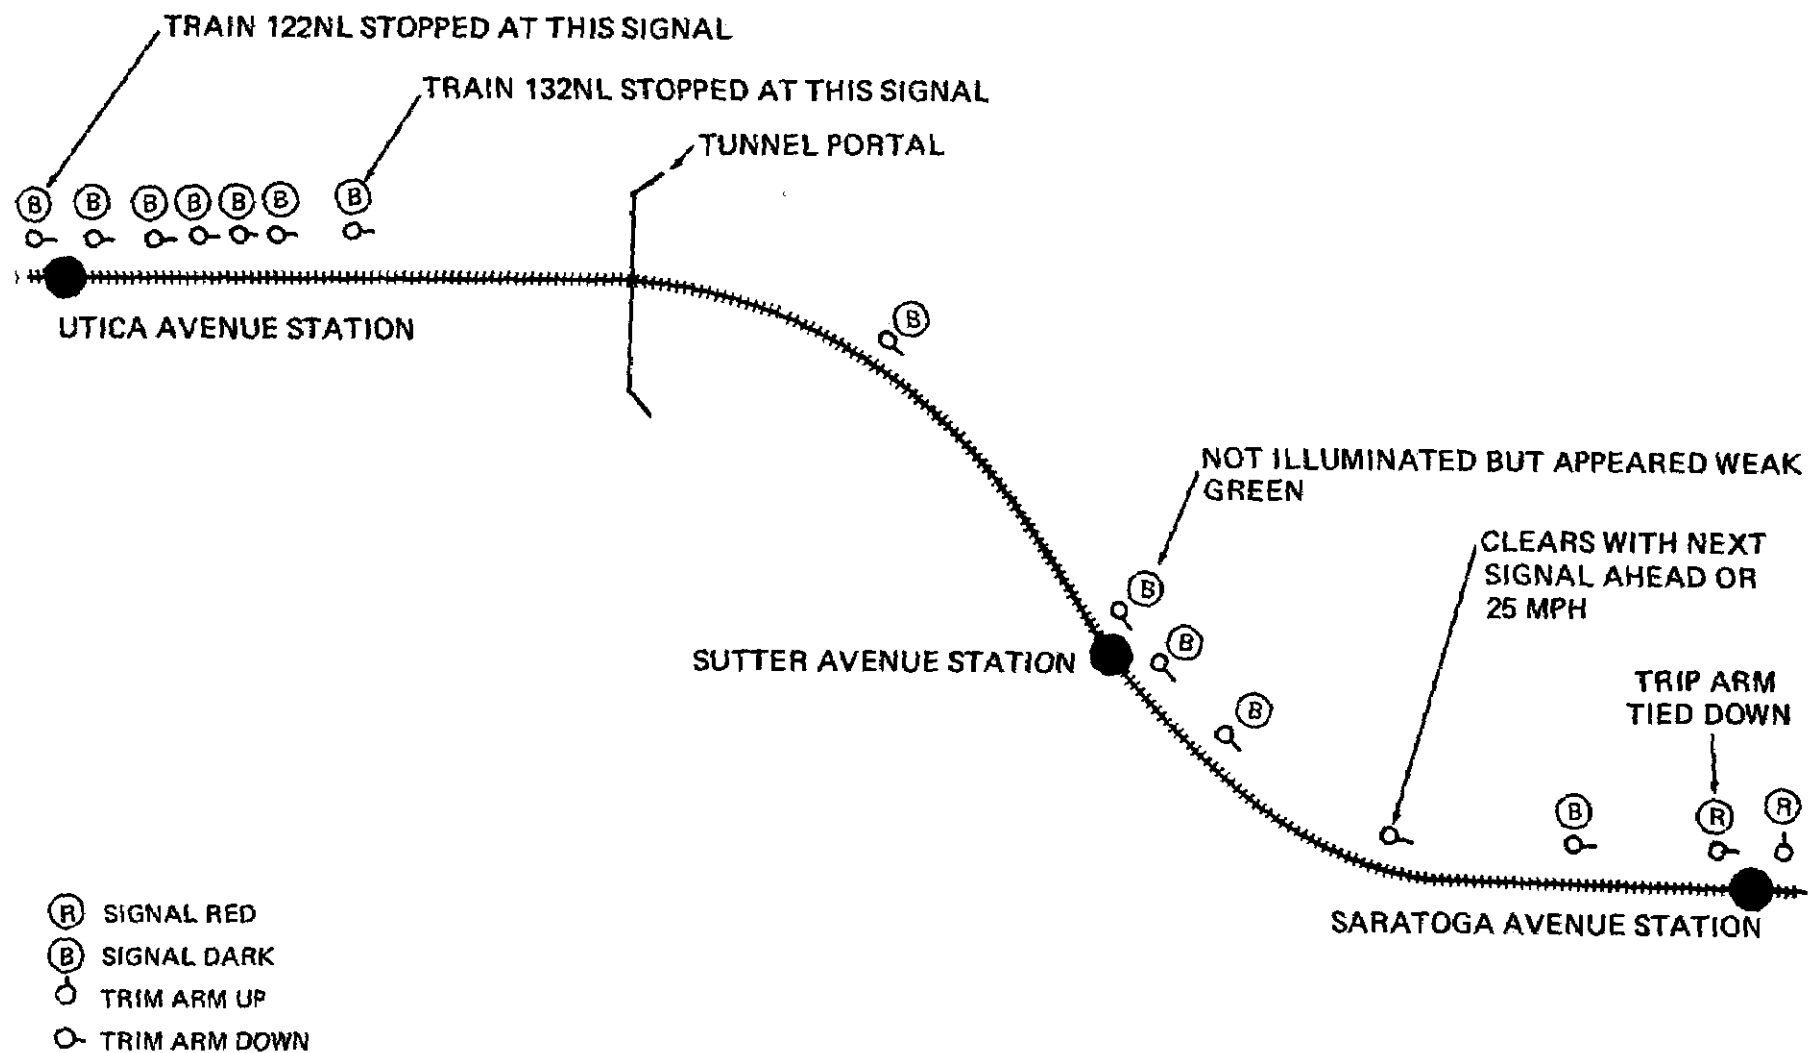
Figure 3.—Display of signals and position of trip arms as train 142NL was traveling from Saratoga Avenue Station.

A postaccident inspection by NYCTA personnel revealed that the signals were dark from the Saratoga Avenue Station to Nostrand Avenue. They did note that the signal on the north end of the Sutter Avenue Station appeared to be displaying a dim green indication. The signal was opened and the lamp was found to be not illuminated. It was determined that the green lens was reflecting sunlight. Subsequent to the accident the NYCTA signal department applied a longer sunshield to this signal. This postaccident inspection also found that the trip arm at the north end of the Saratoga Avenue Station was tied down.

Train 142NL was flagged through the red signals at Saratoga Avenue by an employee of the signal department, and because the trip arm on the north end of the station was tied down and because of the dark signals from the Saratoga Avenue Station to the point of collision, it was not necessary for the motorman to stop the train at each dark signal to cause the trip arm to fall into the nontripping position. In fact, the motorman may have believed that the block ahead was clear because the trip arm was in the down position and the signal at the north end of the Sutter Avenue Station appeared to be green. He also may have thought that the trip arm had been put down by signal department employees to indicate that the track ahead was clear. Since none of the operating employees involved in this accident, including command center personnel, understood that the trip arms did not rise automatically to the up or stop position when signals failed in this area, it is doubtful that the motorman of train 142NL understood that fact. It is also unlikely that he heard the communications from trains 122NL and 132NL to the command center concerning their being stopped because of dark signals, since he would have been boarding his train at the New Lots Avenue Station about that time. He may have heard only the radio transmission from the command center trainmaster to key by automatic signals and to use extreme caution. All these circumstances may have led the motorman of train 142NL to believe that the track ahead was clear. After the train departed the Sutter Avenue Station and approached the tunnel entrance, the motorman must have assumed that the track was clear and failed to maintain a diligent lookout ahead.

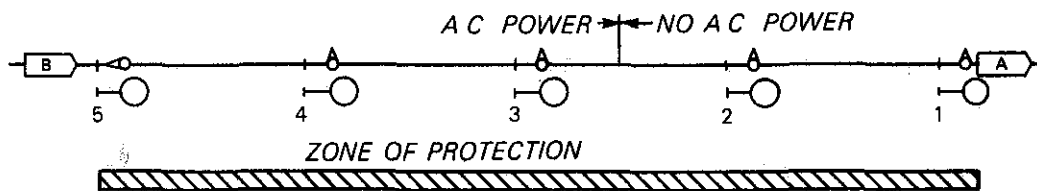
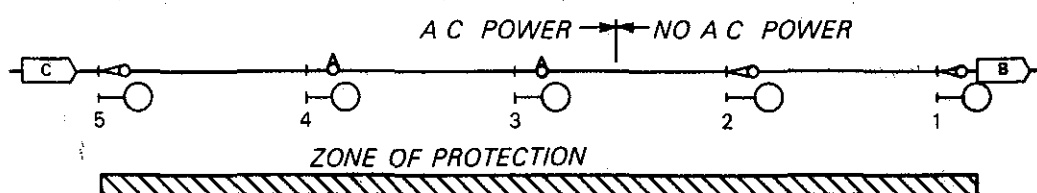
Figure 5.—Original IRT train control signal system and trip arm diagram.

The original IRT train control system was designed so that when a portion of the system became deenergized, the two signals immediately before the deenergized area would display red and the trip arms would raise. The third signal before the deenergized area would display yellow. In the deenergized portion, the signals would be dark, but the trip arms adjacent to the signals would not necessarily be in the raised position; rather they would remain in the position, either up or down, that they were in immediately before the loss of power. (See figure 5.) The modernized train control system, designated by the NYCTA as the prevalent TA train control, is used on the major portion of the NYCTA subway system. As portions of the original IRT train control system are replaced, the prevalent TA train control system is being installed. The prevalent TA train control system is similar to the original IRT train control system except that (1) when a portion of the system is deenergized, only the signal immediately before the deenergized portion is red--with the trip arm up, and (2) in the deenergized portion all the signal lights are dark and all the trip arms raise to the stop position. (See figure 6.) The signal color light aspects and signal indications are the same on the New Lots to White Plains Road line even though both the original IRT train control system and the prevalent TA train control system are used on various sections of this line.

Interviews with the train crewmembers and command center personnel indicated that they did not know that, because of the design of the original system, it was possible that all trip arms in the area of the accident would not move to the up or stop position when the signals were deenergized. The NYCTA engineering department is aware of the differences in the two systems and has an ongoing modernization plan to replace the original IRT system. The NYCTA superintendent of signals testified on August 5, 1981, at the public hearing held in connection with this accident that the portion of the New Lots line from New Lots Station to Sutter Avenue Station is being modernized and the work should be completed in 1983. He also said that the new signal system for the portion of the New Lots line where this accident occurred was in the design stages, and that he believed funding would be requested in the fiscal year 1983 capital budget. If this occurred, the work could begin in 1983. The modernization program described at the public hearing indicates that the northern portion of the line from 180th Street through the White Plains area would be planned for completion in the year 2001 or 2002.

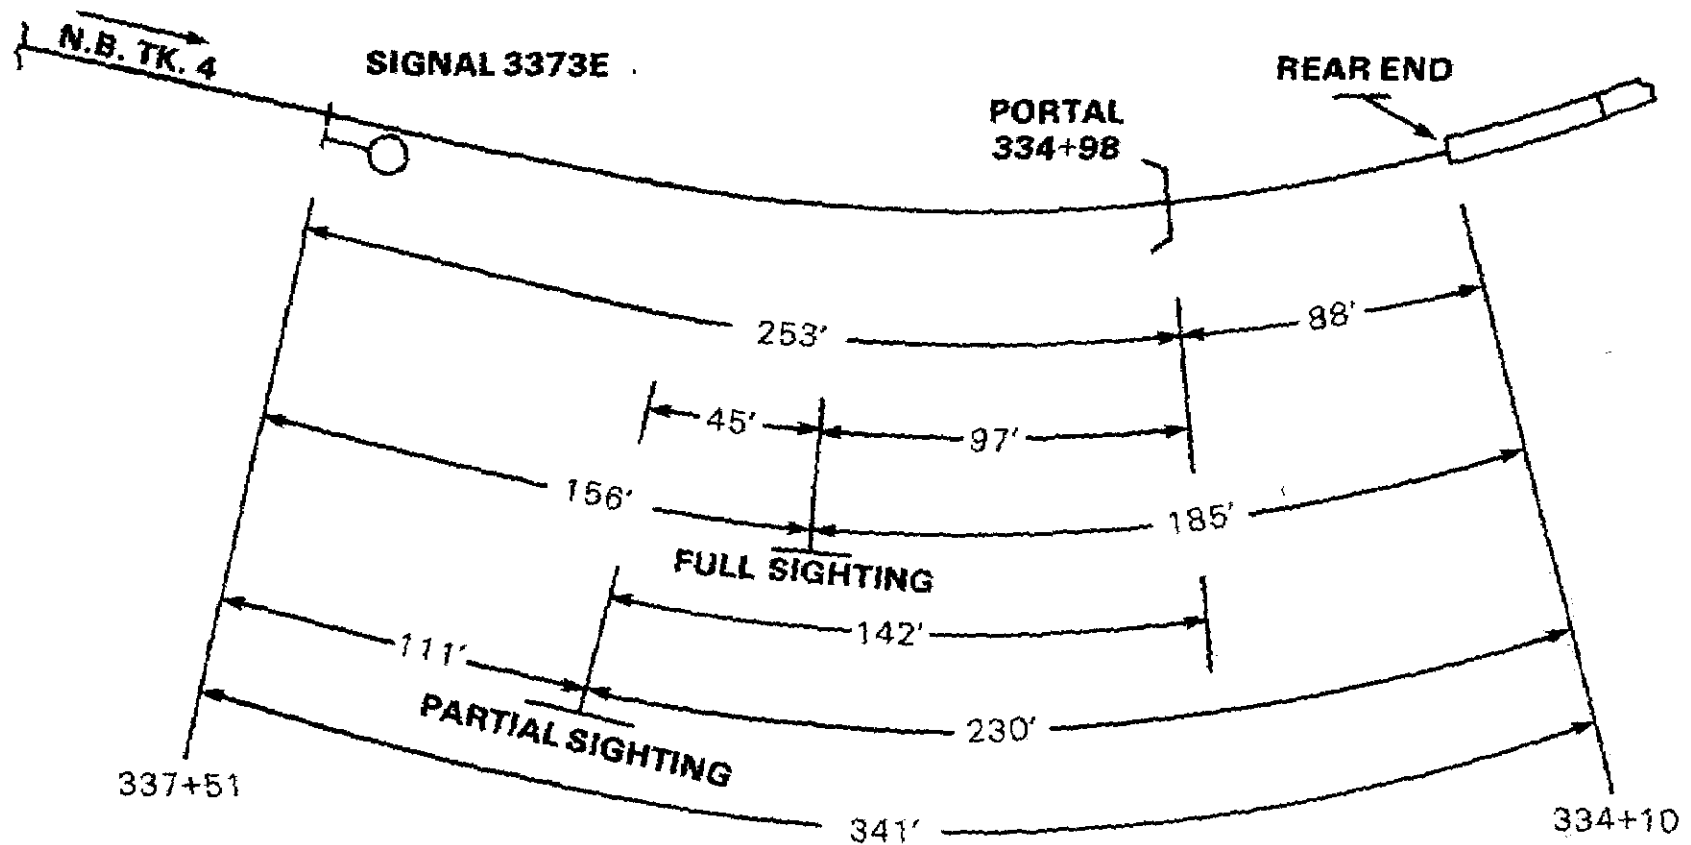
APPENDIX C
SIGHT DISTANCE TEST RESULTS

On July 11, 1981, a test train was assembled for a test run to observe site conditions and stopping distances. The weather on the day the test train was operated was bright and sunny as compared to a light overcast on the day of the accident. The train proceeded on the schedule of train 142NL. The preceding train was stopped at the location train 132NL had been struck, and its left rear light was turned off. The signals were deenergized from the Saratoga Avenue Station to Nostrand Avenue. The motorman of the test train was instructed to proceed, to "key by" all automatic signals, and to stop when he first sighted the standing train ahead. After leaving the Sutter Avenue Station, the motorman operated the test train at a speed of approximately 5 mph and brought his train to a stop when he sighted the stopped train ahead. The last car of the stopped train first became identifiable to the motorman of the test train when he had closed to a distance of 185 feet and was able to see the lights of the car in the dark tunnel, at which time he brought the train to a stop in 20 feet. (See appendix C.) After the test train stopped, observers walked back to a point 230 feet to the rear of train 132NL, from where they could see partially the right corner of the last car.

As the train descended from the elevated section toward the tunnel, and came to the point where the train ahead would have become identifiable at 185 feet as indicated in the test at 5.0 mph, the motorman of train 142NL moving at 12.7 mph would have had 9.9 seconds to respond to the emergency. Because he did not react and apply the brakes, he must have been distracted. Because he had been observed by the signal foreman with his head out of the side window of the cab and it was a warm day, he simply may have been attempting to cool off. Also, he may have been looking out to observe the cars in his train if he suspected something was wrong with the equipment. But for whatever reason, it is apparent from the lack of any braking or slowing of train 142NL that the motorman was not looking ahead to observe conditions as required by NYCTA rules.
