SIDE COLLISION AND DERAILMENT OF
NORFOLK & WESTERN RAILWAY
COMPANY TRAINS NOS. 6BS78,
YARD SHIFTER, & 67HNP,
CREWE, VIRGINIA
NOVEMBER 28, 1981

NTSB-RAR-82-3

1. Report No. NTSB-RAR-82-3.	2. Government Accession No PB82-916303	3. Recipient's Catalog No.	
4. Title and Subtitle Railroad Accident Report--Side Collision and Derailment of Norfolk & Western Railway Company Trains Nos. 6BS78, Yard Shifter, and 67HNP, Crewe, Virginia, November 28, 1981		5. Report Date May 18, 1982	6. Performing Organization Code

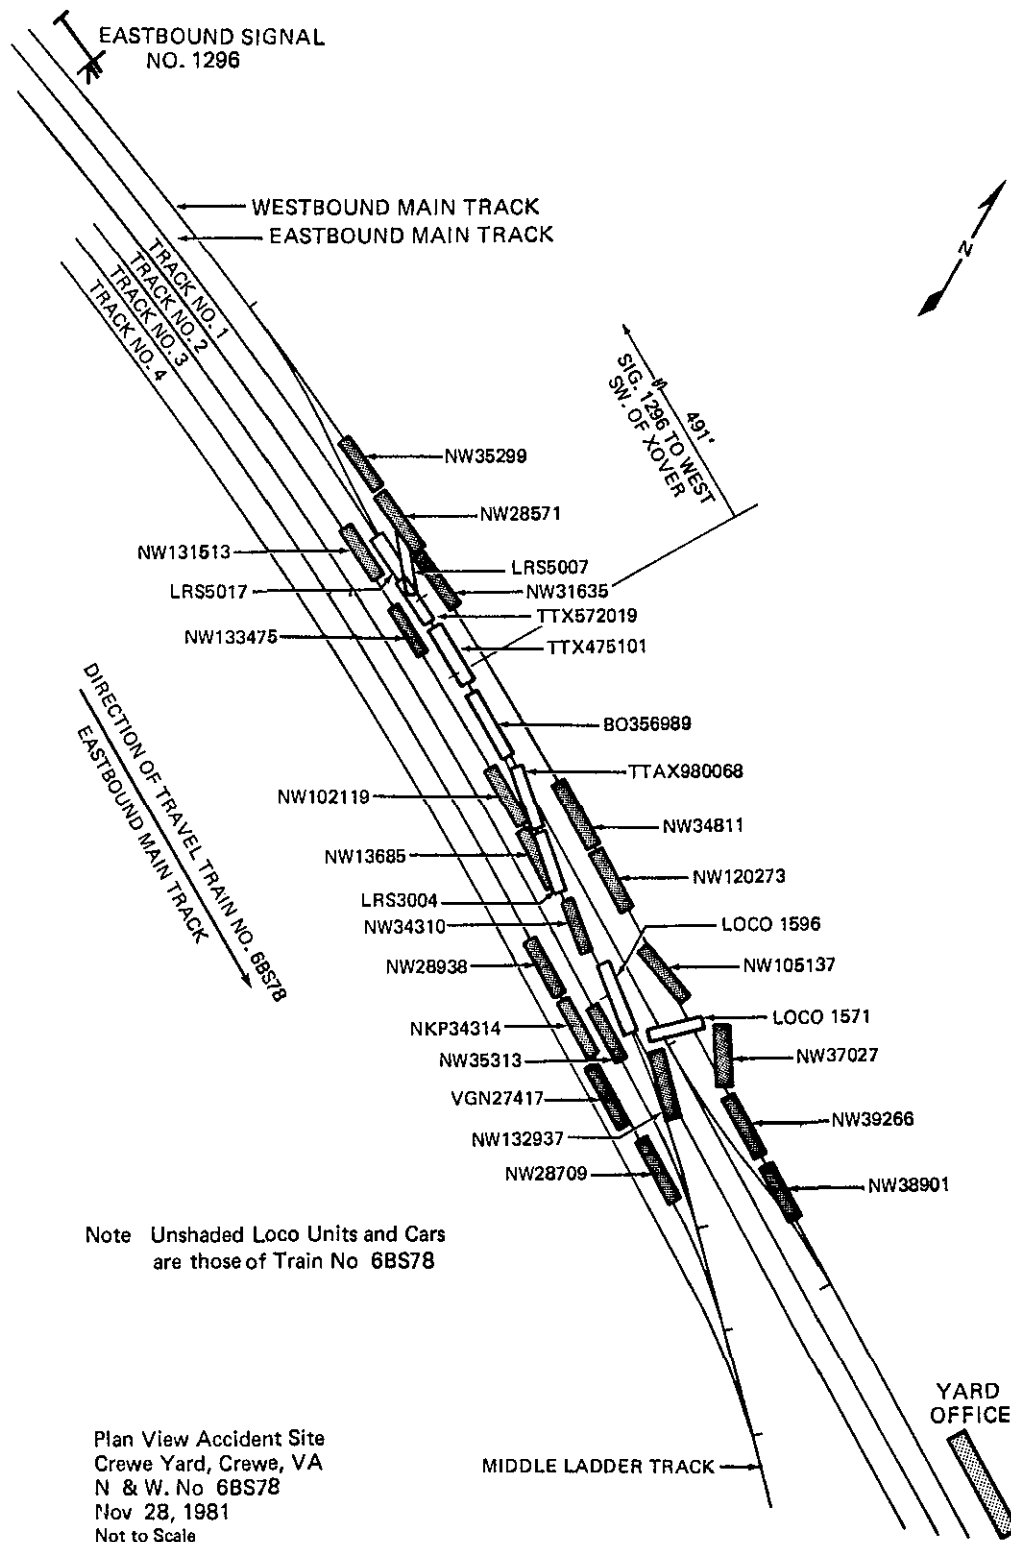
Figure 2.--Plan view of accident site at the Crewe yard.

Shortly before 8:20 a.m., train No. 6BS78 was arriving at the Crewe yard on the eastbound main track. The 3,345-ton train, consisting of 2 locomotive units, 29 loaded and 35 empty cars, and a caboose was equipped with a two-way radio. The engineer radioed the yardmaster and received permission to pass the green (clear) eastbound signal No. 1304 at the west end of the yard. Timetable instructions require all eastbound trains entering Crewe yard limits to contact the yardmaster and receive permission to proceed. The engineer and front brakeman testified that they called out the signal indications to each other as required by the carrier's operating rules. They also called out the green (clear) indication on the eastbound signal No. 1296. As the train approached the crossover from the eastbound main track to yard track No. 1, it was proceeding through a 2-degree curve to the right. Because the engineer was preparing to stop the train for a change of crews, the speed of the train had been reduced from about 45 miles per hour to about 27 miles per hour. The locomotive was equipped with a speed recording tape. (See appendix C.) The engineer and brakeman said that they observed the switch lined into yard track No. 1 when they were about one car length away from the switch and that they both applied the automatic air brake in emergency at the same time. They stated that they then lay on the floor because of the impending collision. The train entered the west switch of the crossover at about 27 miles per hour and was routed from the eastbound main track to yard track No. 1 where it collided with the coal hopper cars being handled by the yard shifter. No. 6BS78 then struck the empty hopper cars of train No. 67HNP on the westbound main track. The locomotive of train No. 6BS78 derailed and jackknifed across the two main tracks. (See figure 2.) Four coal hopper cars on yard track No. 3 were also derailed by impact from the cars on yard track No. 1. The front brakeman on train No. 6BS78 and the conductor on train No. 67HNP received minor injuries as a result of the accident. Damage was estimated at \$690,305.

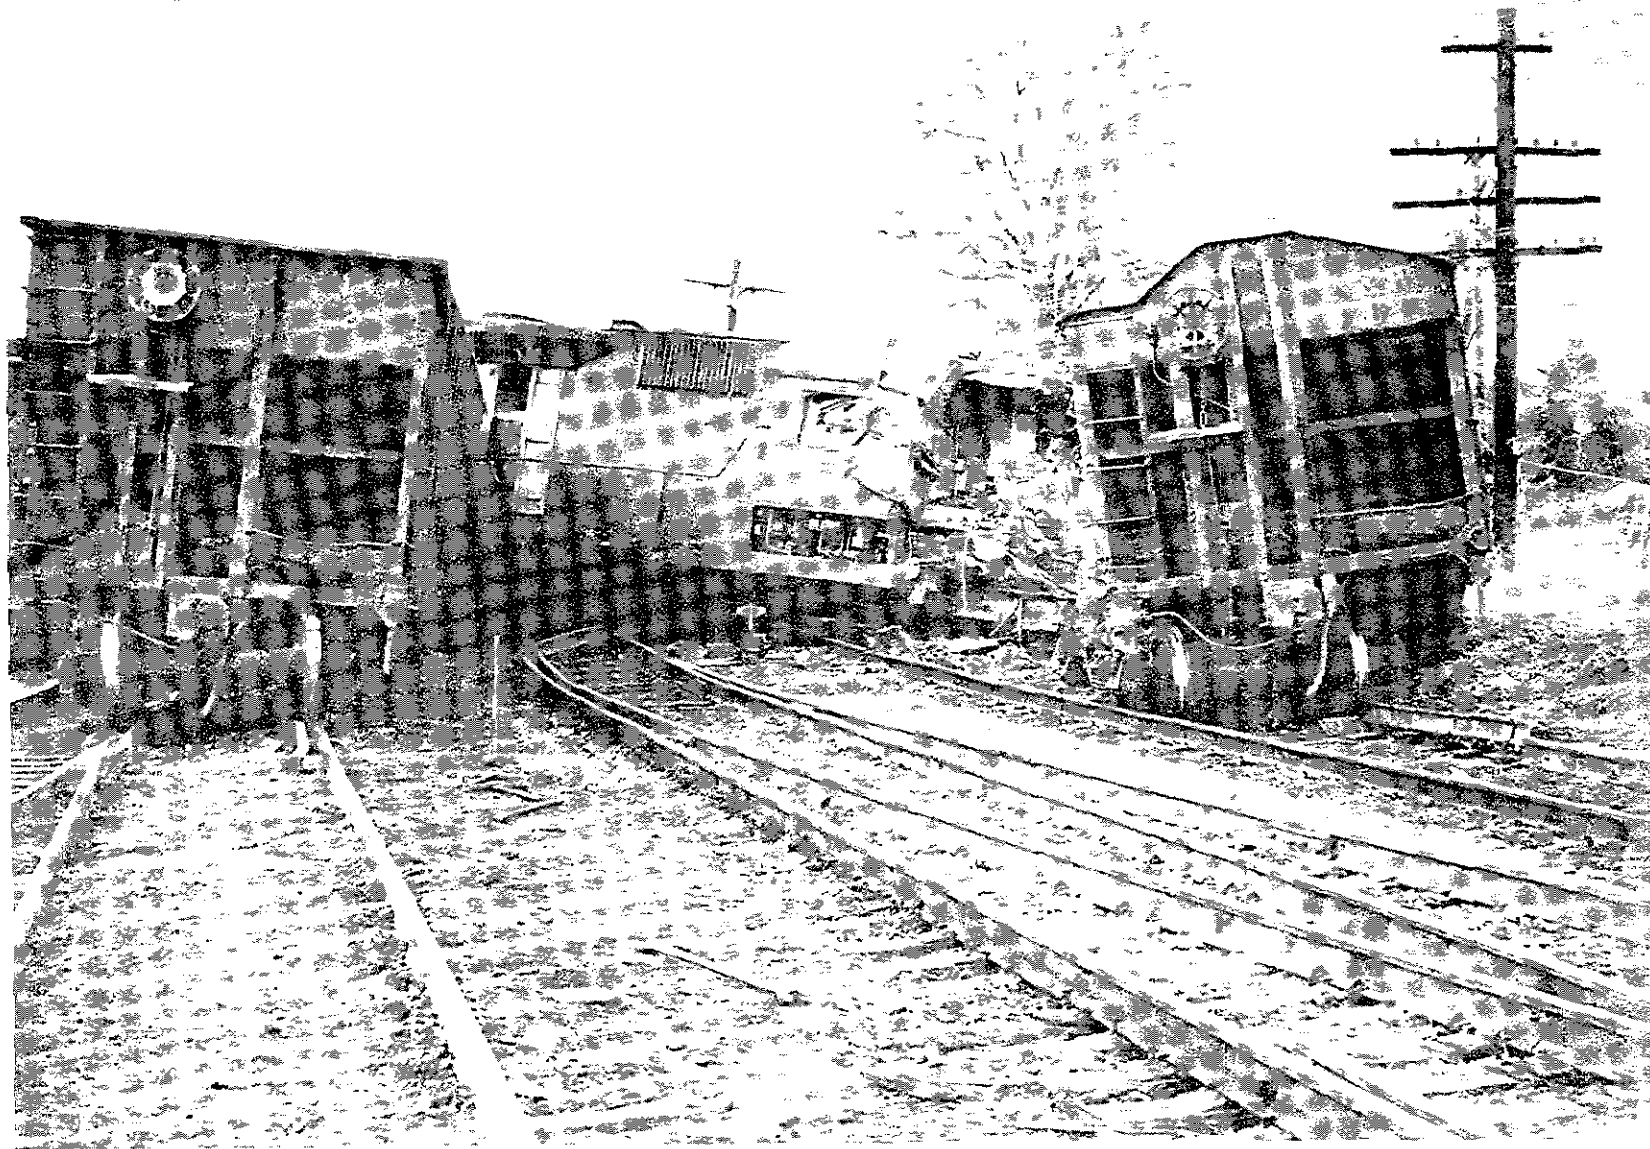
Figure 3.--Lead locomotive 1571.

The lead unit of train No. 6BS78, locomotive No. 1571, was damaged extensively. The short forward hood was demolished and the forward cab wall and the front right side of the cab were severely damaged. (See figure 3.) The front truck and fuel tanks and the underframe appurtenances were torn from the locomotive in the derailment. Locomotive No. 1571 was a model SD-35, 6-axle, 2,500-horsepower diesel-electric locomotive built by the Electro-Motive-Division (EMD) of General Motors. The locomotive unit weighed about 393,000 pounds and was equipped with type 26-L air brakes. The second locomotive unit, No. 1596, was damaged less severely and received only minor damages. Although the fuel tanks of both units were ruptured, there was no fire. The second locomotive unit of train No. 6BS78 was a model SD-40, 6-axle, 3,000-horsepower diesel-electric locomotive, also built by EMD. The unit weighed approximately 392,000 pounds and was equipped with type 26-L air brakes.

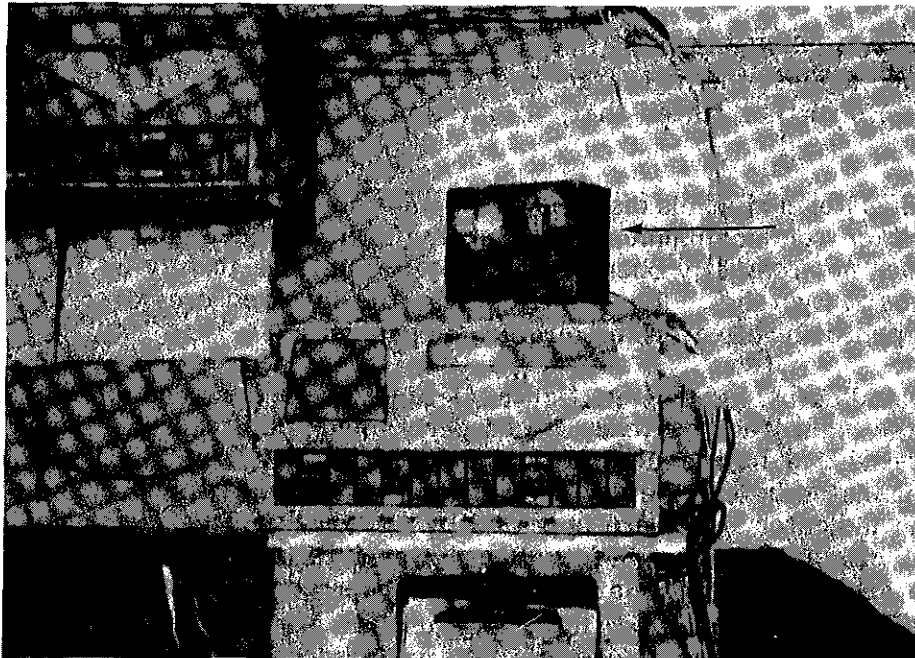
Figure 4.--Indicator lights in yardmaster's office.

Position indicator lights (see figure 4) located in the yard office are used to determine if the main track switches are properly lined and if the track is occupied. The yardmaster stated that he recalled seeing that the indicator light for the eastbound main track was illuminated before the accident, indicating a vacant track and properly aligned switches. The indicator lights are operated by the track relay 1/ which is part of the signal control circuit. 2/ The Safety Board was informed that in the 30-day period preceding the accident, approximately 180 trains were operated on the eastbound main track through Crewe, Virginia.

The Safety Board believes that the potential false proceed condition existed for more than 3 months. The position indicator lights in the yardmaster's office did not disclose this potential false proceed condition. The indicator lights were connected to and reflected the indication of the automatic block signal. The broken shunt wires prevented the shunt of the misaligned switch from being imposed on the signal circuit.

10. Position indicator lights in the yardmaster's office were not effective in disclosing the false proceed condition.
11. Train No. 6BS78 was operated in accordance with applicable rules and regulations.

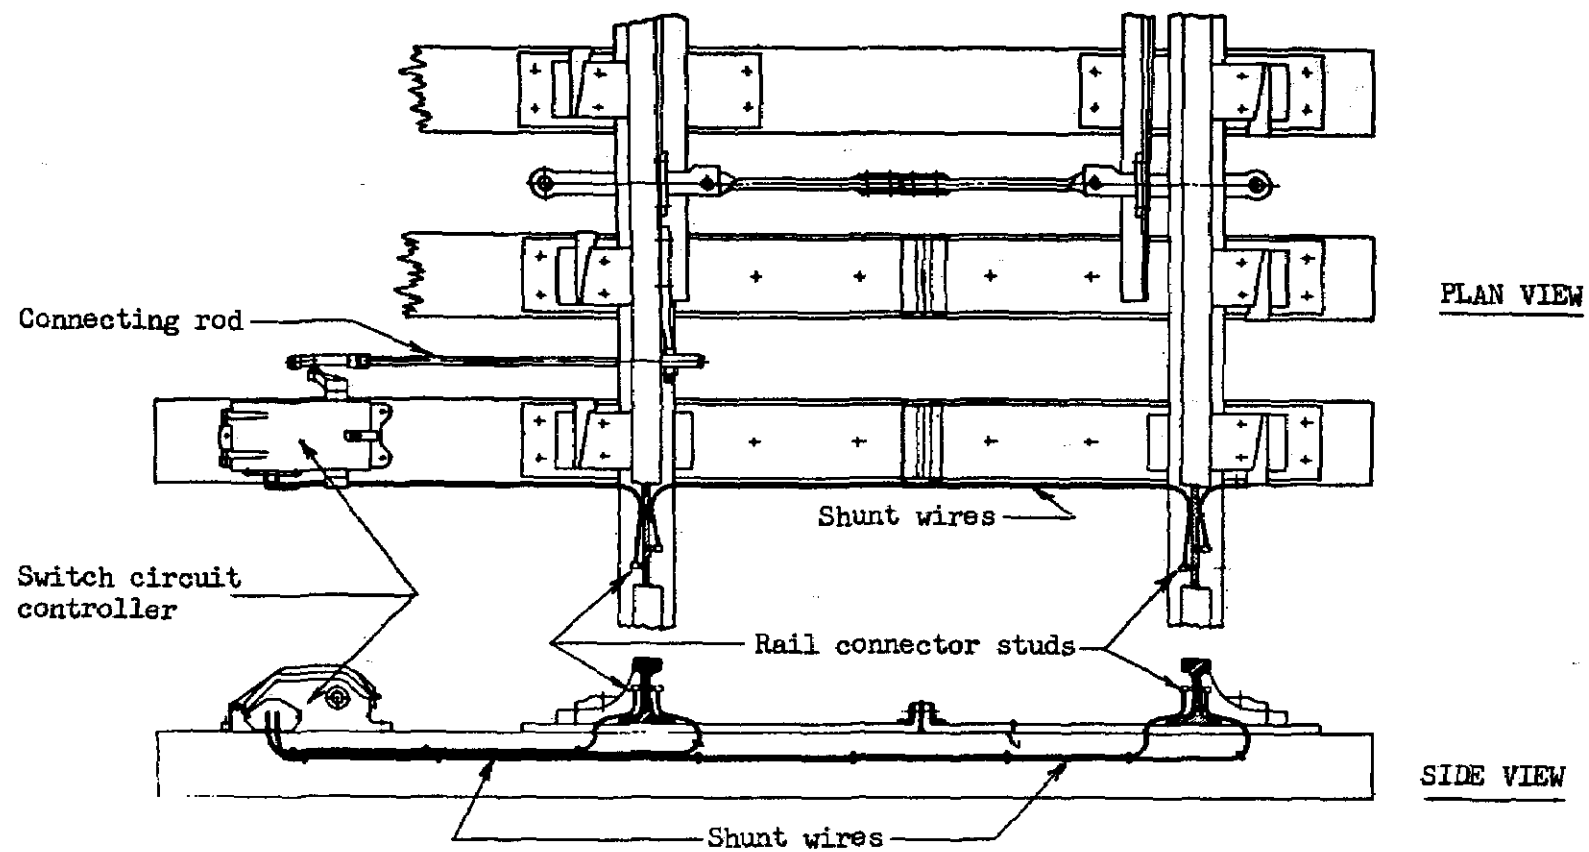
Figure 7.--Switch shunt installation.

A red (stop and proceed) aspect on signal No. 1296 is normally caused by the imposition of a shunt ^{4/} between the two rails of a track. A shunt can be imposed by the presence of a train or by a switch that is not completely closed in the normal position. A switch lined for a diverging move should result in a shunt circuit. The track shunt removes voltage from the track relay which in turn affects the signal circuit and causes the signal to display a red aspect. The shunt is imposed by the closure of electrical contacts within a switch circuit controller. The connecting rod between the switch points and the switch circuit controller activates the closure of the contacts. The shunt circuit path proceeds through these contacts within the circuit controller through the shunt wires to the rails. (See figures 7 and 8.) The shunt wires are stranded insulated wires which have four tapered rail connectors, one at each rail end of each wire. The rail connector studs are driven into 3/8-inch holes in the web of the rails. Each running rail normally accepts two of the rail connectors.

The installation of a series break-type circuit, a variation of the shunt circuit which was involved in this accident, would have provided more positive protection. The involved shunt circuit was not designed on the closed-circuit principle and did not have the inherent fail-safe feature of the series break-type circuit. If the involved shunt circuit had been so designed, signal No. 1296 would have displayed a red (stop and proceed) aspect because of the unconnected shunt wires. The display of such a red (stop and proceed) aspect, even with no train occupying the governed signal block, would have indicated a fault within the signal system. The Safety Board believes that had a series break-type circuit been in place at the time of the accident, a red aspect would have been indicated, and the accident could have been avoided.

4. The type of shunt circuit system involved in this accident was not designed on the closed-circuit principle, and did not have an inherent fail-safe feature when the shunt wires were removed or broken from the rails.

Replace, as soon as practicable on a priority basis, track shunt circuit switch protection that does not have series break-type circuits, with series break-type circuits. (Class II, Priority Action) (R-82-43)

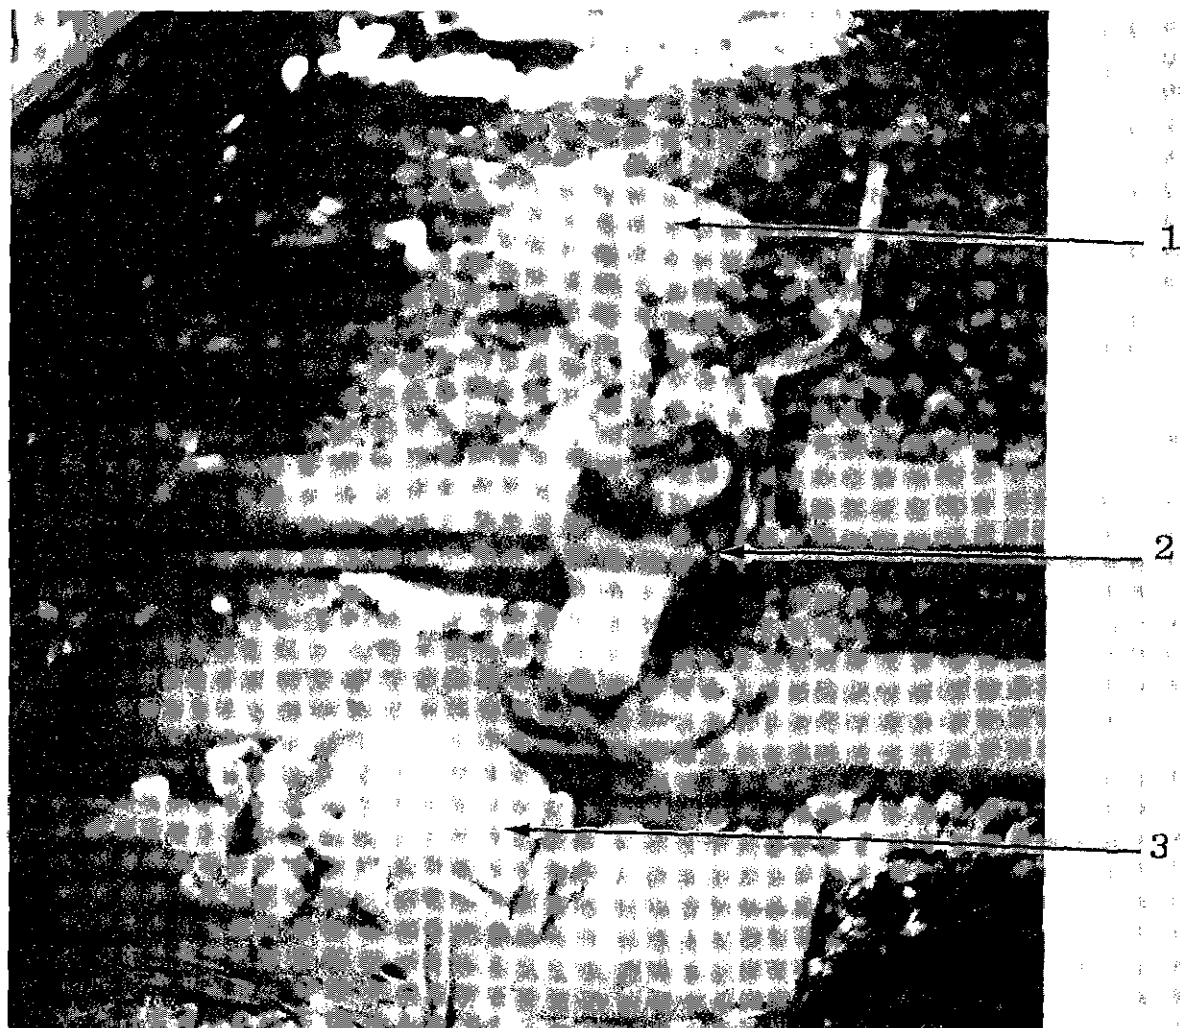
Figure 8.--Switch stand and circuit controller at west switch of crossover.

1. Reflectorized switch position indicator.
2. Hand throw switch stand.
3. Switch circuit controller.

After the accident, the circuit controller at the west switch of the crossover was opened to determine its condition. There was no external damage to the circuit controller. The contacts were found to be in proper physical correlation with the switch points being in the reversed position. Each of the contacts was found to be clean, and the pressure on each was sufficient to ensure good contact closure. After the damaged track had been replaced and the rail ends bonded, a new set of shunt wires, replacing those which were not connected before the accident, was put into service between the rails and the switch circuit controller. Signal No. 1296 was found to function in the manner in which it was designed to at this time. Officials of N & W's Signal & Communication Department (S & C) stated that signal No. 1296 would display a green (clear) aspect with the west switch of the crossover reversed, given that the shunt wires were not connected to the stock rail and that the east switch of the crossover was lined for the normal movement. The east switch circuit controller and shunt wires were in place. The N & W notified the FRA on November 30, 1981, of this failure of the signal system. (See appendix F.)
