NATIONAL TRANSPORTATION SAFETY BOARD

RAILROAD ACCIDENT REPORT

**HEAD-ON COLLISION OF AMTRAK TRAINS
EXTRA 769 EAST AND NO. 195
BRISTOL, PENNSYLVANIA
MARCH 29, 1982**

NTSB-RAR 82-5

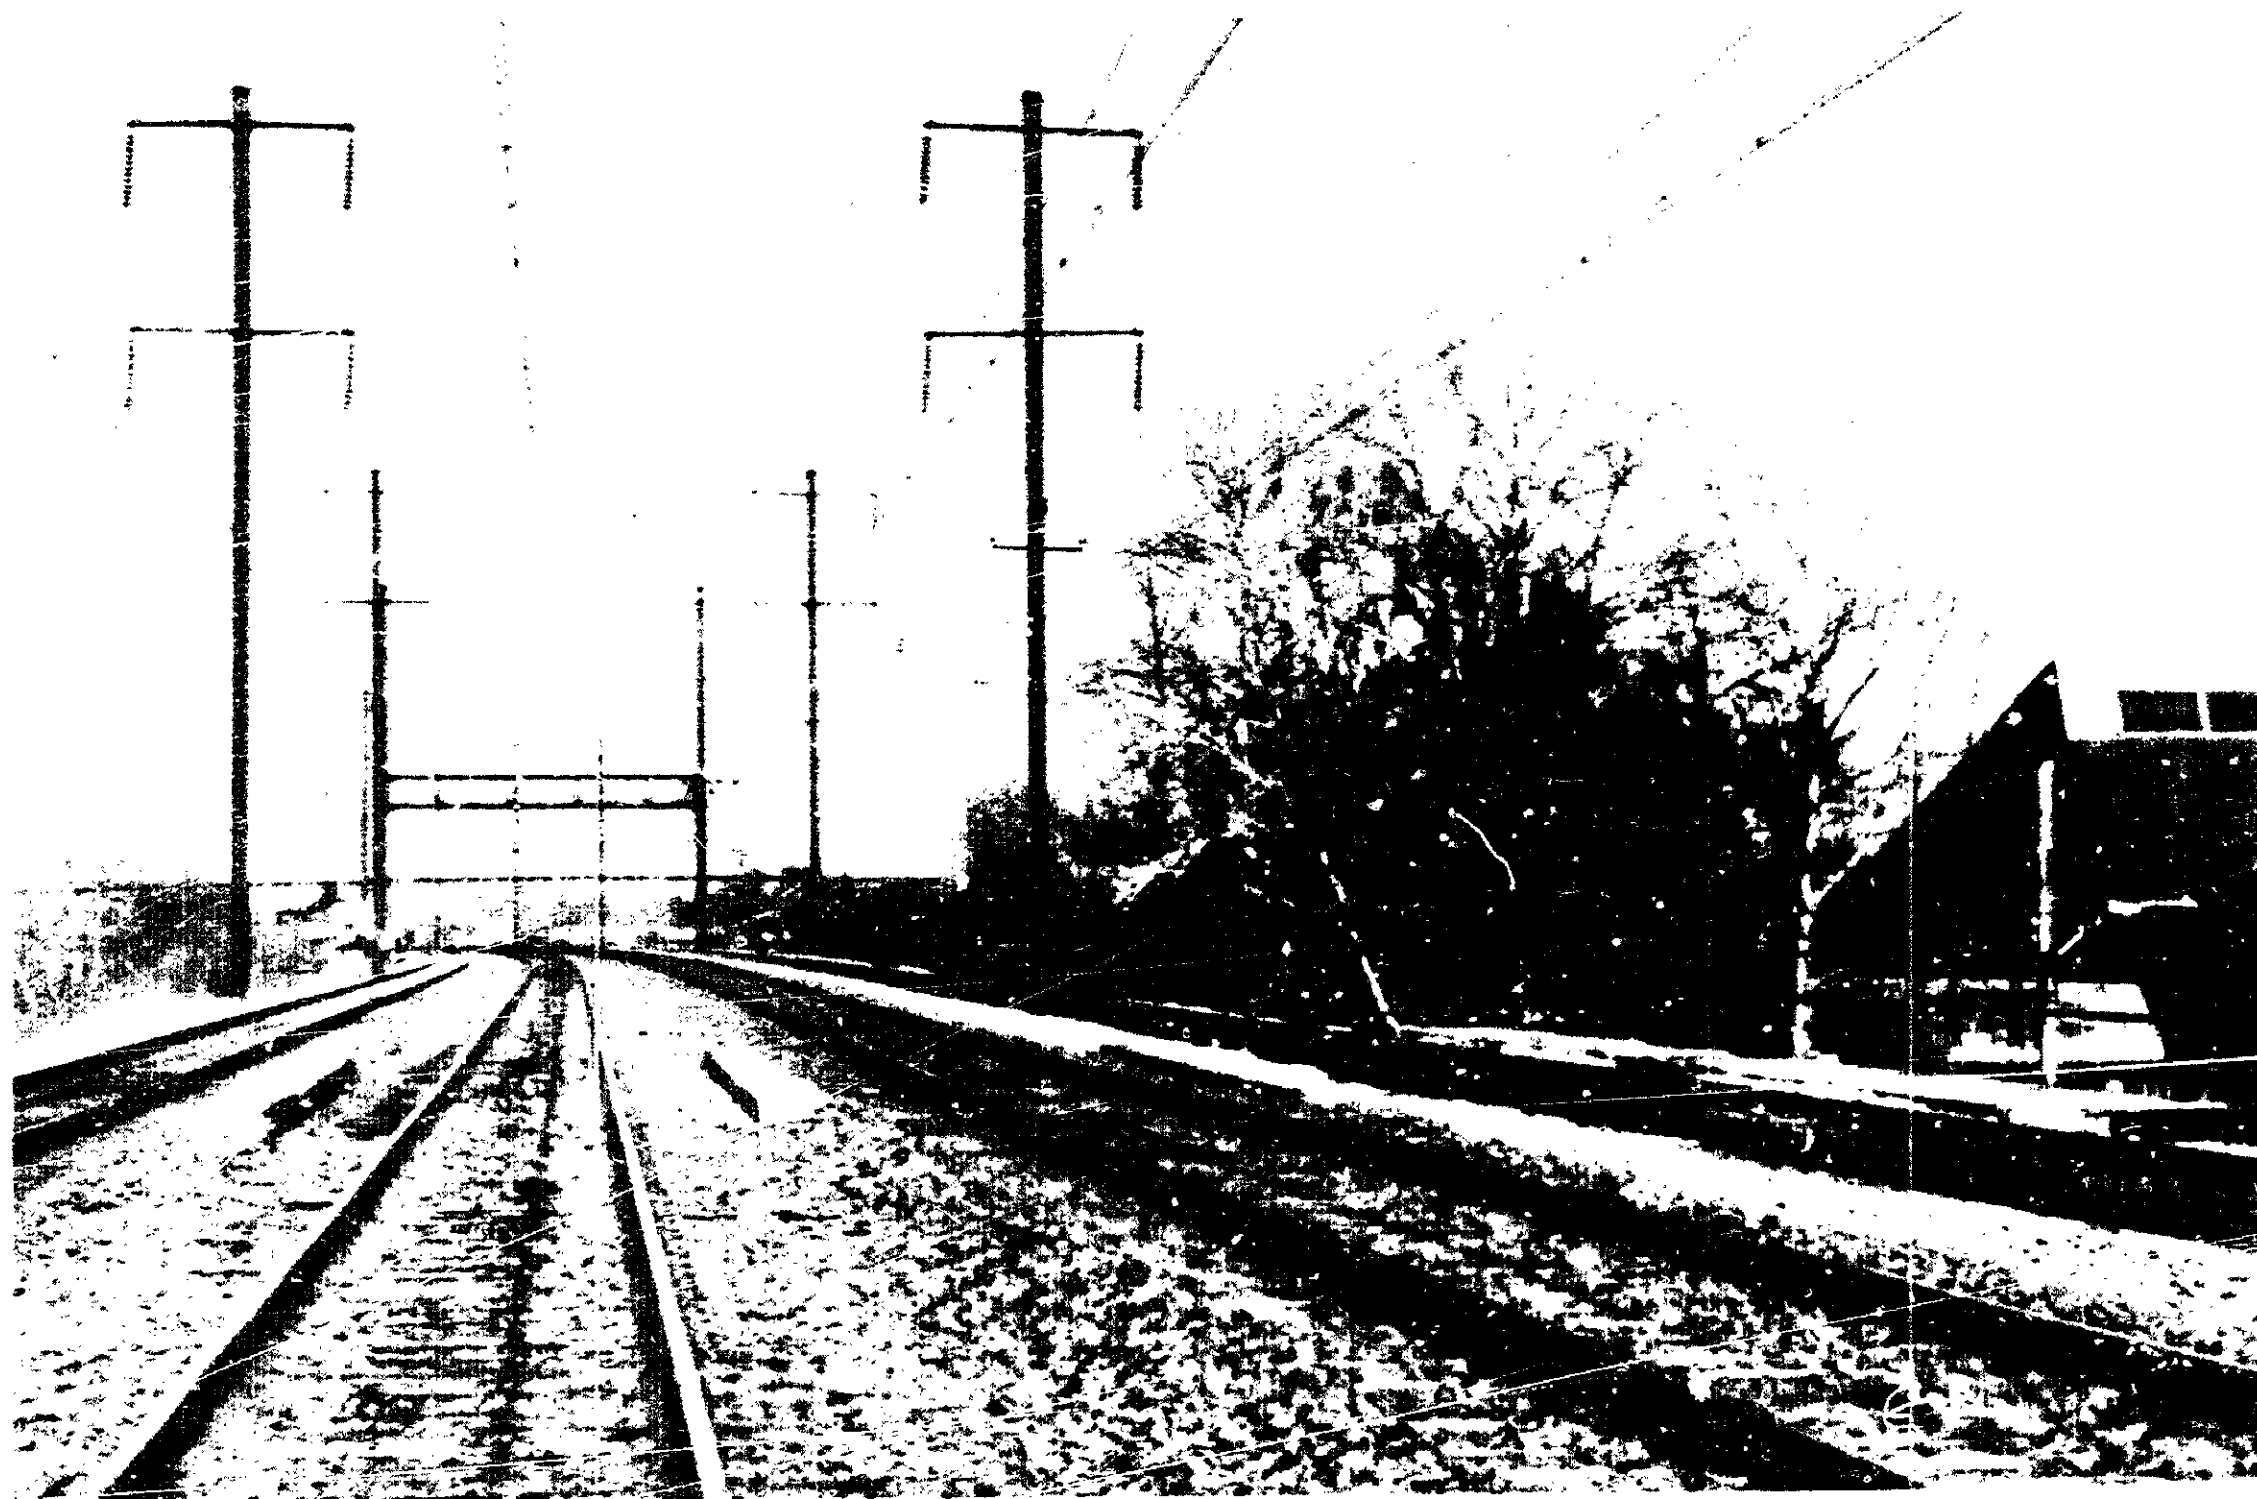
Although there were passenger shelters at the track level on the north and south sides of the tracks at Bristol Station, the platform lights were not illuminated and there were no station signs by which the station could be identified from a passing train when Extra 769 East approached Bristol Station on the morning of March 29. However, the trainmaster said that when Extra 769 East was about 500 feet west of Bristol Station, he told the engineer that they were approaching Bristol Station and that he should slow down from the approximate 40-mph speed Extra 769 East was moving at that time. (See figure 2.) The trainmaster said the engineer reduced the throttle and applied the brakes but that the locomotive did not seem to slow appreciably. Therefore, about 550 feet east of the station, the trainmaster told the engineer to apply more brakes. Immediately thereafter, the trainmaster said he saw the red glare of fuses reflected on the surface or the gauge side of the rails and he told the engineer "there he is Frank get some more brakes down." The trainmaster stated that the engineer responded and applied more

Figure 2.--Approach view to standing train No. 195.
