# **NATIONAL TRANSPORTATION SAFETY BOARD**

## **RAILROAD ACCIDENT REPORT**

**DERAILMENT OF ILLINOIS CENTRAL GULF RAILROAD  
FREIGHT TRAIN EXTRA 9629 EAST (GS-2-28)  
AND RELEASE OF HAZARDOUS MATERIALS  
AT LIVINGSTON, LOUISIANA  
SEPTEMBER 28, 1982**

NTSB/RAR-83/05

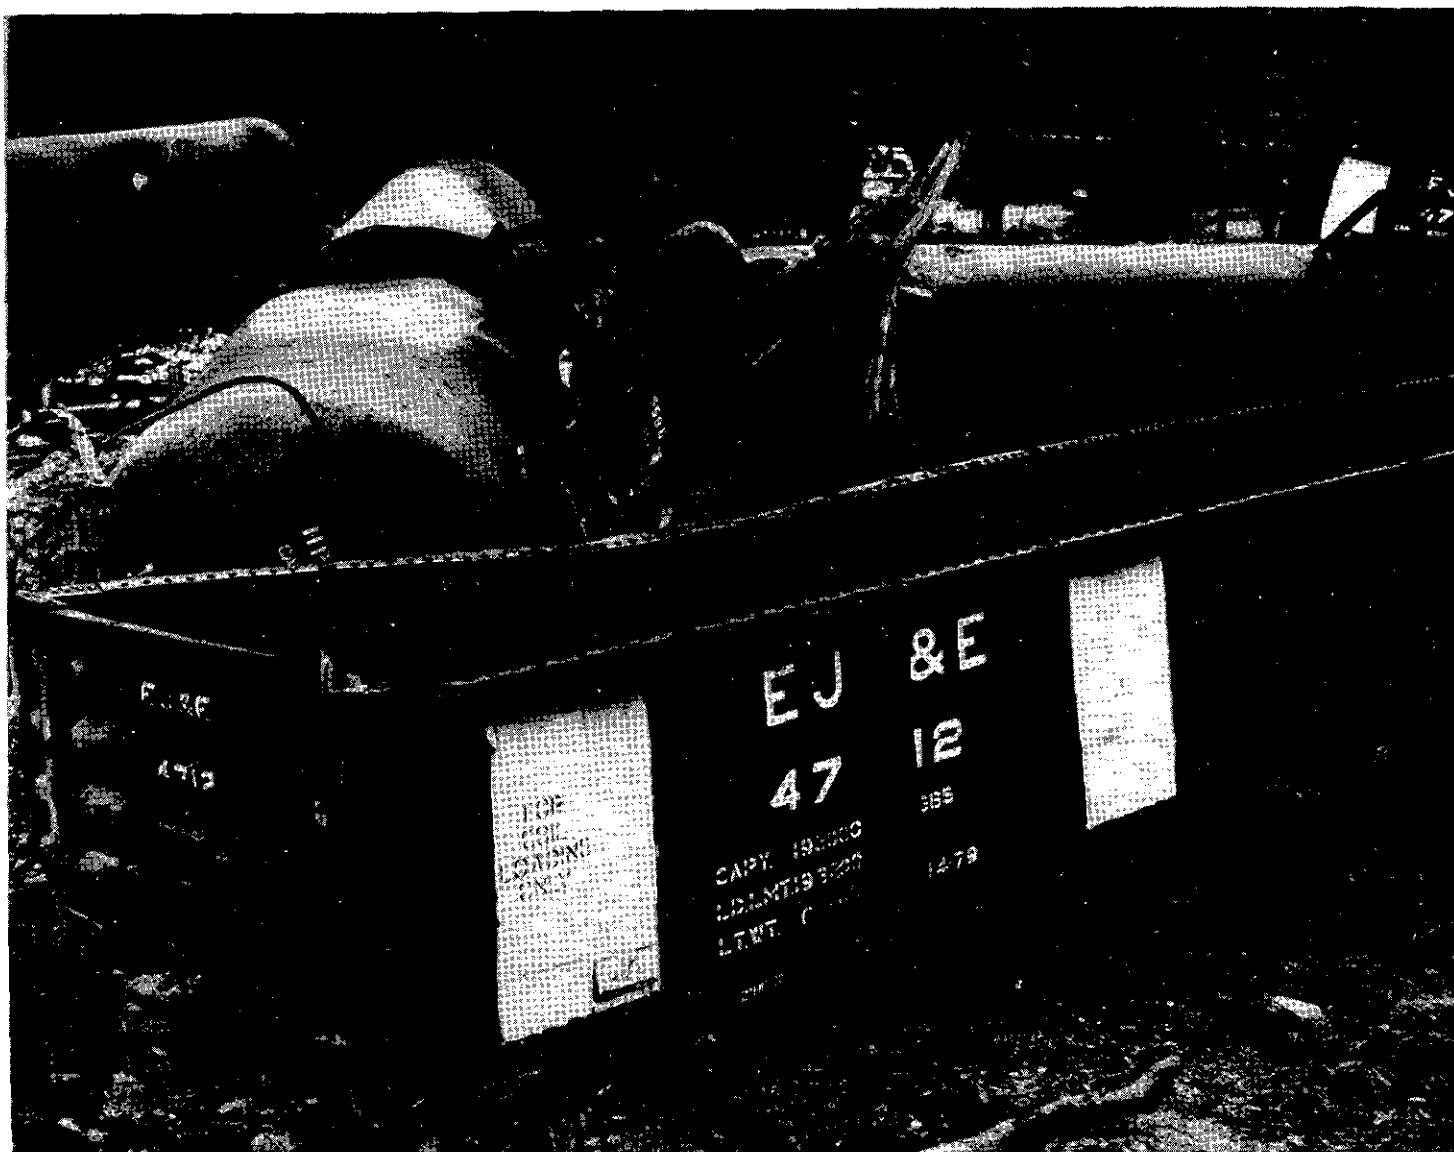
Figure 4.--Lead end of gondola car EJ&E 4712 showing strike damage to end and side. The tank car standing alongside was immediately behind the gondola car in the train.

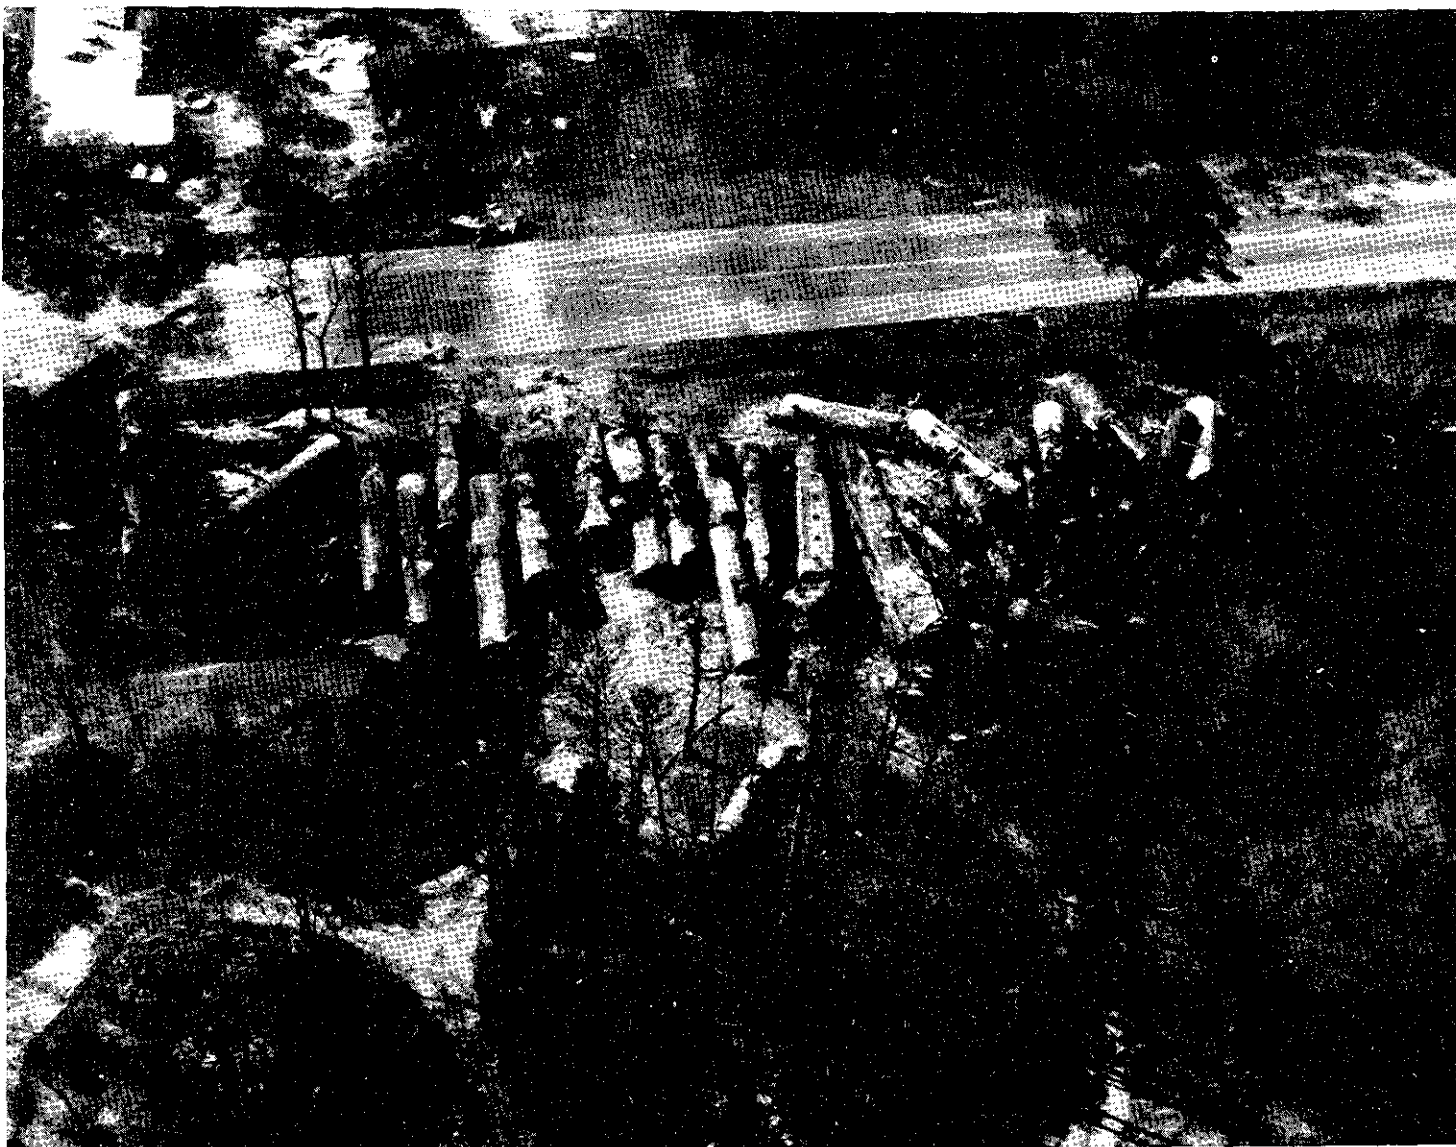
Figure 6.--The derailment site on October 4, 1982, viewed facing south.  
Parts of the vinyl chloride tank car which rocketed are on and just  
south of the highway. Buildings that were destroyed or severely damaged  
are shown in the upper left corner.

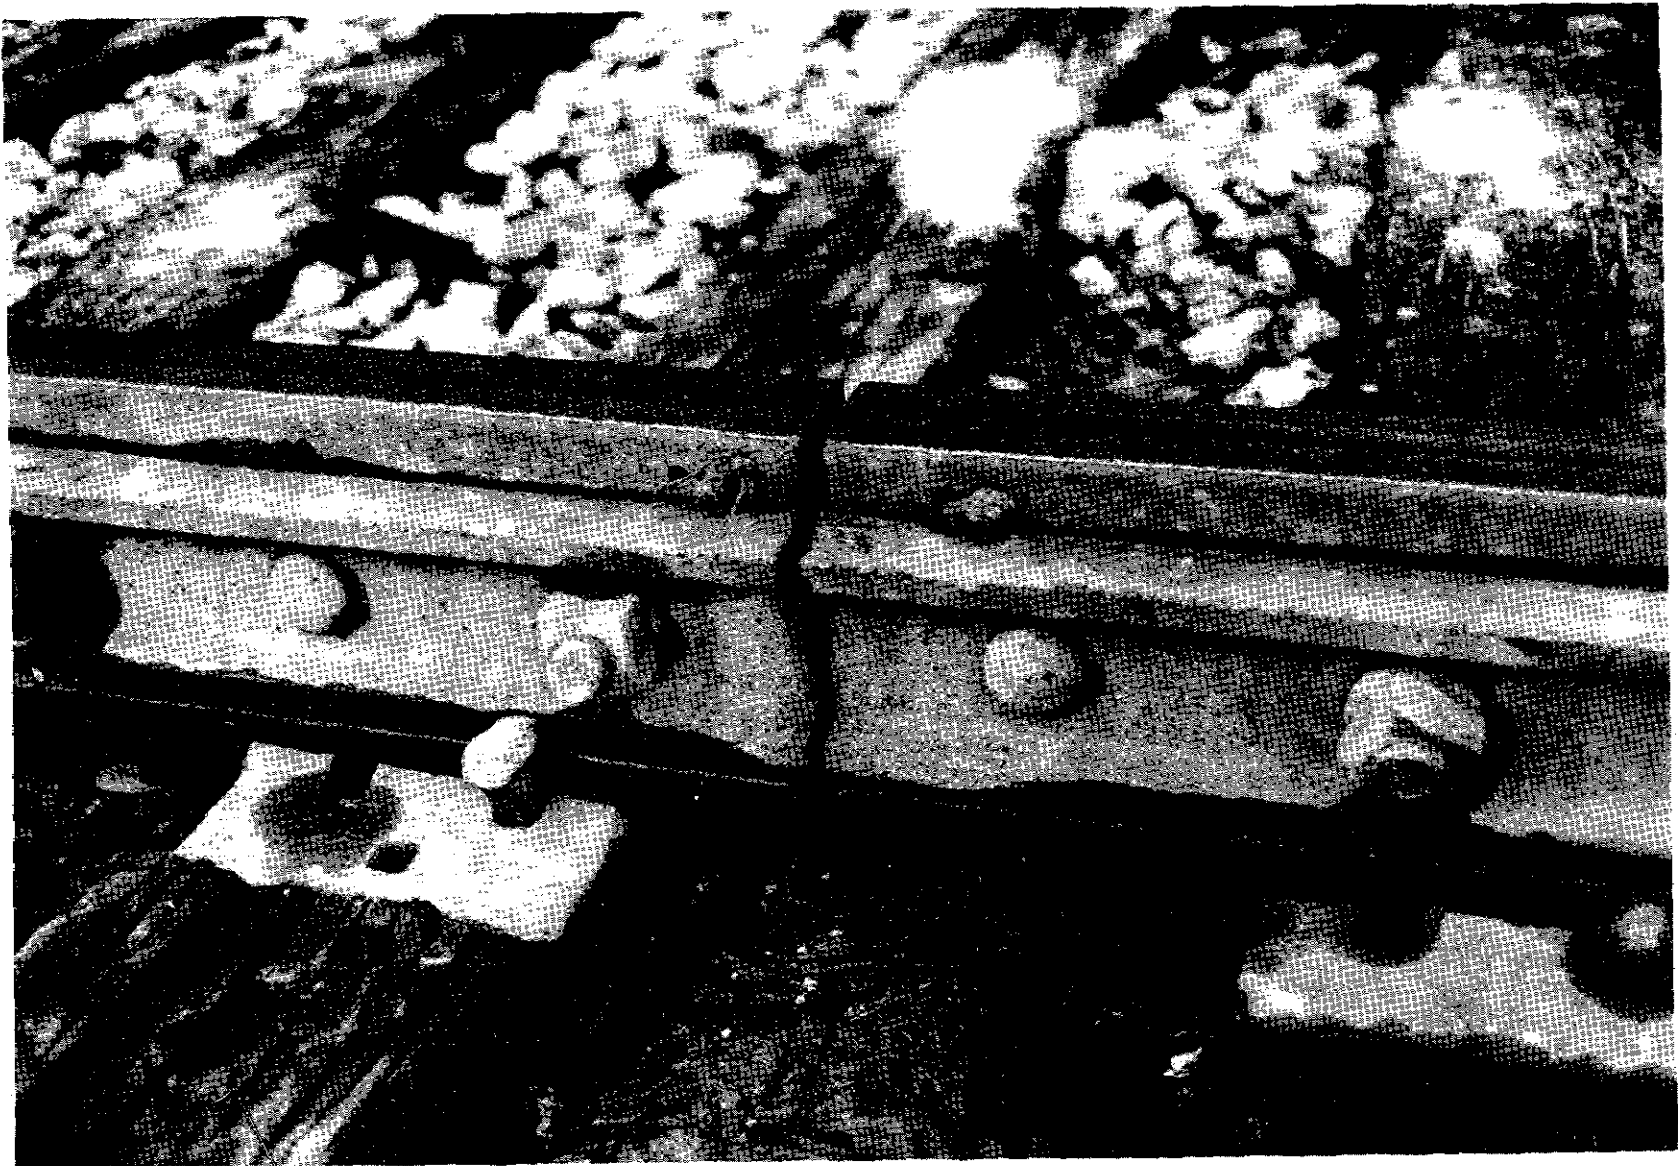
Vertically-pumping joint conditions were found at mileposts 26.45, 26.66, 26.96, 26.99, and 27.1. All but the first of these were near grade crossings. None of the pumping joints were beyond the limits of the track standards, but the bars in the joint at milepost 27.1 fractured on a transverse plane under a work train following the accident. The fractures were similar to those in the bars found in the wreckage at milepost 26.8. (See figure 7.)

Figure 7.--Joint bar with center transverse fracture located at a pumping joint near milepost 27.1. This failure occurred after the Livingston derailment and was similar to the joint-bar failure at the culvert (milepost 26.8)

The fractured joint bars were examined by ICG's metallurgist and the Safety Board's metallurgist on December 31, 1982. The bar on the gauge side of the rail exhibited characteristics of fatigue cracking in two regions. The larger of these two regions was in the head with initiation from numerous places along the interface with the rail. Fatigue propagation was downward to a depth of about 1 1/4 inches. The second fatigue area was in the toe with upward propagation of about 1 inch. Approximately 30 percent of the fractured cross section of this joint bar was cracked by slow growth fatigue. Most of the fracture between the two fatigue regions was typical of fast propagation stemming upward from the toe.

Examination of the field side joint bar disclosed a fatigue crack in the toe region with upward propagation to a depth of about one-half inch. Rapid fracture stemming upward from the fatigue region was indicated.

According to the Safety Board's metallurgist, the deformation of the rail heads at the joint appeared to have been caused by repeated pounding by wheels moving in both directions. The extent of batter, or deformation, was considered to be consistent only with the rails being separated either vertically or horizontally as a result of complete fractures of both joint bars.

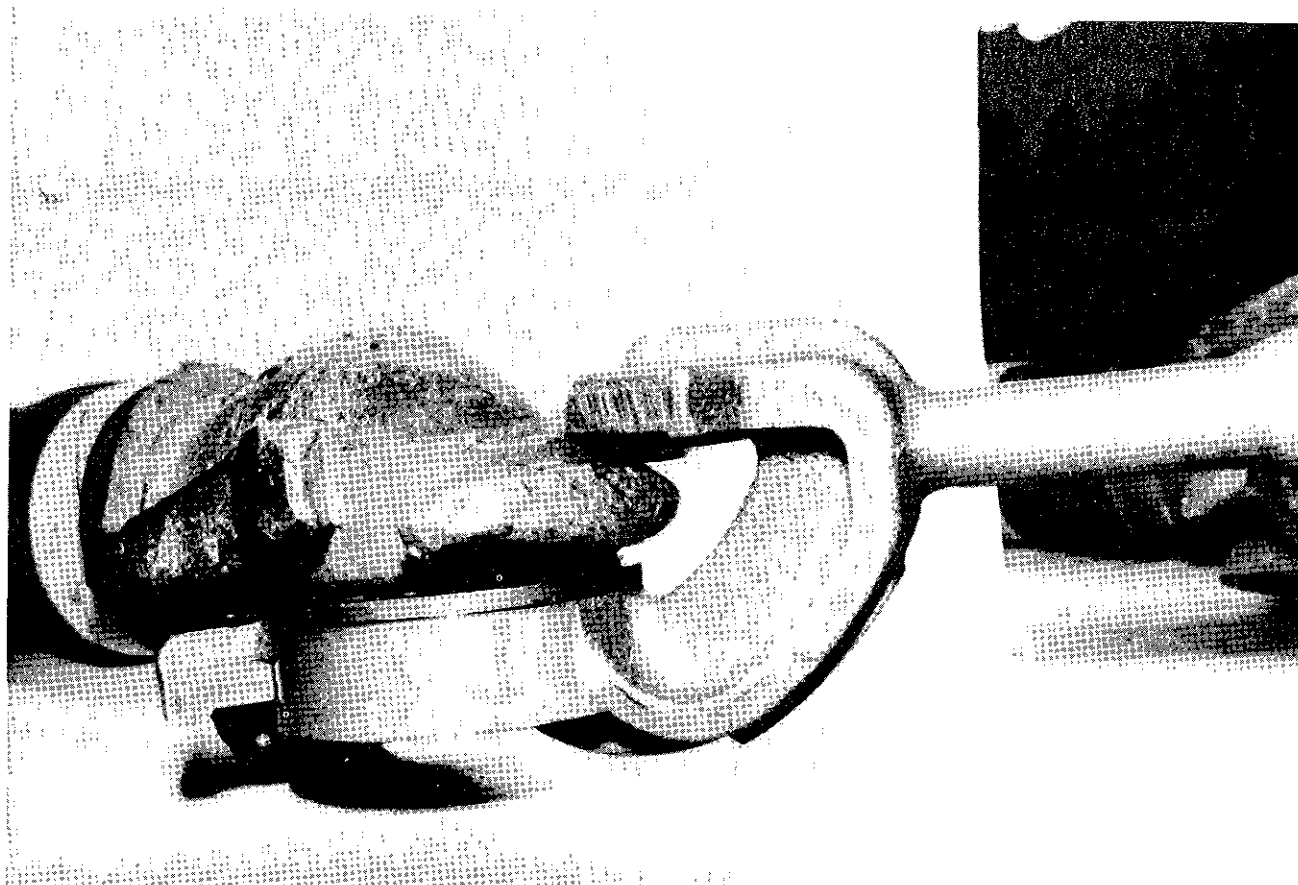
Figure 9.--AAR gage applied to air hose coupling from ICG Unit 3022.  
The gage could not be fully or properly applied.

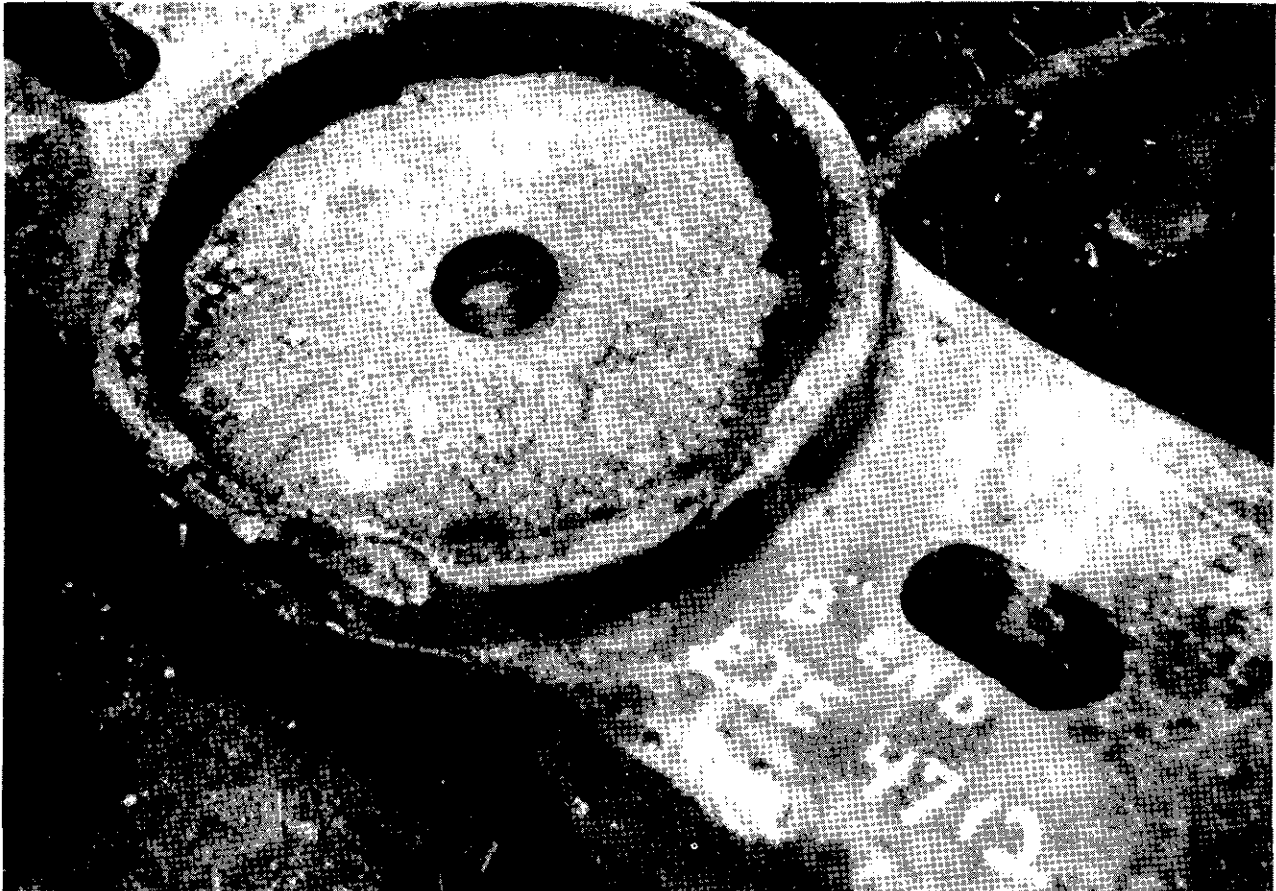
Figure 10.--Center plate of trailing truck bolster, gondola EJ&E 4712, with lower remnant of center pin lodged in the bolster.

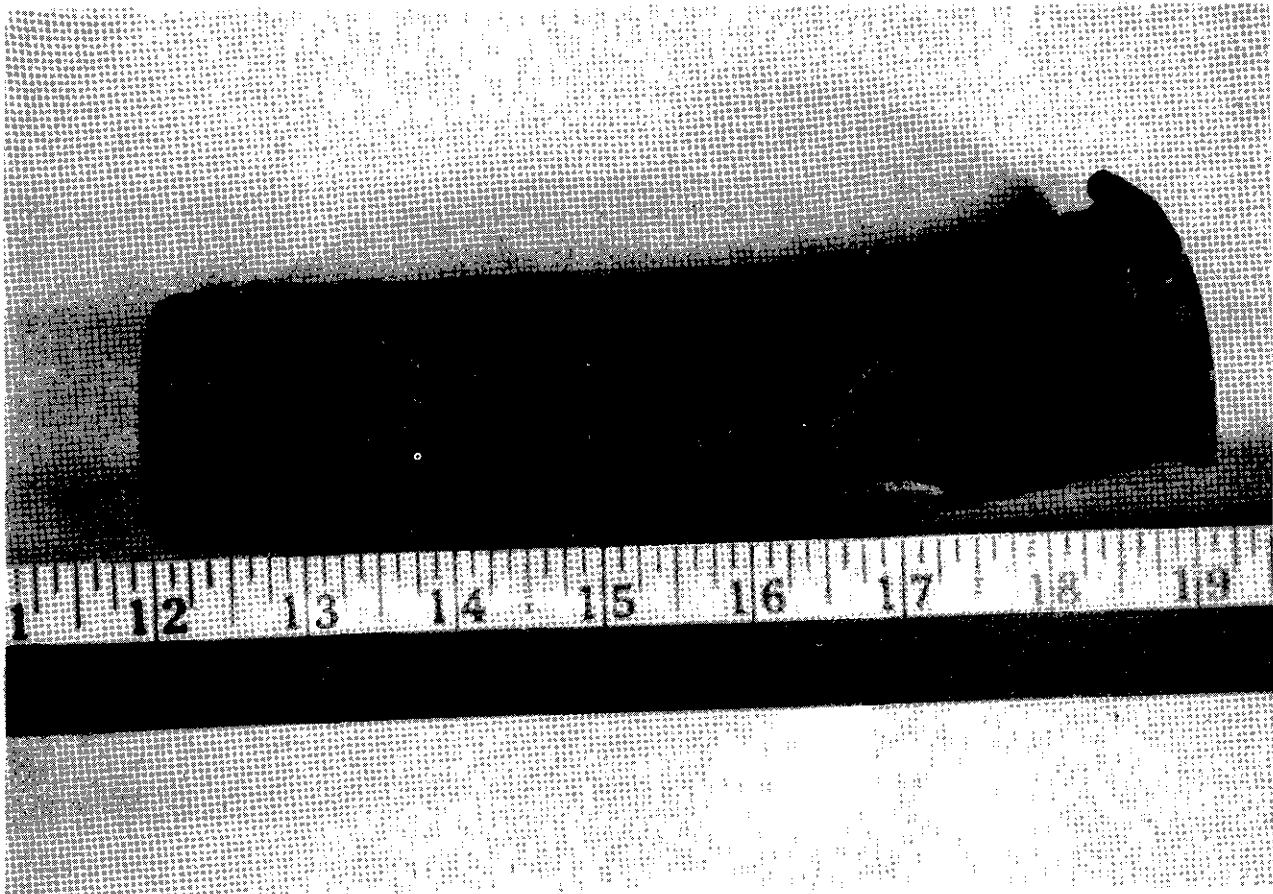
Figure 11.--Center pin remnant removed from truck bolster of EJ&E 4712.  
Fracture face mushroomed by battering from upper remnant over a prolonged period.
