# NATIONAL TRANSPORTATION SAFETY BOARD

## RAILROAD ACCIDENT REPORT *2110.*

HEAD-ON COLLISION OF CHICAGO,  
SHORE AND SOUTH BEND RAILROAD  
TRAINS NOS. 123 AND 218  
GARY, INDIANA  
JANUARY 21, 1985

NTSB/RAR-85/13   (PB85-916313)

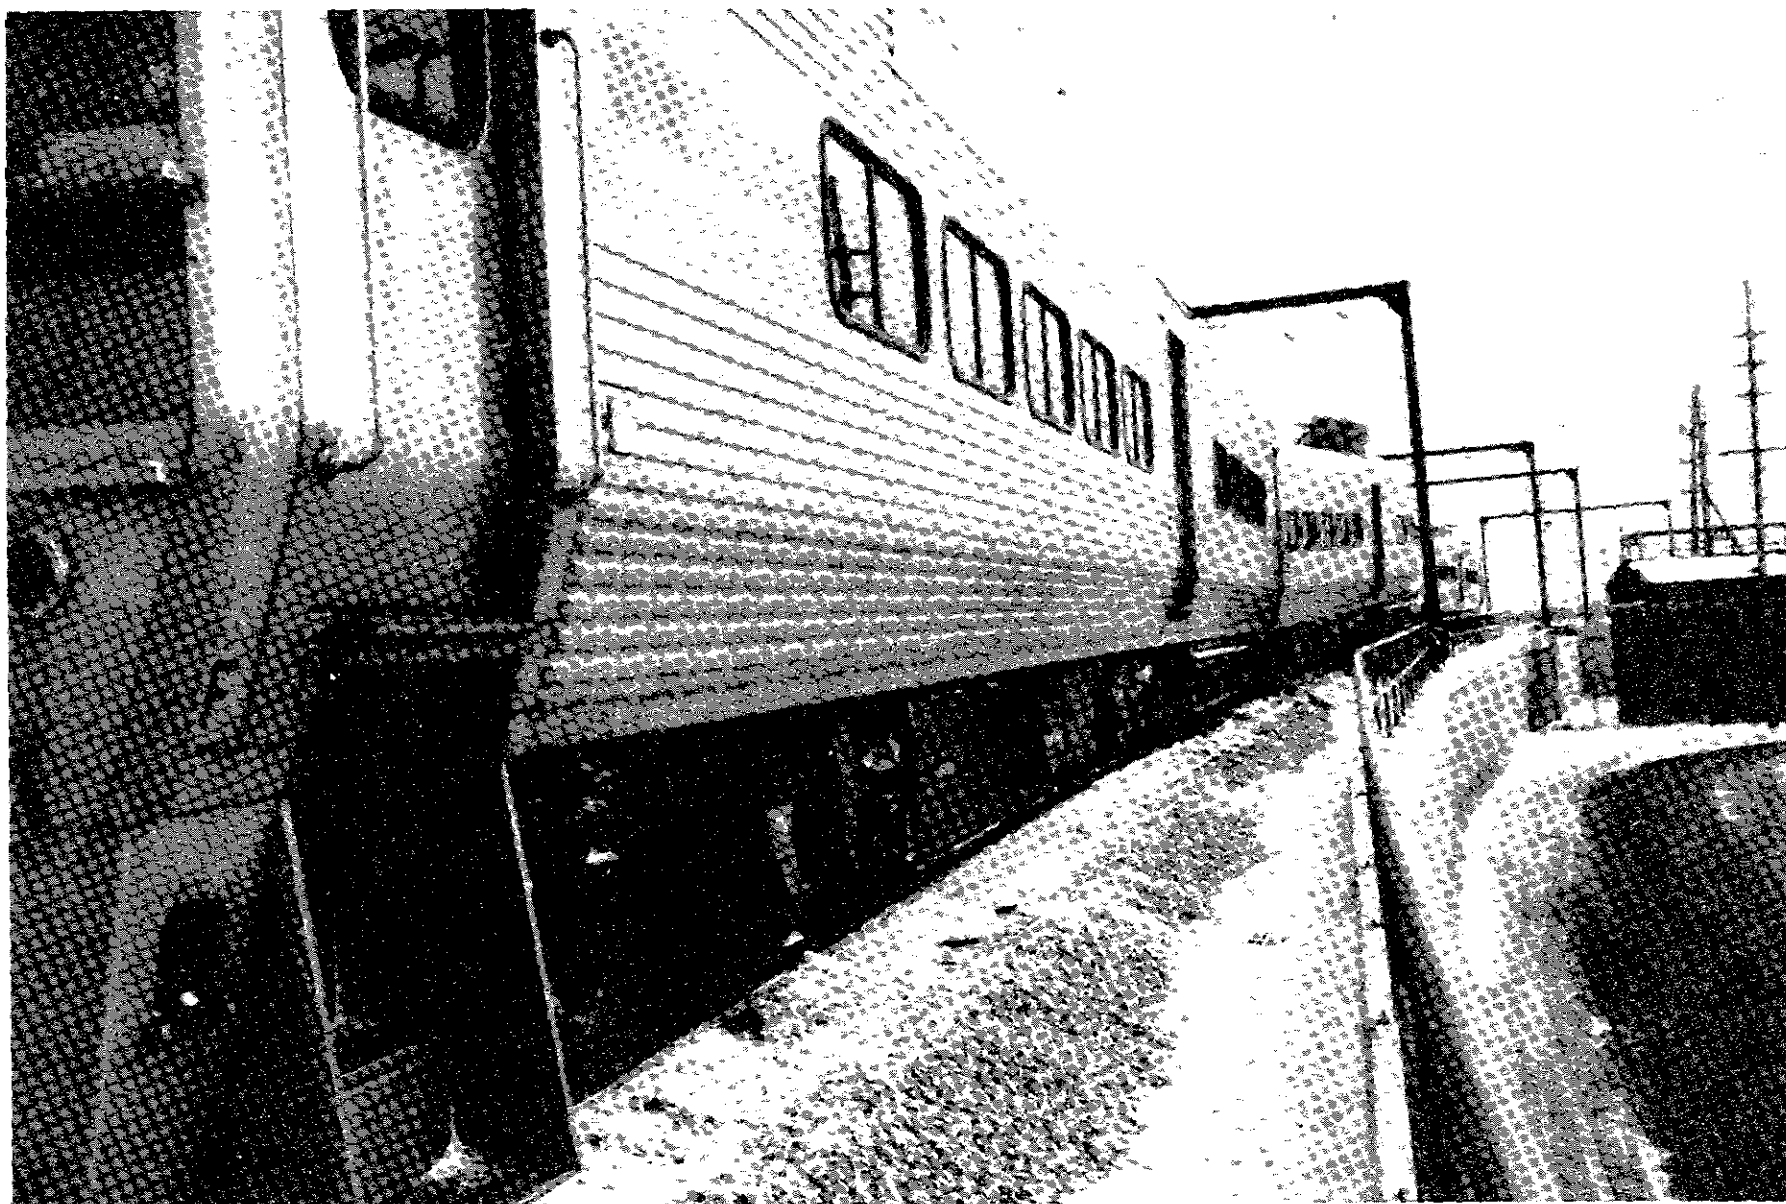
The forward vestibule areas of the two lead cars were crushed on impact. Frame and body deformation was evident to a depth of about 8 feet into the passenger compartment of each unit. (See figures 2, 3, and 4.) The two lead cars were estimated to be a total loss, while the trailing cars received only minor damage. Damage to the track was negligible, and there was no damage to the catenary or signal systems.

Figure 2.--East view of first and second cars of train No. 123 (foreground) and train No. 218 (background).

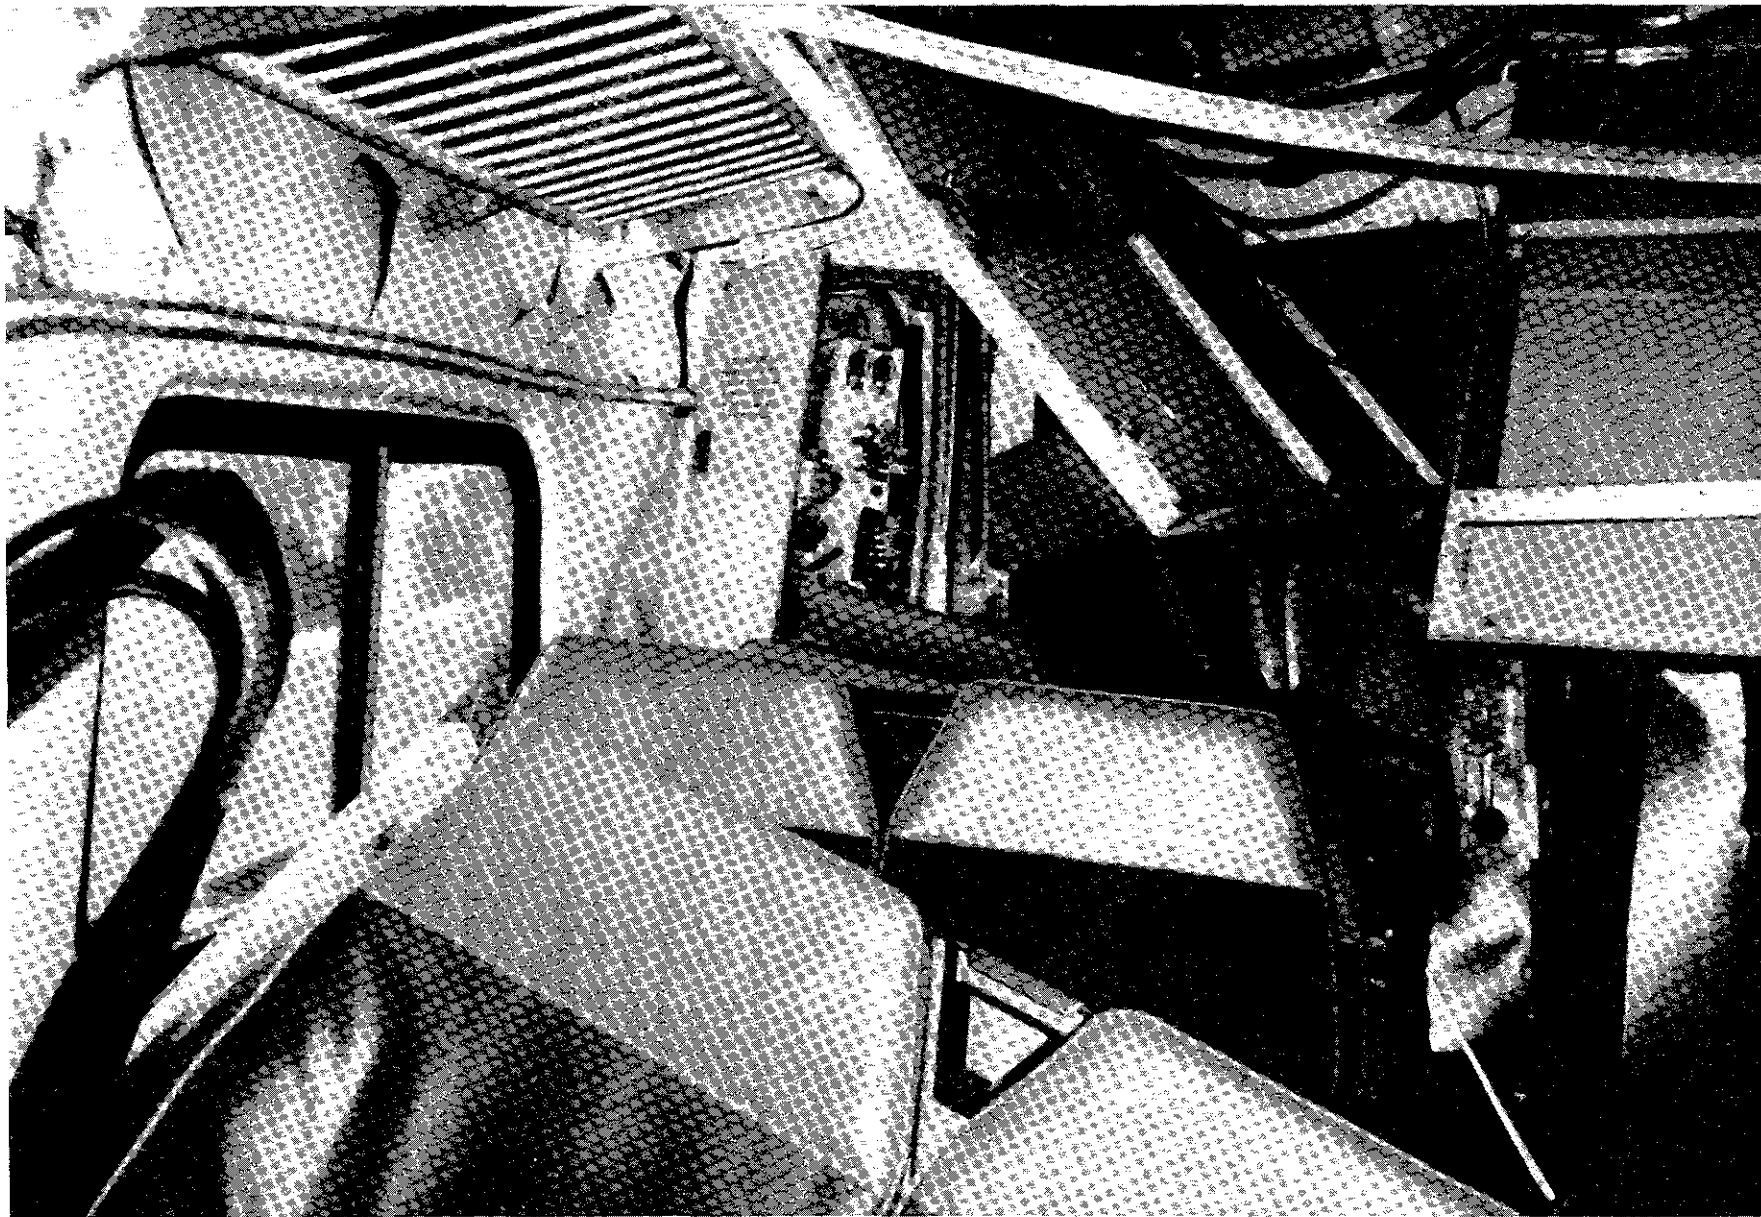
Figure 4.--Interior of lead car of train No. 123.

The forward outside body shell of the vestibule on each lead car was crushed so that the vestibule was compacted. The first rows of seats for a distance of about 8 feet were squeezed together. The sides of the cars bulged outward near the impacted ends. The luggage racks in the forward ends of the cars bent, and some became detached. The seats in the cars, except for those in the crush areas, did not separate from their floor moorings. No seat cushions were knocked loose in any seats behind those affected by the crushing forces. Passengers could not exit through the forward ends of the lead cars, but the doors to the rear and the side doors could be opened manually by following the emergency sequence indicated in the printed information on the coach walls.
