# **NATIONAL TRANSPORTATION SAFETY BOARD**

## **RAILROAD ACCIDENT REPORT**

**DERAILMENT OF AMTRAK PASSENGER TRAIN 8  
OPERATING ON THE SOO LINE RAILROAD,  
FALL RIVER, WISCONSIN  
OCTOBER 9, 1986**

NTSB/RAR-87/06

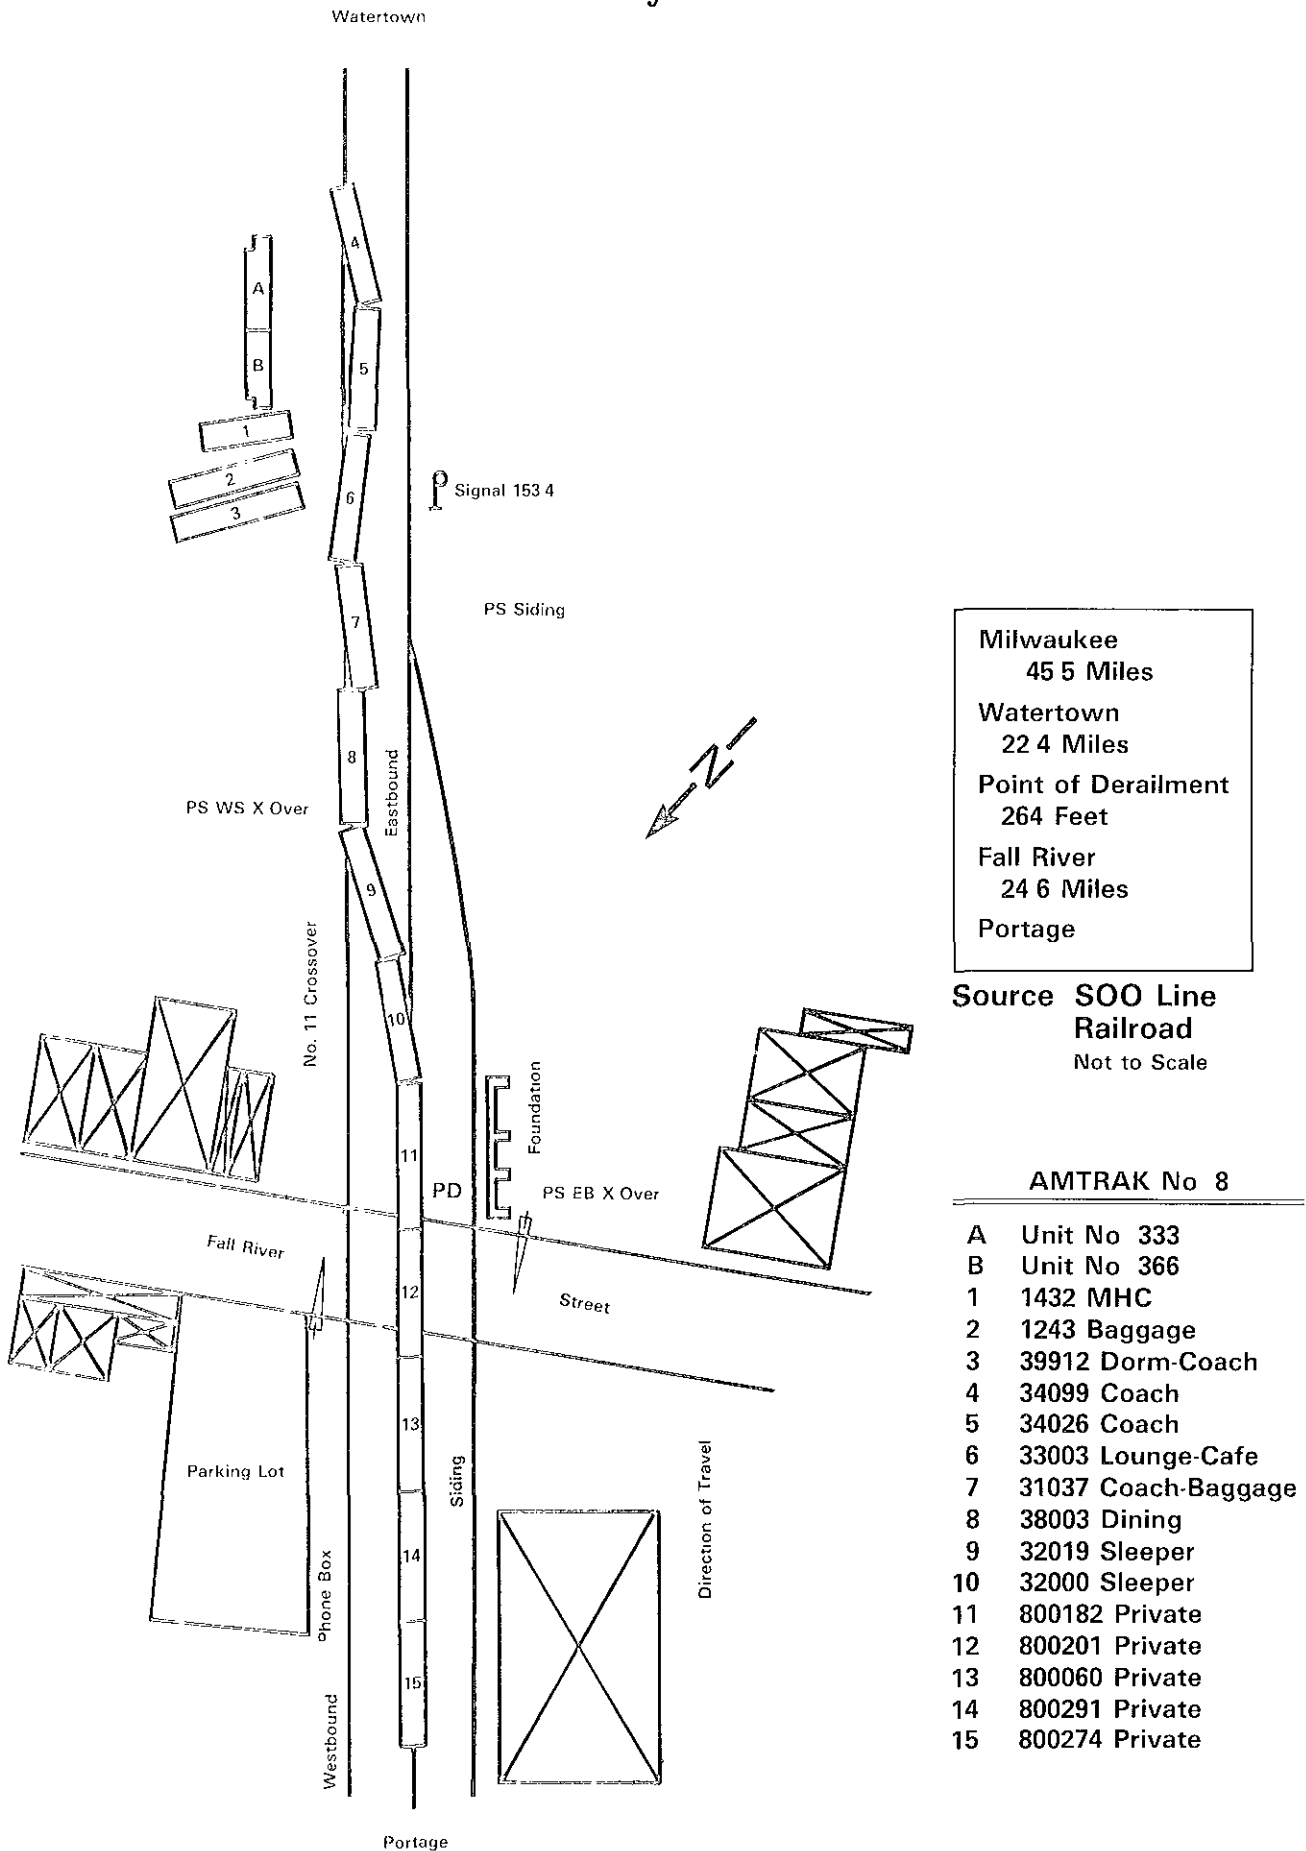
The lead locomotive unit slid on its left side and down an embankment after overturning (figure 3). The door on the left side came open and the left side of the cab interior was filled with rain-soaked dirt. The front of the locomotive was moderately damaged with some of the steel sheets pushed inward, and it was pierced with several sections of cast-iron pipe culvert. The left side of the locomotive was extensively damaged with the side torn and pushed inward, and the roof was buckled. The second locomotive had been coupled to the lead locomotive with the rear end leading, and when it overturned to the north of the track structure, turned on its right side. The right side of this unit was torn and pushed inward and the roof was buckled. The first car behind the locomotives was a material handling car (U.S. mail). This car overturned and was destroyed because of the extensive damage.

Figure 3.--Accident site at Fall River, Wisconsin.

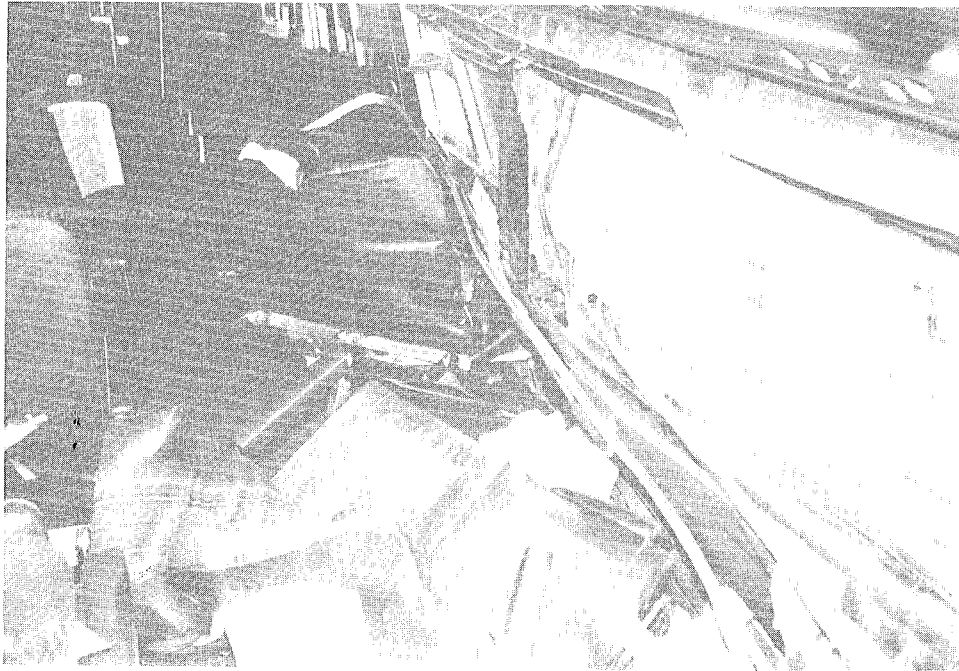
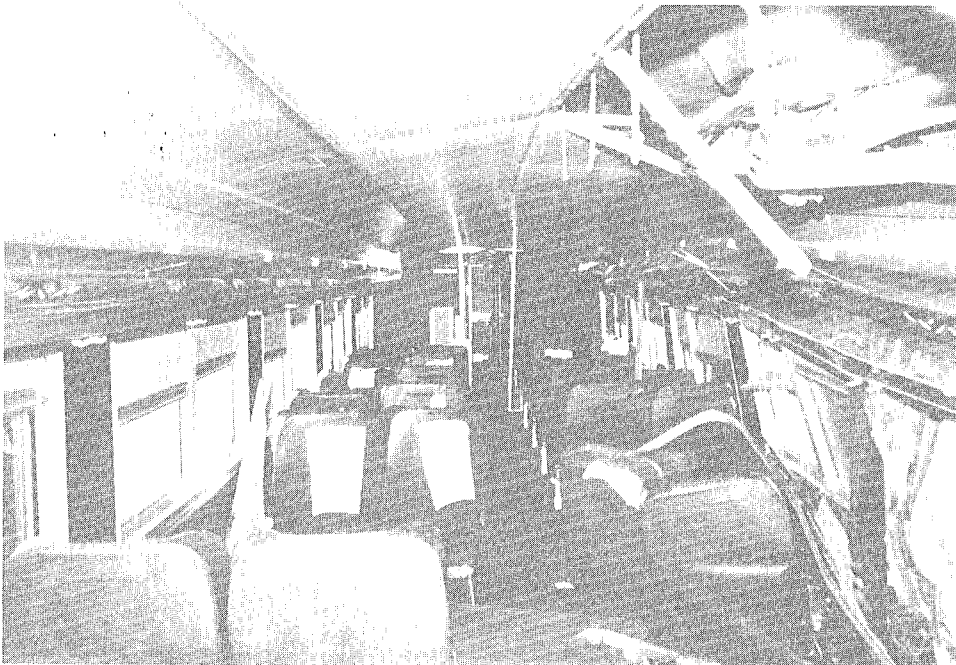
Figure 5.--Foreward end interior of coach/dorm car;  
seats 1-2 and 9-10 are in the aisle (top).

All of the injured train crewmembers were located in the coach/dorm car. On the inside of this car, the left side seat 15-16 was torn from its mounting. The luggage rack above seat 33-34 was displaced upward 4 inches and showed evidence of body contact. At seat 29-30 the window glass was fractured with twisting striations. Seat 21-22 had the right side interior sidewall collapsed approximately 6 inches. Seats 17-18 and 13-14 were bent inboard and partly collapsed. Seats 9-10 and 1-2 were torn free and were lying in the aisle (figure 4).

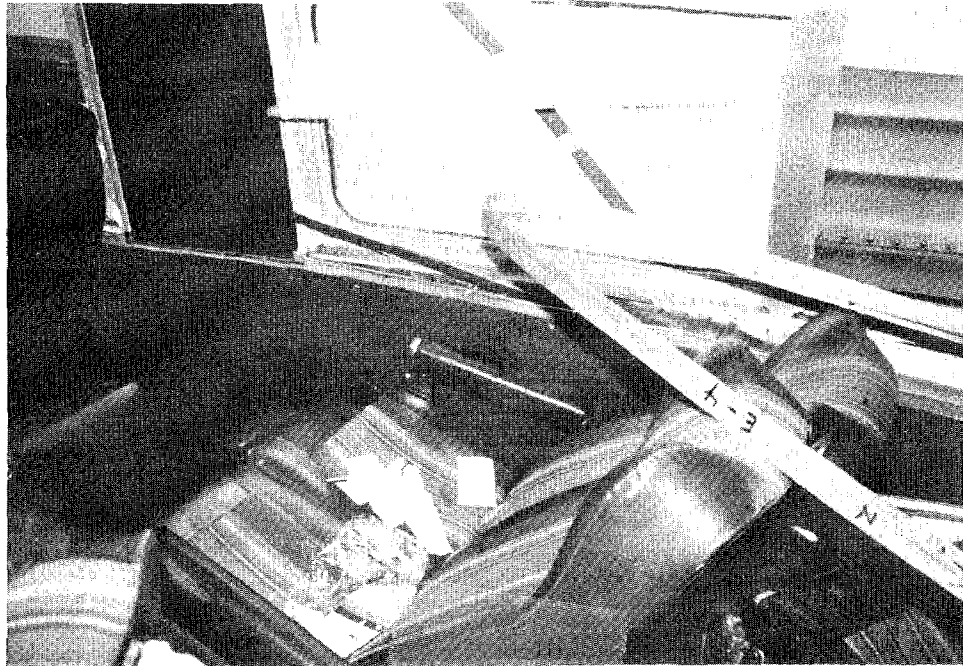
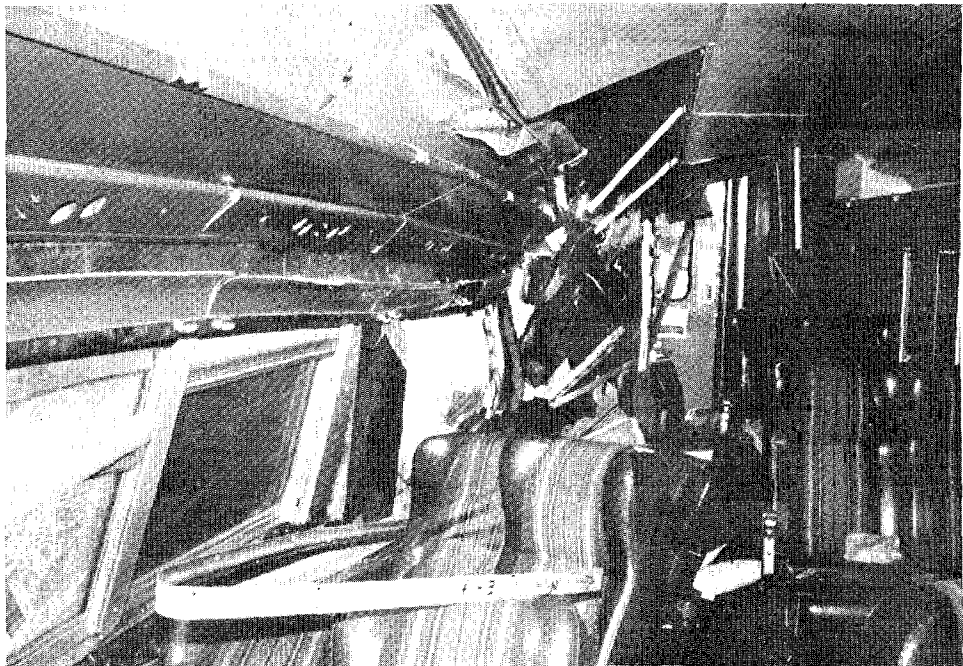
Figure 6.--Rear end interior of coach/dorm car;  
bent metal trim strip at seat 29-30.

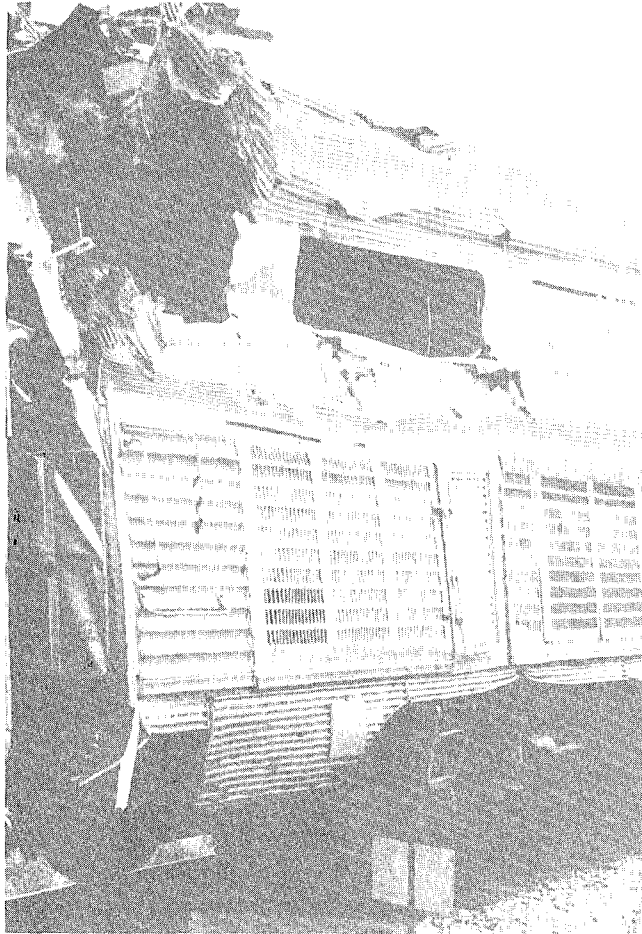
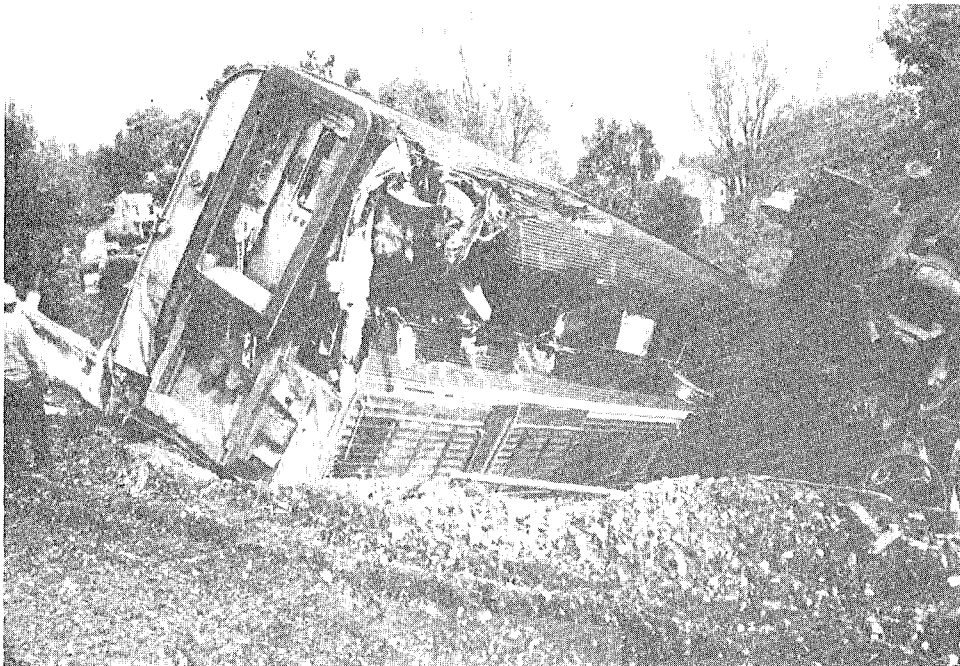
The baggage car, next in line, also overturned. This car was extensively damaged; both ends of the car were crushed. The following car, a coach/dorm car, sustained extensive damage as a result of the collision with other cars during the derailment. This car did not overturn but jackknifed from the train, went over the embankment, and was leaning to one side. The roof of the car was crushed inward about 4 feet, and the side of the car at seat locations 1, 5, 9, and 13 was torn away; the windows were also torn away. At seats 13 and 14 the sidewall was crushed inward about 15 inches, crushing the window seat armrest (figure 4). The window frame was twisted with the outside glass missing, but the inside Lexan window remained in place (figures 5, 6, and 7).

Figure 7.--Dorm/coach car No. 39912 exterior damage.

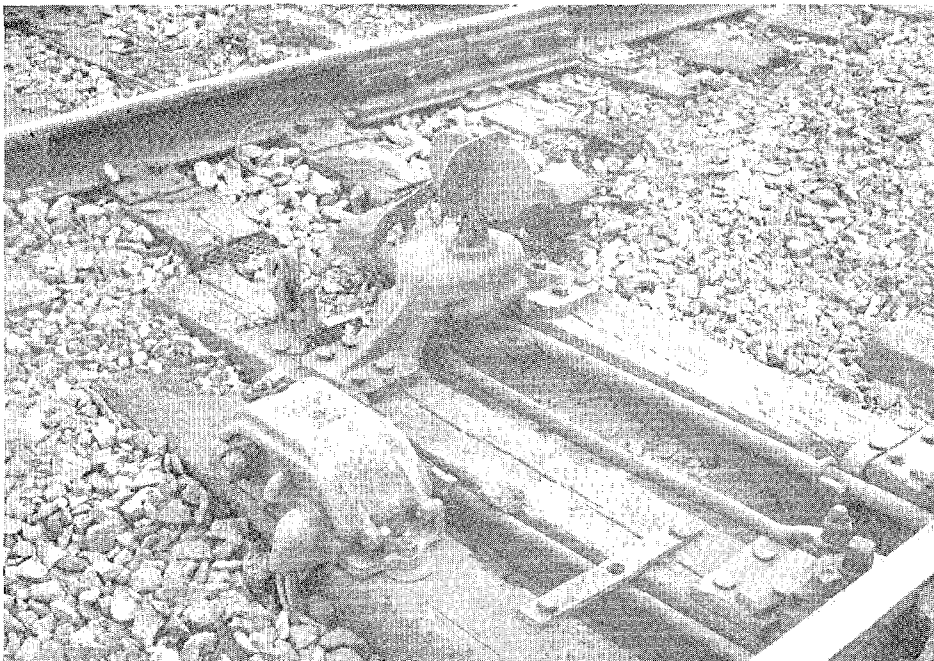
Figure 8.--Low switch stand at Fall River.

When the switchtender lined the switch after train 8 passed the two green signals, the engineer had no way of knowing the condition of the switch until he could see the points of the switch. There was a low switch target on the cross over switch about 102 feet from the center of the grade crossing at Main Street in Fall River. However, because it was low and close to the grade crossing, it could not be seen by the engineer to warn him in sufficient time to bring the train to a stop before entering the switch.
