RAILROAD ACCIDENT REPORT

REAR-END COLLISION OF AMTRAK PASSENGER TRAIN 94, THE COLONIAL AND CONSOLIDATED RAIL CORPORATION FREIGHT TRAIN ENS-121, ON THE NORTHEAST CORRIDOR CHASE, MARYLAND JANUARY 4, 1987

NTSB/RAR-88/01

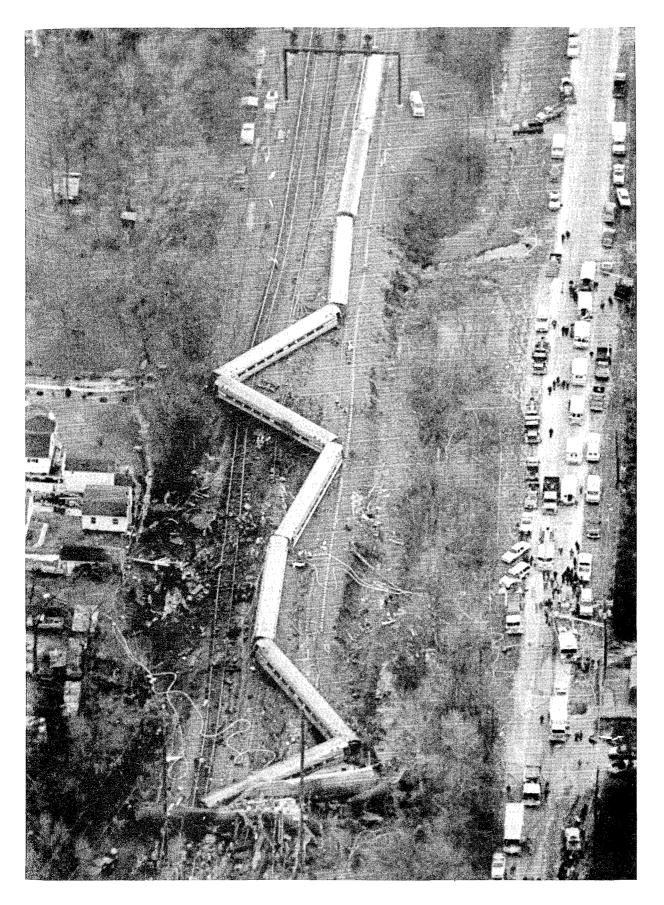
Figure 3. Aerial view of the accident site.

The rear Conrail unit was virtually disintegrated with parts scattered across the tracks and property east of the tracks. The largest piece of wreckage came to rest about 150 feet northeast of the collision point. The rear of the middle Conrail unit was crushed by the rear unit. Uncoupled from the lead unit, it was propelled forward on track 2 for about 700 feet. Only the rear truck of this unit derailed. The lead Conrail unit sustained relatively superficial damage, although driven forward about 900 feet, it was the only piece of equipment in the two trains that was not derailed.

The forward cab and superstructure of the lead Amtrak locomotive unit was crushed downward and inward to the underframe. Separated from the trucks, the remains of the car body came to rest west of the tracks about 400 feet north of the collision point. The trailing Amtrak unit remained in line with the track, although separated from its trucks, and came to rest leaning about 45° to the right at a point about 45° feet north of the collision point (see figure 3).

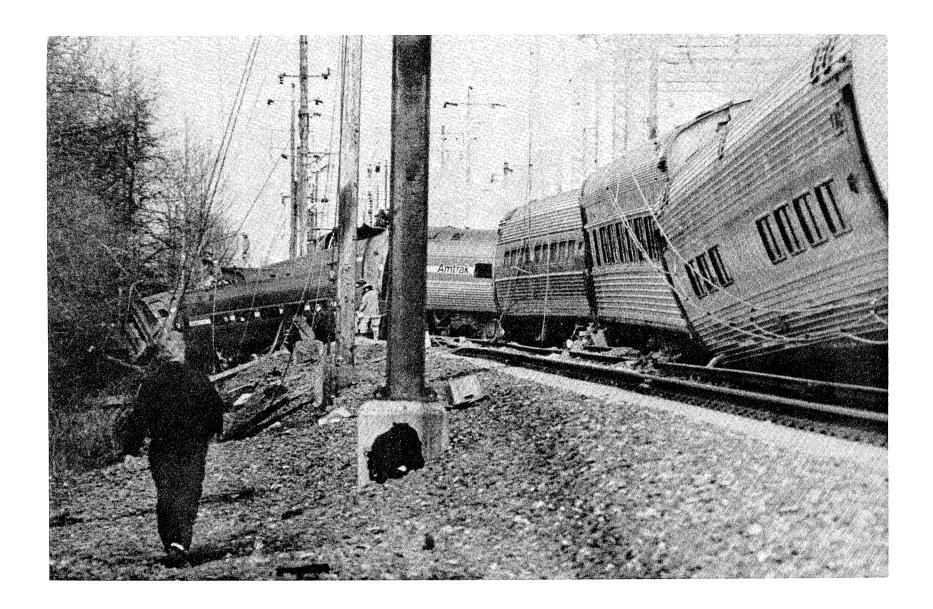
The head car of the passenger train, an unoccupied food service car, came to rest behind the trailing Amtrak locomotive. After passing over the food service car, the second car came to rest on its side on top of the rear of the trailing Amtrak locomotive unit. It was more or less perpendicular to the track, badly deformed and bent or crimped downward in the middle at an angle of about 30° (see figure 4). The third car stopped diagonally to the track, leaning to one side, on top of the crushed food service car. One end was crushed between the second and fourth cars. The fourth car stopped diagonally to the track, upright and with the car body essentially intact. The 5th through 12th cars remained coupled and upright, although the 5th, 7th, 8th, and 9th cars had jackknifed and stopped diagonally to the track. The other derailed cars remained in line with the track (see figure 5).

Figure 5. View from west side of the tracks facing north and showing derailed passenger cars of train 94. The car at the extreme right was the rear car of the train, and the car ahead of it was the second car from ther ear. The piles in the middle held up the catenary wires. Fallen catenary and high-voltage transmission lines are on both sides of the poles.

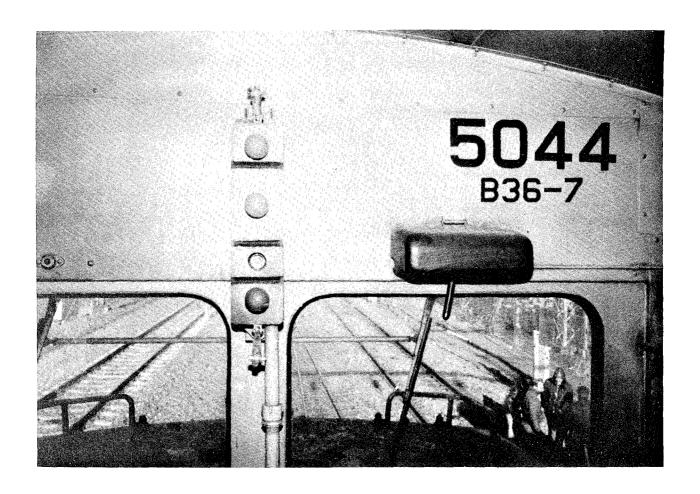
The four-aspect cab signal of unit 5044 was of the same configuration as the Amtrak AEM-7 locomotives; it was mounted in the middle of the forward cab bulkhead at the top of the windshield. The hinged cover had two sets of aspect ports set at oblique angles so that one could be viewed from each side of the cab. The top port was the "clear" aspect, the next two below were the "approach medium" aspect, the next below was the "approach" aspect, and the bottom port was the "restricting" aspect. There were screw-in receptacles in the signal box for four small white bulbs--one for each aspect. An examination of the signal box after the accident revealed that the bulb for the "approach" aspect was missing (see figure 13). All the other aspects had operative bulbs that were properly inserted.

Figure 13. Cab signal of Conrail unit 5044 with the cover removed; the bulb for the "approach" aspect is missing.

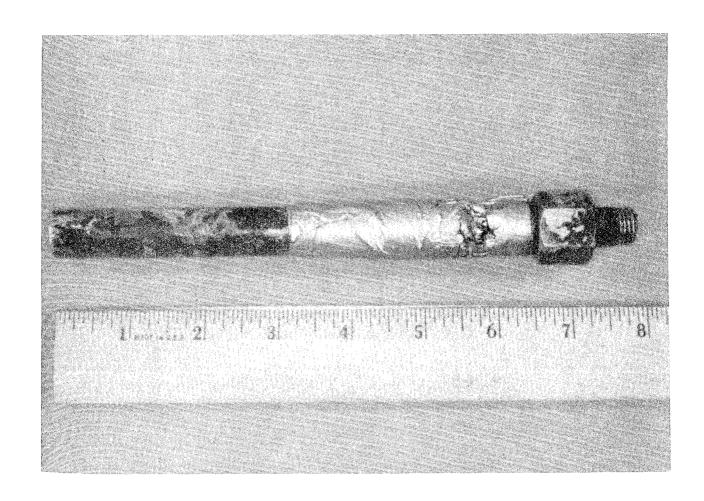
The 6 1/2-inch cab signal whistle was mounted in the airbrake control stand and could be accessed by unsnapping six latches that held the back cover in place. Following the accident, investigators removed the cover from the airbrake control stand of unit 5044 and found the port of the whistle wrapped tightly with duct tape (see figure 14). In this

Figure 14. The cab signal whistle removed from Conrail 5044 with the port covered by duct tape.

condition, no sound could be heard over the sound of the idling engine of an adjacent locomotive. When the tape was slit at the port, the whistle emitted sound at a normal 95- to 105-decibel level.

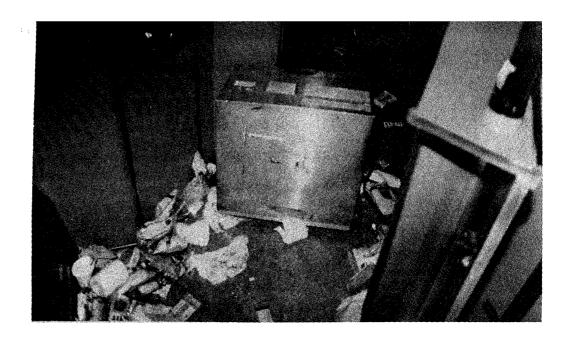
The train crewmembers related that most of the passengers remained calm and there was little panic, although the aisles of most of the coaches were blocked by fallen luggage. In the food service cars, unsecured microwave and convection ovens and other articles in the pantry sections were thrown to the floor and blocked movement through the cars (see figure 15).

Figure 15. Microwave oven and other pantry material blocking the aisle of the rear car of train 94, the food service car.

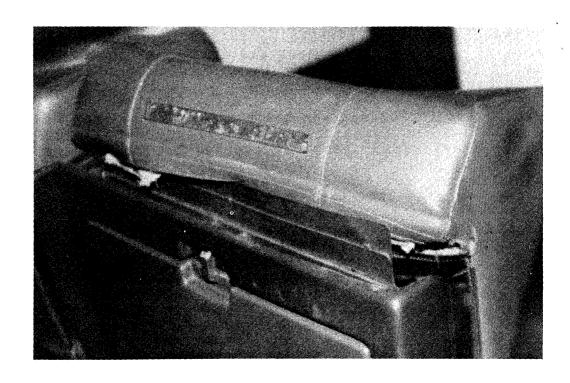
Passengers throughout the train reported that they had been struck by fallen luggage. Others stated they were injured when thrown into sheet metal seatbacks exposed by dislodged cushions (see figures 16 and 17). A number of seats had been dislodged altogether in the seventh car (see figure 18). Postaccident inspections revealed that the emergency windows in the 11th car, a rebuilt Heritage-class coach, could not be pulled inward as designed because the inside framing around them was too wide. Of the 45 passengers who were interviewed or who responded to questionnaires, 20 reproted they were struck by luggage falling from overhead racks; additionally, 8 of the 45 passengers reported they had difficulty in evacuating because of fallen luggage in the aisles.

Figure 16. Edges of sheetmetal seatback frames exposed by displacement of the cushions.

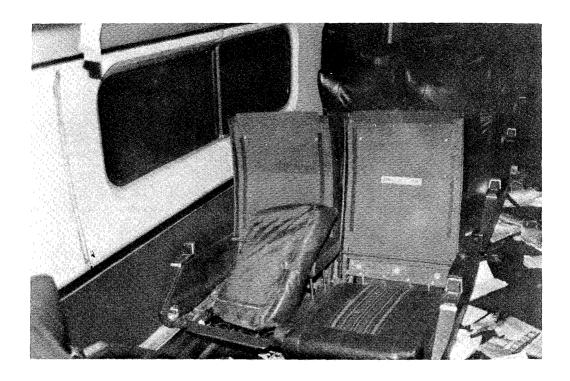
Figure 17. Missing seatback cushions and exposed sheetmetal seatback frames in a coach.

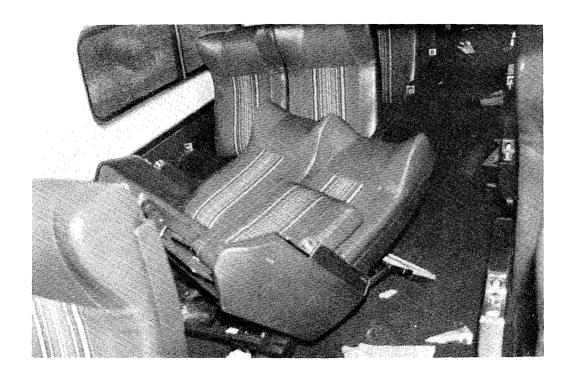
Figure 18. Seats separated from pedestals in the seventh car of train 94.

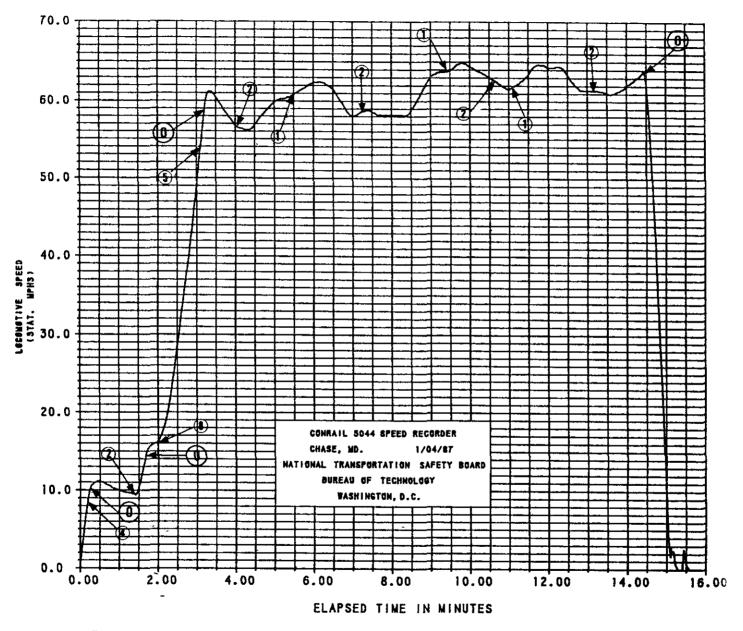
Figure 20: Speed data from the event recorder on Conrail locomotive 5044, the lead unit of train ENS-121, as reproduced in enhanced graphic form. The locations of changes in the throttle setting have been plotted on the graph. Throttle settings are 0 (idle) through 8 (fully open).

The data from the lead unit's recorder indicated that 15 minutes 15 seconds passed between the time train ENS-121 left the vicinity of Bay View yard office and the time it stopped at Gunpow. The times 1:15:15 and 1:30:30 were used as reference points for the start and stop times. At 1:17:15, 2 minutes after the start, the throttle was opened to the eighth or full throttle position; at the time, the train was moving at about 15.5 mph. At 1:18:20 and 52 mph, the throttle was reduced from the eighth to the fifth position, and 10 seconds later, at 57 mph, the throttle was reduced to idle. Acceleration ceased and deceleration began at about 60 mph; at about 56 mph, the throttle was opened to the second position.
