NATIONAL TRANSPORTATION SAFETY BOARD

RAILROAD ACCIDENT REPORT

**COLLISION AND DERAILMENT
OF AMTRAK TRAIN 6
ON THE BURLINGTON NORTHERN RAILROAD
RUSSELL, IOWA
OCTOBER 12, 1987**

NISB/RAR-88/04

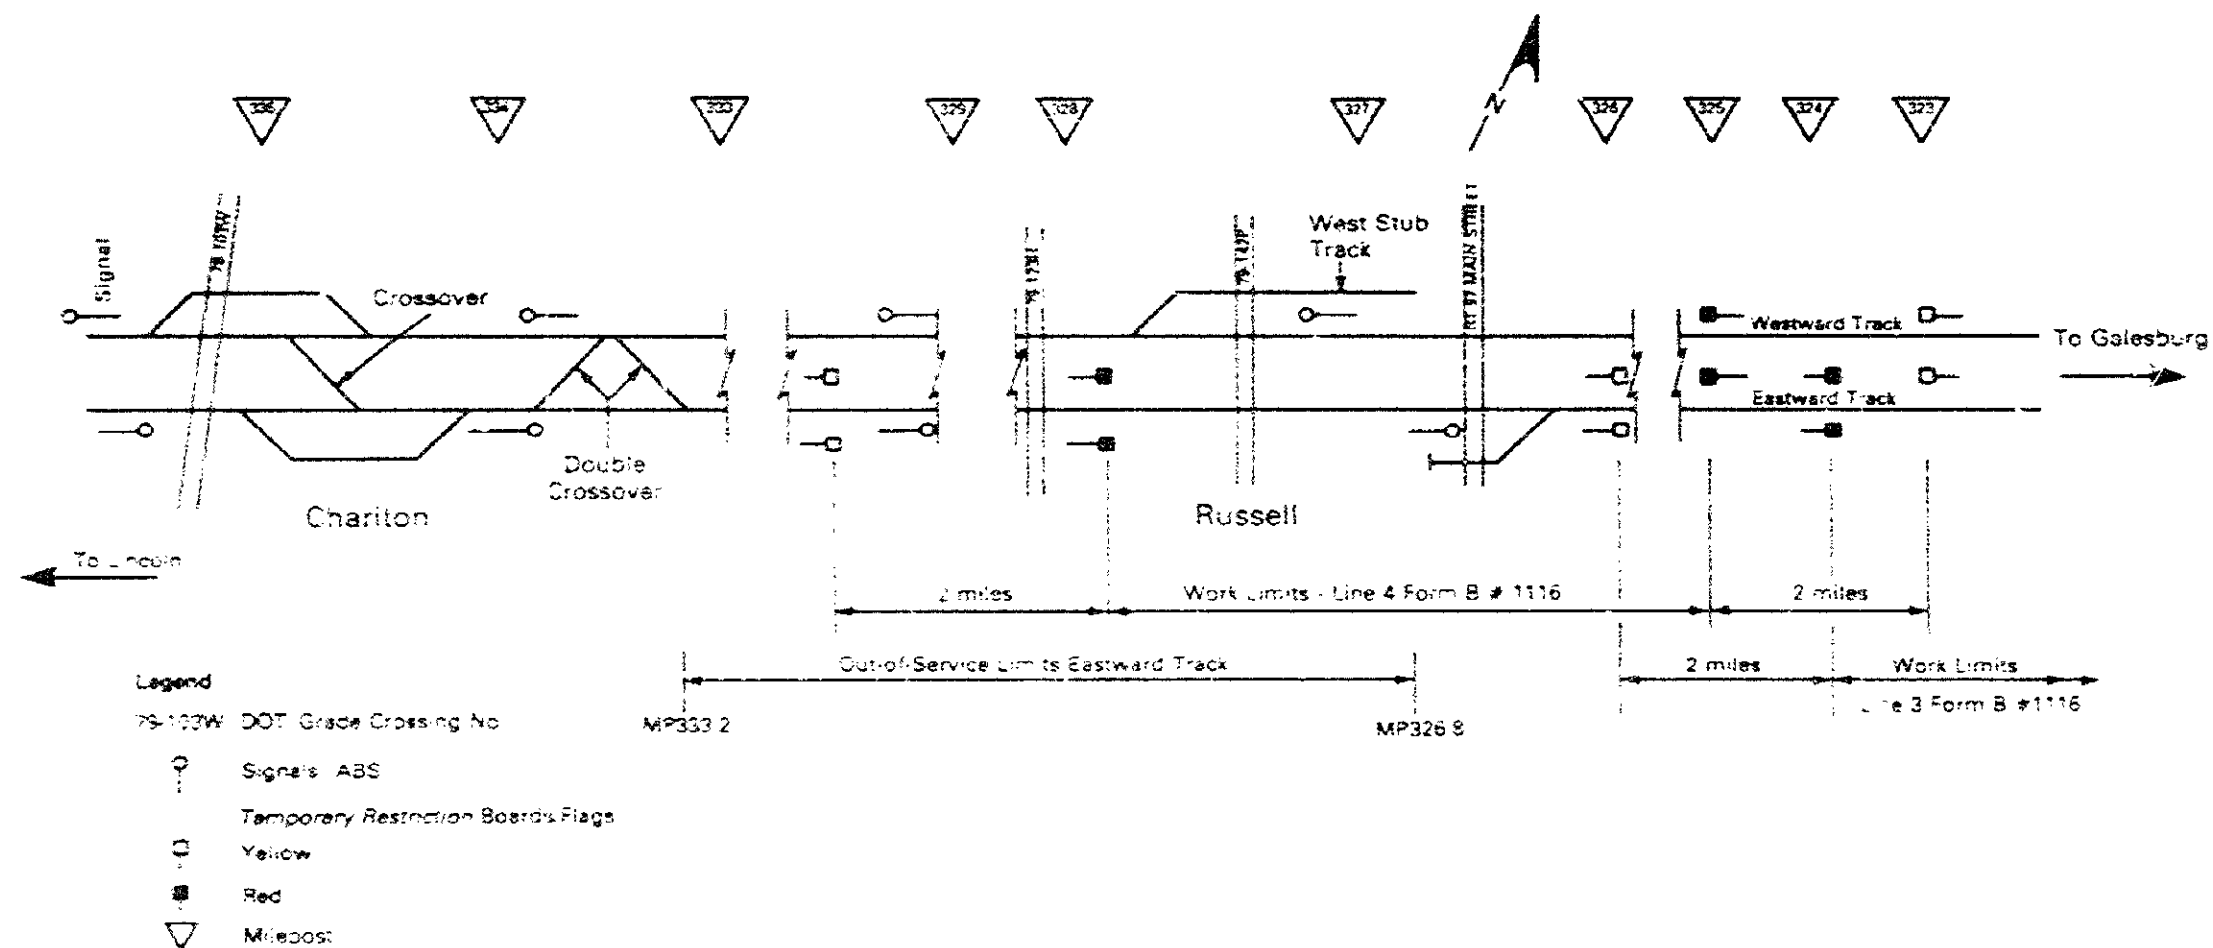
Figure 2.-- Chariton to Russell track conditions - October 12, 1987.

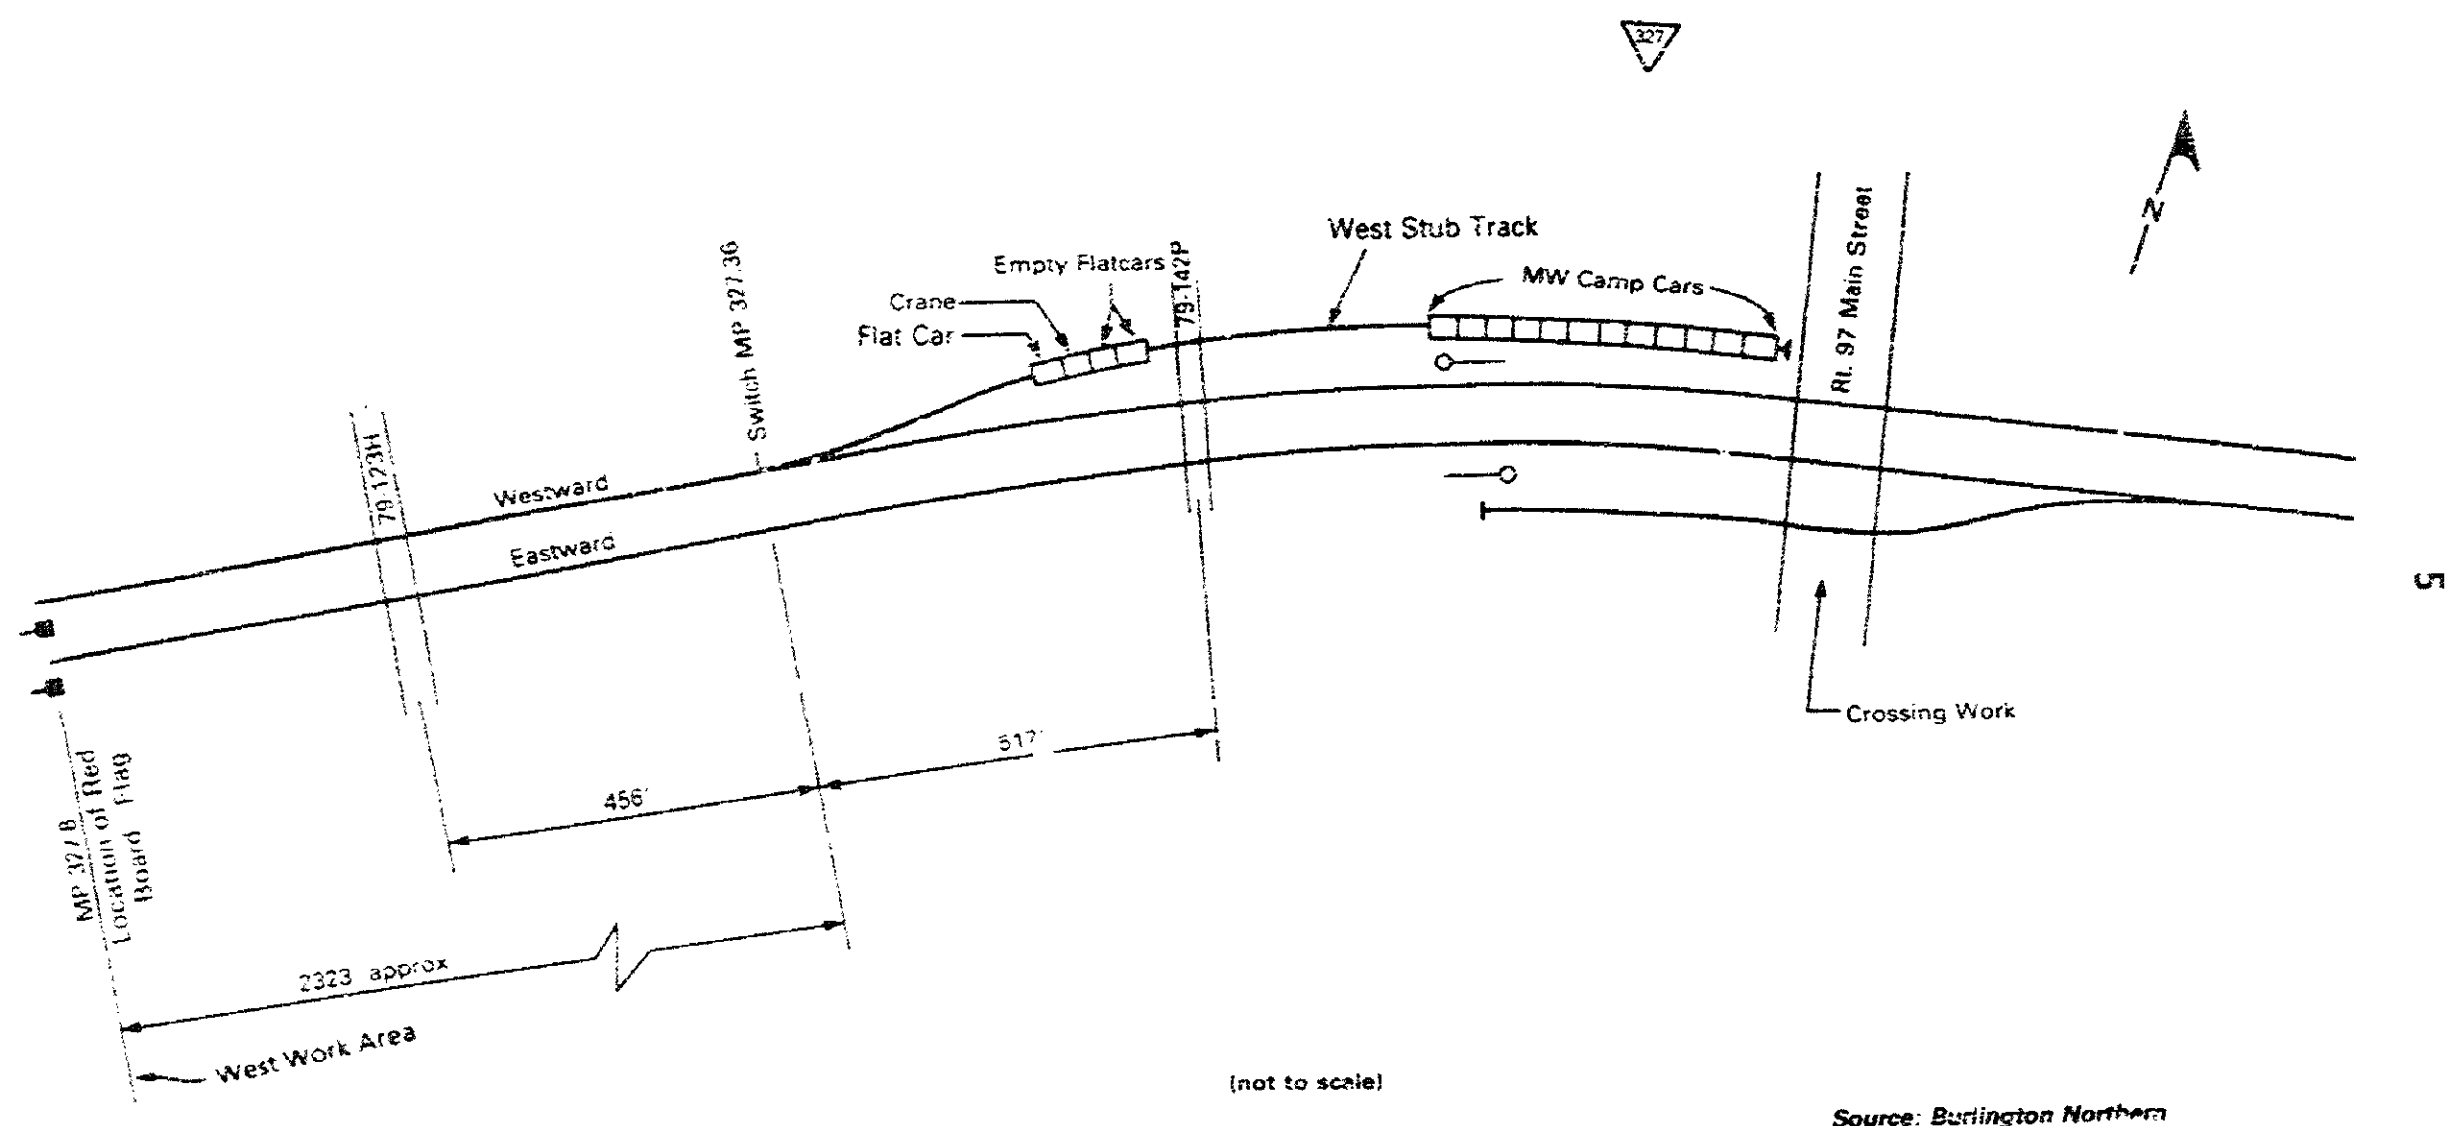
Figure 3.--Russell west stub track - October 12, 1987

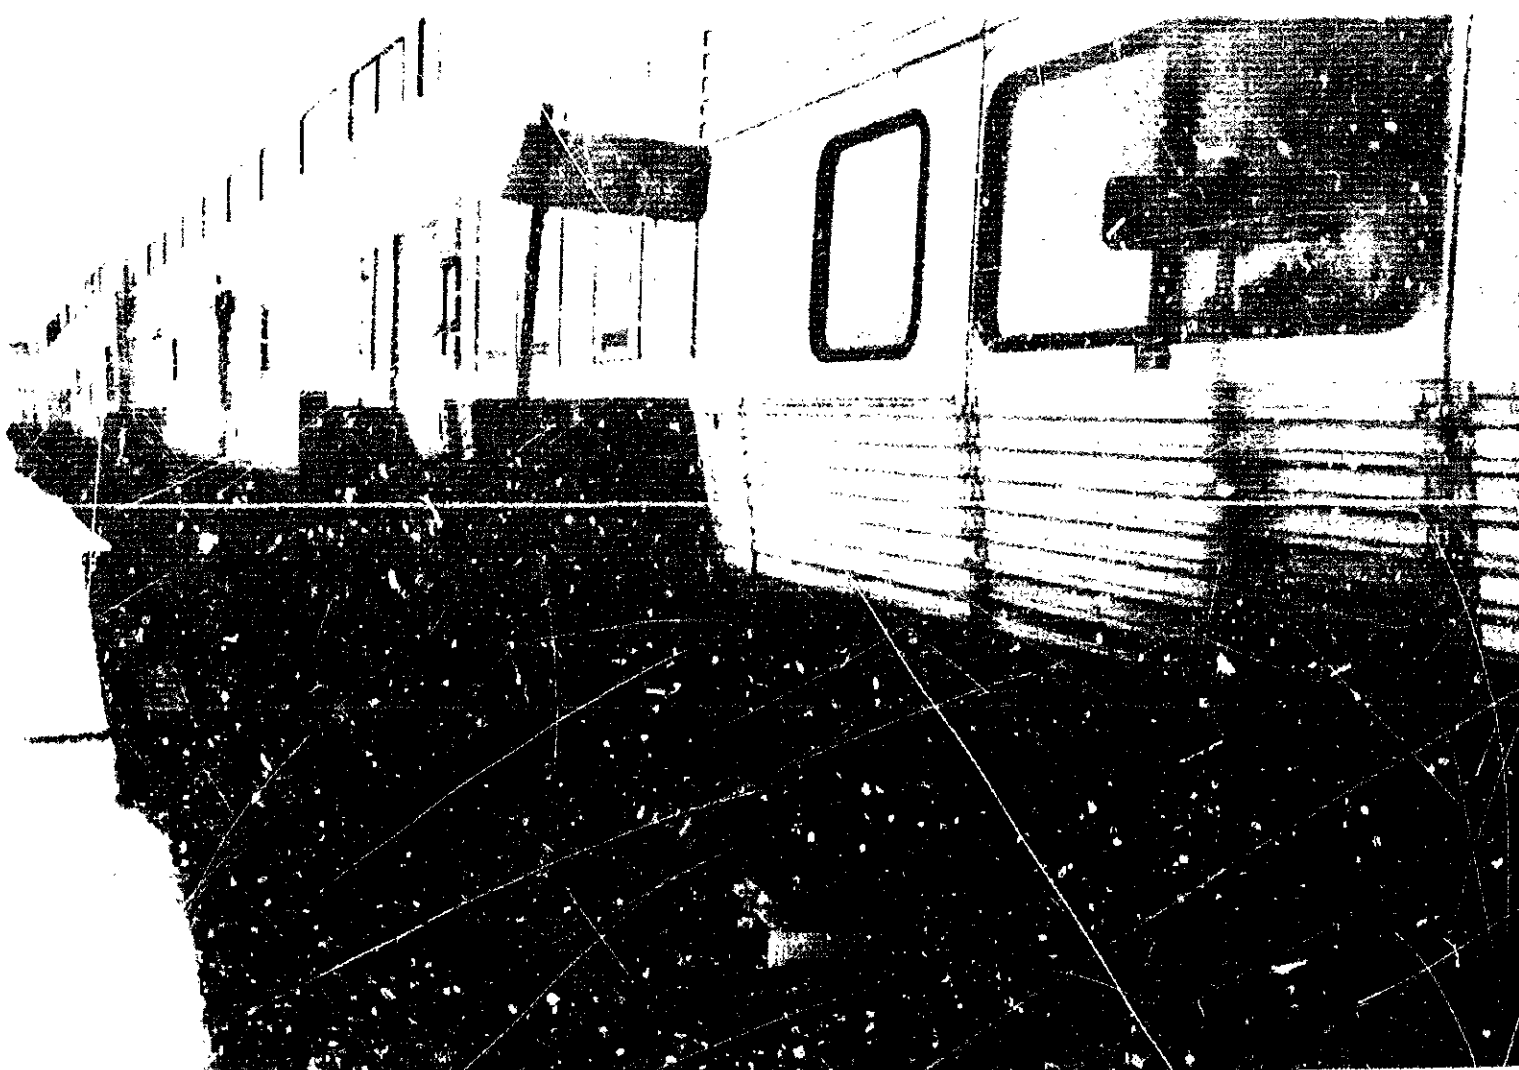
Figure 5.--AMT 34076 on turnout switch point rails
(north side view).

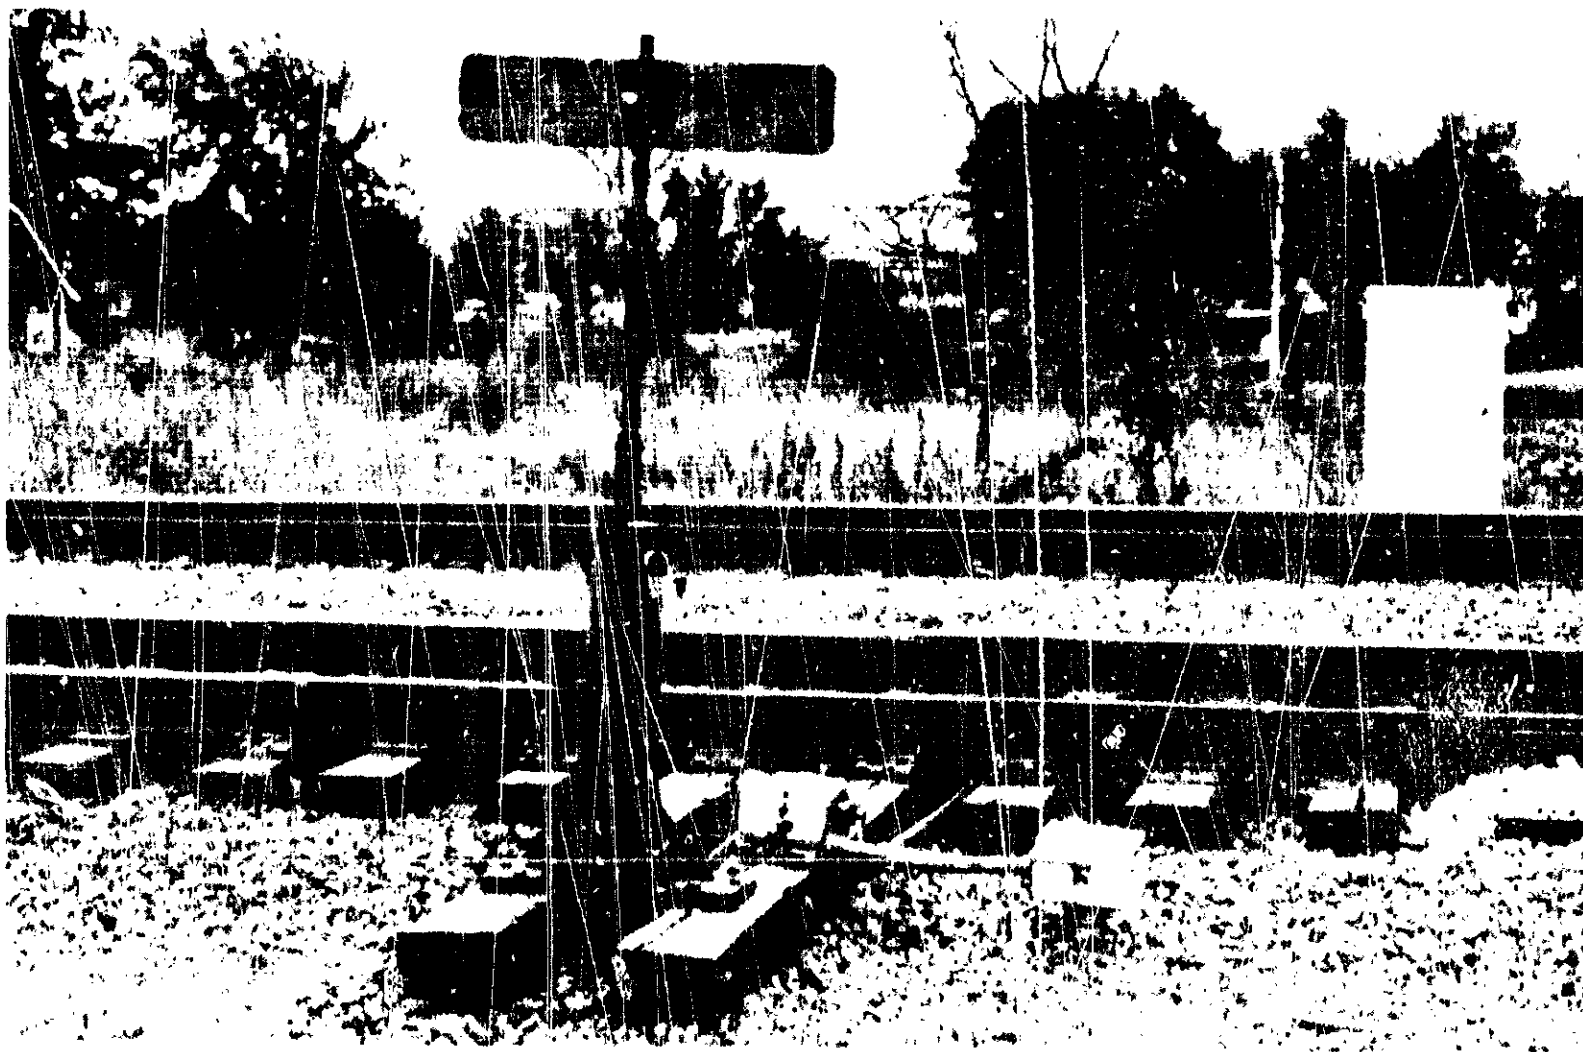
From the track switch located at about MP 327.36, the west stub track extends eastward for about 3/4 mile on the north side of the double main track. The track switch was part of a No. 11 turnout.⁷ The switch points, 19 feet 6 inches in length, were mated to undercut stock rails. The switch stand was a Racor column-throw high stand, without a switch-point locking mechanism. It was equipped with a partially rusted, red-painted banner measuring 8 inches by 36 inches and located approximately 5 feet above the top of the rail. (See figure 11.)

Figure 11.—West stub track switch banner.
