RAILROAD ACCIDENT REPORT

REAR-END COLLISION OF
AMTRAK/MASSACHUSETTS BAY
TRANSPORTATION AUTHORITY COMMUTER TRAINS,
BOSTON, MASSACHUSETTS,
NOVEMBER 12, 1987

NTSB/RAR-88/05

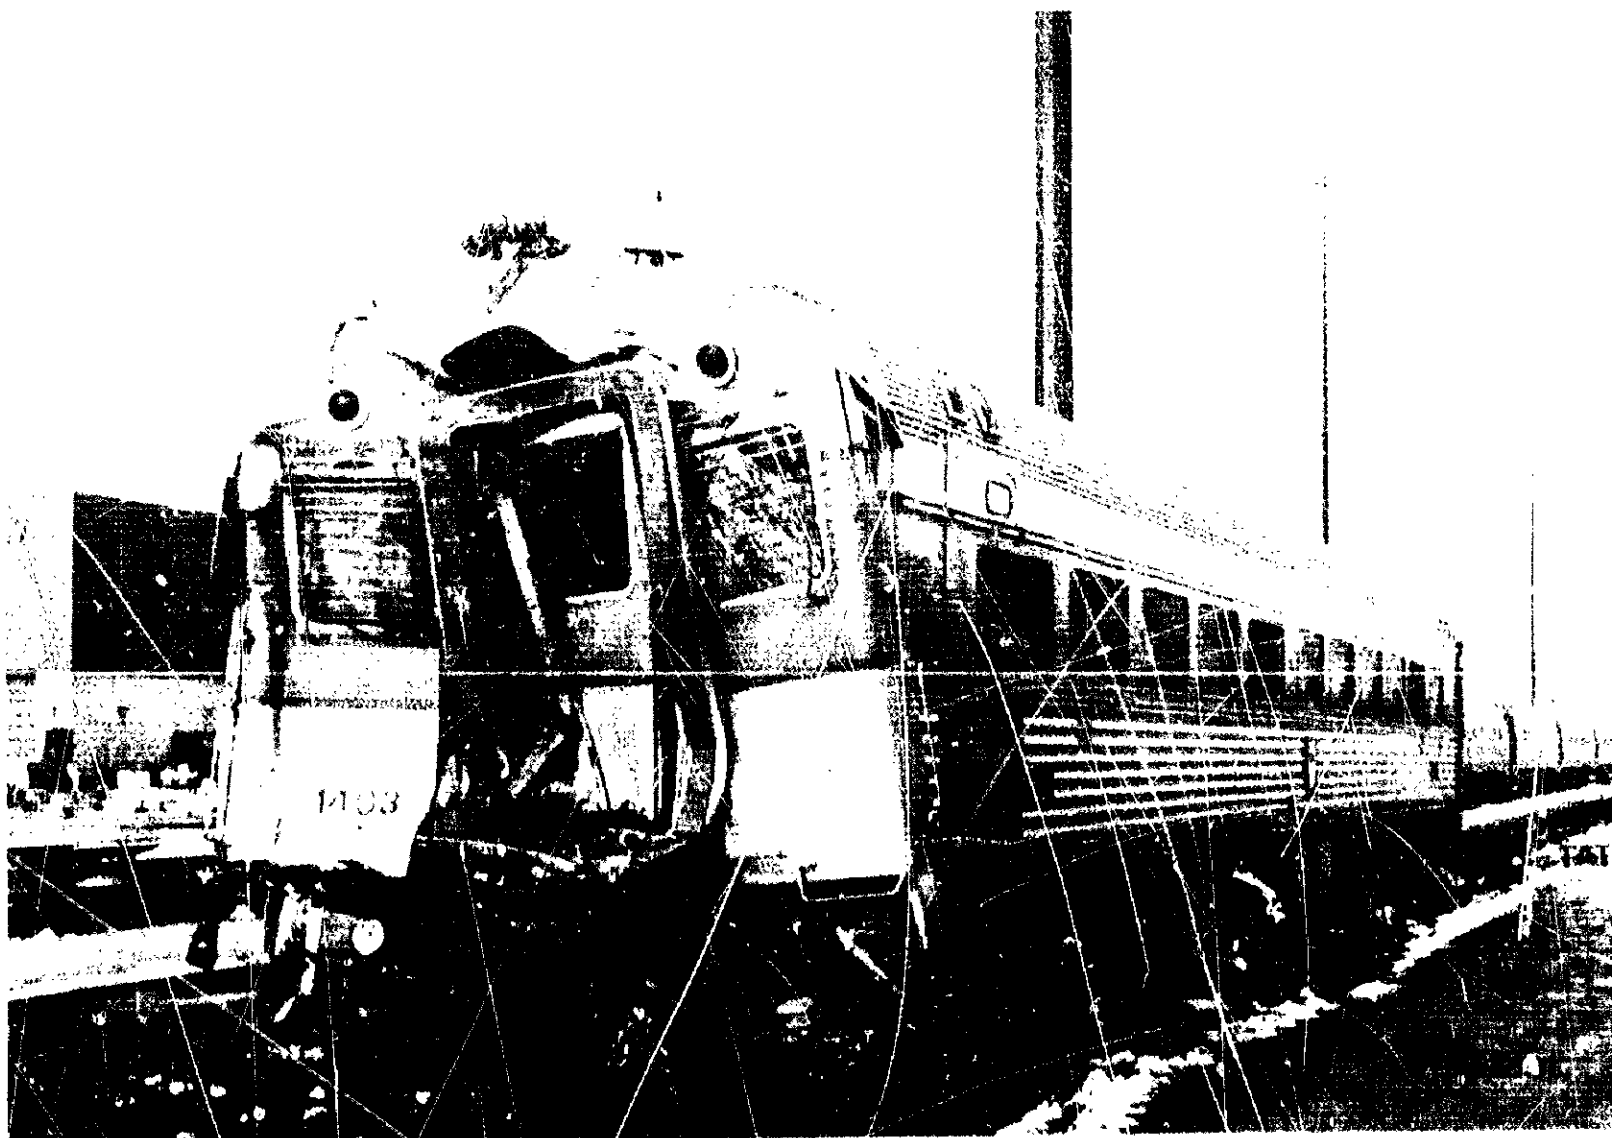
Figure 4.--Damage to the control car (1403) of train 8114.

There was major crush damage to control car 1403 of train 8114. (See figure 4.) At the engineer's control position the cab was displaced 4.5 feet rearward, the floor was displaced 17 inches upward, and sheet metal displacement extended 2.5 feet beyond the left outboard side. (See appendix C.)

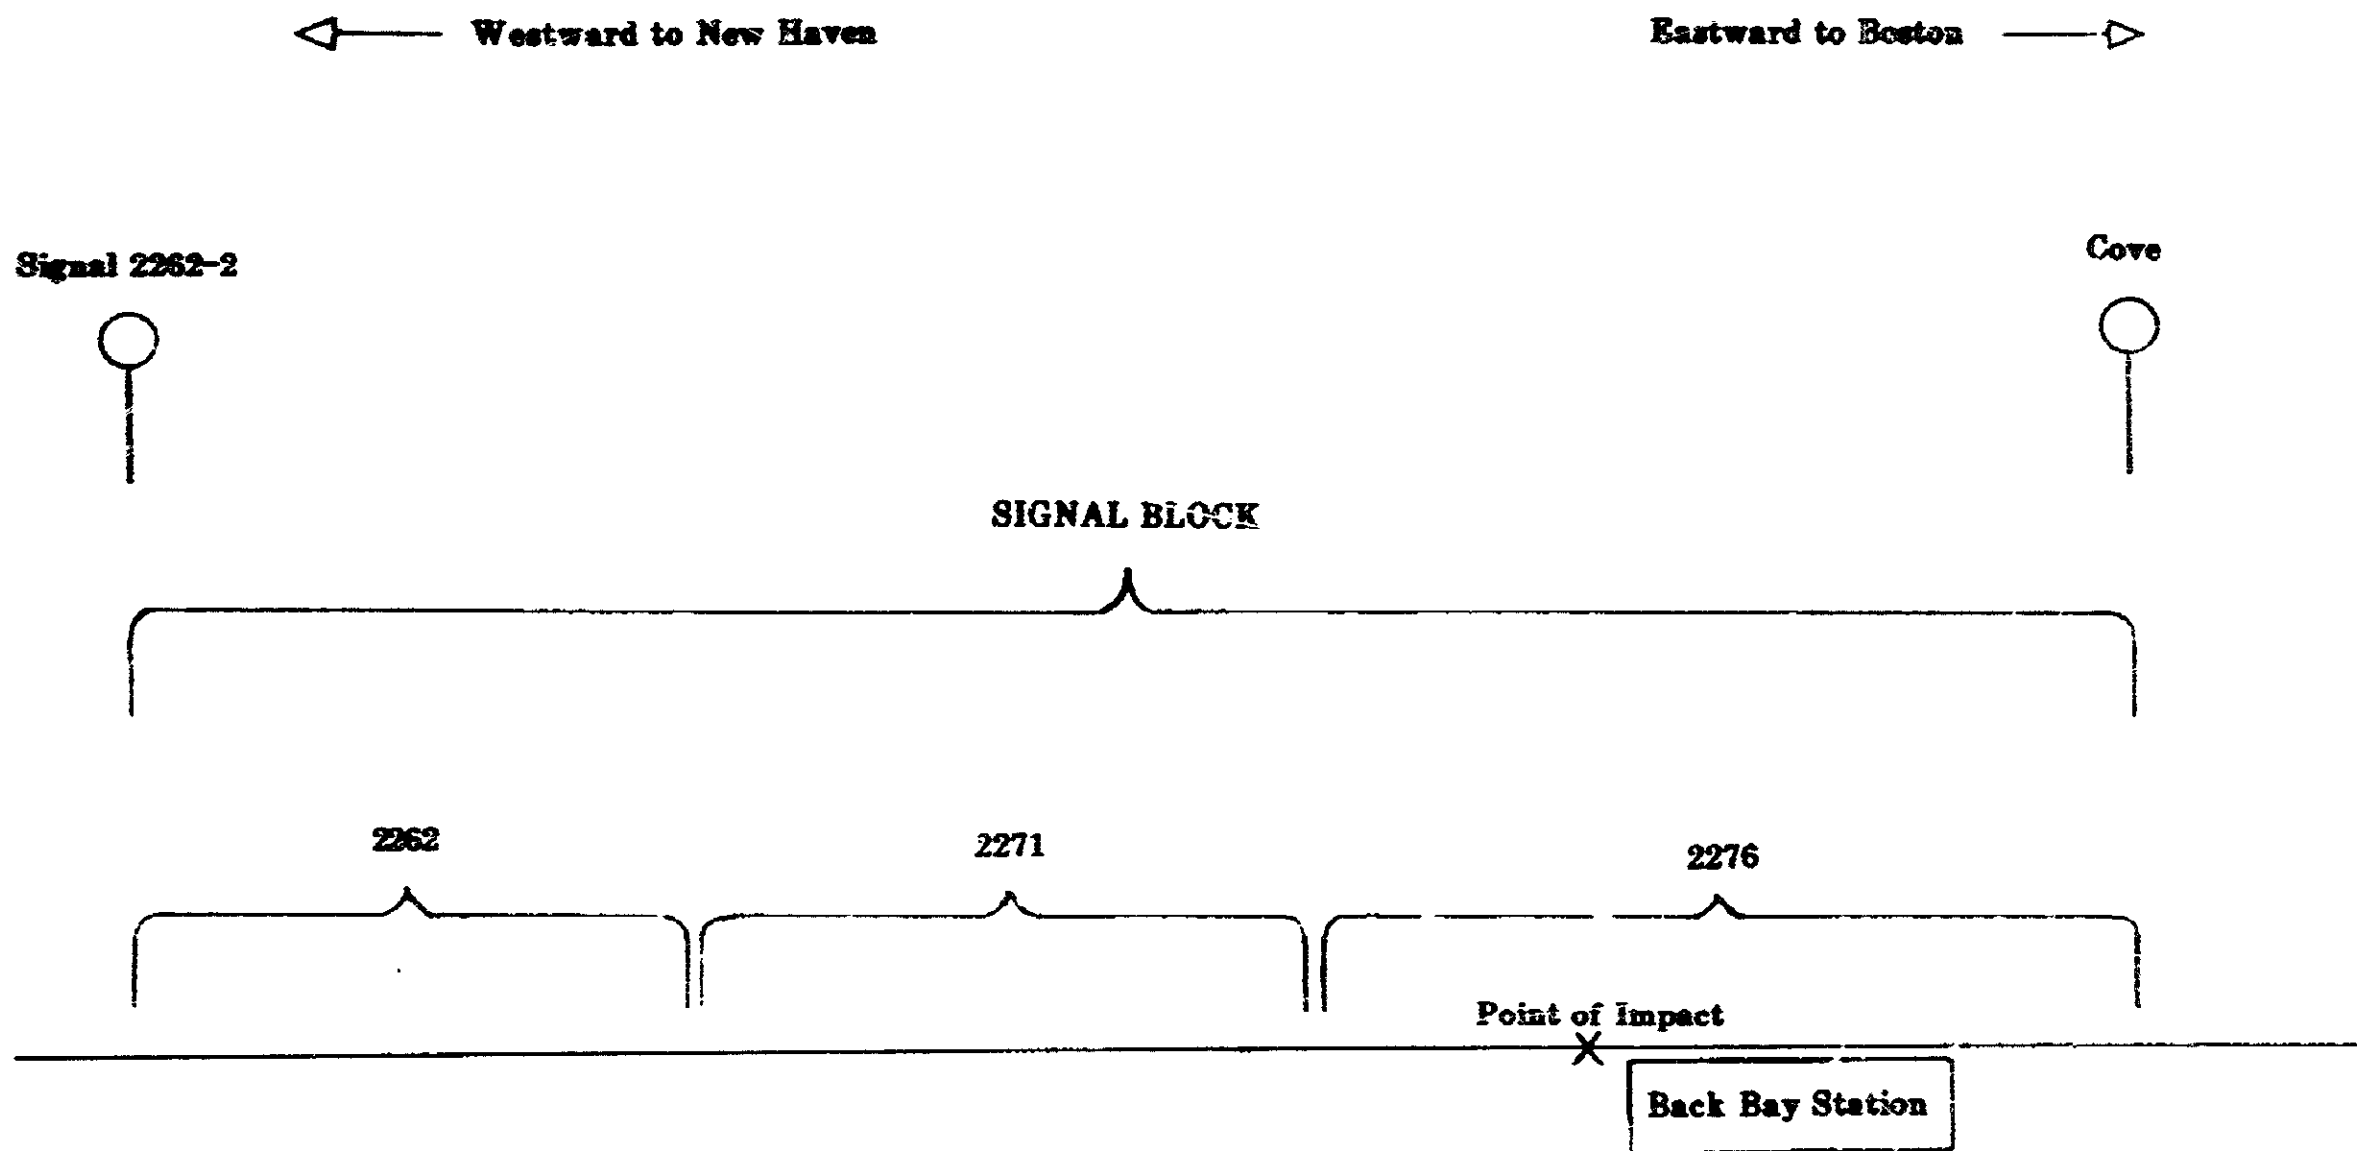
Figure 5.—Signal block section at the accident site.

Train 8110 entered the signal block governed by wayside signal 2262-2 ahead of train 8114. Wayside signal 2262-2 displayed a false proceed indication (approach aspect) to train 8110 because with train 8910 in the signal block, wayside signal 2262-2 should have displayed a stop and proceed aspect (train 8110's cab signal went to restricting). Further, field tests conducted after the accident established that wayside signal 2262-2 displayed false proceed indications with a train in the signal block. The investigation determined that the signal failure resulted from excessive wear on the contacts of the 2TBPR relay because of a unique design feature of the signal systems.

The track circuits misinterpreted the cycling reset feature as a code and improperly displayed an approach aspect on the wayside signal when a stop and proceed aspect was required and intended.

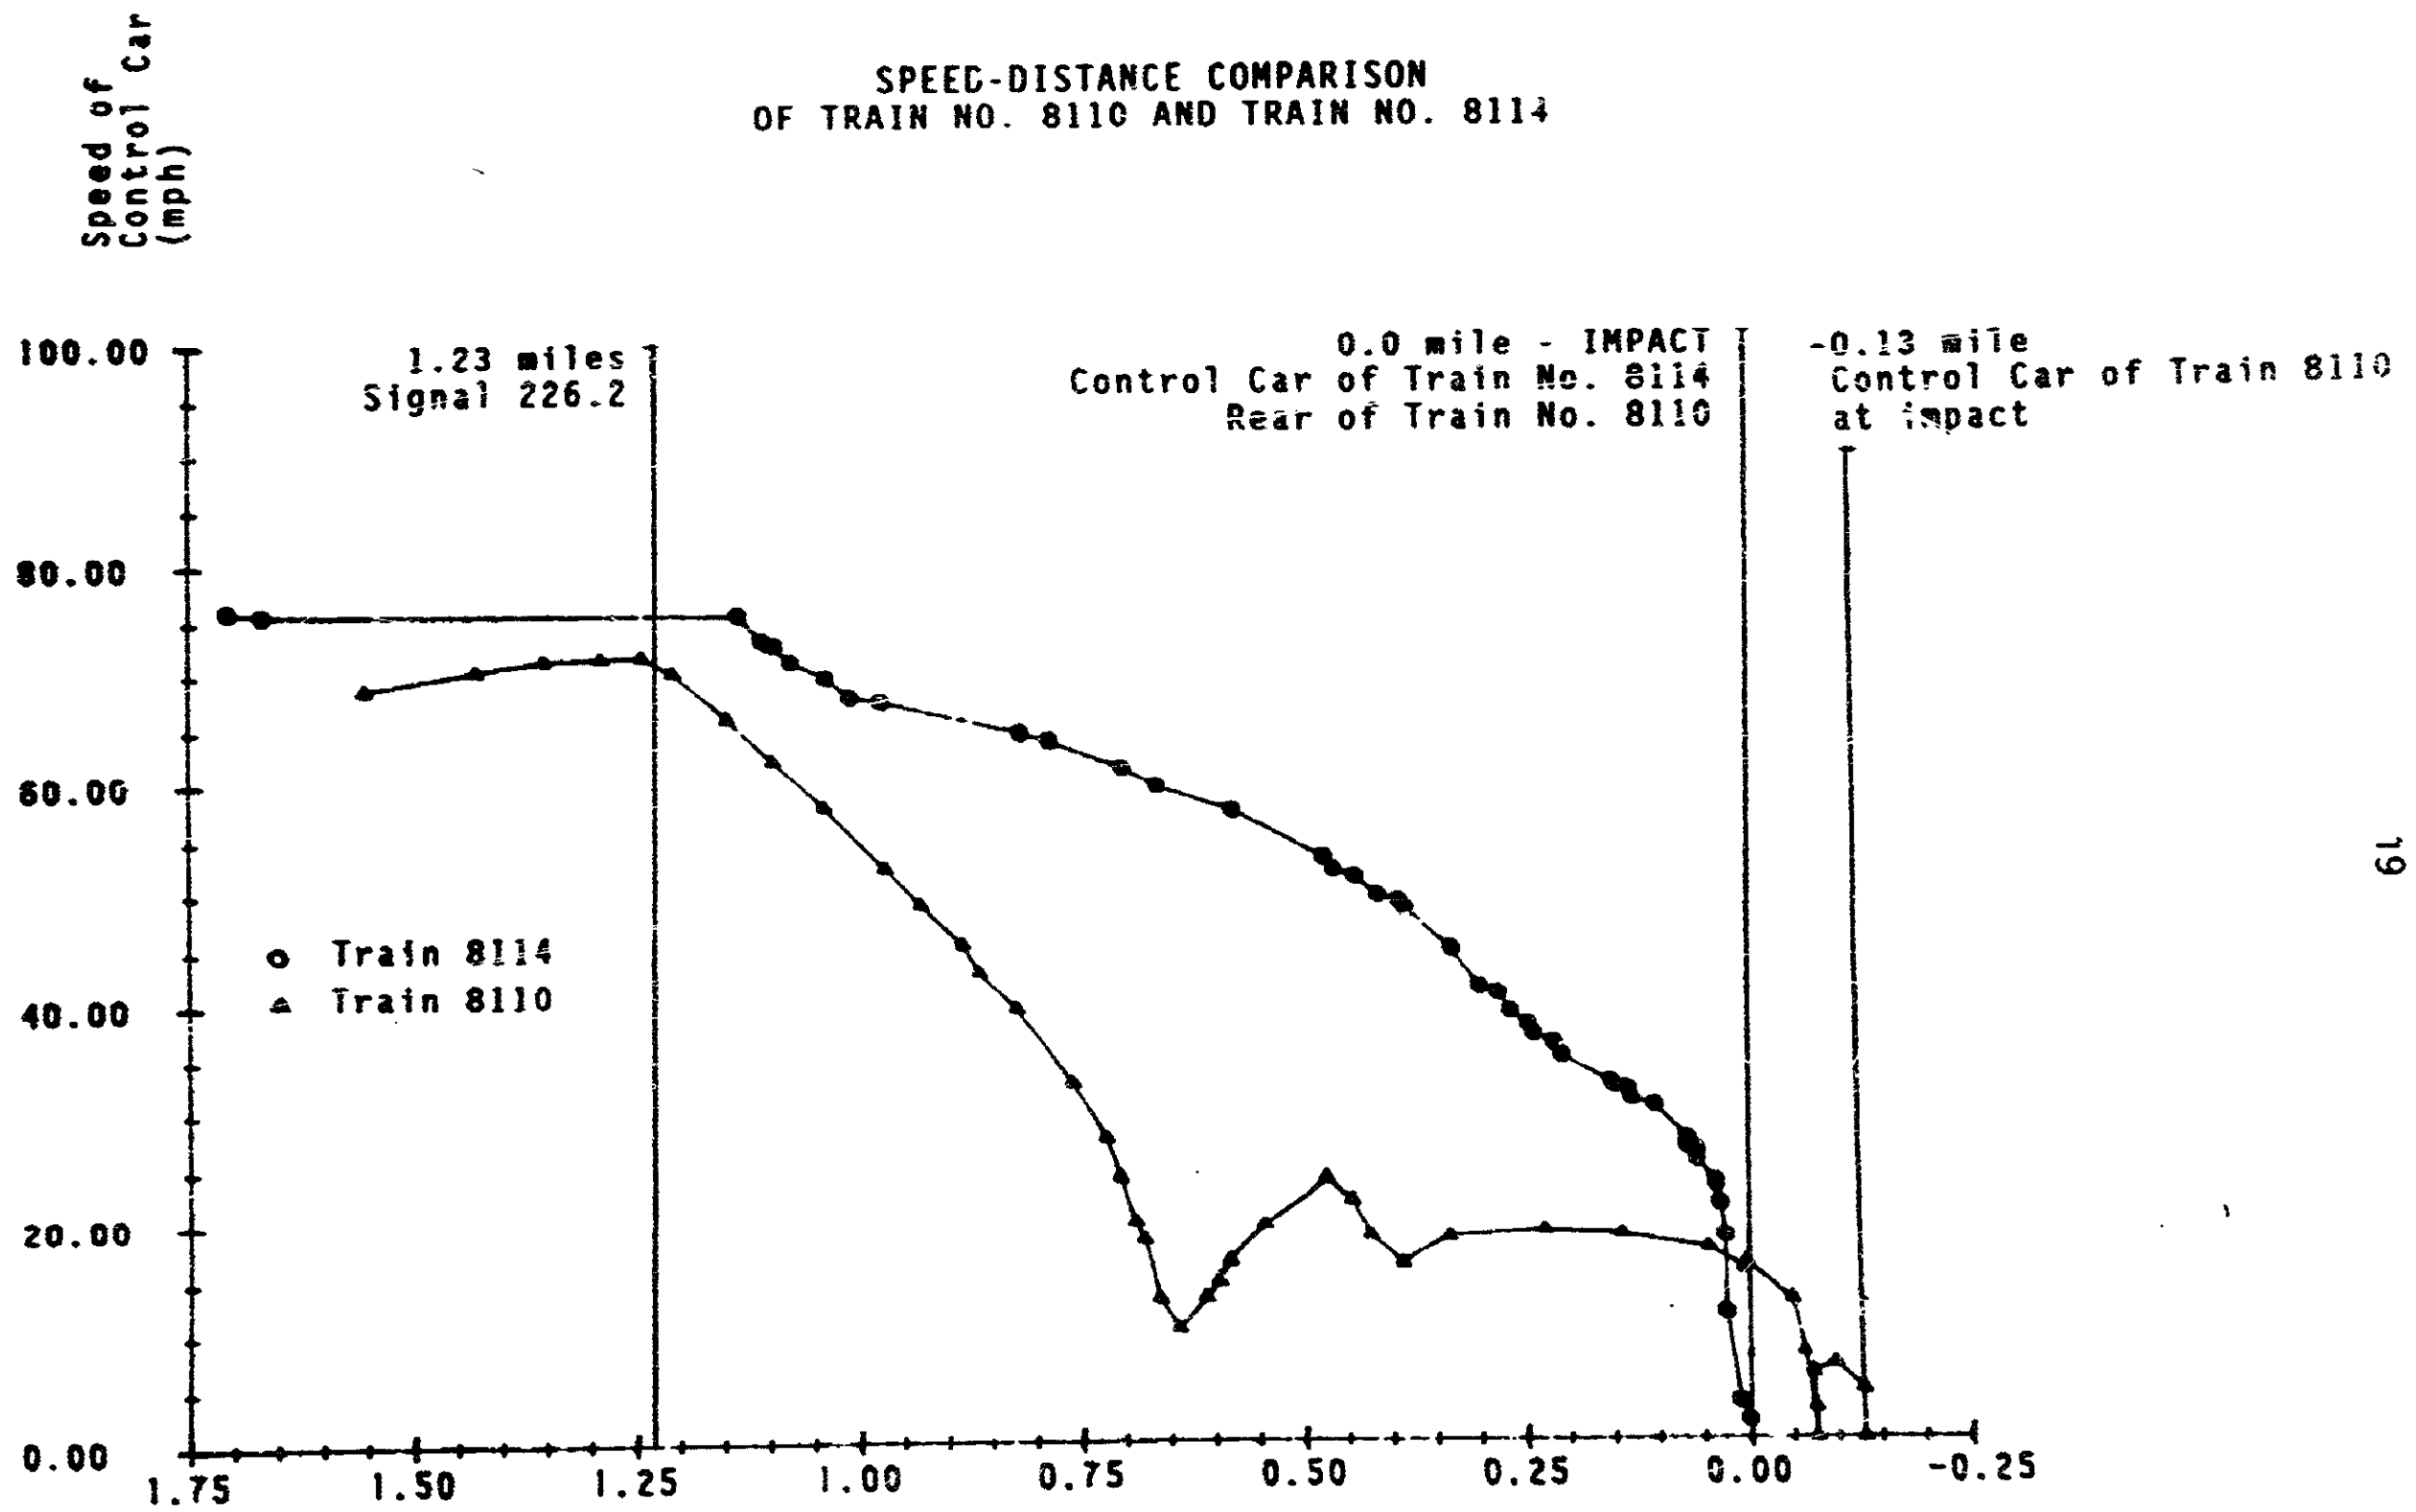
Figure 6.--Speed-distance comparison of train No. 8110 and train No. 8114.

Speed tape comparisons were consistent with the testimony of the engineers and indicated that each engineer had a different method of train handling. The engineer of train 8110 began to apply service braking 53 feet (0.5 seconds) before reaching wayside signal 2262-2. When the engineer of train 8110 observed the cab signal degrade to restricting after the control car passed wayside signal 2262-2, he continued the brake application to the maximum service braking available and simultaneously reduced throttle, which resulted in a sharp deceleration rate and an available stopping point 2,630 feet short of the point of collision. Train 8114 did not begin to decelerate until 480 feet (4.3 seconds) past signal 2262-2. After the engineer of train 8114 applied maximum service braking, the deceleration rate still did not drop as sharply as that of train 8110. Since both trains had the same braking ratio, train 8114 would have had a braking advantage over train 8110 because train 8114 had an extra control car that applied sand to the rail head. The Safety Board concludes that the primary difference in stopping distance was the use of locomotive power by the engineer of 8114 after he had applied the trains' brakes in a manner (in suppression) that satisfied the requirements of the automatic train control system. Using train 8110's braking curve, without any braking advantage factored in, train 8114 could have stopped 2,150 feet short of the point of collision by using train 8110's braking method. The collision occurred at about 11 mph.

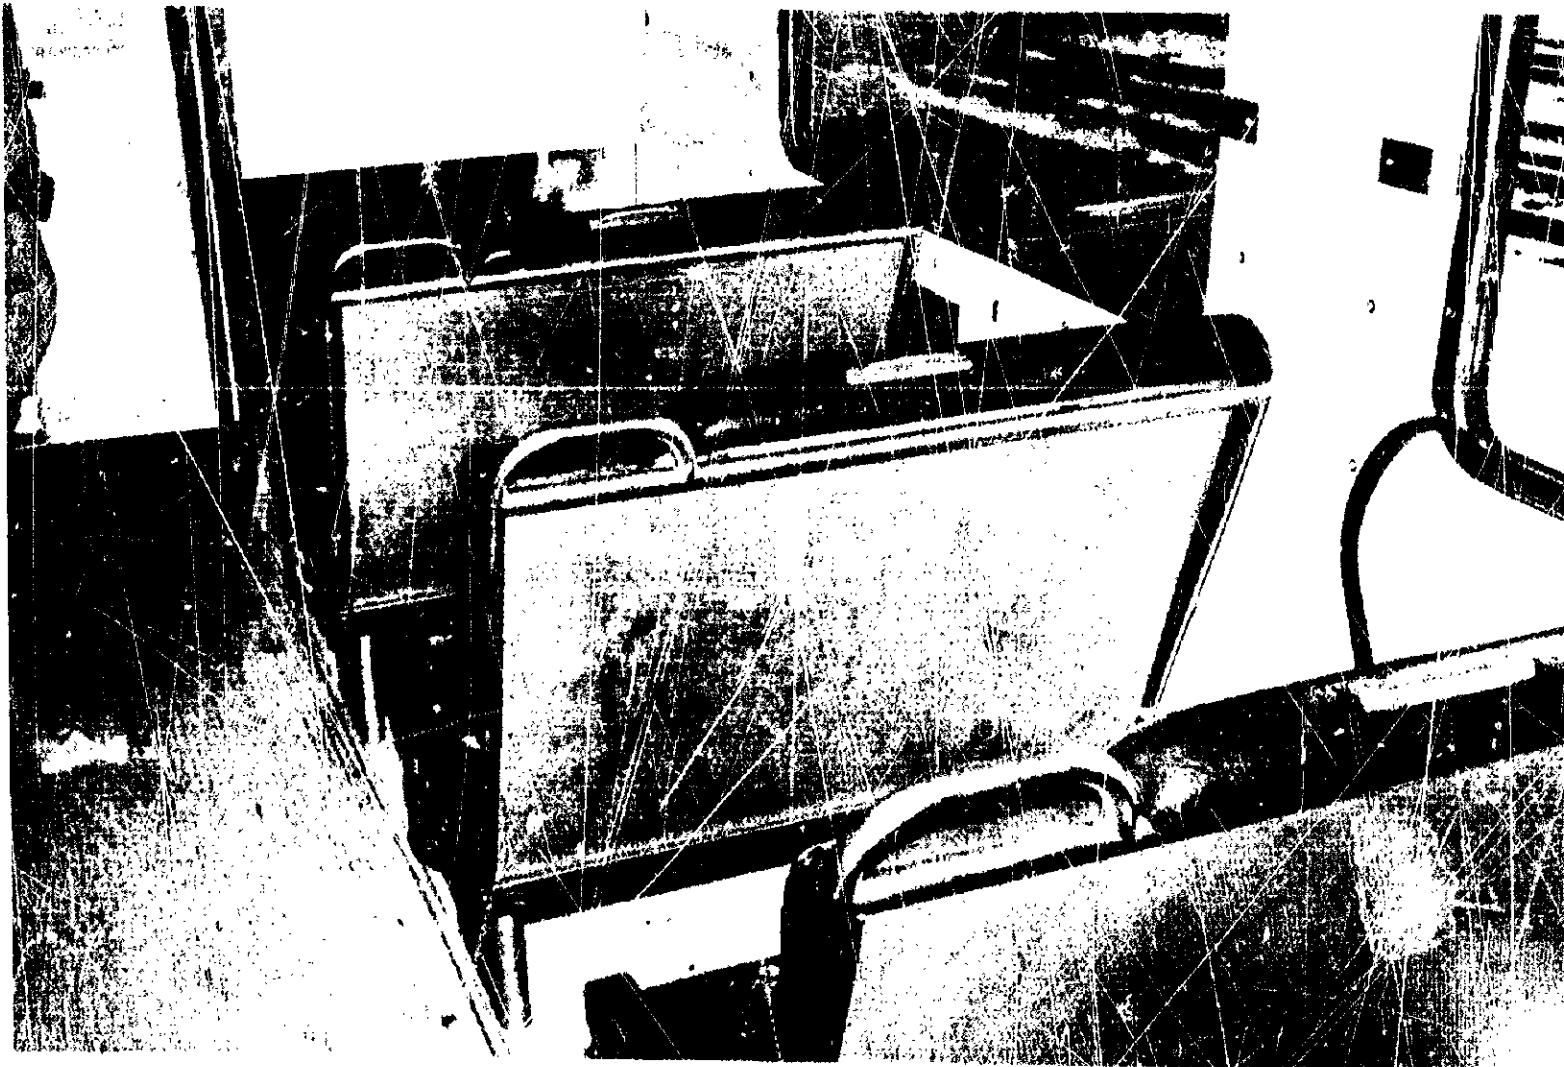
Evidence of emergency triage was found near the rear seats of this car. Bandage material and blood splatters were scattered about the floor.

Figure 1.--Blood on facing seatback.
