PB91-916302
NTSB/RAR-91/02

RAILROAD ACCIDENT REPORT

COLLISION AND DERAILMENT
OF NORFOLK SOUTHERN TRAIN 188
WITH NORFOLK SOUTHERN TRAIN G-38
AT SUGAR VALLEY, GEORGIA
AUGUST 9, 1990

**ADOPTED: JULY 9, 1991
NOTATION 5367A**

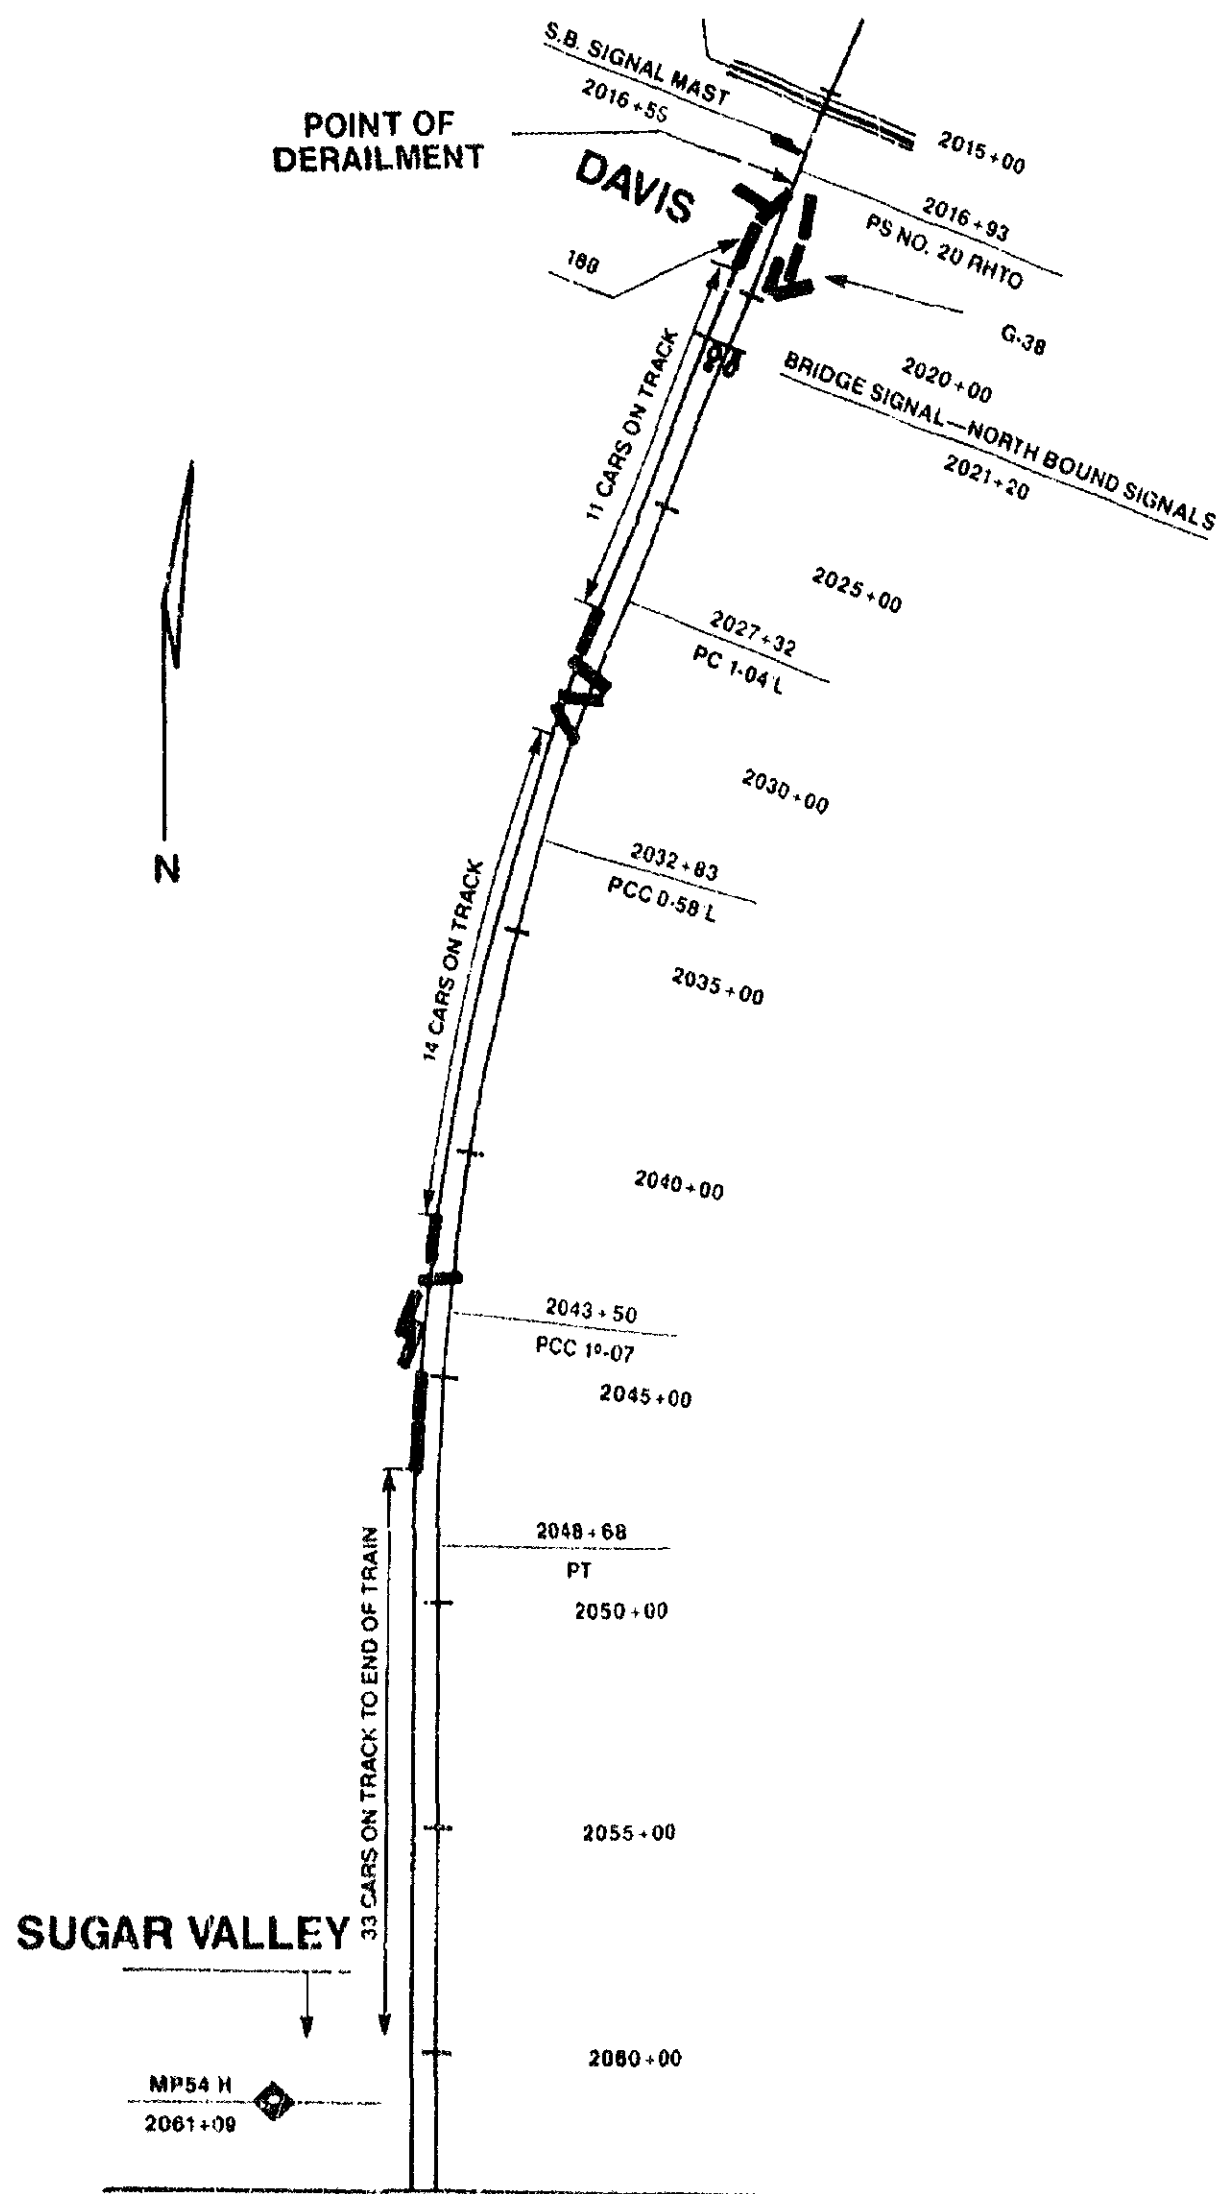
Figure 2.--Accident site CP SUGAR Valley to CP DAVIS.

Train 188 proceeded through the siding and failed to stop at the northward home signal at the north end of the siding, CP DAVIS. It continued on to the turnout, striking train G-38 nearly head on. Train G-38 had been given clear signals to operate southward on the main track over the normal switch at CP DAVIS and on to CP SUGAR VALLEY and beyond. To find out why the engineer of train 188 did not stop his train and why the conductor, flagman, and brakeman did not intervene, the Safety Board examined the work and rest cycle of the traincrew, their physical condition, NS operating rules 34 and 106, the effectiveness of the alerter system, and the influence that positive train separation provided by the ATCS could have had on this accident. Another area investigated was the locomotive diagnostic computer checking.

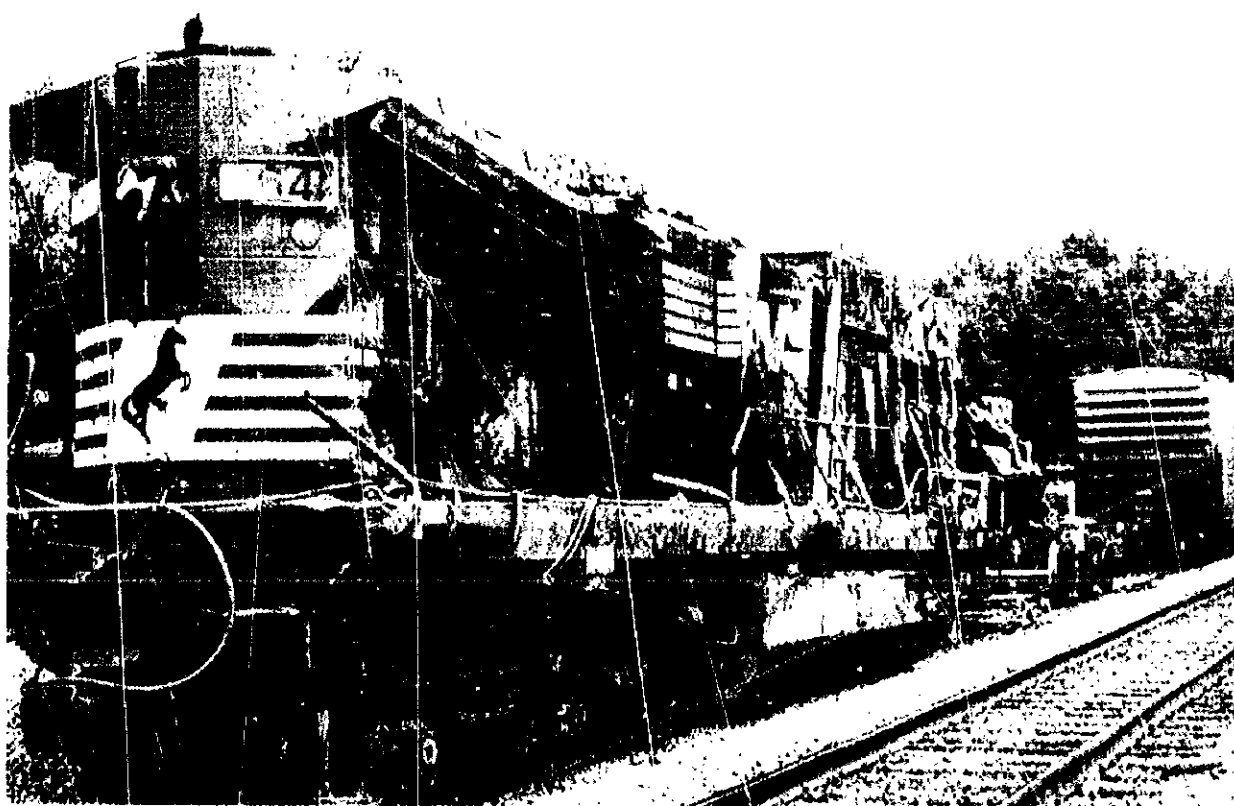
Train 188.--The lead locomotive unit derailed and came to rest about 90 feet to the west of and at a 90-degree angle to the track. It lay on its right side with the short hood pointed toward the west. Both trucks were separated from the unit, and its fuel tank was dented and ruptured. Fire had damaged the short hood and the part of the long hood that was over the fuel tank. The right side of the control cab was severely crushed inward, and no survivable space remained between the conductor's console and the right exterior wall. The interior of the cab was extensively damaged by heat (see figure 3). The grab rails along the exterior right side had collapsed inward. The power switch was on, and the dynamic braking switch was off.

Figure 3.--Two photos of damage to the lead unit, NS 8641, of train 188.

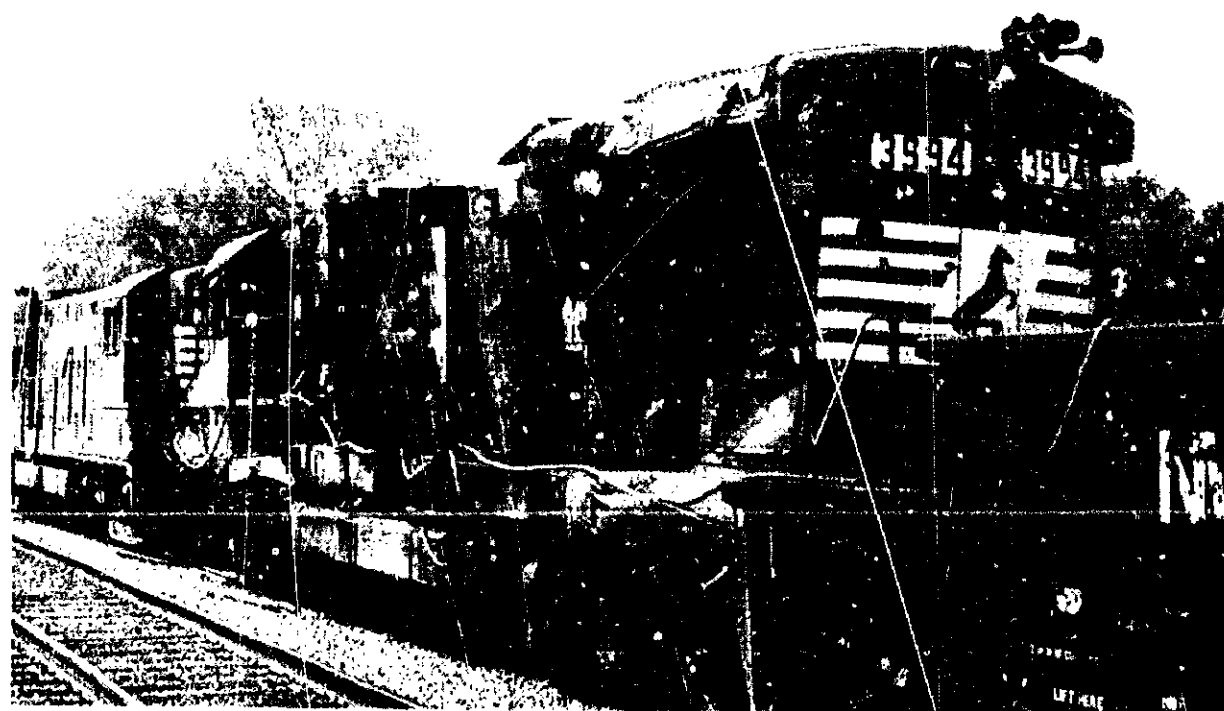
Train G-38.--The lead locomotive unit derailed to the east of the main track; it lay on its right side with the long hood pointed south. All the sheet metal that had surrounded the engine was torn away. The locomotive was off its trucks, and its fuel

tank was torn off. The cab interior was intact and had no apparent structural damage, but thermal damage was extensive. (See figure 4.)

The sheet metal and grab rails of the right front of the second locomotive unit were damaged thermally and structurally. (See figure 4.) The fuel tanks were punctured, and the locomotive was on its right side. The interior of the cab was not visibly damaged.

Figure 4.--Two photos of damage to the locomotive of train G-38.
