PB92-916302
NTSB/RAR-92/01/SUM

RAILROAD ACCIDENT/INCIDENT SUMMARY REPORT

CHASE, MARYLAND--APRIL 12, 1991

Accident Number:	DCA-91-MR-005
Location:	Chase, Maryland
Date and Time:	April 12, 1991, 0309 eastern daylight time
Railroad:	National Railroad Passenger Corporation (Amtrak)
Type of Trains:	Amtrak Extra 390 North light locomotive with three locomotives in tow and Conrail freight train UMP-22B
Persons on Board:	Amtrak, two crewmembers; Conrail, five crewmembers
Injuries:	One serious and one minor
Damage:	\$800,000
Type of Occurrence:	Collision and derailment
Phase of Operation:	Amtrak--en route northbound on number 2 main track; Conrail--southbound crossing over from number 3 main track to "A" main track

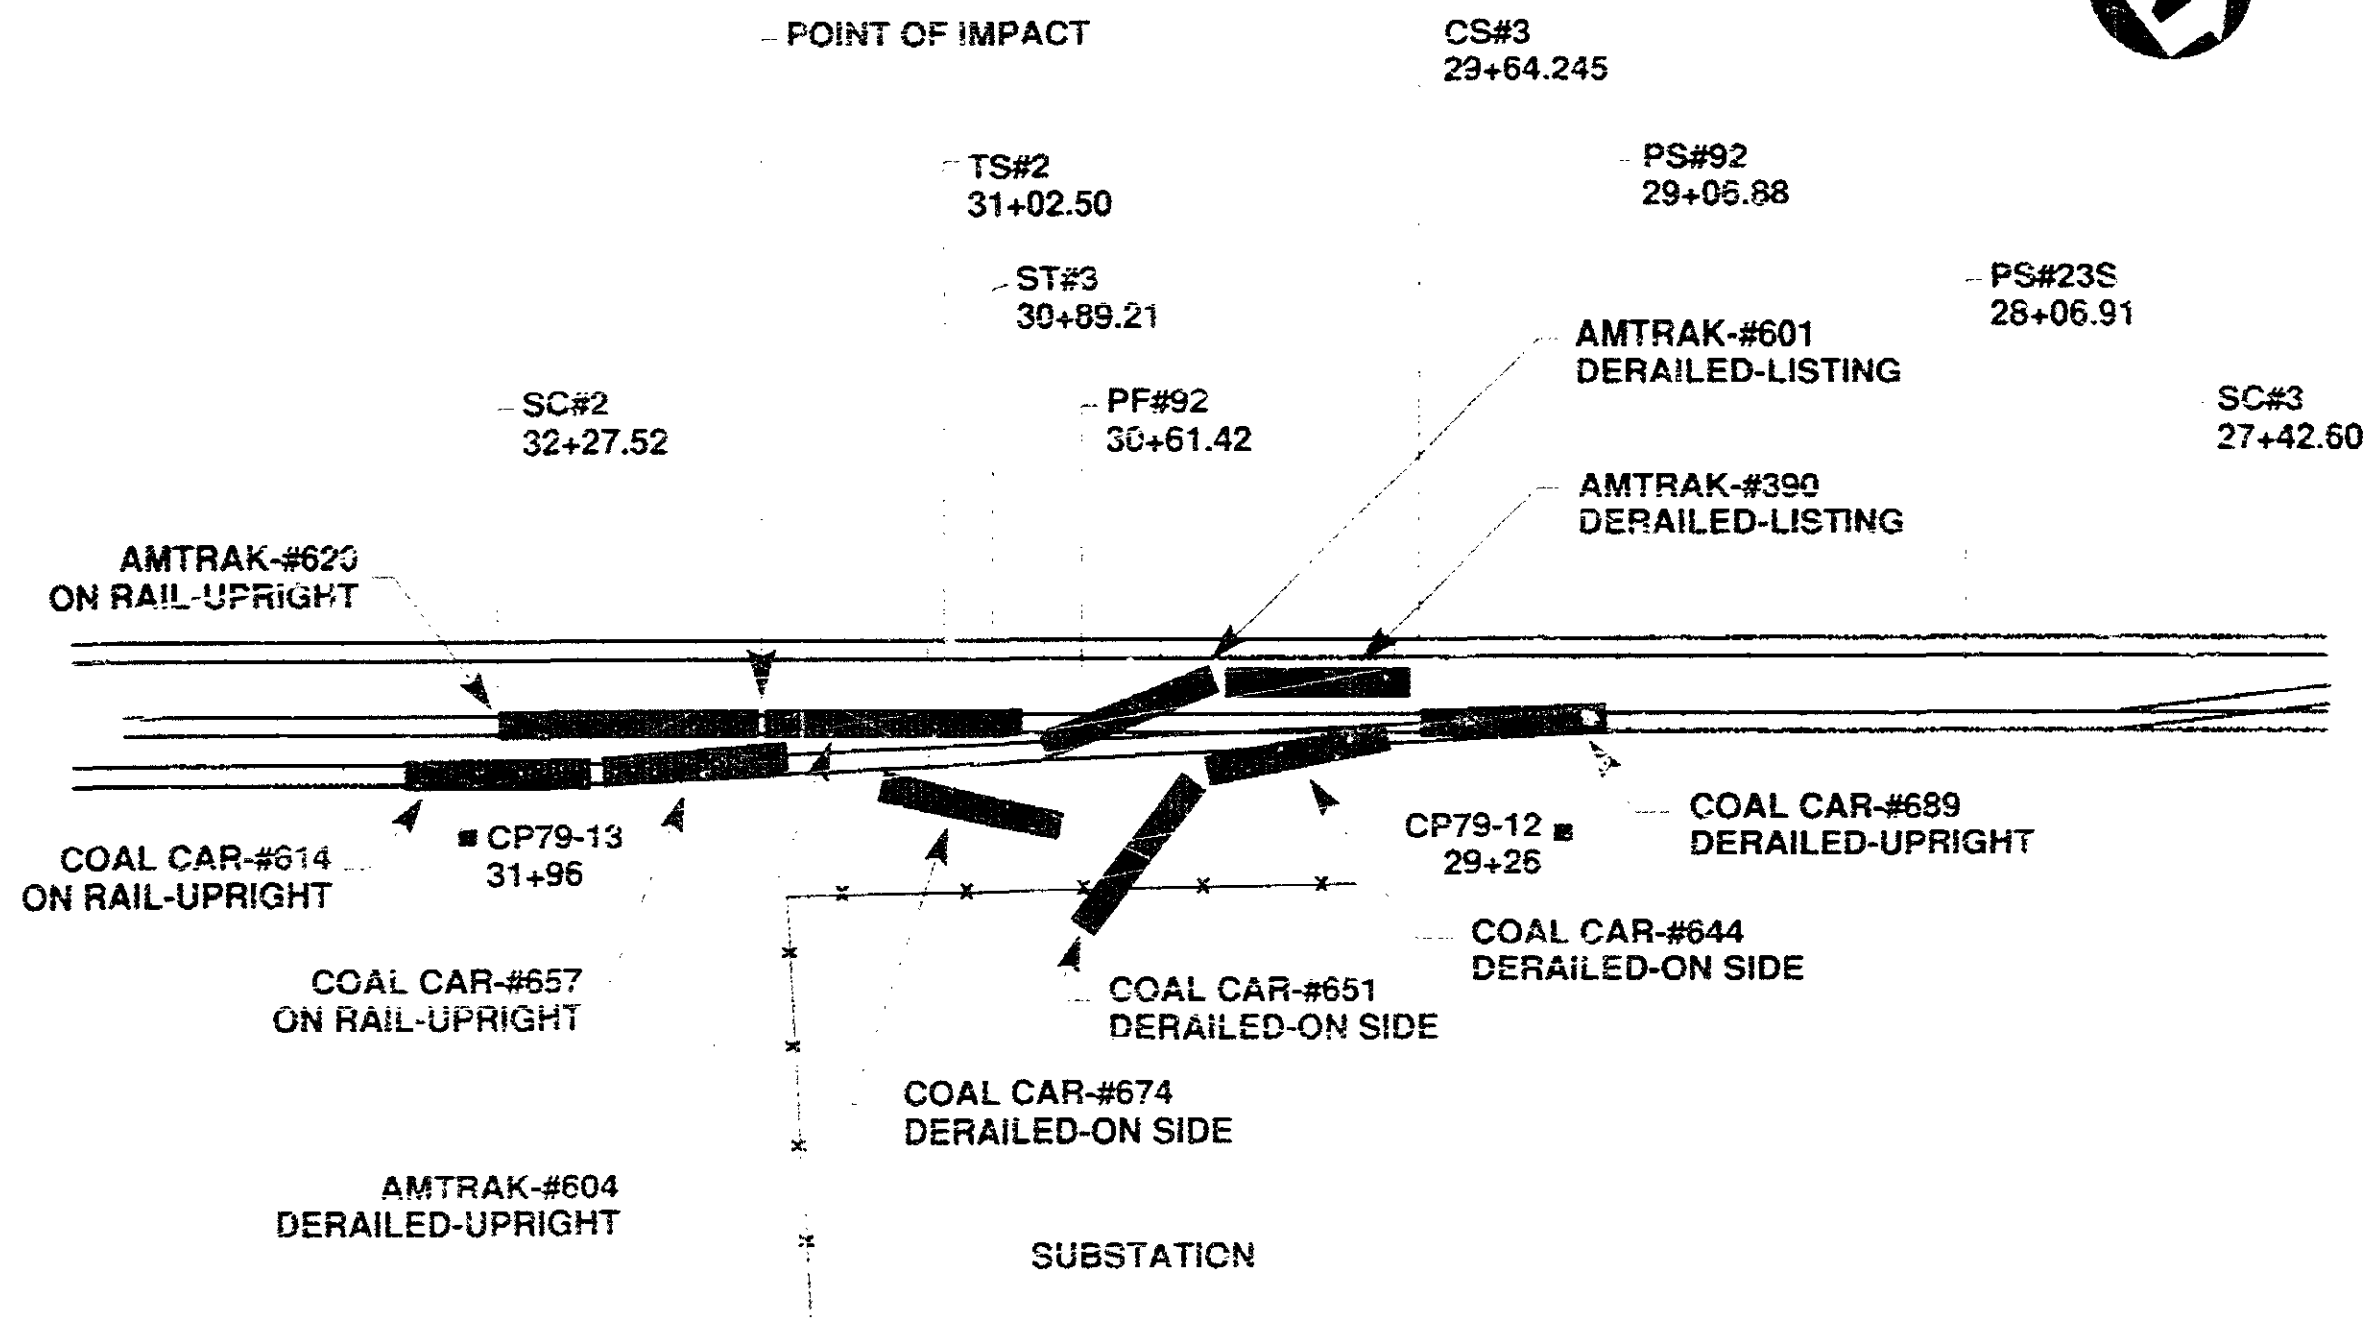
Figure 2.--Identification of derailed equipment.

According to the signal event recorder at Gunpow interlocking, signal 3S had been cleared for a southbound Conrail coal train (UMP-22B) at 0303. Amtrak Extra 390 North entered the northbound approach circuit on track 2 at 0306. The coal train entered the interlocking at 0307 with a route aligned from track 3 southbound through crossover 23 and switch 92 reversed to track A. Switch 12 was aligned against a northbound move. Extra 390 North proceeded north on track 2 through switch 12, striking the coal train. (See figure 1.) Amtrak Extra 390 North struck the moving southbound train UMP-22B beginning at the 65th car, derailling 4 cars and damaging 2 others. (See figure 2.) At the time of the collision, train UMP-22B occupied all three tracks, and about 30 of its cars remained on track 3. The collision derailed the lead unit and the second and third trailing units of Extra 390 North; the locomotive cab compartment of the lead unit sustained extensive damage.

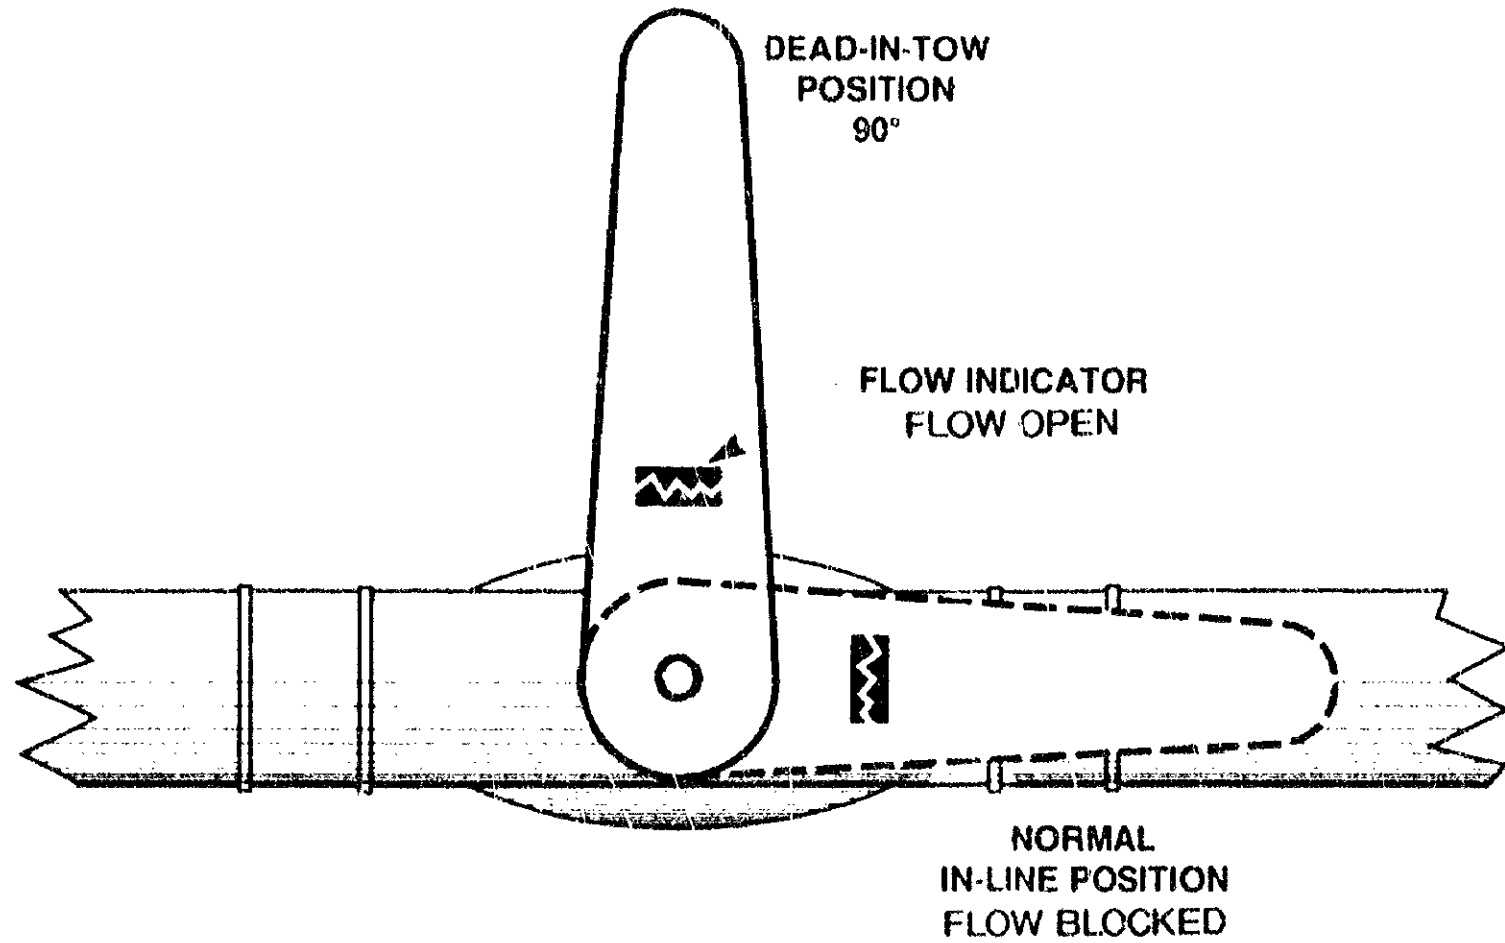
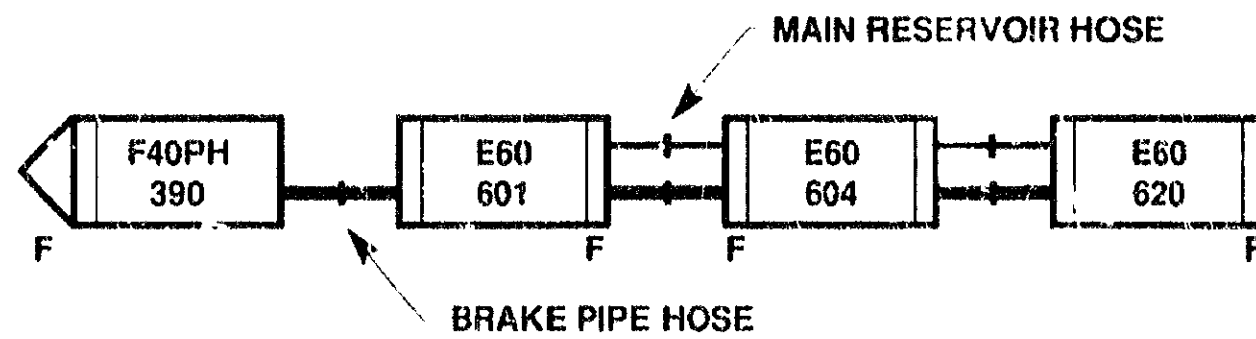
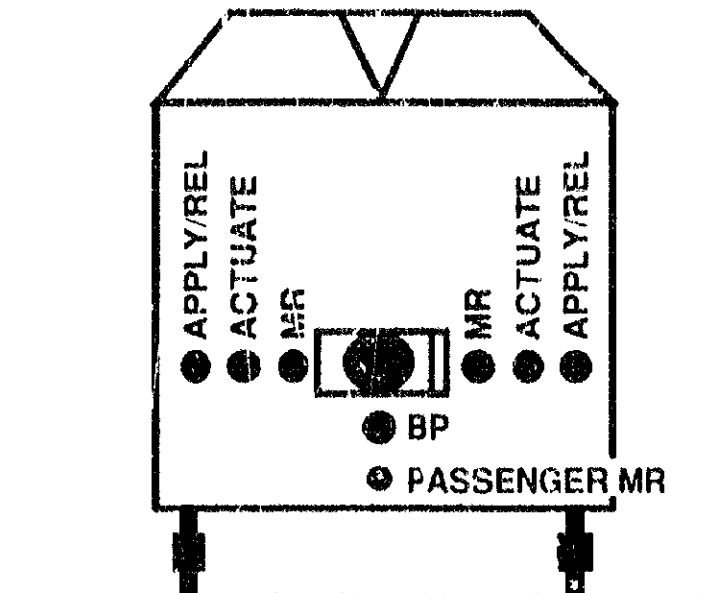
Figure 3.--Dead-in-tow engine feature and brake hose arrangement, Extra 390 North.

Following the accident, Safety Board investigators examined Amtrak Extra 390 North. They found that the main reservoir hose connection between the lead unit and the second unit had not been made and that both cutout cocks,² which control the flow of compressed air to the main reservoir system, were closed. As a result, the airbrake system was not providing full braking capability to the locomotive consist, and Extra 390 North was unable to reduce speed and stop at the "STOP" signal.

- (1) Brake pipe hose (trainline) connected: the dead-engine feature must be placed in the dead-in-tow (handle perpendicular to the pipe) position.
- (2) Main reservoir hose connected (cutout cock open): the units may be operated normally, with the dead-engine feature in the normal in-line position. (See figure 3.)

In accordance with this rule, the dead-engine feature on the E-60 units of Extra 390 North should have been in the dead-in-tow position. In other words, because the main reservoir hose connection between the lead and second units had not been made, the dead-engine feature should not have been in line.
