# **NATIONAL TRANSPORTATION SAFETY BOARD**

## **RAILROAD ACCIDENT REPORT**

**COLLISION AND DERAILMENT  
OF UNION PACIFIC RAILROAD  
FREIGHT TRAINS 5981 NORTH AND 9186 SOUTH  
IN DEVINE, TEXAS  
ON JUNE 22, 1997**

**Adopted: May 19, 1998  
Notation 6889A**

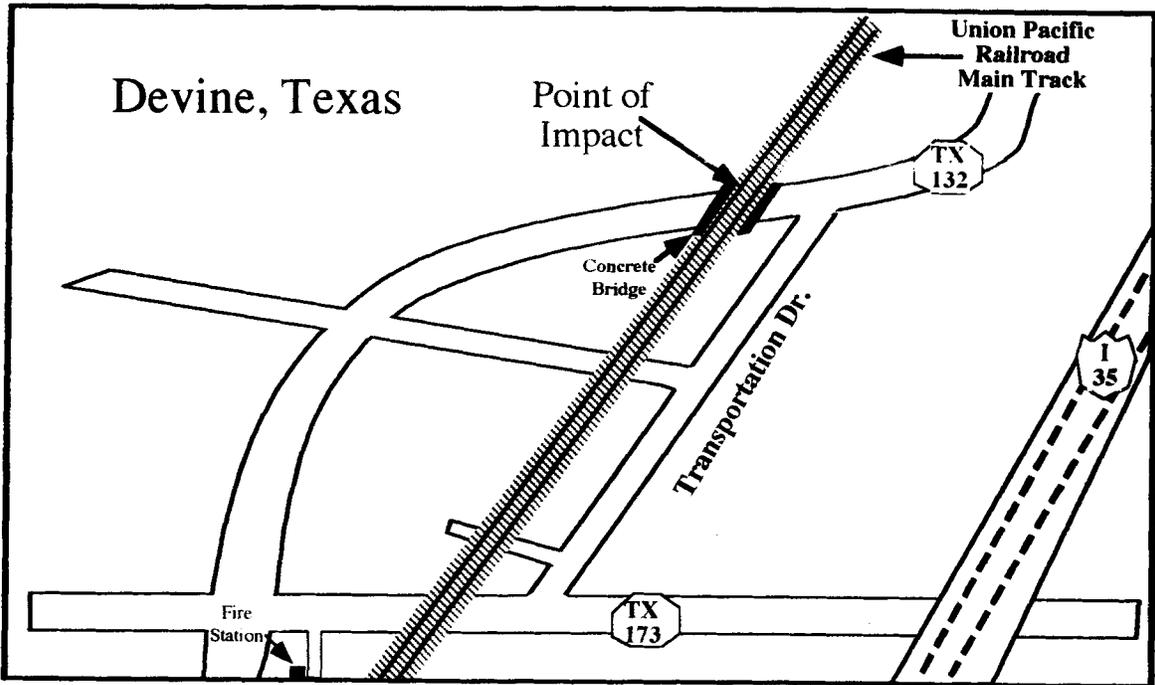
Figure 1—Point of impact between trains 5981 North and 9186 South at Devine.

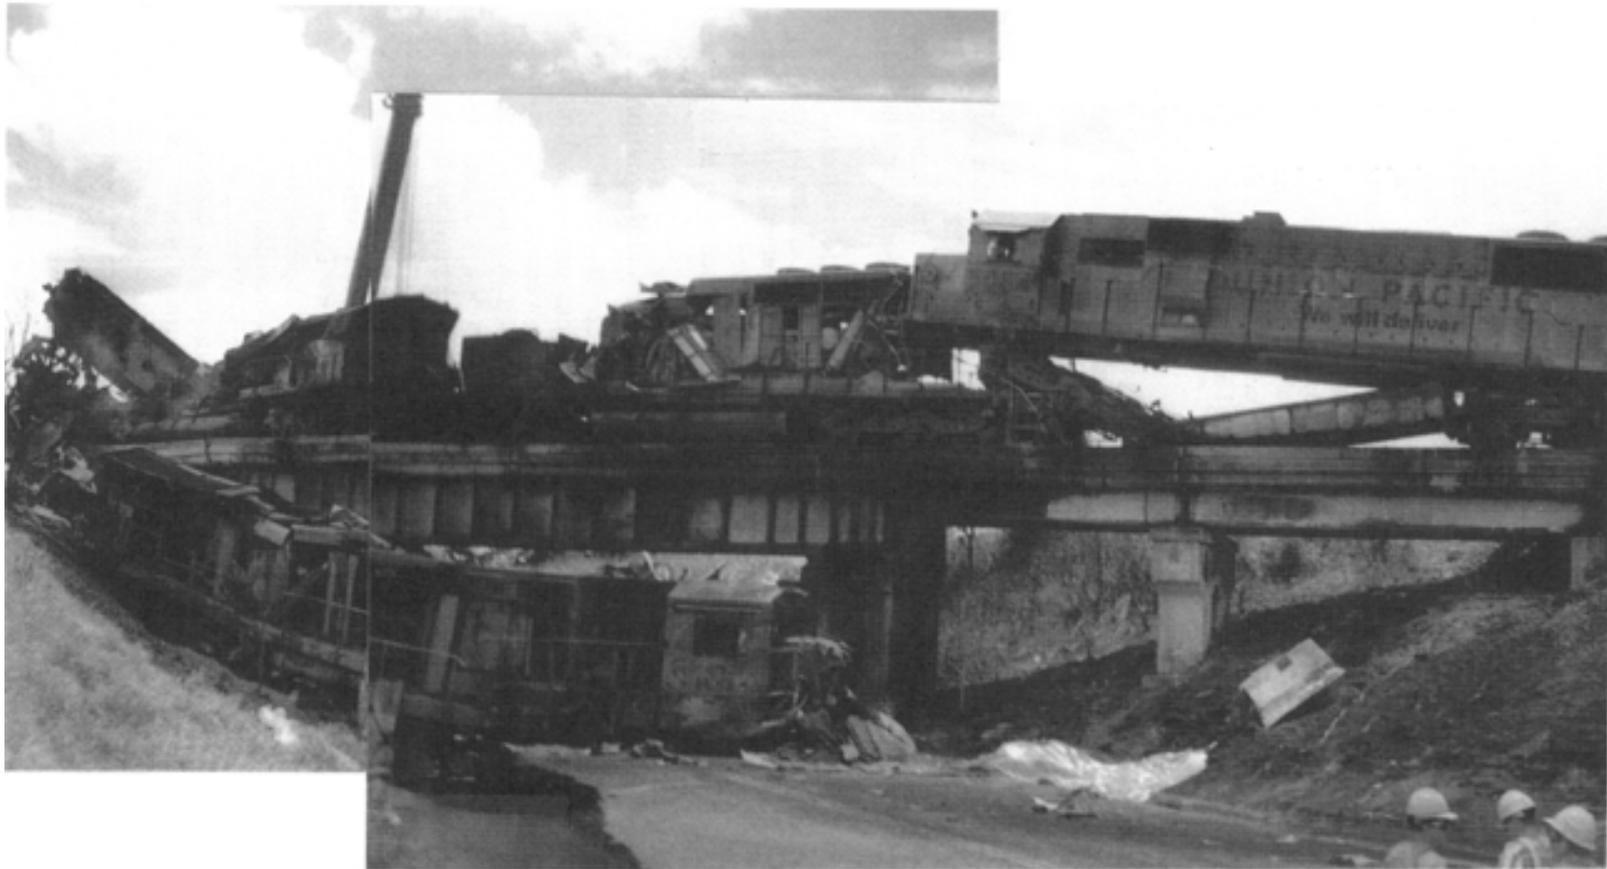
**Train 5981 North** -- The lead locomotive unit UP5981 exhibited massive catastrophic structural damage; the short-hood structure, cab assembly, and electrical cabinet were effectively sheared off horizontally at the top of the frame assembly deck plate surface. The diesel engine was found to have been displaced aft about 8 feet, and the main generator had separated from the engine. The frame had bowed downward, displaying a bend estimated at 1 foot. The remaining car body (sheet metal) was heavily deformed, and the entire unit had been consumed by the fire.

The trailing locomotive unit UP4211 also exhibited massive damage; the cab assembly and electrical cabinet were found to be sheared off level with the top deck of the short-hood structure, which remained relatively structurally undamaged. The car body (sheet metal) and internal machinery on the aft-end of the unit were compressed in a forward direction, having been contacted by the third locomotive in the consist, which overrode this unit. Approximately one-third of the front of the unit exhibited fire damage.

The trailing locomotive unit UP5084 overrode the aft-end of the succeeding unit and came to rest with its lead-end resting on top of the frame of the locomotive in the number two position. The leading truck assembly had detached from its mounting and was wedged between the two locomotive structures. The trailing truck remained attached. The fuel tank was detached from its normal mounting position and came to rest on the ballast beneath the unit. The locomotive, which exhibited fire damage on its exterior surfaces, was the least damaged of the units involved.

Figure 5 - Photograph of trains 5981 North and 9186 South after impact.

**Train 9186 South** -- The lead locomotive unit UP9186 traveled down the northwest embankment slope and landed upright on the road, approximately parallel to the bridge, with the aft-end of the unit resting on the northwest embankment slope. The unit lost its front truck assembly, exhibited inward deformation to its front pilot plate and short-hood structure, and was consumed by the fire. The cab structure remained intact and was not crushed by the impact.

The trailing locomotive unit UP6143 fell toward the pavement on the east side of the bridge, landed cab-end down, and oriented slightly on its right side on top of derailed freight car wreckage, with the aft-end raised up and the left side resting on wreckage that remained on the bridge. The front truck assembly had separated, and the fuel tank showed massive deformation damage. The front pilot plate and short-hood structure were substantially deformed inward; the cab remained structurally intact. The remainder of the unit exhibited extensive car body panel (sheet metal) deformation, and the entire unit was consumed by the fire.
