# NATIONAL TRANSPORTATION SAFETY BOARD

## RAILROAD ACCIDENT REPORT

COLLISION OF  
NORFOLK SOUTHERN CORPORATION TRAIN 255L5 WITH  
CONSOLIDATED RAIL CORPORATION TRAIN TV 220  
BUTLER, INDIANA  
MARCH 25, 1998

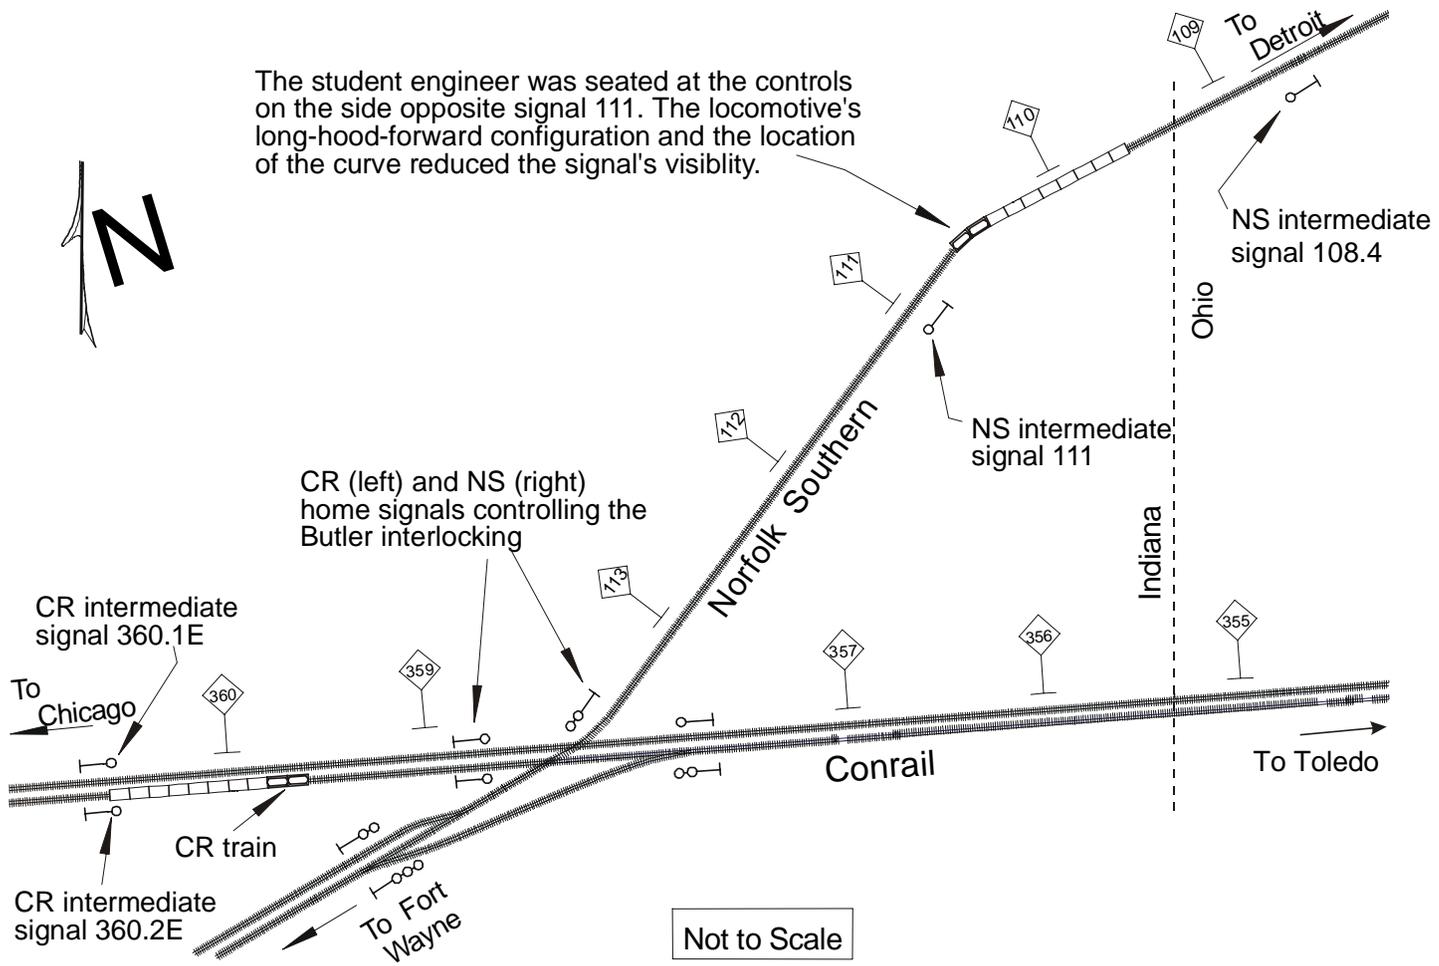
**Figure 4.** Conrail (CR) and Norfolk Southern (NS) signals in area of Butler interlocking

**Norfolk Southern**—Postaccident signal testing was conducted to determine the aspects for the intermediate signals preceding Norfolk Southern home signal 113.9 as the Norfolk Southern train approached the Butler crossing. (See figure 4.) The tests, which included signals 108.4 and 111, found that the proper codes were being transmitted to signal 111 from the electronic track circuit unit at Butler interlocking (Conrail CP 358). When tested, the signal system transmitted codes in a logical progression and displayed signal aspects that were not in conflict with each other. Further, tests indicated that the proper codes were being transmitted to signal 108.4 from the electronic track circuit unit at signal 111 under all conditions. When signal 111 displayed a yellow, or approach, aspect, signal 108.4 displayed a green, or proceed, aspect. When signal 111 was dark, signal 108.4 downgraded to a yellow, approach, aspect. Crew interviews and recorded radio conversations between the student and dispatcher indicated that signal 108.4 displayed a green, proceed, aspect when the Norfolk Southern train went past it on the day of the accident.

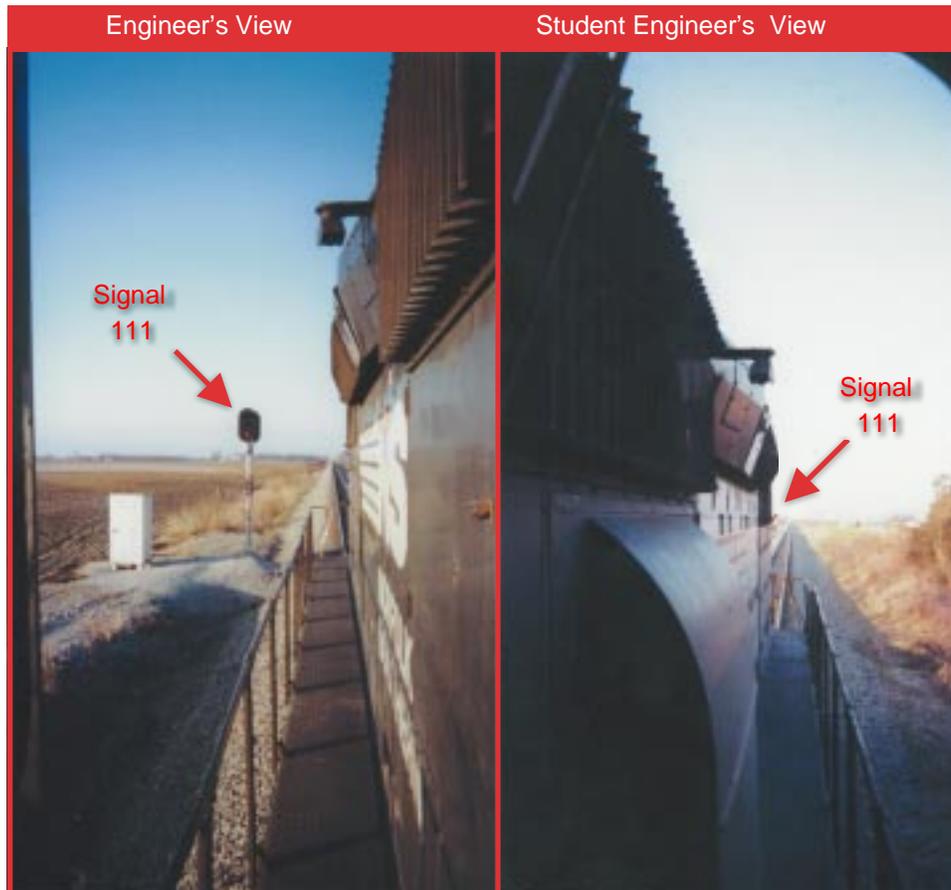
**Figure 5.** Signal 111 at last viewing point from left and right sides of cab on a locomotive configured with the long hood forward

when it is being operated in this mode, as shown in figure 5. The student told Safety Board investigators that he had never been formally trained in long-hood-forward operation and had operated in this mode only once before, on a trip with the same crew from Peru, Indiana, to Detroit, Michigan, that concluded the day before the accident.

Signal malfunction reports indicated that signal 111 had been reported on two different occasions as downgrading from a yellow, approach, aspect to a dark aspect as trains approached it. Following the first reported dark signal on February 19, 1998, the Norfolk Southern signal maintainer responsible for the territory responded to the call and reported that signal 111 was working properly. Because the cause for the malfunction could not be determined, the signal maintainer installed a signal event recorder card so that the signal log could be downloaded later and checked for abnormalities in the signal's operation. However, Norfolk Southern personnel did not download the log.

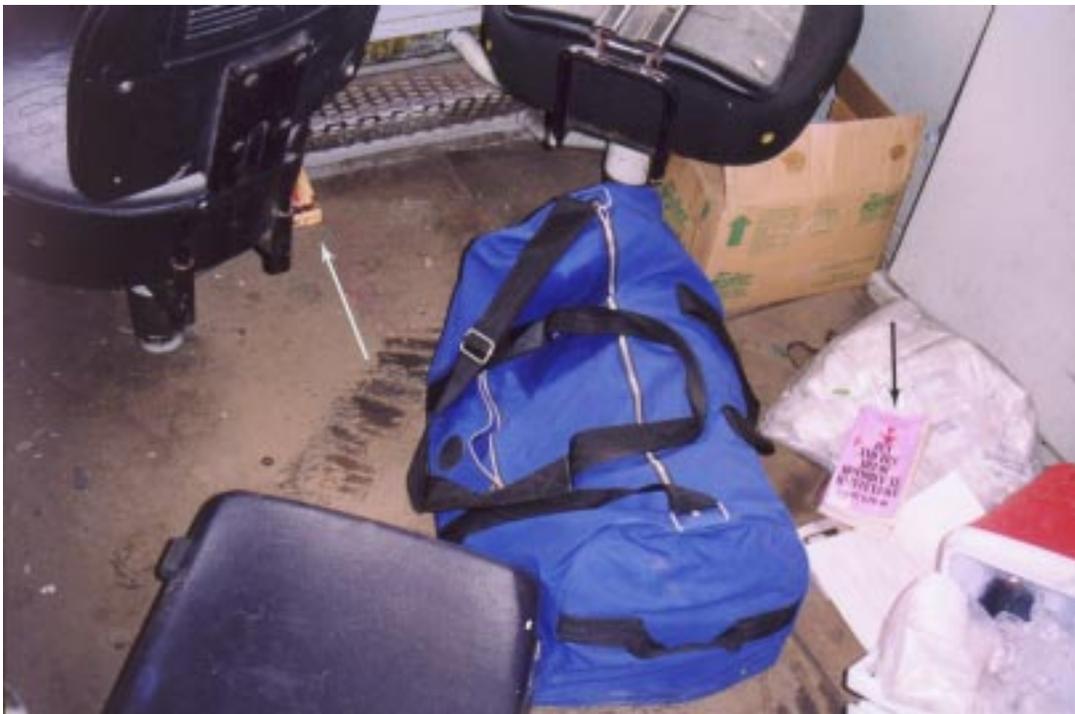
**Figure 6.** Books on floor of lead locomotive

In postaccident interviews with the Safety Board, the student engineer said that the engineer and conductor both started reading what he thought were paperback books shortly after 3:00 a.m., about 30 minutes after departing Detroit. Two paperback books<sup>14</sup> were found on the floor of the lead locomotive after the accident. (See figure 6.) The student engineer also said that about 30 minutes to an hour before the collision, the conductor or the engineer turned off the overhead light on the left side of the control compartment. The student said that he left the light on above his position to better observe the controls. The student was unsure how long the light was out on the other side of the cab, stating “It could have been a half hour, it could have been an hour. I don’t know.” He said that during the time the light was off, he did not talk to the engineer or the conductor or hear them talking to each other. He was unable to state with certainty whether the engineer or the conductor was asleep while the light was out, only that no communication occurred between crewmembers during that time.<sup>15</sup>

In postaccident interviews with the Safety Board, the engineer admitted to reading, stating, “I had a paperback book that I was looking at back and forth.” The engineer was unable to explain how or why he missed signal 111 but, while he was at the hospital undergoing treatment, told the Norfolk Southern division superintendent that he recalled

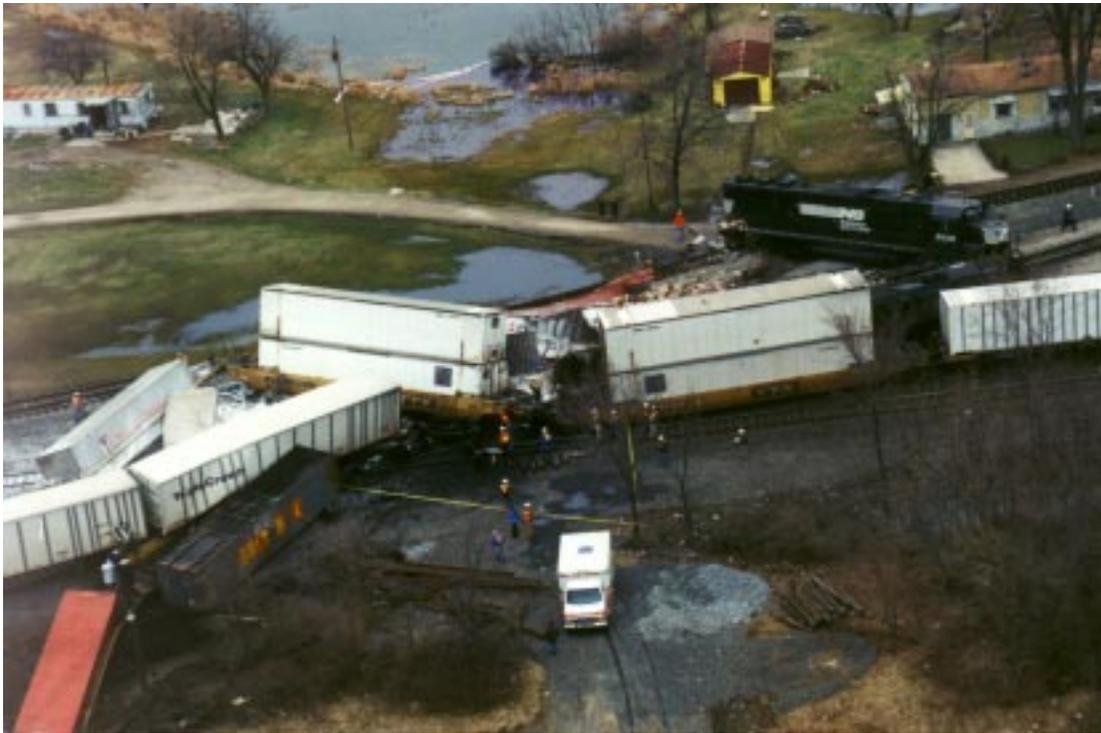
**Figure 7.** Point of impact

About 4:48 a.m., the Norfolk Southern train, traveling at a recorded speed of 30 mph, struck the Conrail train. The lead Norfolk Southern locomotive derailed, remaining upright but facing east, while the trailing locomotive rolled over on its right side. Both Norfolk Southern locomotive cabs remained intact with only minor damage to the left side window of the lead unit, resulting in survivable space in both cabs. Both locomotive fuel tanks ruptured,<sup>19</sup> releasing about 7,000 gallons of fuel oil. The first through the fifth cars of the Norfolk Southern train derailed; the first four cars were completely destroyed. Norfolk Southern estimated total damages of \$264,000 (\$187,000 to equipment, \$18,000 to track and signals, and \$59,000 to cargo).

The Norfolk Southern locomotives passed completely through the sixth car of the Conrail train. Three of the cars from the Conrail train derailed, one of which was a five-unit articulated car. (See figure 7.) Conrail estimated total damages of \$352,200 (\$314,000 to equipment, \$33,500 to track and signals, and \$4,700 to cargo).

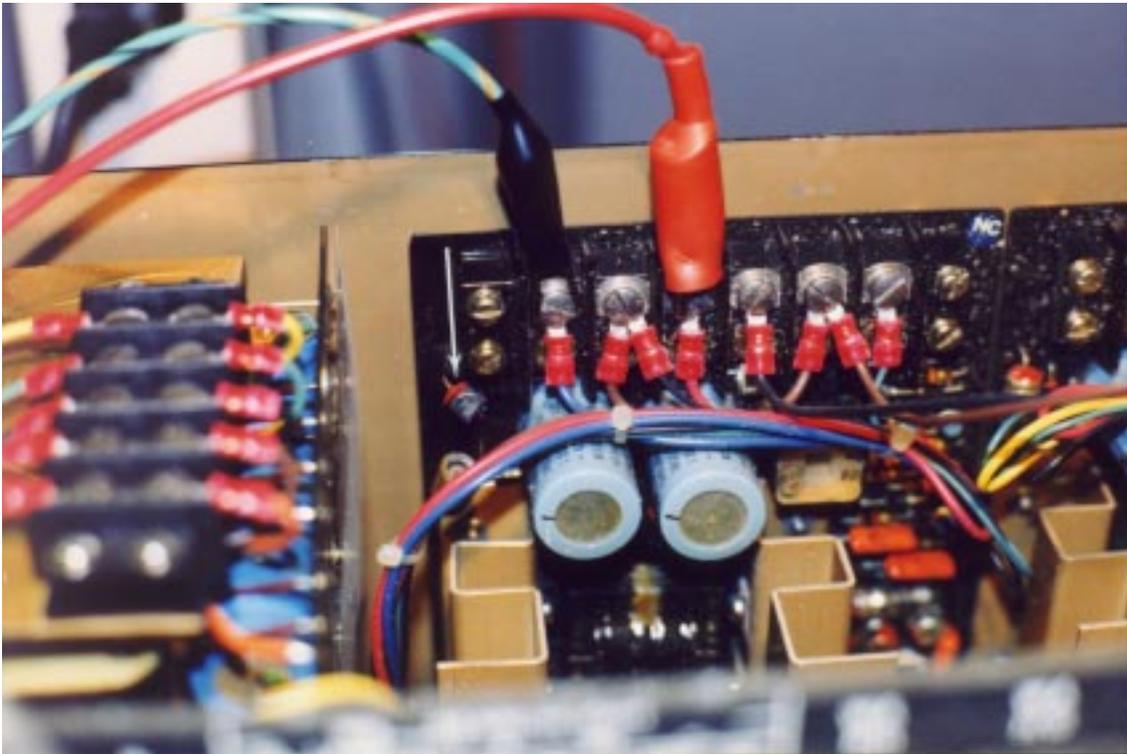
**Figure 8.** Failed capacitor (*at arrow*) from MP 111 Electro Code unit

Signal 111 was observed going dark at random intervals during the postaccident investigation; consequently, the Electro Code 4 unit containing the lighting module was removed and bench tested. Bench tests identified failed internal aluminum electrolytic capacitors<sup>27</sup> that caused the signal to go dark for 10 to 24 seconds. (See figure 8.) This failure did not cause the signal to show any other inappropriate aspect, such as a less restrictive signal aspect. Norfolk Southern operating rules require that engineers treat a dark signal as the most restrictive aspect possible for that signal, which in the case of signal 111 is a restricted signal, meaning that the train could proceed at a restricted speed.

The investigation further revealed that the signal data recorder<sup>28</sup> at MP 111 was affected by the failed capacitors. The device recorded events despite no physical changes occurring in the operational status of the signal location, thus rapidly filling the memory buffer and overwriting older recorded events, including events that occurred at the time of the accident.

Field inspections of other Harmon Electro-Code 4 units in the Lake Division found evidence of capacitor failures on the 212A modules manufactured from 1987 to 1988. On May 15, 1998, Harmon Industries issued product improvement announcement PIA 98-101 detailing the failure of the capacitor and explaining how to exchange the 212A module for a replacement. (See appendix A.) By the time Harmon issued this announcement as a result of the failures at signal 111, the faulty unit at signal 111 had been replaced. The company also offered components and modification instructions to railroads preferring to and capable of making their own modifications.

The investigation revealed that the failed capacitors were on an electronic unit not accessed during required maintenance tests and inspections. Thus, a signal maintainer would either have to observe the signal failure or receive a report of one to be aware of a problem.

Harmon Industries provided field technicians to aid Norfolk Southern in a systemwide program to identify and replace all modules manufactured from 1987 to 1988.
