**RAILROAD/HIGHWAY
ACCIDENT REPORT**

ILLINOIS CENTRAL RAILROAD COMPANY

Train No. 1 Collision With Gasoline Tank Truck At

Loda, Illinois, January 24, 1970.

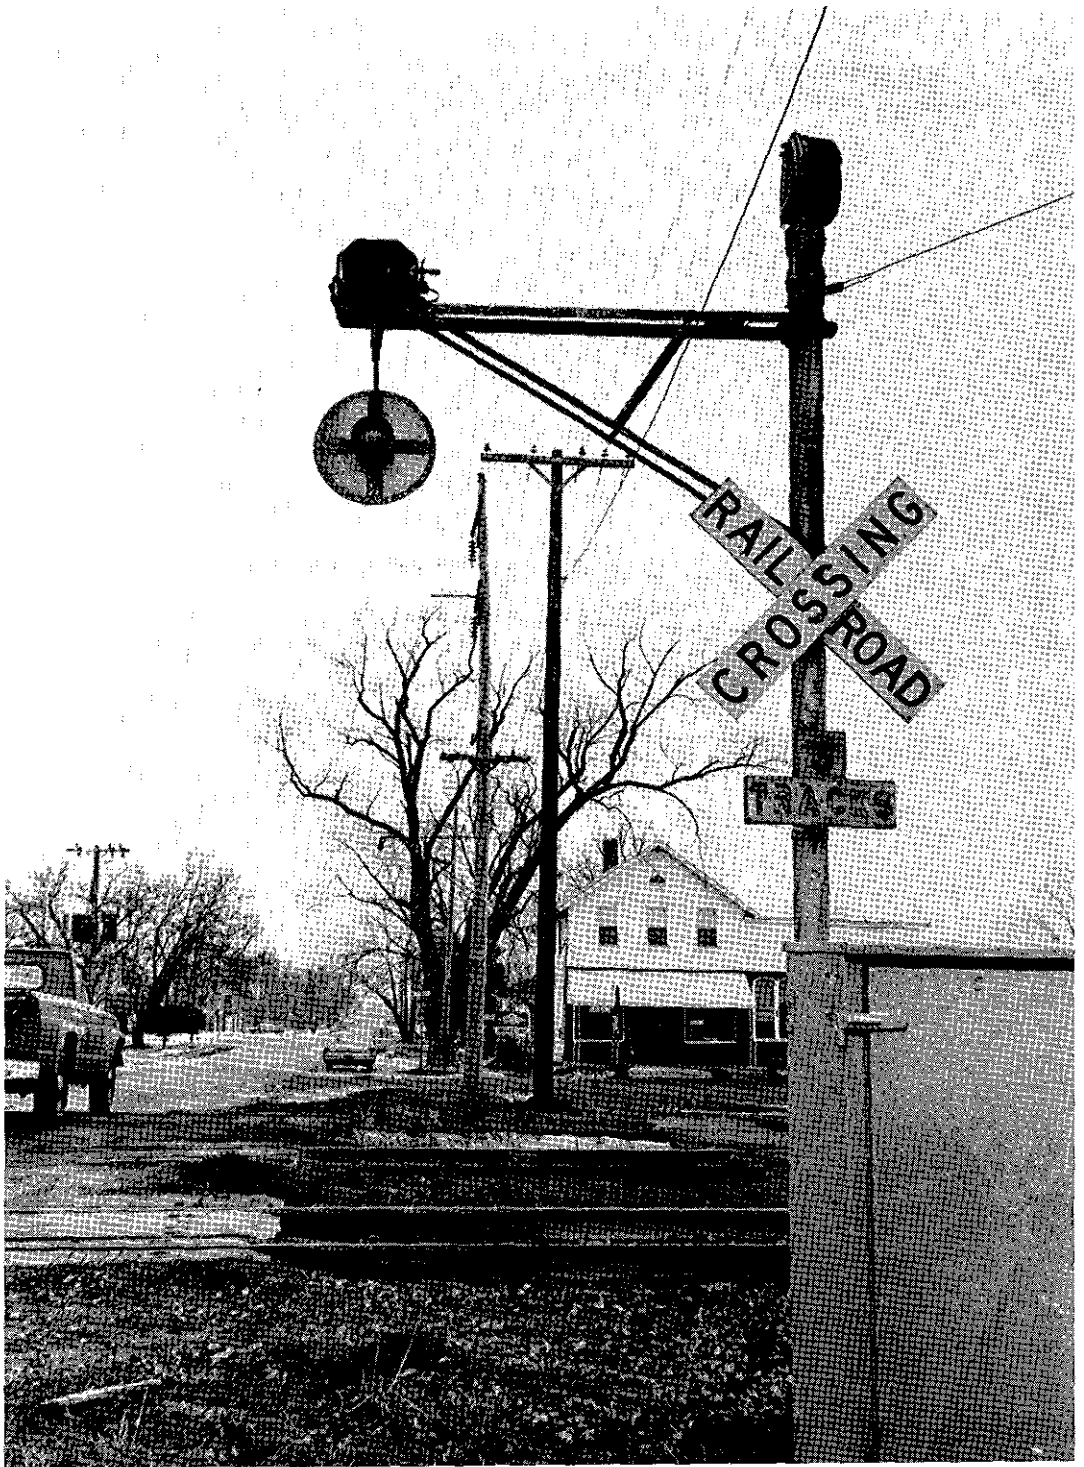
FIGURE 2

crossarm, and it was located in the northeast quadrant of the crossing, 11 feet north of the paved surface of the roadway. A warning bell was mounted on top of the mast. A multiple-track sign and a crossbuck warning sign were attached to the mast, 6 feet 11 inches, and 9 feet 11 inches, respectively, above the ground. A wig-wag banner, 20 inches in diameter, was suspended from the crossarm. The banner, a white, circular, metal disc with a black cross and border, was located 10 feet 11 inches above the ground and swung in an arc 30 inches in length parallel with the tracks. A light contained between two red lenses, 6-3/8 inches in diameter, was mounted in the center of the banner. This light illuminated the red lenses and could be seen on each side of the crossing. (See Figure No. 2) The signal was installed April 9, 1927.

An inspection made of the automatic warning device the day following the accident disclosed that the light between the red lenses in the center of the banner was so dim that one had to look closely during daylight hours to determine whether the light was lighted. It was observed that the paint on the banner was worn and faded. When operating, the movement of the banner through its 30-inch swing appeared short and was above the normal line of sight of the driver. The alarm bell was not loud and if there had been any distracting noise such as a running engine it would have been difficult to hear in an enclosed motor vehicle.

The design and worn condition of the automatic warning device was such that when the signal was operating during daylight hours it would not effectively attract the attention of an approaching motorist. Typical modern warning signals, used at other grade crossings and having bright alternately flashing red lights positioned at the level of the motorist's line of vision, are much more effective in providing attention-getting warning than the device described in this accident.

4 The Illinois Central Railroad and the town of Loda, Illinois, improve the grade crossing involved in this accident. Improvements should include an effective warning device capable of drawing the attention of highway drivers and conveying a warning of the approaching train, improved condition of crossing surface, and improved vision of track to approaching drivers.

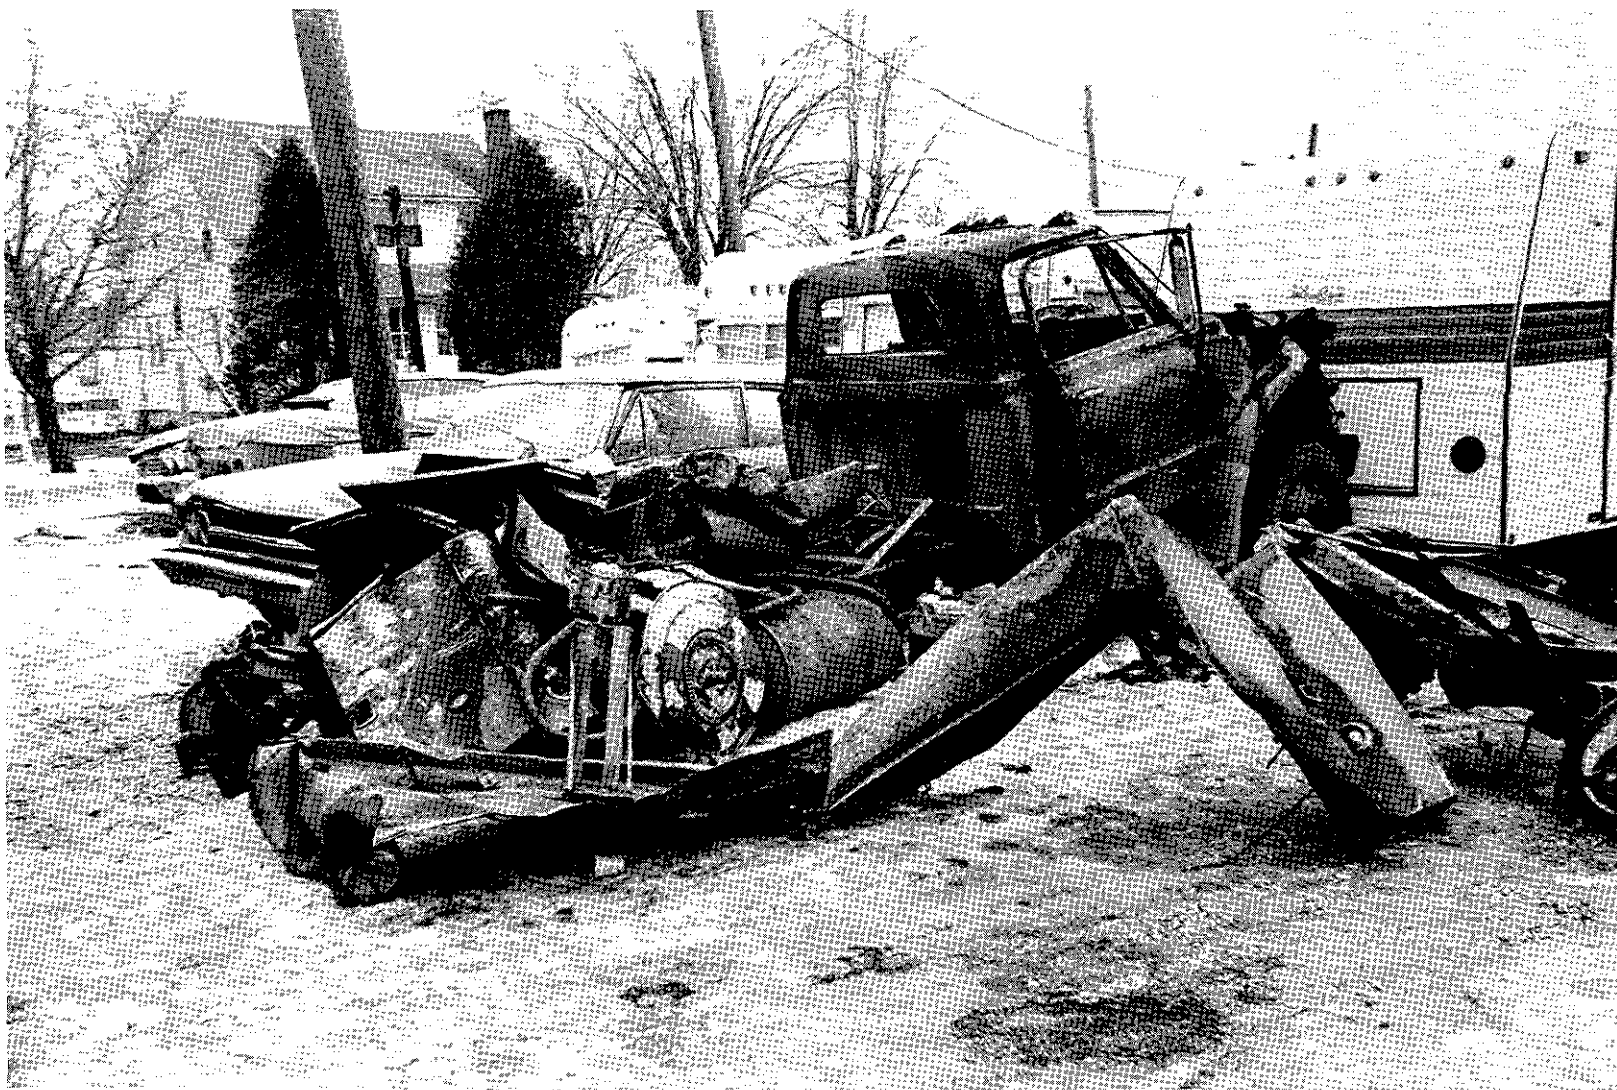
The locomotive struck the right side (north side) of the truck at about the center of the tank. The motortruck cab and part of the chassis were either carried, or hurled by the forces of the impact, to a point 85 feet south of the point of the collision. They came to rest along the west side of the business track. The motortruck rear wheels and cargo tank were separated from the chassis and were carried, or propelled by the force of the explosion and impact, south of the crossing and stopped along the west side of the business track. The rear wheels and axle and the cargo tank stopped 245 feet and 265 feet, respectively, south of the collision point. The motortruck and tank were completely demolished (See Figure No. 3).

FIGURE 3
Photo showing right side of motortruck after it had been moved from accident point.

The design of the vehicle did contribute to the severity of the injuries to the driver and to the occupants of the locomotive. The tank ruptured on impact and separated from the vehicle. Large quantities of fuel were propelled through the rupture and sprayed over the truck cab and the locomotive. The tank was not provided with material to limit the flow of a commodity in the event of a container rupture. Such techniques as filling tanks with special reticulated foam are technically effective in preventing the rapid discharge of liquid from a ruptured tank. The locomotive struck the truck at about the center of the tank which completely destroyed the tank and the rear portion of the vehicle. The force of the impact caused the front of the truck to turn northward and strike the locomotive. The structural integrity of the cab, however, was not violated by the collision. (See Figure No. 3)
